MEMORANDUM

DATE: May 17, 2019
RE: 100 Duchaine Boulevard, Parallel Products, DEP# SE49-0771, Raingarden

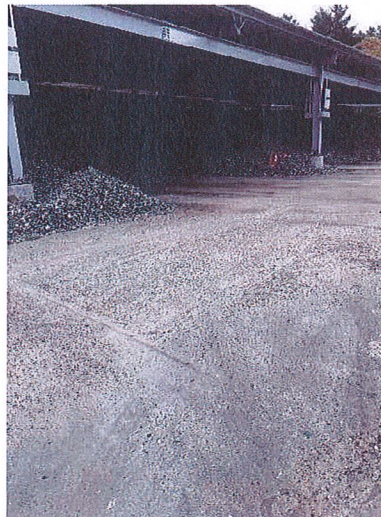
- 1.) The area beneath the solar panels contains a significant amount of stockpiled glass that is mixed with sediment. Some of the sediment has been tracked onto the pavement in the parking area located underneath the solar panels. This pavement drains towards the access driveway and rain garden. The pavement needs to be swept regularly to limit the amount of sediment that is transported down the driveway and towards the raingarden.

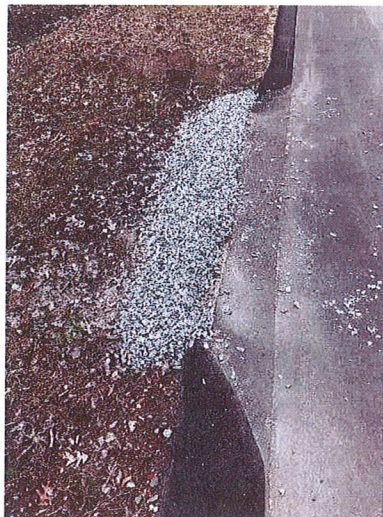
- 2.) The stone located at the inlet to the raingarden appears too small and was placed above the elevation of the inlet from the access driveway. It appears to be restricting water from flowing into the raingarden from the access driveway. We observed sediment along the edge of the access driveway where water appears to have settled.

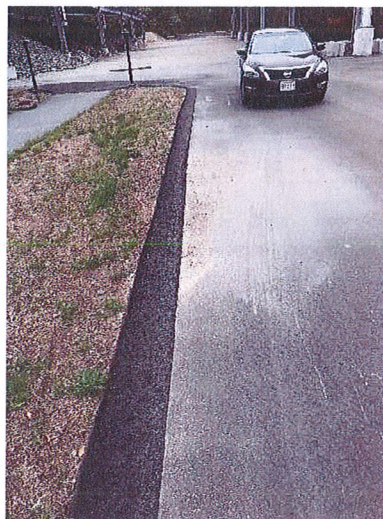
- 3.) It is unclear whether the access driveway was graded properly. The as-built plan does not show grades along the driveway. Our recollection is the driveway was supposed to be superelevated to direct water towards the raingarden. There is sediment located along the edge of the access driveway opposite the raingarden. If the driveway were superelevated, sediment would not collect on the opposite side of the access driveway.

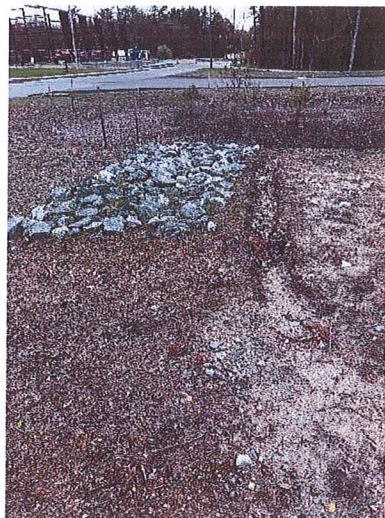
- 4.) The rip-rap overflow appears to have been set too high. There are no elevations shown on the as-built plan regarding the grading of the raingarden or the overflow.

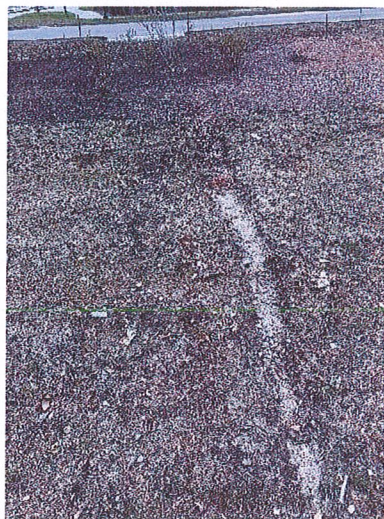
- 5.) There appears to be shallow “trenches” that were created on the south side of the rain garden. These “trenches” appear to be directing water from the raingardens to the wooded area located to the south of the raingarden. Since they appear lower than the rip-rap overflow, water that is collected in the basin never reaches the rip-rap elevations. (see pictures above and below)
