MEMORANDUM

DATE: May 17, 2019
RE: 100 Duchaine Boulevard, MIH1, LLC, DEP# SE49-0738, Sediment forebay

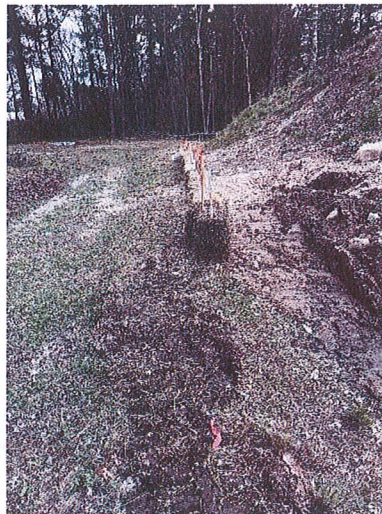
- 1.) Nitsch Engineering visited the site on May 10, 2019.
- 2.) The sediment forebay appears to be constructed consistent with the approved plans. We cannot verify the stormwater volumes described in the May 2, 2019 letter. However, the letter describes volumes significantly in excess of the approved volumes.
- 3.) There are haybales and other construction materials that are providing a sediment barrier on the upstream side of the forebay. We agree with generally maintaining these barriers to reduce the amount of sediment that enters the forebay.

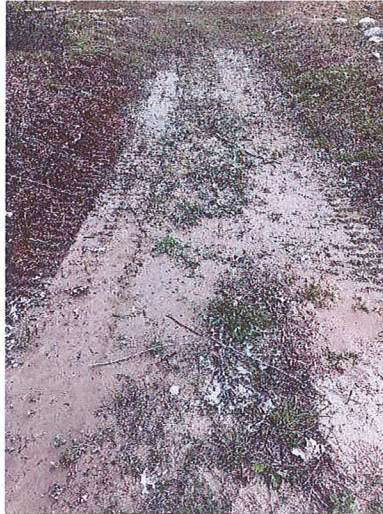
- 4.) There is evidence of significant amounts of silt being deposited in the forebay. The forebay is designed to collect sediment that would have otherwise discharged into the adjacent wetlands and is therefore working as intended. We recommend that the sediment be removed regularly to maintain the forebays volume and also allow infiltration to the maximum extent practicable.

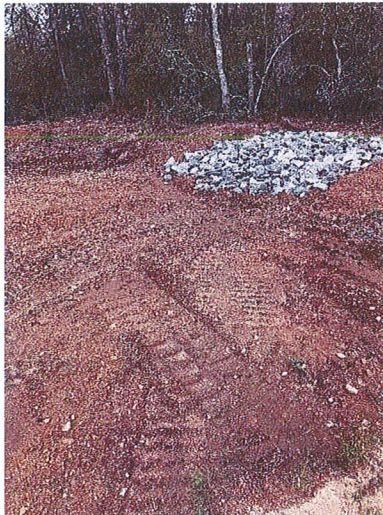
- 5.) There was evidence of construction vehicles moving within the forebay. This may have been necessary to install the rip-rap overflow. We recommend that the construction vehicle movement in the forebay be limited to prevent compaction of the forebay and allow as much infiltration as possible.

- 6.) Areas of the forebay require reseeding. (See above)
7.) We have no issues with the forebay as constructed. We recommend that regular maintenance be performed as described above.
