August 17, 2015  
Project No. 1998

**RE: NEW BEDFORD-LOGAL LLC**  
DEP File No. SE 049-0702 - Response to Amended Order of Conditions (OOC) and Construction  
Review Comments-100 Duchaine Boulevard

**WET BASIN 1 REMEDIATION EXHIBIT PLAN**  
**LOGAL, LLC**  
100 DUCHAINE BOULEVARD  
NEW BEDFORD, MASSACHUSETTS

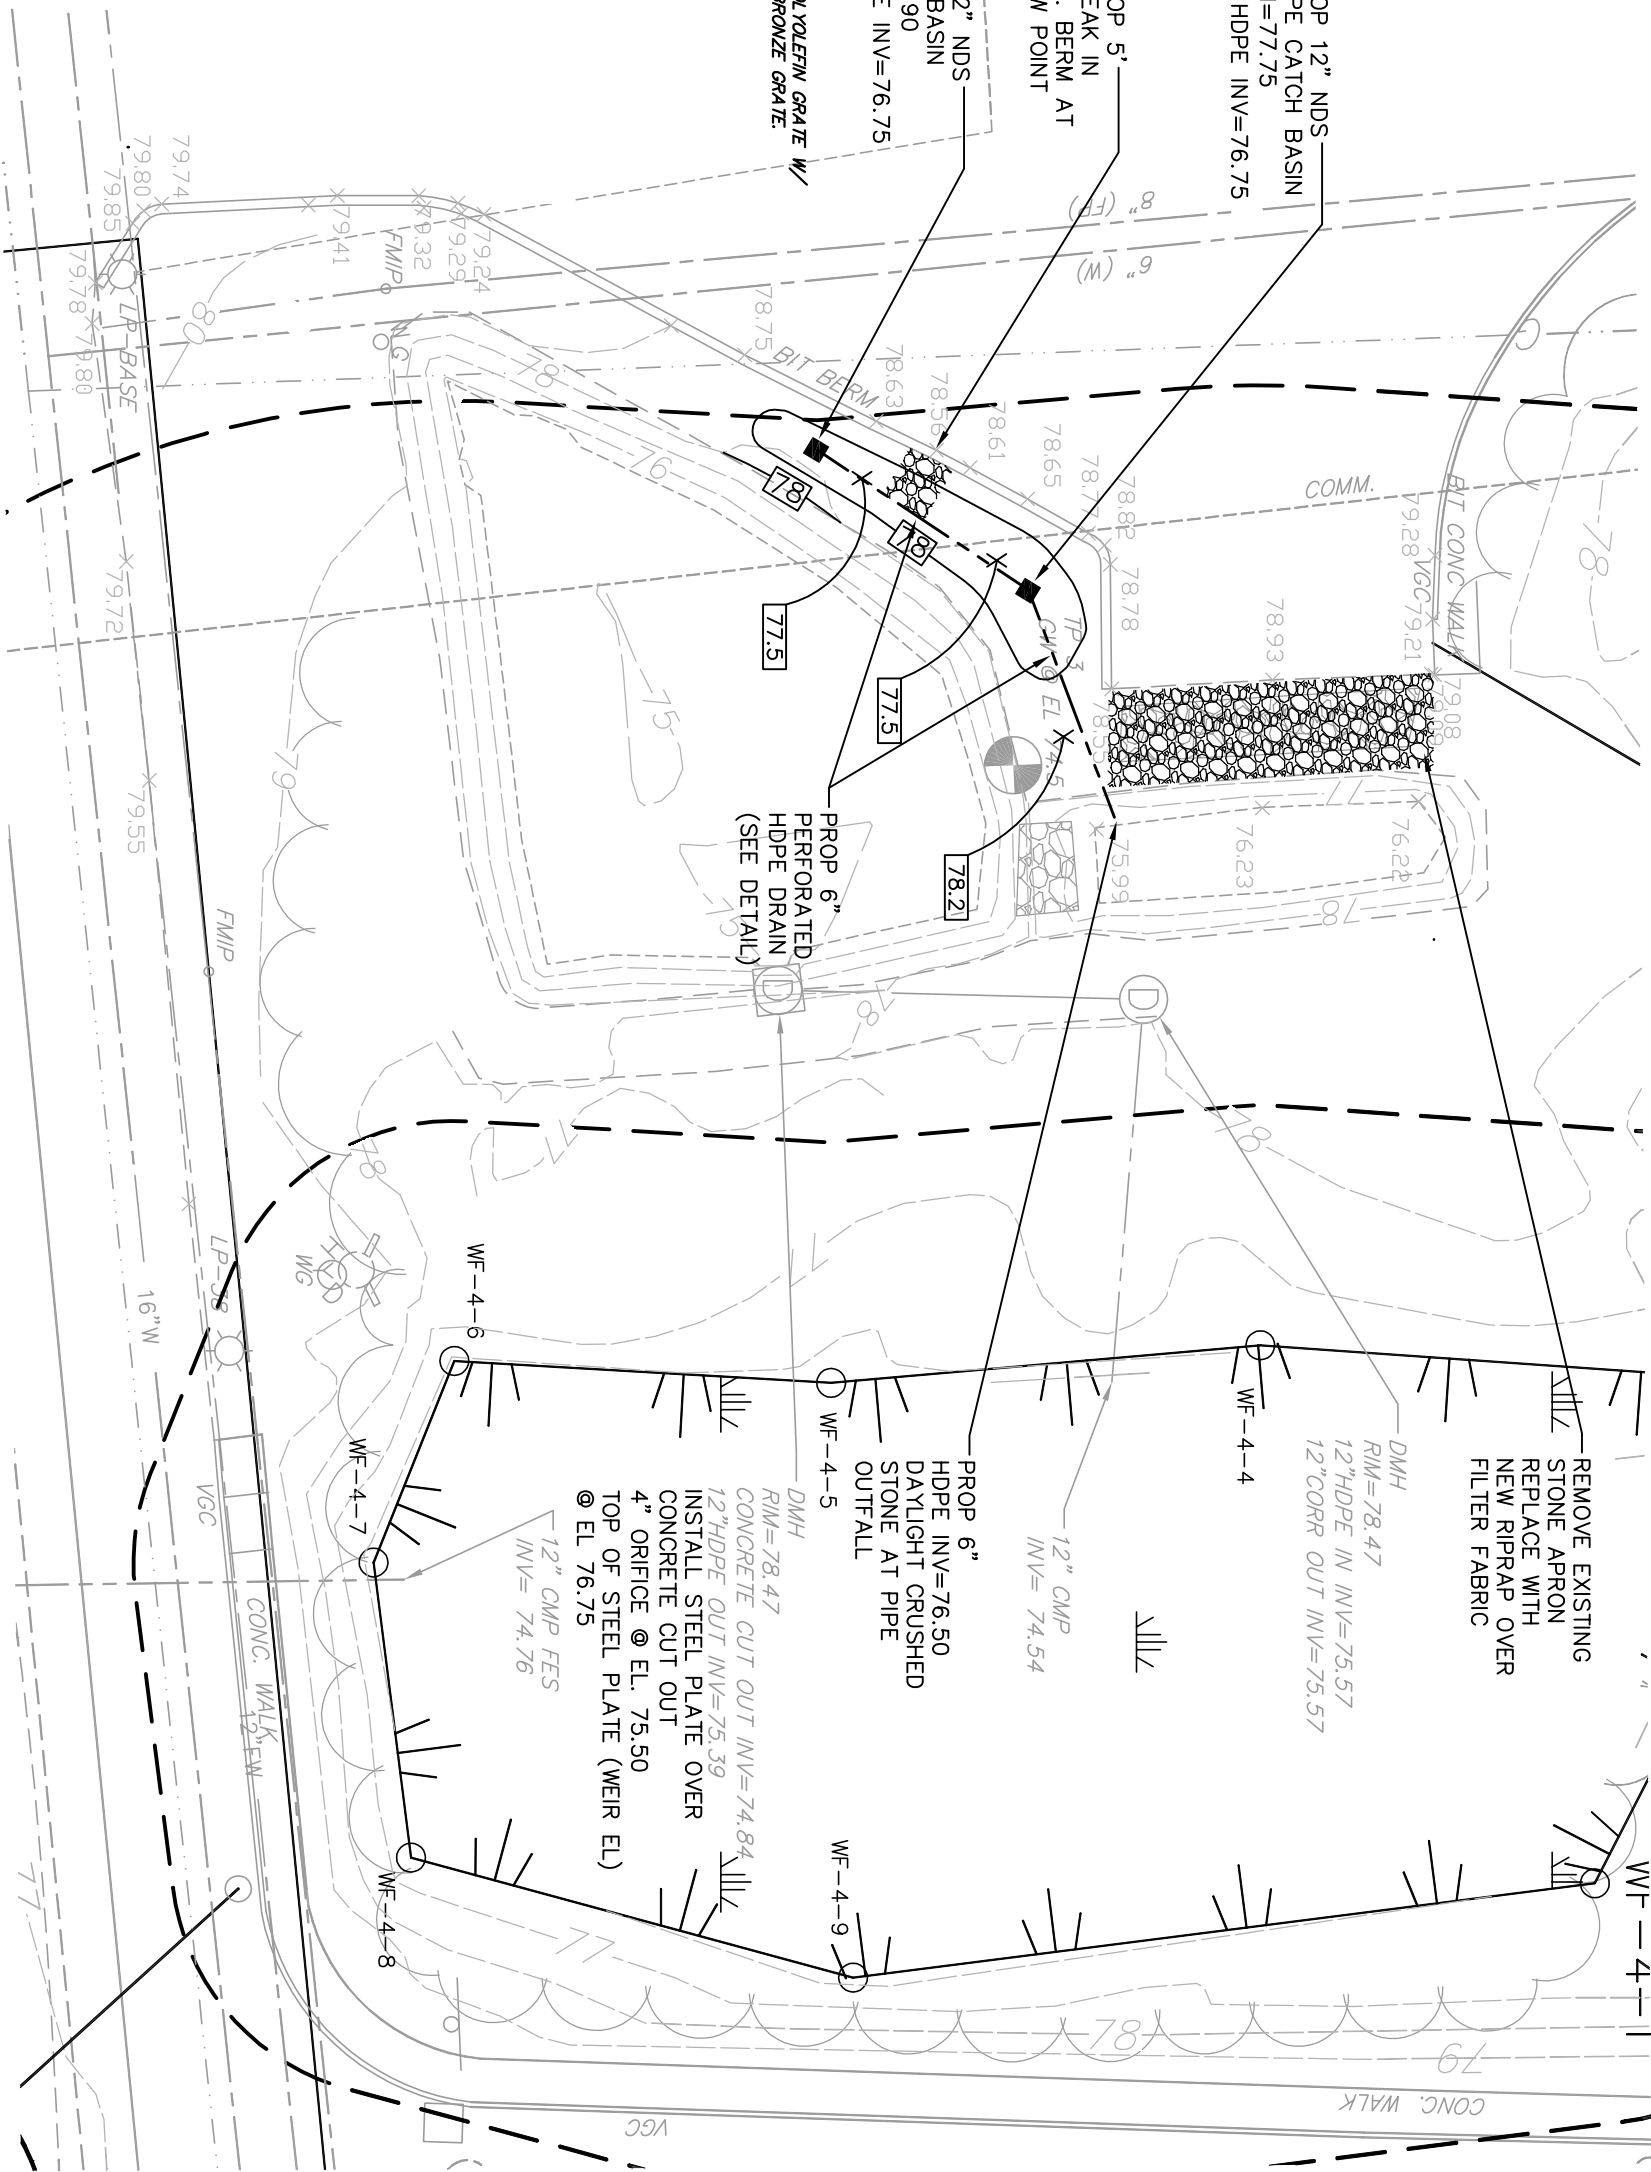
7. The side slopes of the wet basin appear to be too steep. The owners' representative indicated that they do not mow them because they are too steep. The side slopes should be checked to see if they are at the proper slope. Any areas of the side slopes that have experienced significant erosion need to be repaired.

condition and recommend additional solutions should erosion continue. The as-built data shows that wet basin 1 was constructed with steeper side slopes than recommended and less storage volume than originally proposed. We have reviewed the as-built hydrologic calculations of the basin with a slightly revised plate configuration on the outlet control structure and the wet basin will still function in accordance with the design plans (following installation of the steel plate) in meeting or reducing the rates of runoff to the subject Analysis Point. A revised comparison of the pre-development versus post development hydrologic calculations has been provided as an attachment to this response letter. The installation of the steel plate will occur prior to the submittal of a Request for Certificate of Compliance.

**Response: We have collected as-built data for wet basin 1 and this information is depicted on the attached updated Exhibit Plan to accompany the Request for Amended Order of Conditions. The owner has been repairing the side slopes as necessary and we will continue to monitor their**

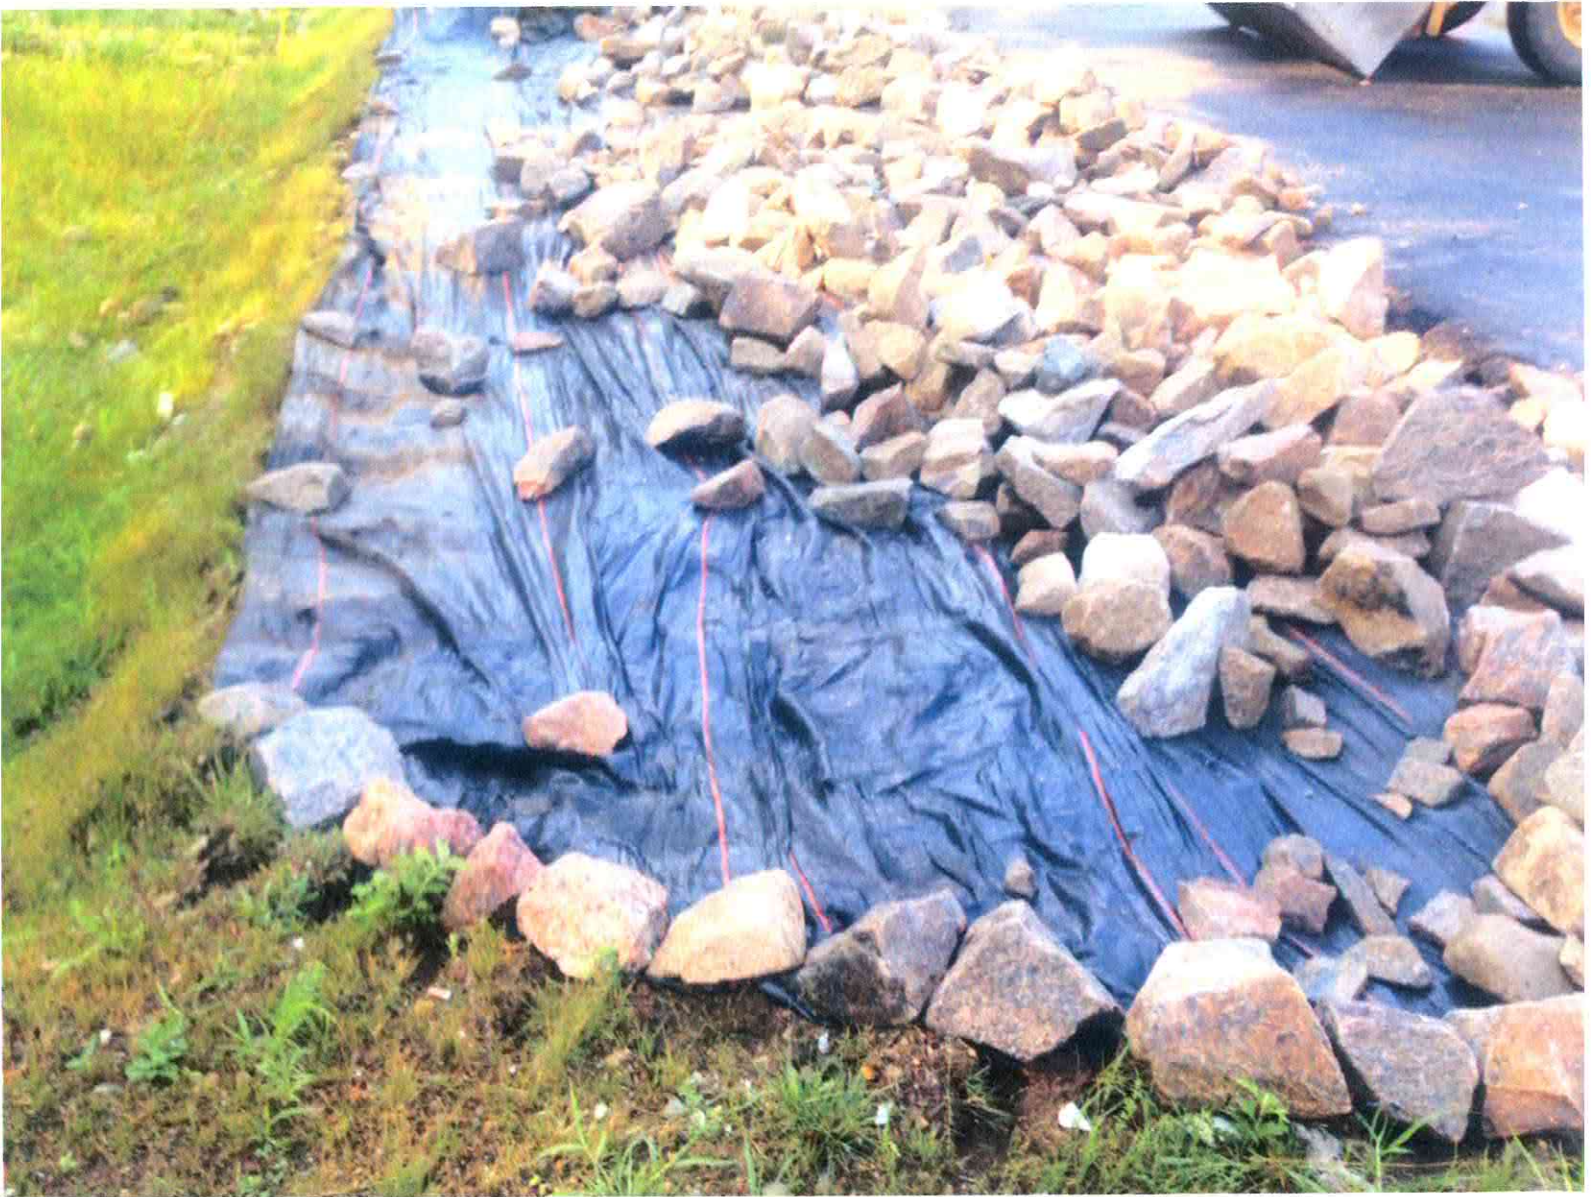
New RipRap Pad  
Wet Basin 1

**Response: The owner has already replaced the "riprap" pad located upstream of the sediment forebay with new riprap placed over a layer of filter fabric. Pictures of this work have been submitted to the Commission.**

**Response: In repairing the "riprap" pad referenced above, the owner has brought in larger stone and has "buted" the stone right up to the existing edge of pavement. We feel that with the larger stone right up against the edge of pavement, backing of trucks over the edge of the pavement will be minimized. Upon further review of this area during the installation of the new riprap, we do not feel installing the flush concrete curb is necessary at this time, but will continue to monitor this area for any future erosion. Please see attached pictures showing the installation of the riprap in this location.**

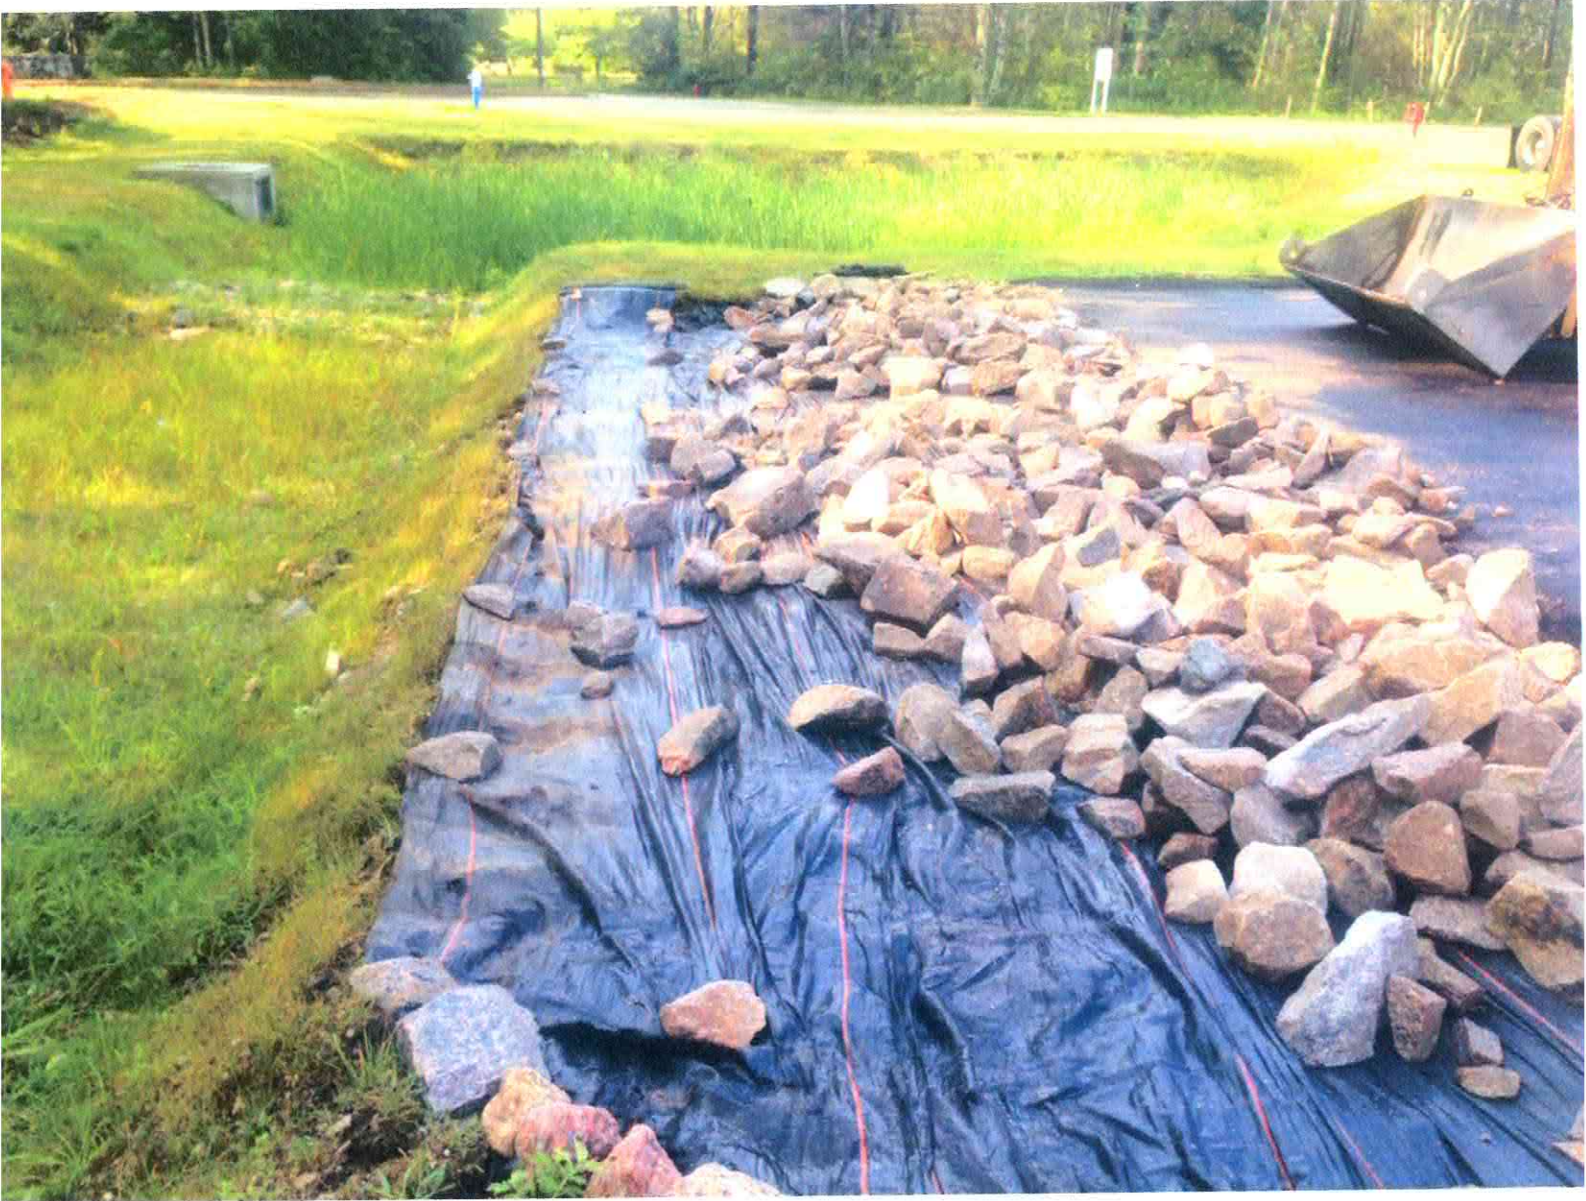
New RipRap Pad  
Wet Basin 1

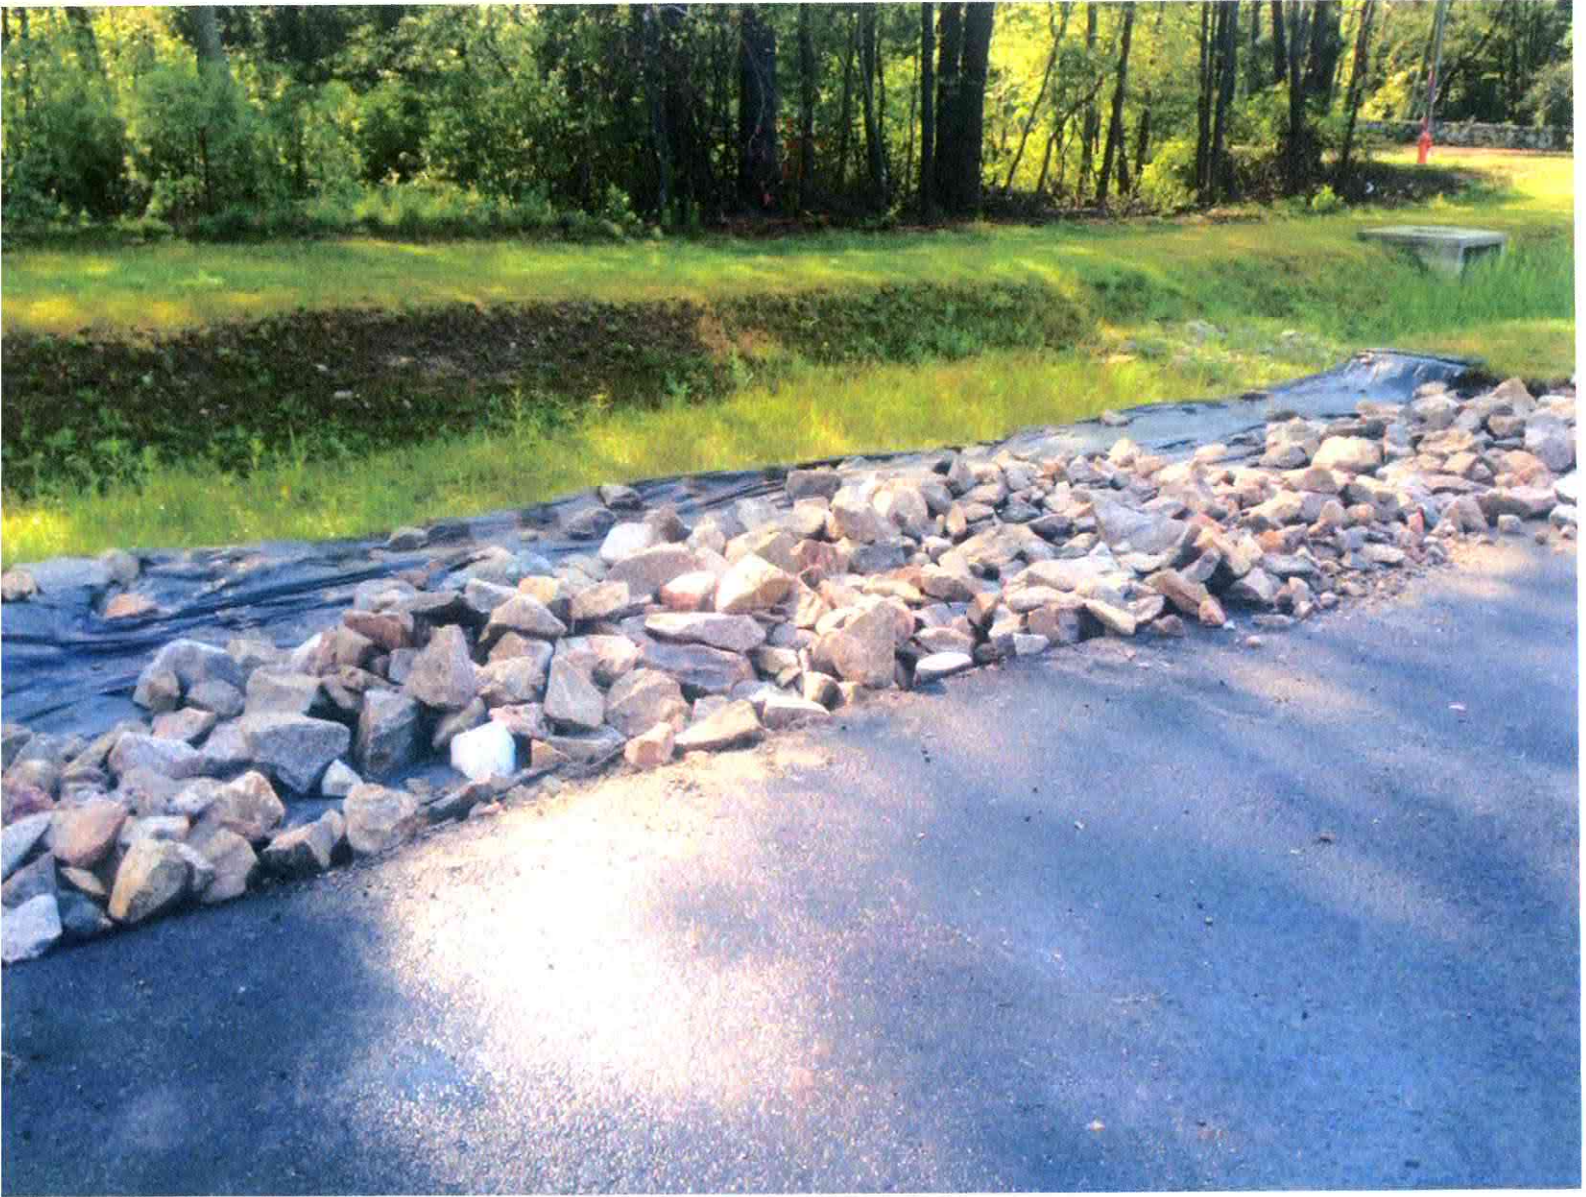
New Rip Rap Pad  
Wet Basin 1

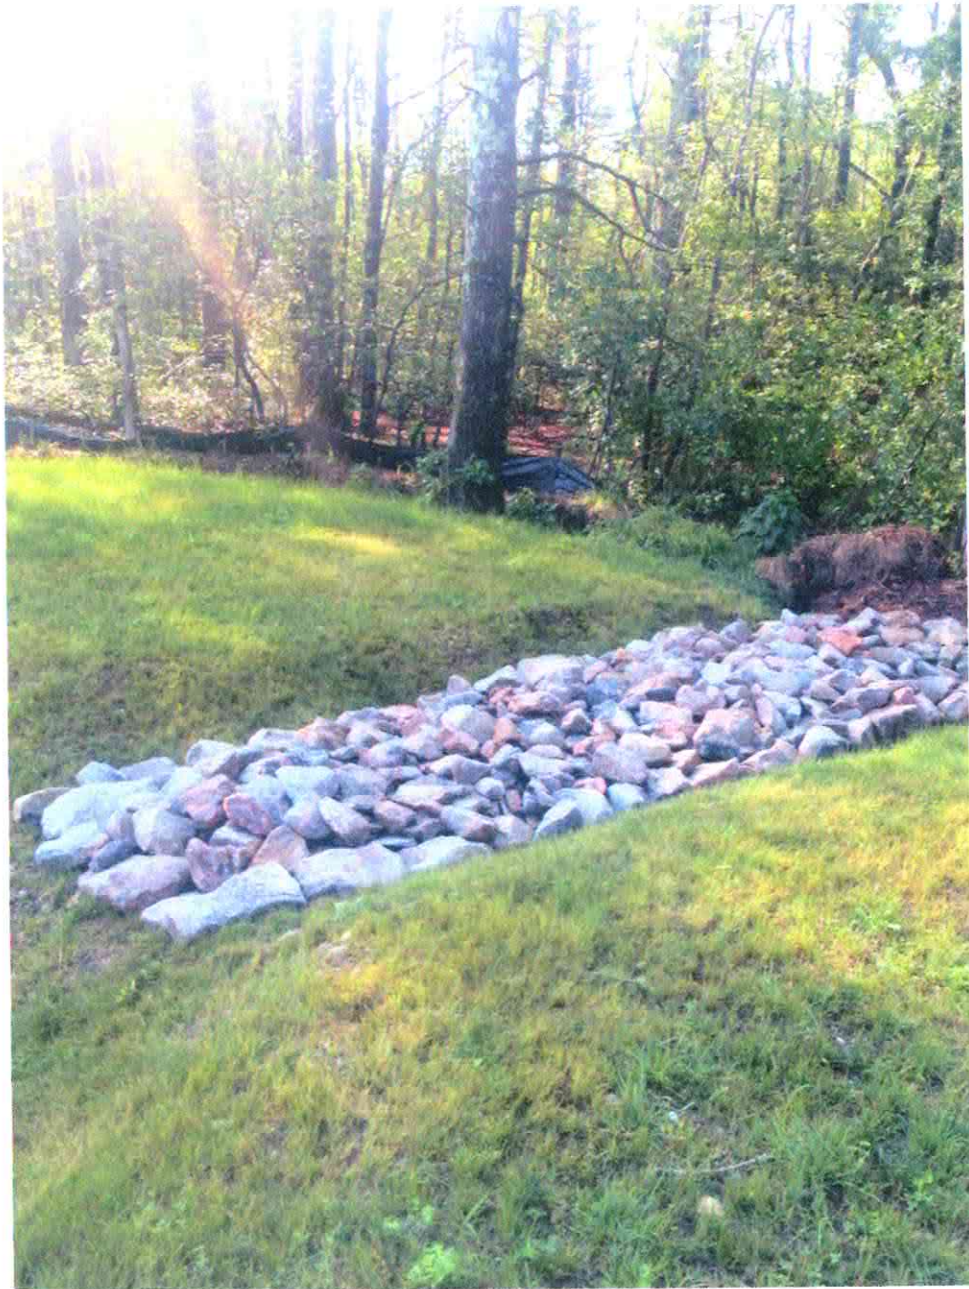
18. Rip-rap needs to be installed at the discharge pipes into detention basin 1. Rip-rap also needs to be placed at the overflow from detention basin 1.

Rip Rap Spillway  
Detention Basin /

**Response: The owner is in the process of installing/replacing the riprap at all discharge points related to the stormwater management system.**

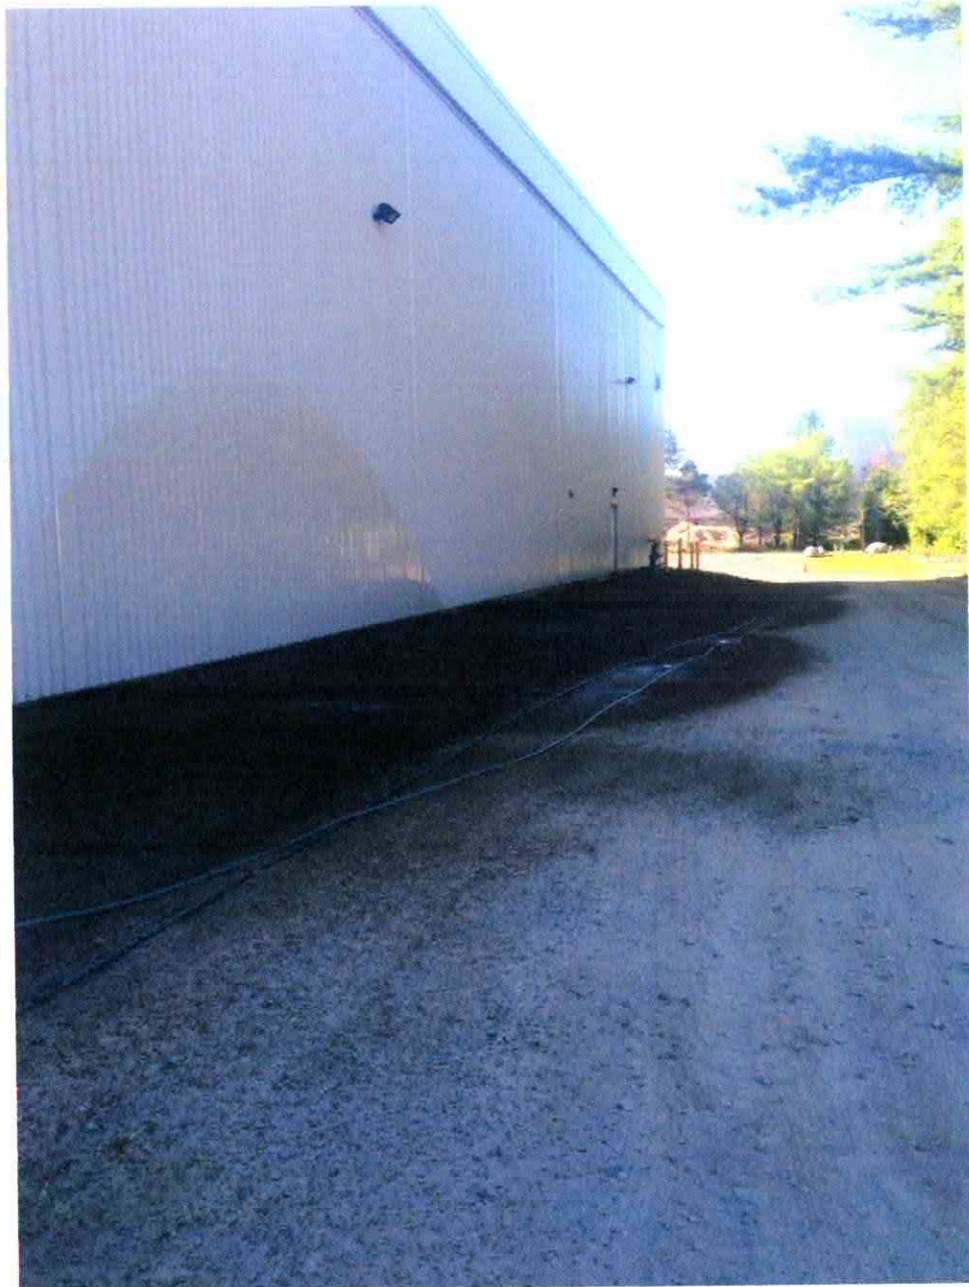
16. The site plans imply that a uniform gravel driveway will be constructed along the western side of the building. The plans show an 18' wide gravel drive with loam and seed on both sides of the gravel driveway. This area has not been loam and seeded. This was discussed with the owner who agreed to formalize the access drive and install the loam and seed.

Loam + Seed West Side  
of Building

**Response: Loam and seed has been placed in this area adjacent to the building to better define the 18' wide gravel driveway in this location. Pictures of this work are included as an attachment to this response letter.**
