NEW BEDFORD REGIONAL AIRPORT
RUNWAY 5-23 – PHASE 4

Reconstruct, Mark and Grove

Partial Weekly Environmental Report

WEEK 13

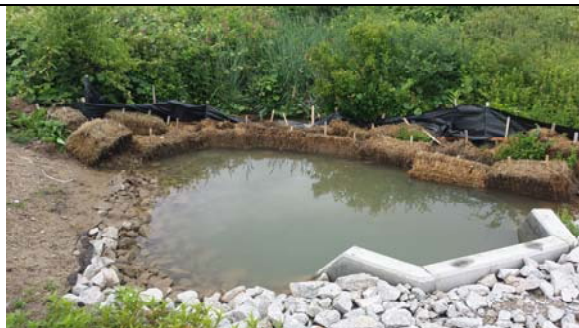
Outfall after Catch Basin 1.
Water slightly turbid. Evidence of sediment in plunge pool. Silt fence on back of 2 rows of hay bales failed. Water elevation difference between plunge pool and wetland about 6”.

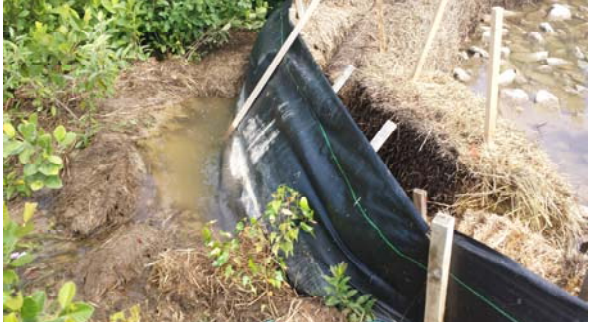
<p>Failed silt at ross culvert on access road. This is on the north side of RW5. Sediment trail leads into upland area. No sediment in wetland. This section has been repaired once already and a second row of hay bales added.</p>

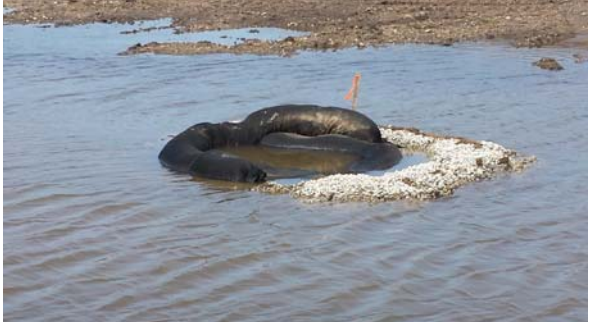
<p>Photo of Catch Basin 11 in the area between Taxiway A and RW5. The catch basin is covered with fabric and no water is discharging to the culvert and outfall.</p>

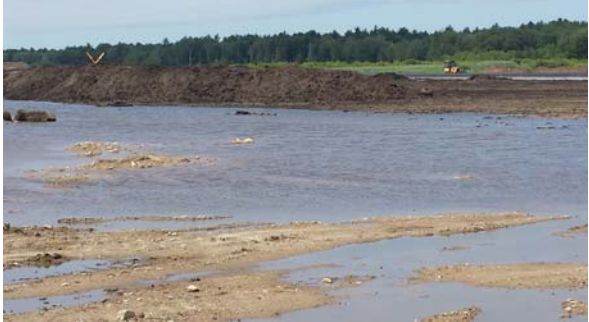
<p>View of the flooded area between Taxiway A and RW5 because CB-11 is blocked off.</p>

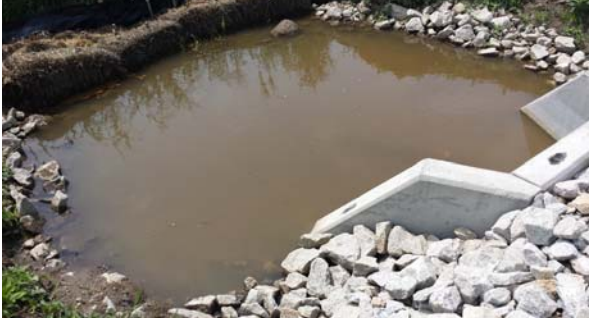
<p>This is the discharge point from CB-11. While there is some cloudiness in the water some of this is due to the organic nature of the surrounding soils. See photo for July 22, 2014</p>

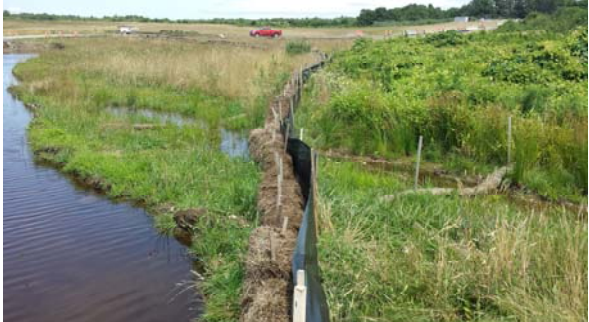
<p>View of silt fence and hay bales along the proposed Taxiway extension on RW23 end. There was no breach in the silt fence and water was discharging clear.</p>

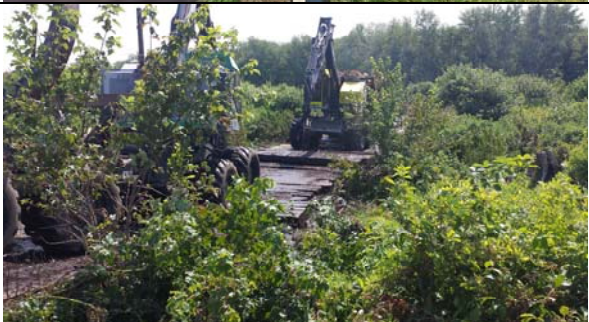
<p>Wagner Wood and the WS continue to monitor the timber mat road and adjust mays and add BMPs as needed.</p>

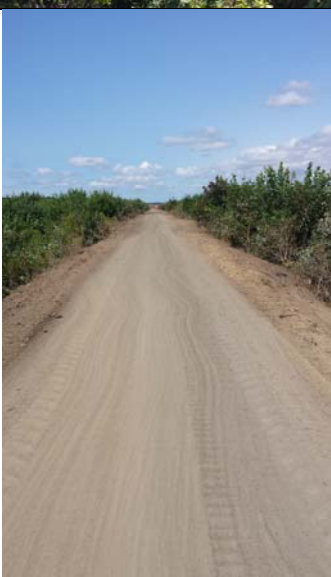
<p>The ILS road is being monitored as swept as needed.</p>

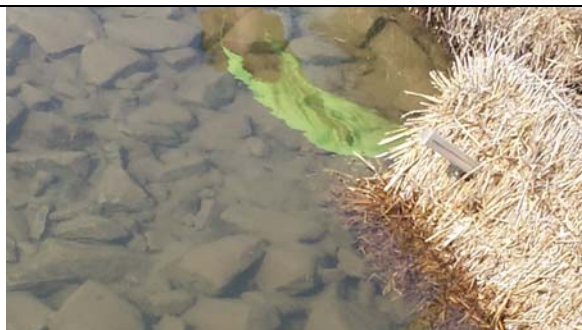
Detail of water clarity in outfall from CB-1 near beginning of access road. Water is slowly filtering through 2 rows of hay bales and silt fence. Silt fence and hay bales will be secured by end of today.

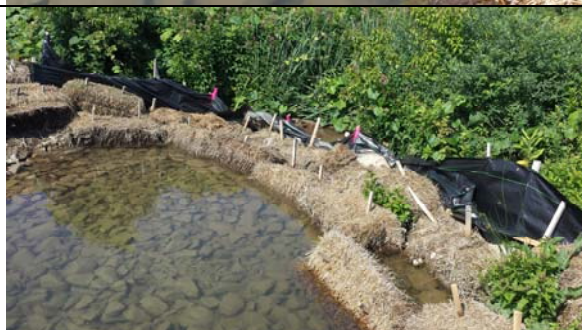
View of silt fence to be reinstalled by end of day. Marking are for ETL crew to identify repair areas.

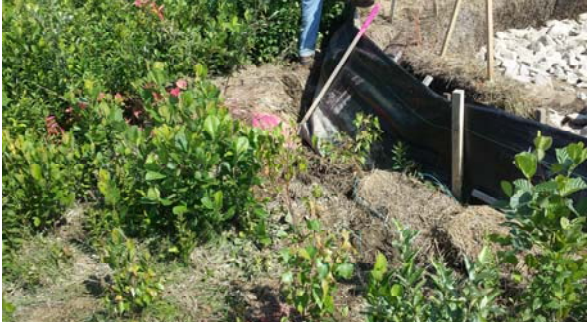
<p>View of blow out at cross culvert at end of access road. Area to be repaired by end of day today and all sediment outside wetland to be removed by hand shovel.</p>

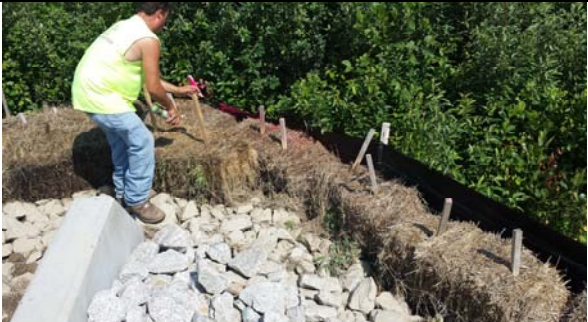
<p>ETL crew marking additional area of repair on cross culvert outfall.</p>

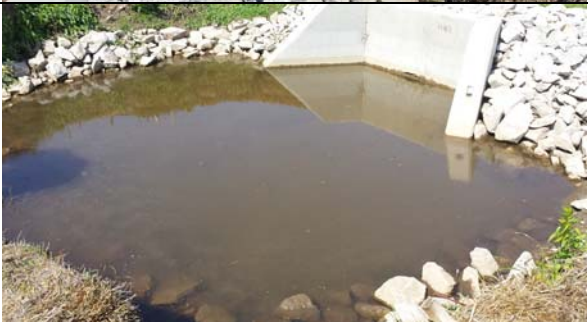
<p>Outfall on Taxiway A from CB-11. Water is still cloudy but appears to be from natural source and not sediment. No discharge occurring.</p>

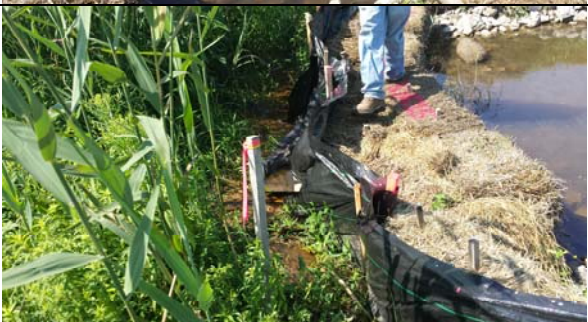
<p>ETL crew marked area to be repaired by end of day today.</p>

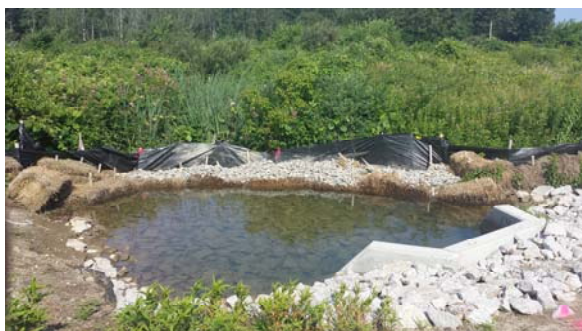
Outfall after Catch Basin 1. Water is clear. Silt Fence was repaired yesterday. The water is discharging through a small gap in the double silt fence row but at a slow rate. The difference in water elevation between the ponded areas within the silt fence and the adjacent wetland is 12". The outlet pipe is totally submerged. It is recommended that no further action be taken here until the design and construction team meet and recommend a solution. Adding a wire backed fence to this would only raise the water elevation and may create a scour on the wetland side of fence if the water reaches the top of the fence.

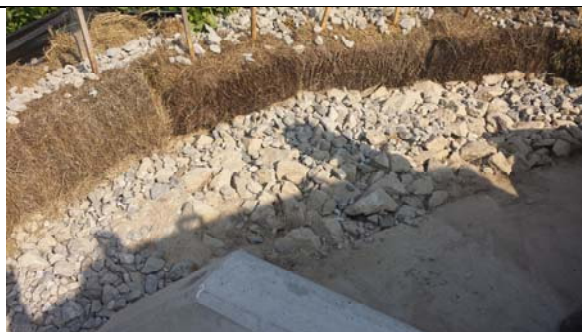
The outfall on the cross culvert under the access road. The silt fence was repaired and re-anchored. Sediment was removed from the upland. The wetlands adjacent to the discharge were investigated and no sediment was observed in the resource area.

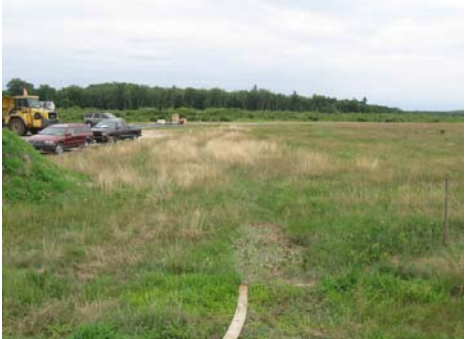
<p>RW 23 -Work Area IV: Dewatering into upland grassy area (outlet end). Flowage was clear.</p>

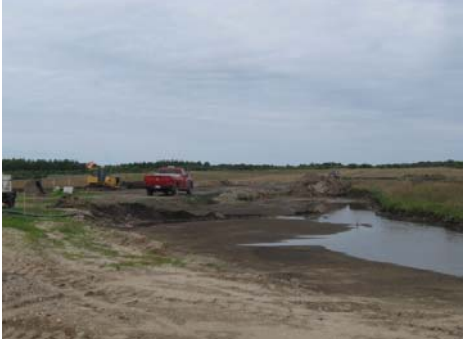
<p>RW 23 -Work Area IV: Dewatering (inlet end) from temporary detention basin. Inlet of hose was protected.</p>

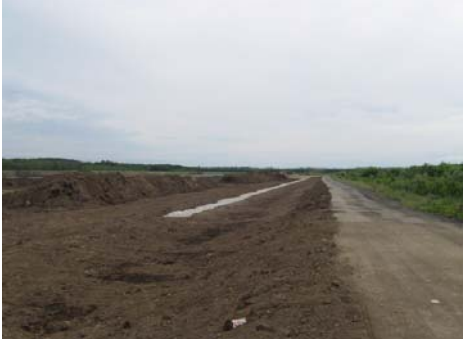
<p>RW 5 – Area south and adjacent the Access Road – along the Drainage Swale and Infiltration Trench (directed to the west): The area between the airstrip and access road was loamed.</p>

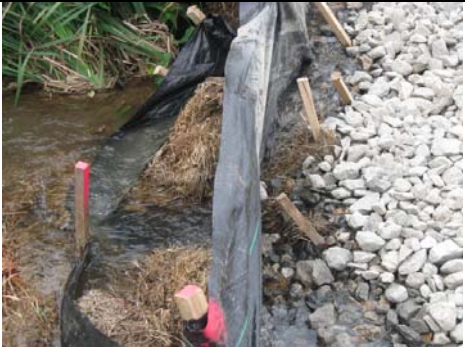
<p>CB-1 near beginning of access road: Discharge noted flowing underneath silt fence – will be repaired on 7/25.</p> <p>Note: This repair was made on 7/25/2014.</p> <p>Participated in Thursday's Construction Meeting at the Field Trailer.</p> <p>Viewed site with the New Bedford and Dartmouth Conservation personnel.</p>

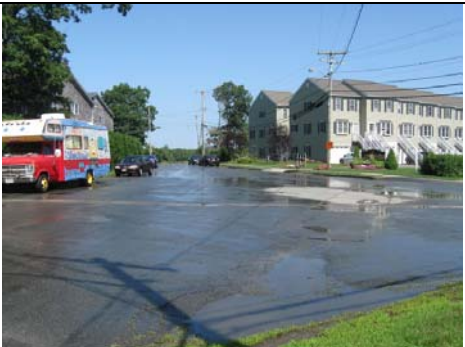
<p>Entrance/exit to RW 23: Pavement sprayed (10 am).</p>

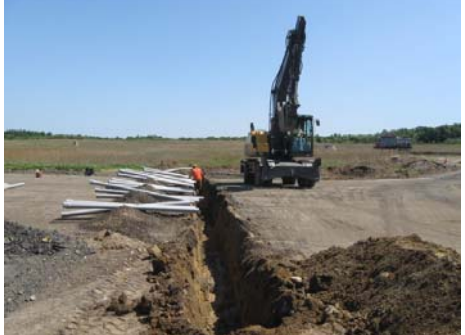
<p>RW 23 -Work Area IV: Newly excavated ditchline – dewatering not necessary</p>

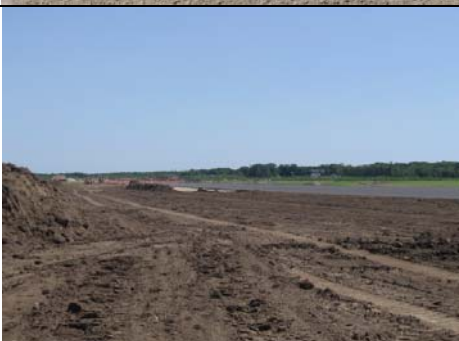
<p>RW 5 – Area south of Access Road: between Drainage Swale and Airstrip (directed in an easterly direction): Further loaming was completed today.</p>

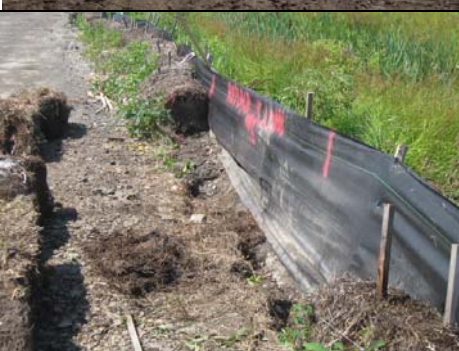
<p>West Ditch: This section of silt fence was trenched and toed-in properly.</p>

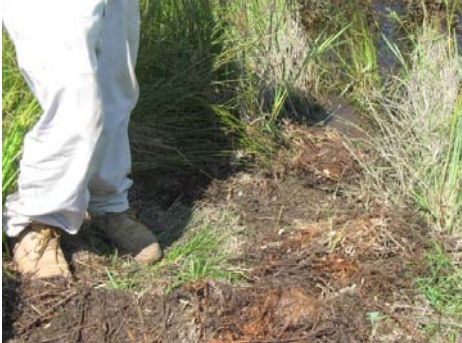
<p>West Ditch: The sedimentation within the resource area behind the silt fence was removed by hand shovel and then mulched.</p>

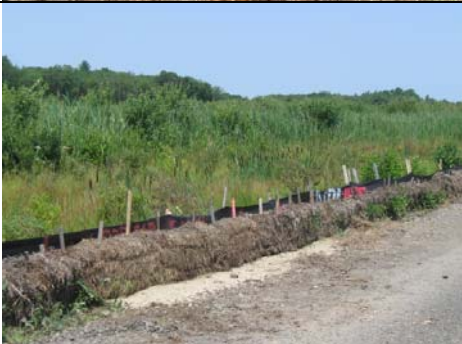
<p>West Ditch: Hay bales put back in place and double staked. This repair was finalized.</p>

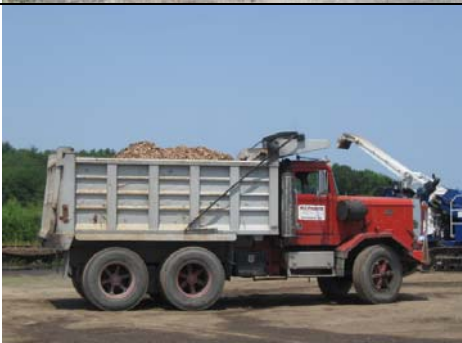
<p>Road from Log Landing to Log Mats: A load of chips was transferred to the very end section of this road where the chips will be used as a bmp at edge of road to prevent migration of soils into the adjacent wetlands.</p> <p>ETL was advised to further delineate the back cut area.</p>
