**New Bedford Regional Airport
Runway Safety Improvements Project – Phase 4
Reconstruct, Mark, and Groove Runway 5-23
MassDEP File No. SE049-0635**

ENVIRONMENTAL MONITOR INSPECTION FORM

Date/ Time of Inspections: **7/17/14 (all day) and 7/24/14 (afternoon).**

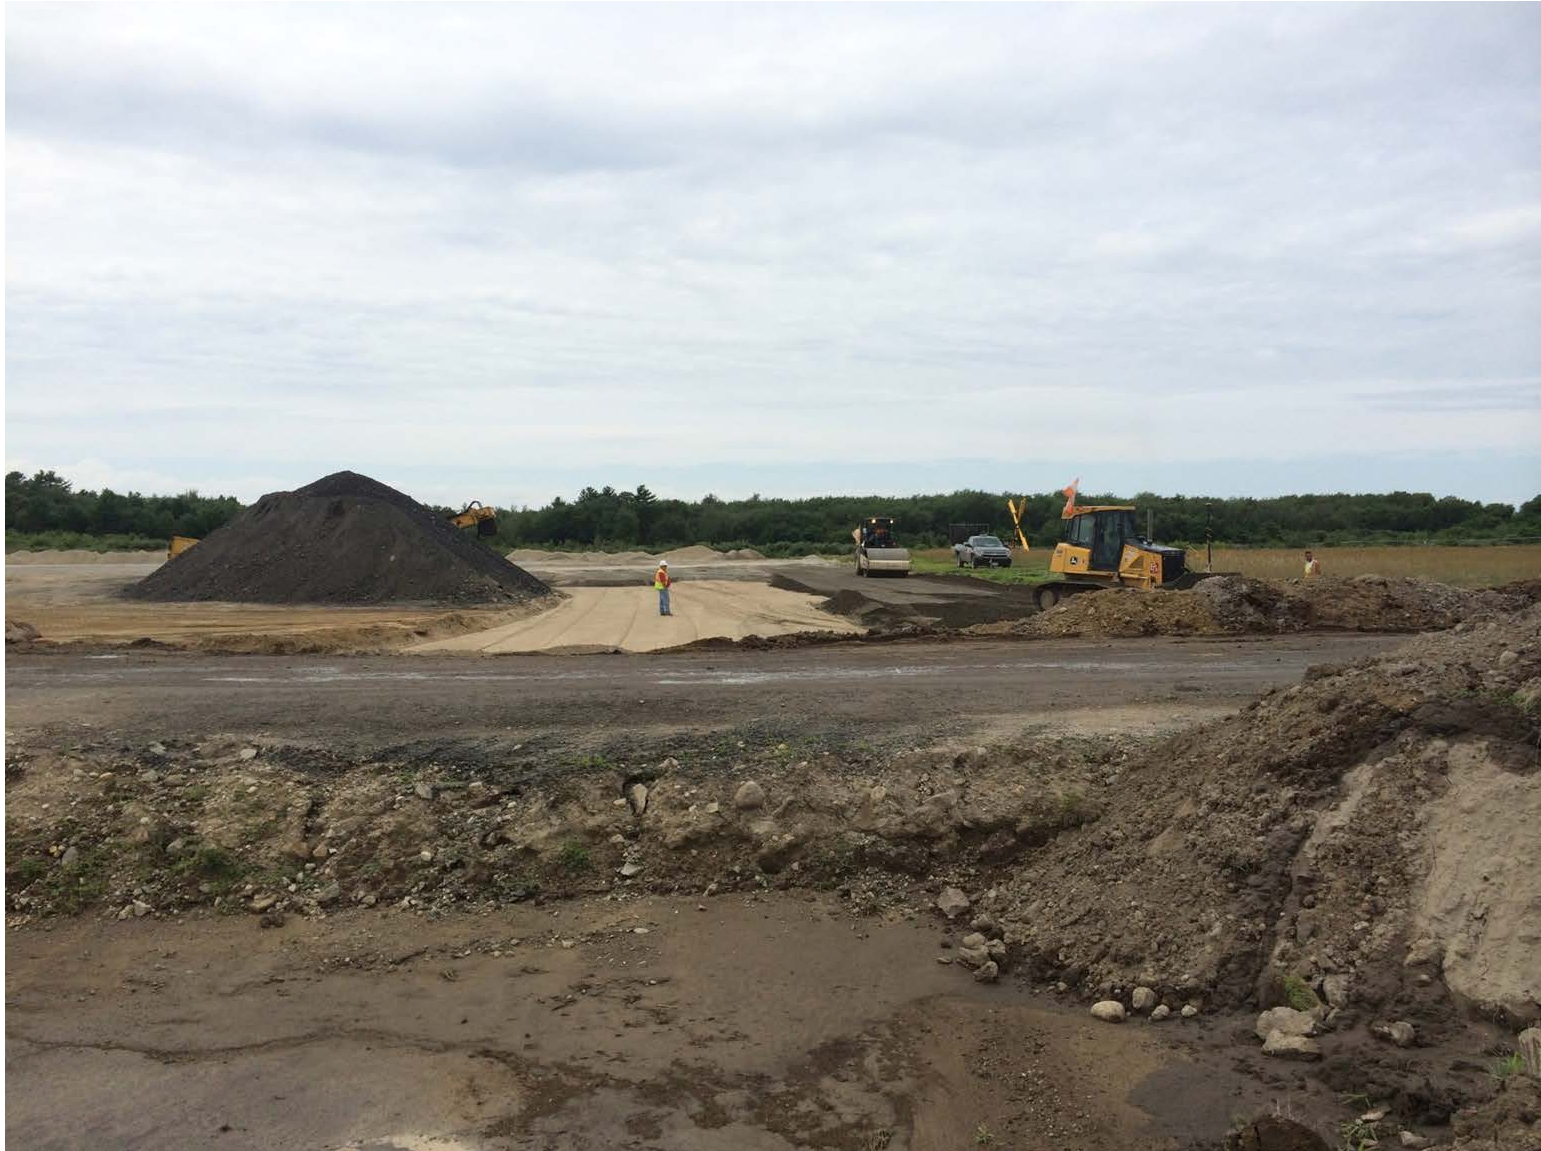
Paving operations at the Runway 23 end (7/24/14).

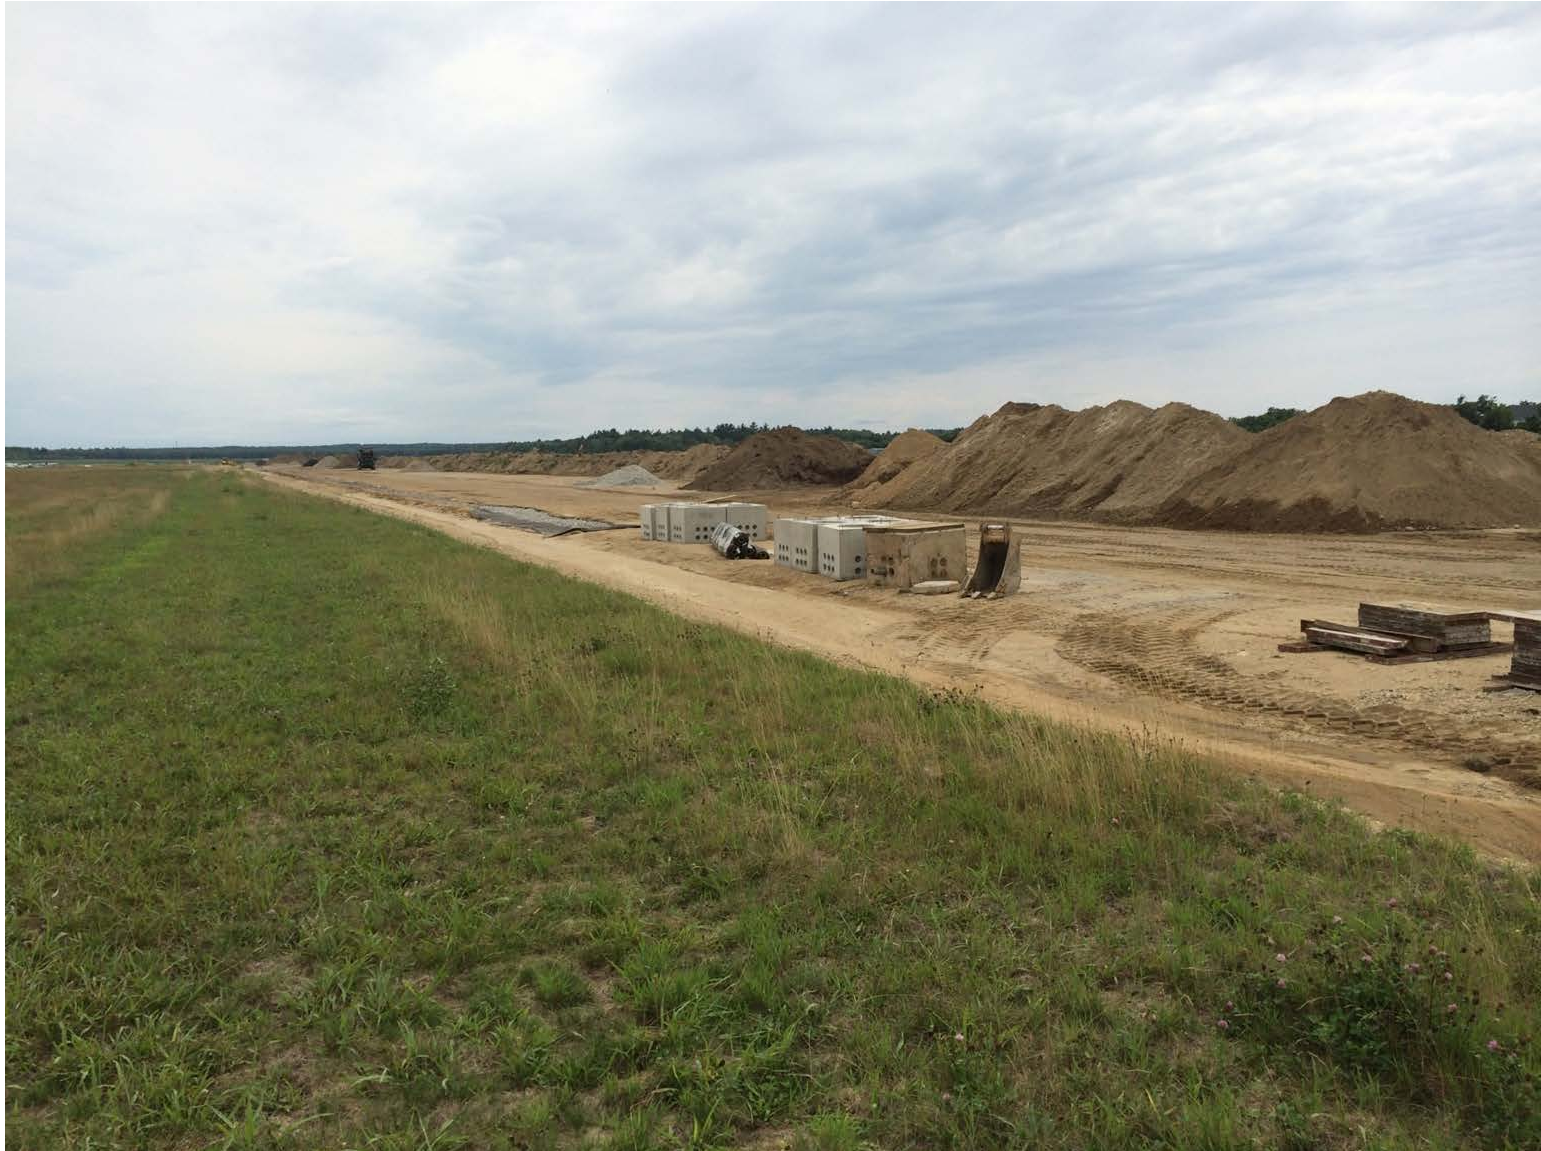
View of partially installed stormwater infiltration and infrastructure at Runway 23 end (7/24/14).

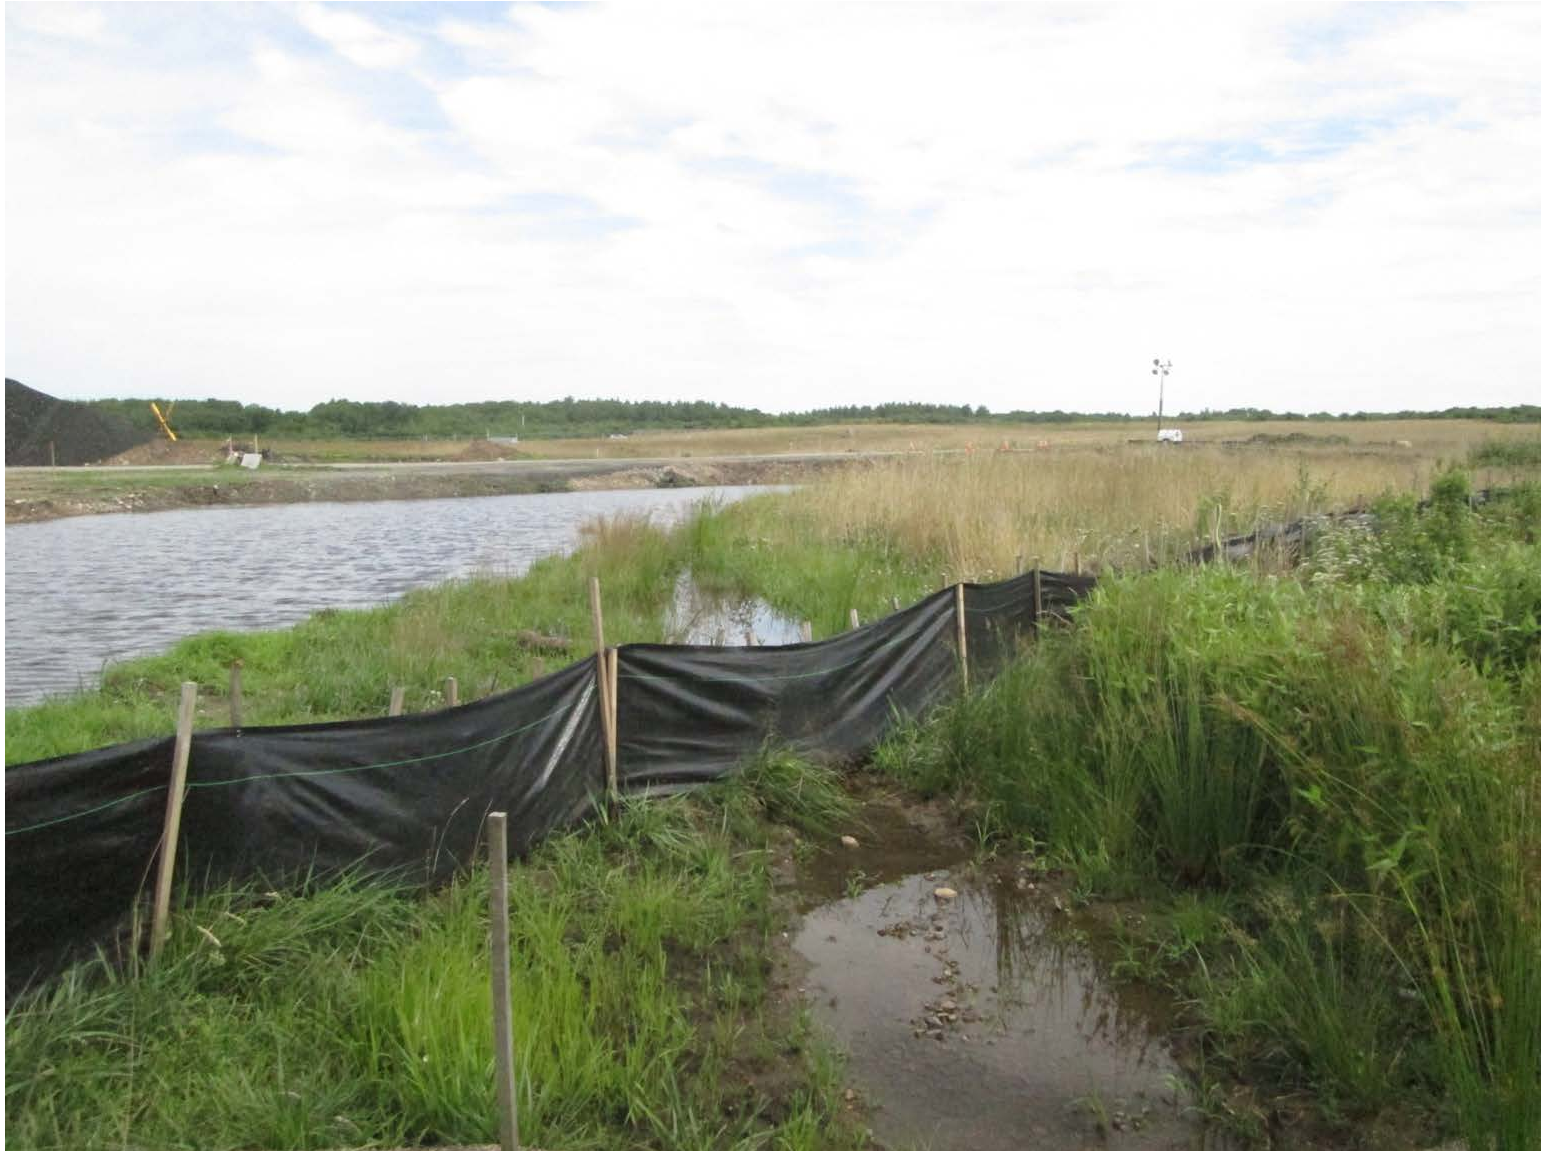
View of temporary holding pond and drainage on south side of Runway 23 end, standing up gradient wetland (7/17/14).

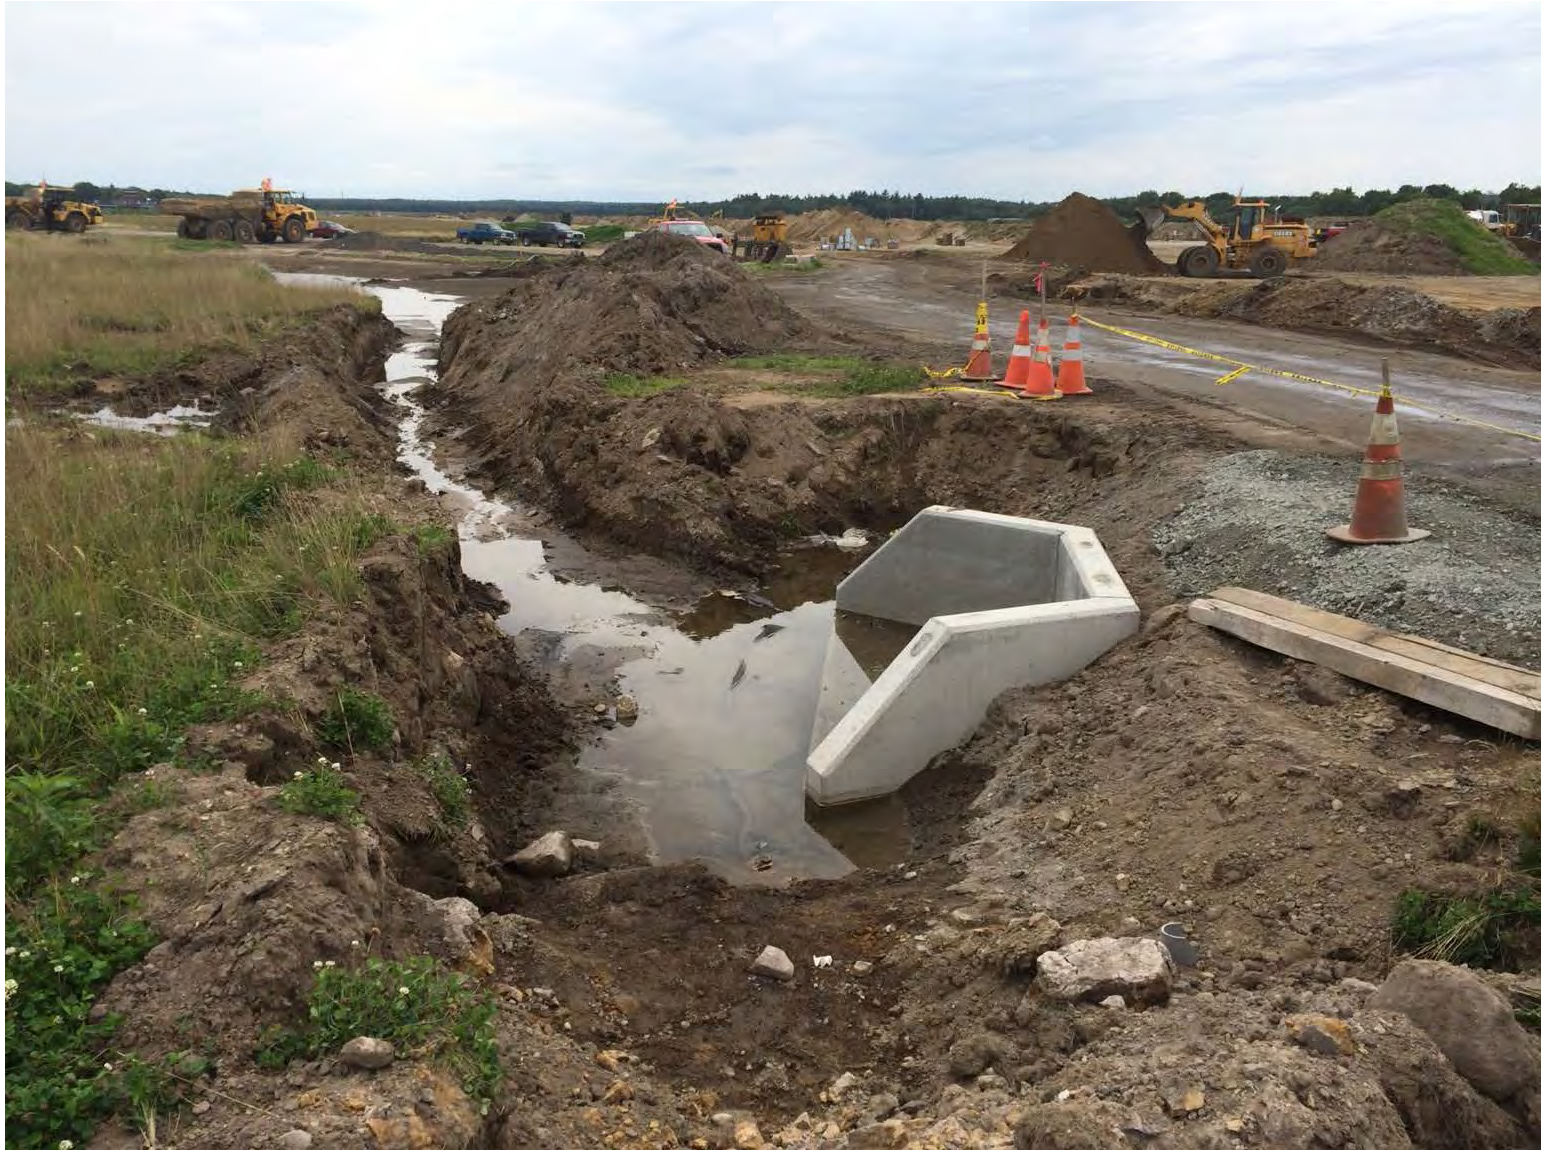
View of newly constructed (interim condition) drainage swale at Runway 23 end (7/24/14).

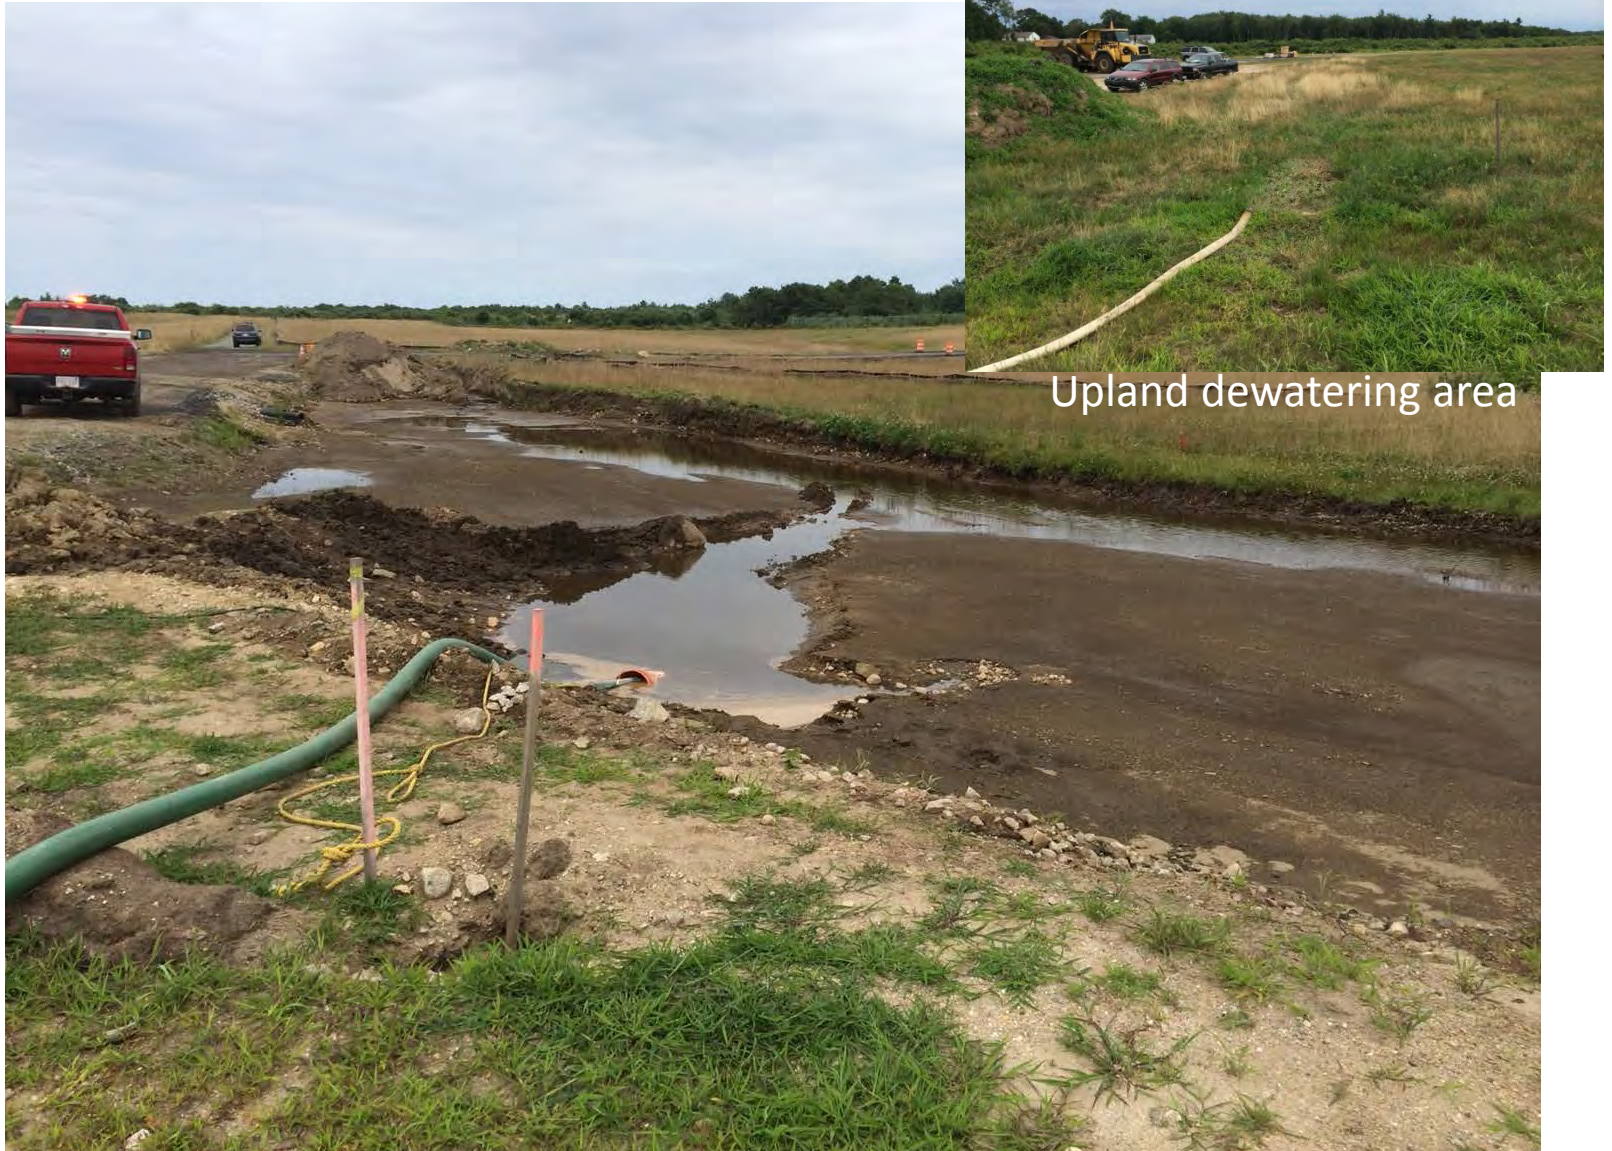
Upland dewatering area

View of dewatering temporary pond, water is retained in the north area and leads to drainage swale and ultimately wetland (note above photo) (7/24/14)

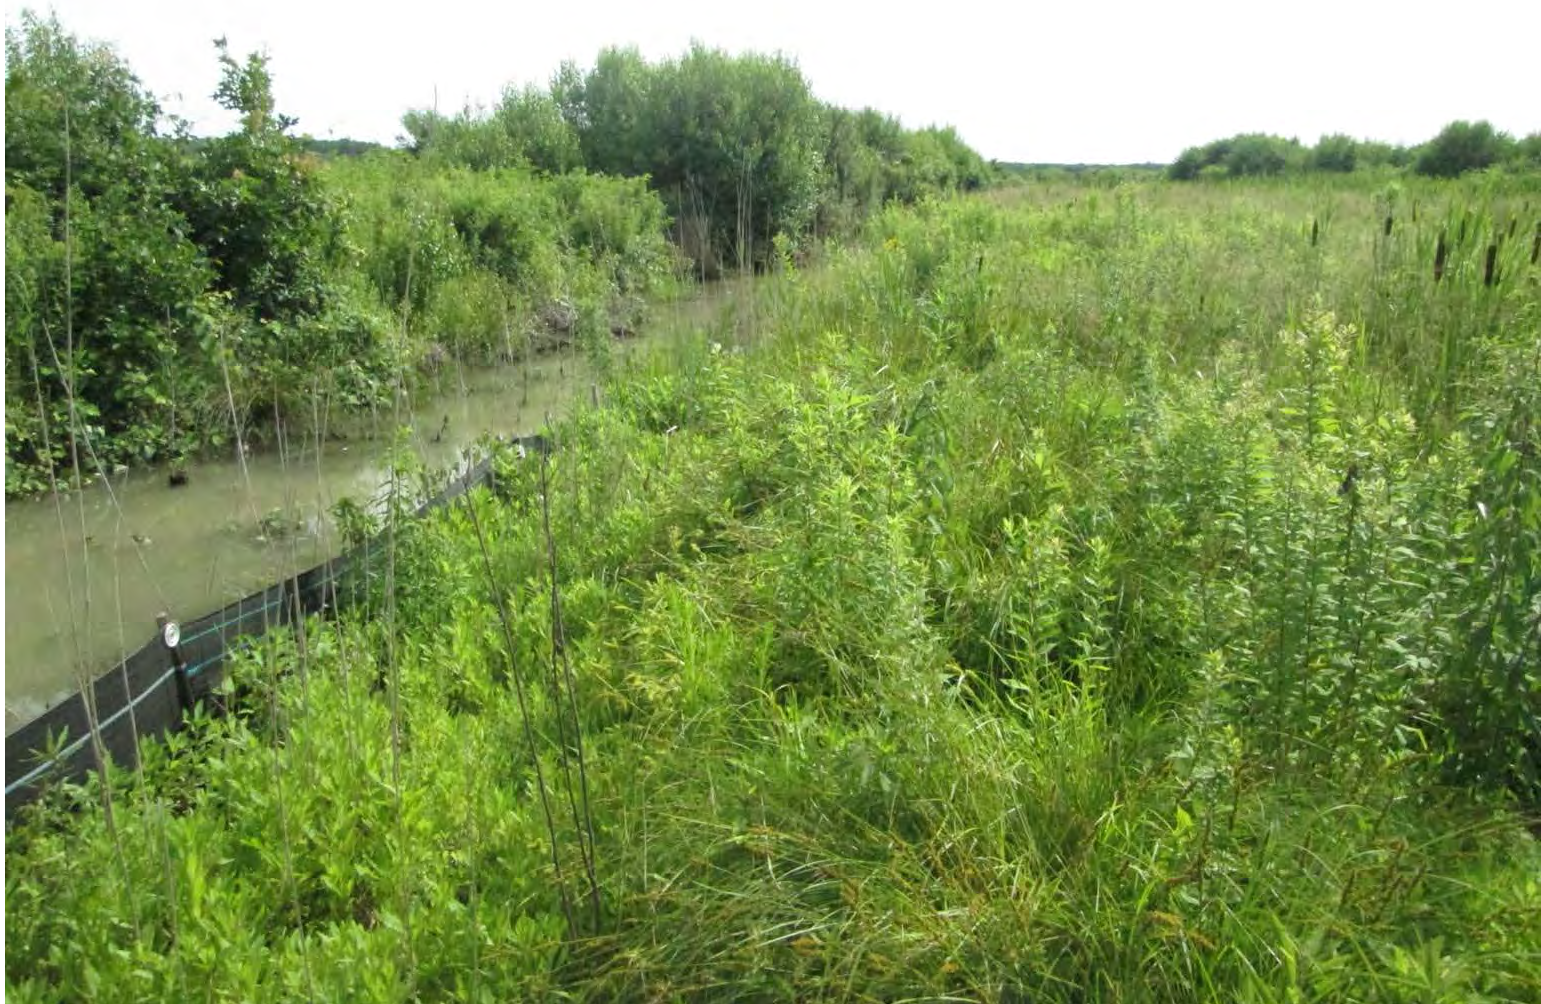
View of temporary turbid condition in west ditch on 7/17/14

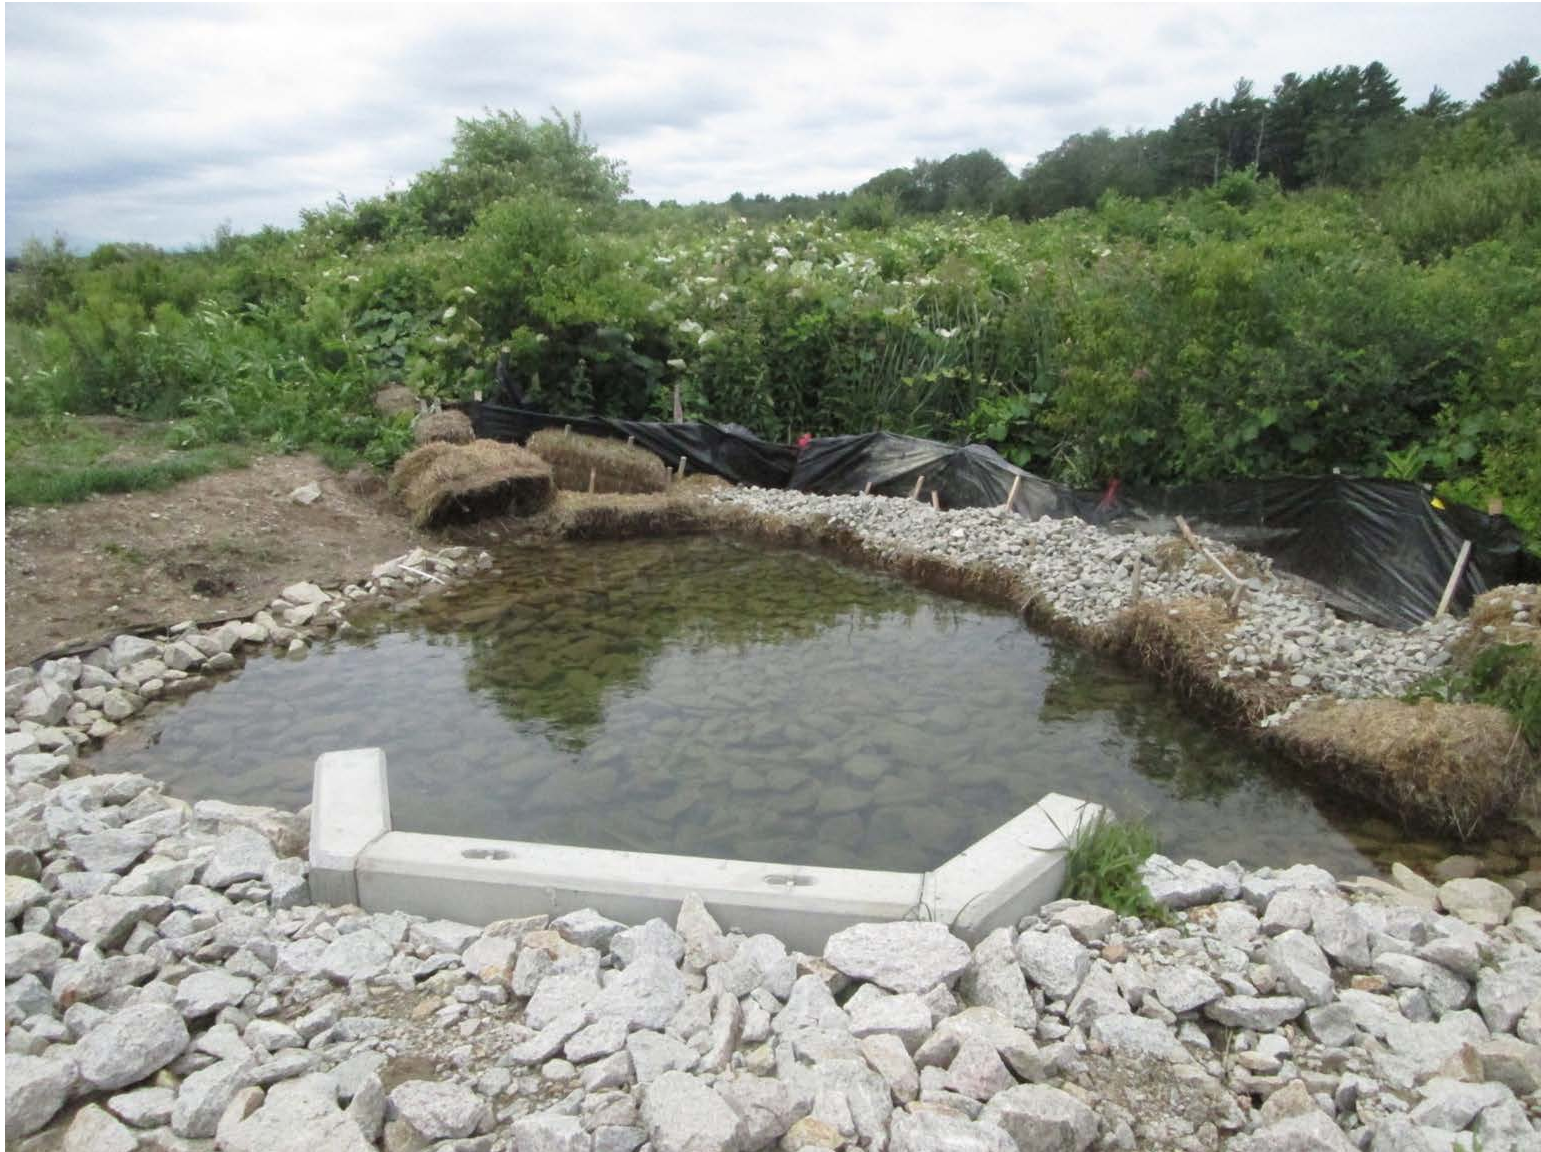
View of headwall from Catch Basin 11 on 7/24/14. A second row of silt fence was added after the failure and the outfall was armed.

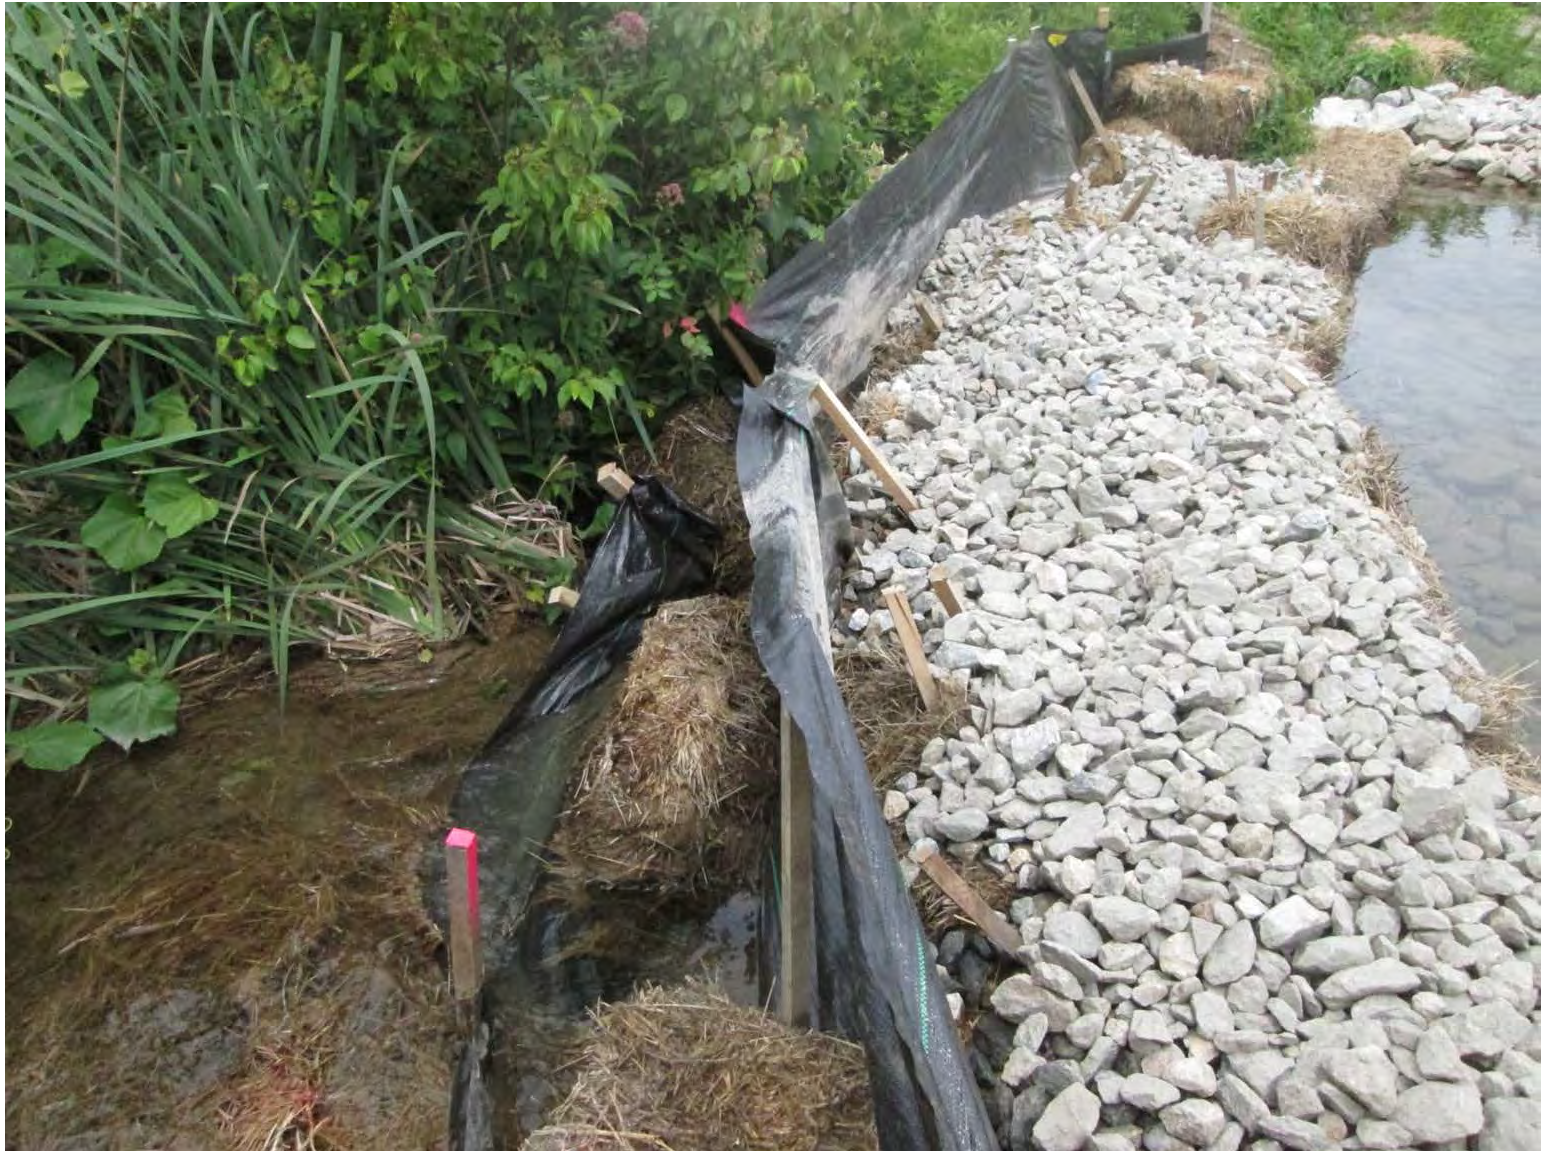
View of water moving through these erosion controls. The lower erosion control had failed. The upper erosion control needs to be properly toed in. (7/24/14)

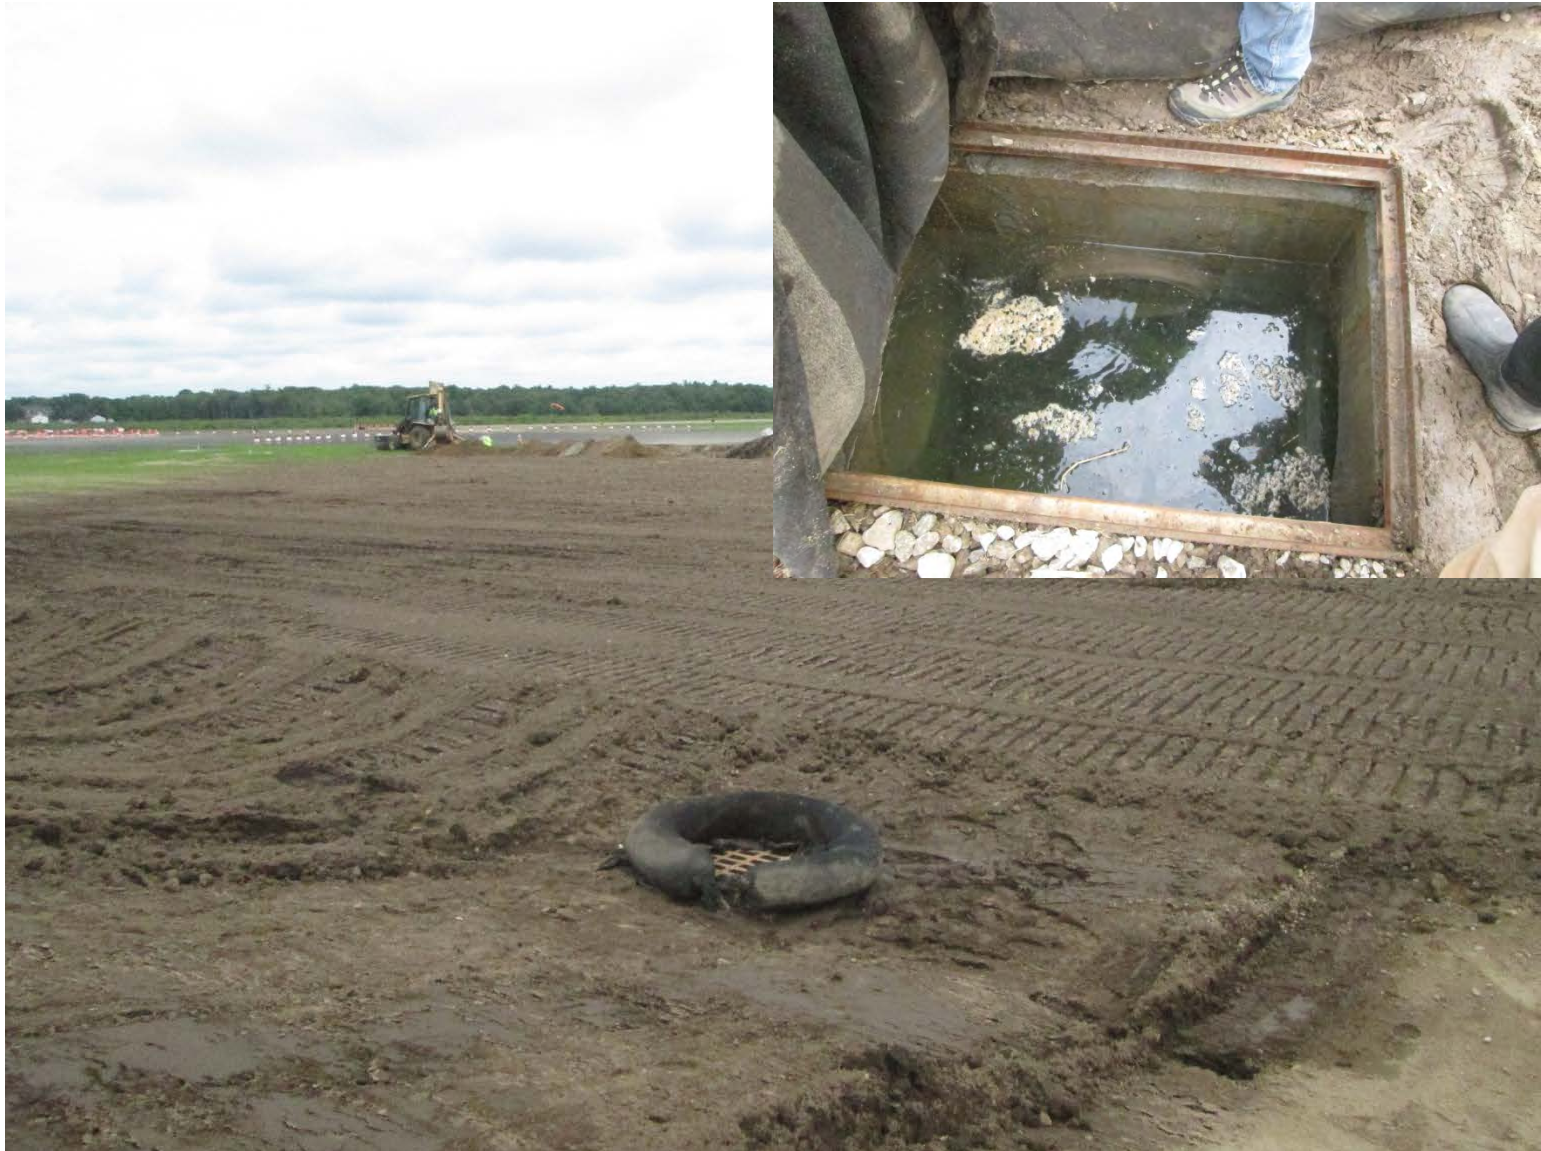
View of Catch Basin 11, water is clear within the catch basin.

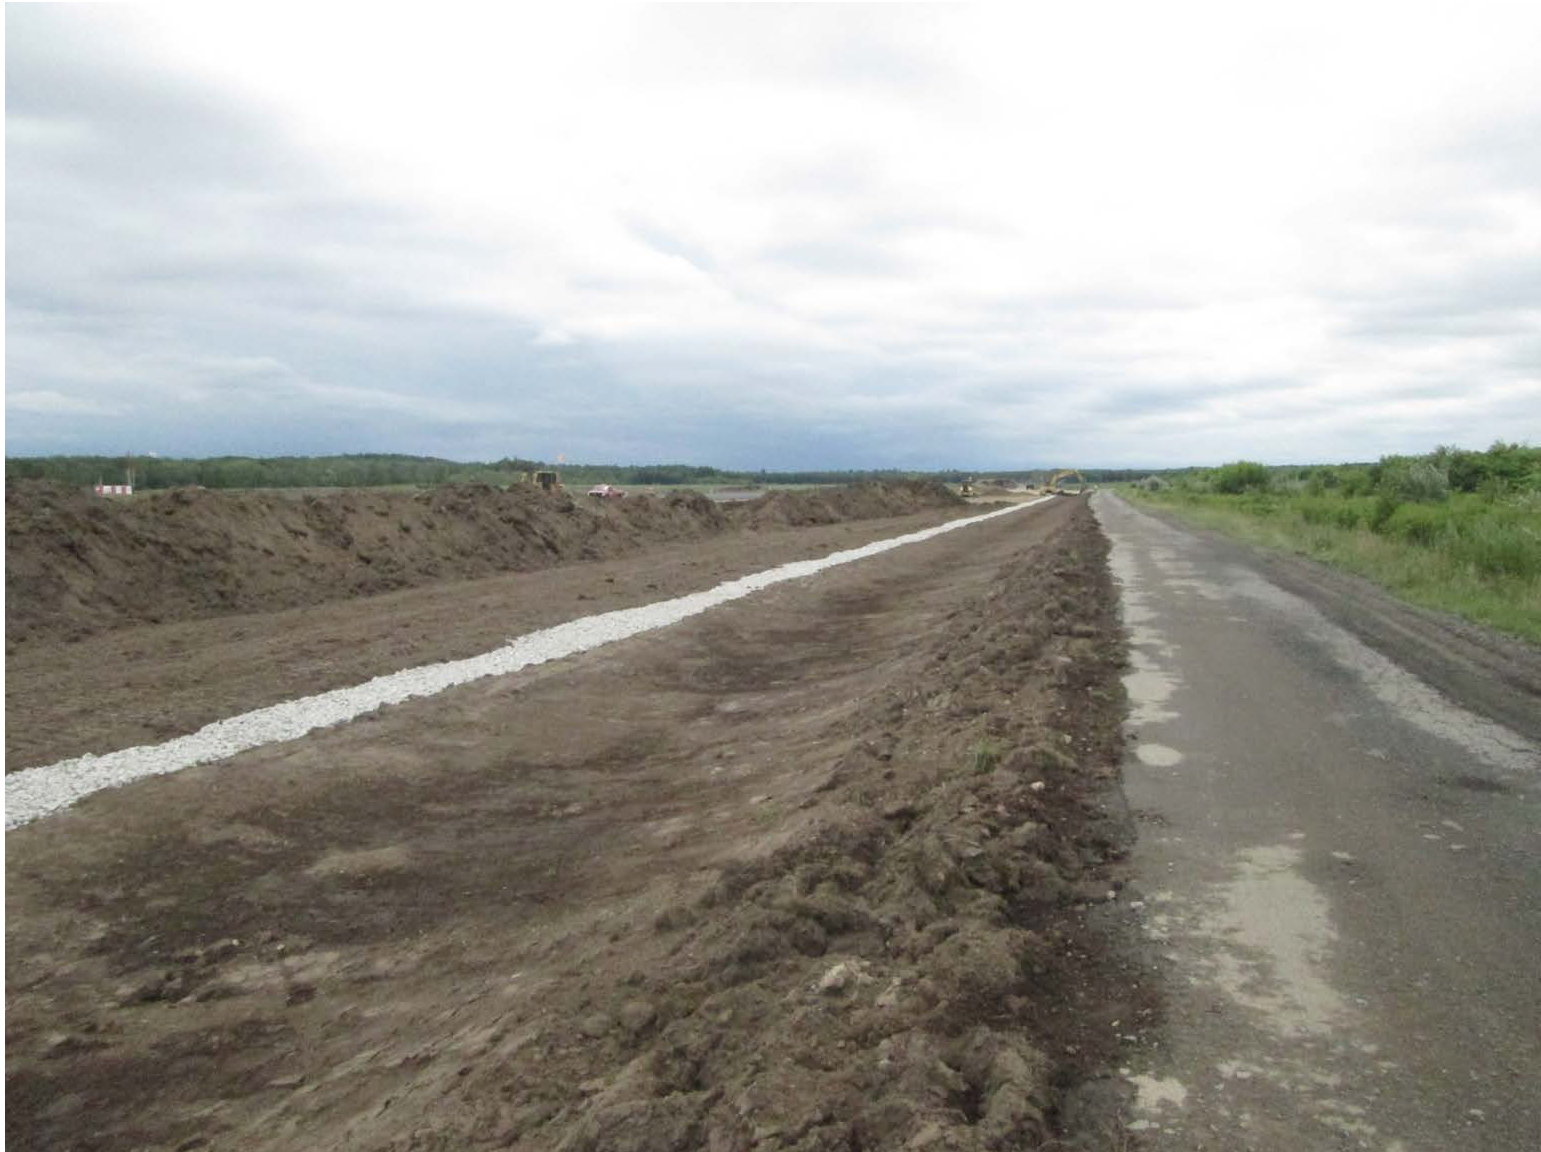
View of newly added loam and Runway 5 end infiltration trench (7/24/14).

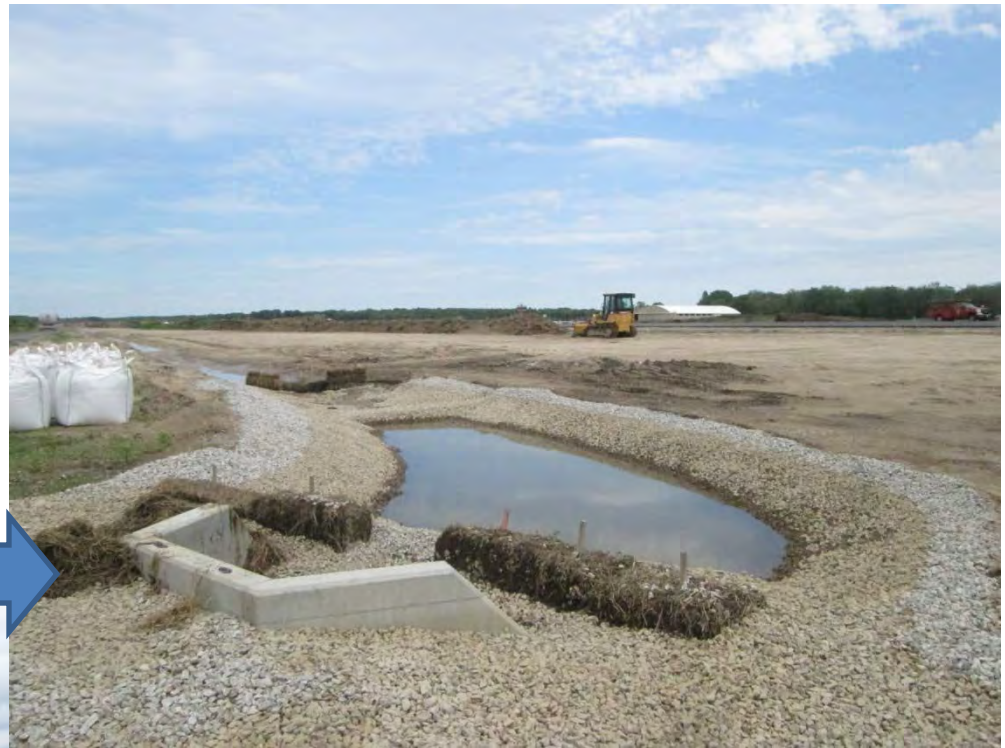
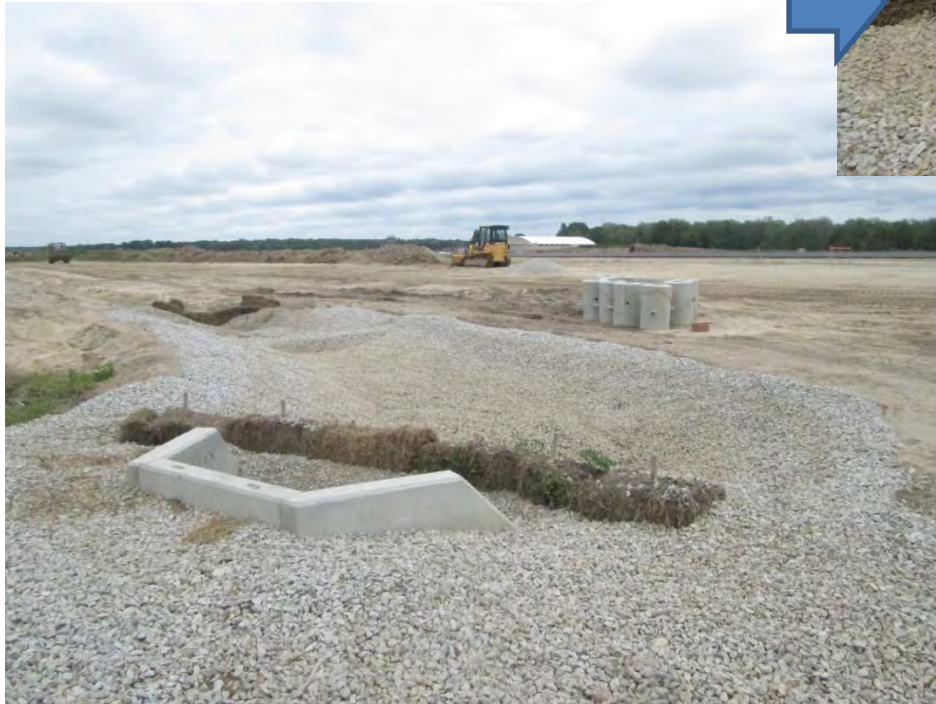
View of infiltration trench outlet on 7/17/14. A hay bale was dislodged by water and holding water back from the outlet, causing water to overtop this area. The WS removed the hay bale from the outlet in order to allow water to flow properly. Arrow shows removed hay bale.

Repaired on 7/24/14.

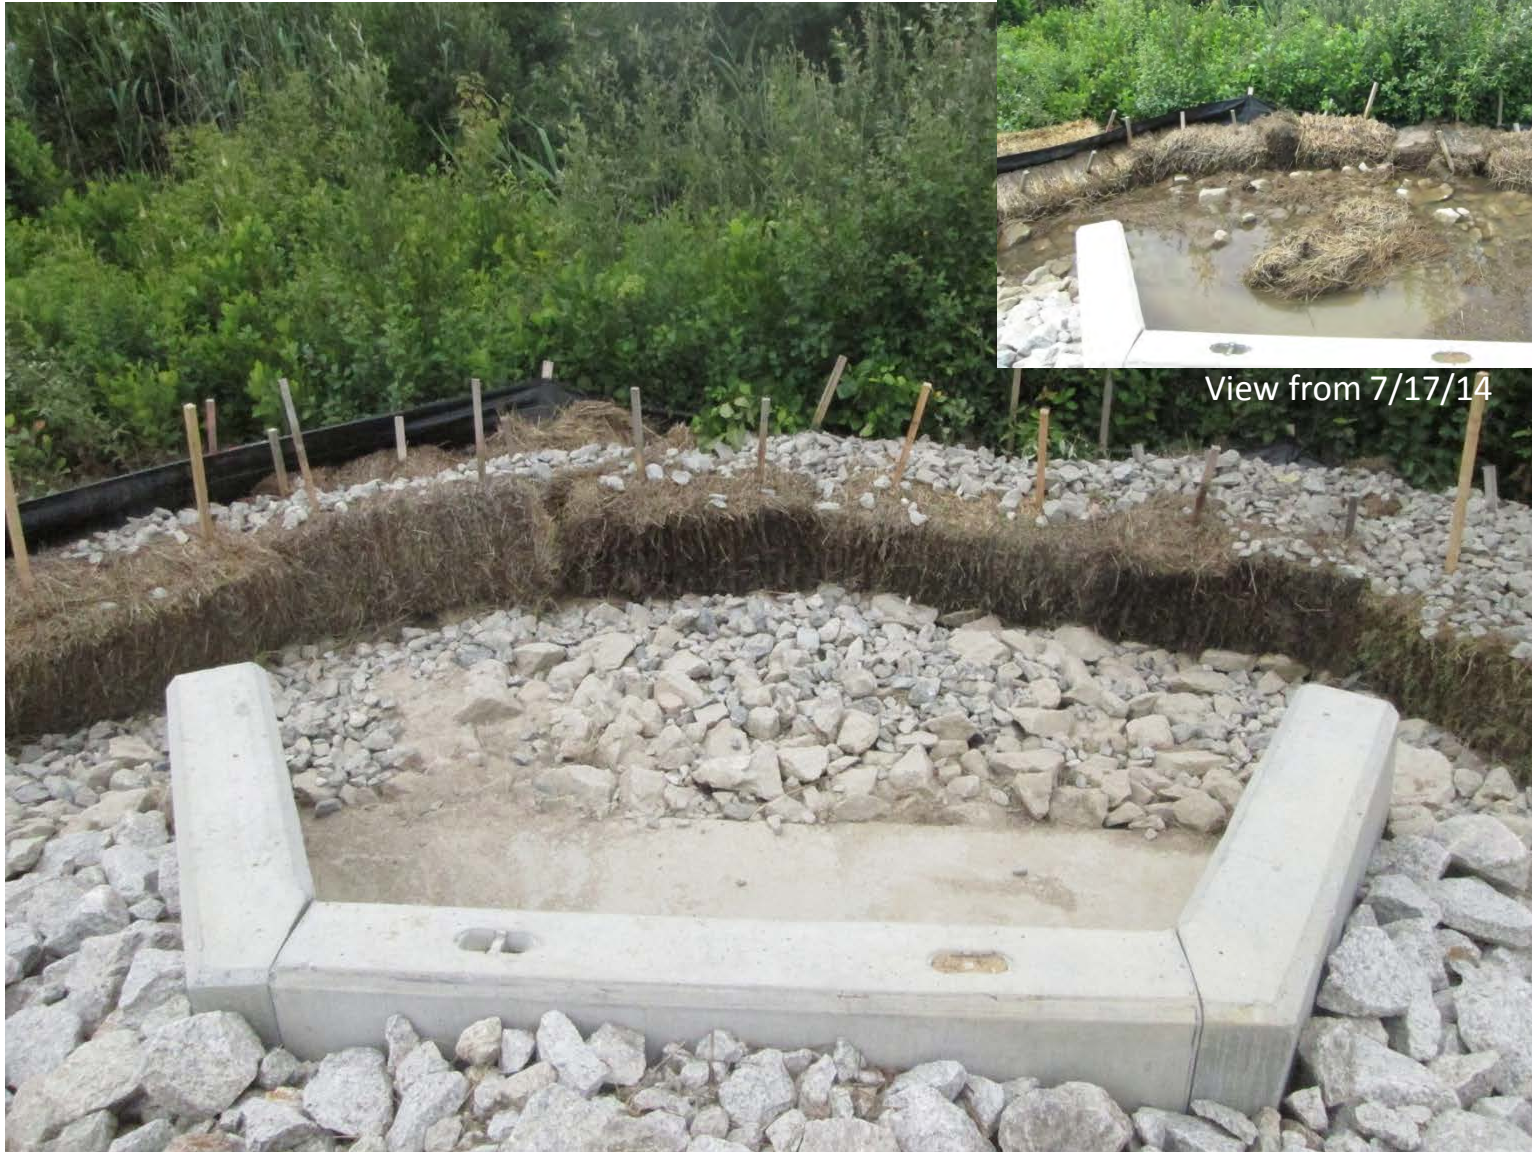
View from 7/17/14

Control Measure	Cleaning or Repair Needed	Comments/Recommendations from the EM
		<p>At the 7/17 visit Epsilon noted that the headwall by the 5 end and infiltration trench was an area of another blow out and sedimentation occurred downslope of the erosion controls. A small amount of sediment was translocated into the adjacent west ditch. Sediment was removed where feasible. This area was repaired and armed significantly as observed during the 7/24 visit.</p> <p>At the 7/24/14 site visit, Epsilon noted that while hay bales were restaked the silt fence at the RSA 5 end blow out location were not properly toed in. The WS was immediately notified. The WS's weekly report indicated that this area was properly toed in and hay bales were restaked. Sediment was mobilized on the slope of the relocated west ditch and a small amount made it into the west ditch, as indicated in photos from the WS report, sediment was hand removed from this area and mulched. Epsilon also noted a small tear in the silt fence by the headwall from Catch Basin 11 (the headwall by Taxiway A). Water was slowly releasing from this tear, but was generally clear as the tear was above the point where settling occurred. The WS was also notified of this issue. Epsilon observed water overtopping the silt fence at the headwall from Catch Basin 1, southwest the runway intersection on 7/17, the WS and RE was immediately notified. The contractor placed a second row of silt fence at that area and armed the area with a second row of hay bales. On 7/24 Epsilon noted that the second row of silt fence was not properly toed in. The contractor is currently working on this area. Currently no sediment laden water is mobilizing, but this area needs to be fixed.</p> <p>Areas where previous failures were observed are continuing to be monitored and no additional issues have been observed except where noted. Erosion controls along the ILS road are discussed within the tree clearing section. The contractor has an emergency supply of silt fence and compost tubes present on the site.</p>
