**New Bedford Regional Airport
Runway Safety Improvements Project – Phase 4
Reconstruct, Mark, and Groove Runway 5-23
MassDEP File No. SE049-0635**

ENVIRONMENTAL MONITOR INSPECTION FORM

Date/ Time of Inspections: **7/17/14 (all day) and 7/24/14 (afternoon).**

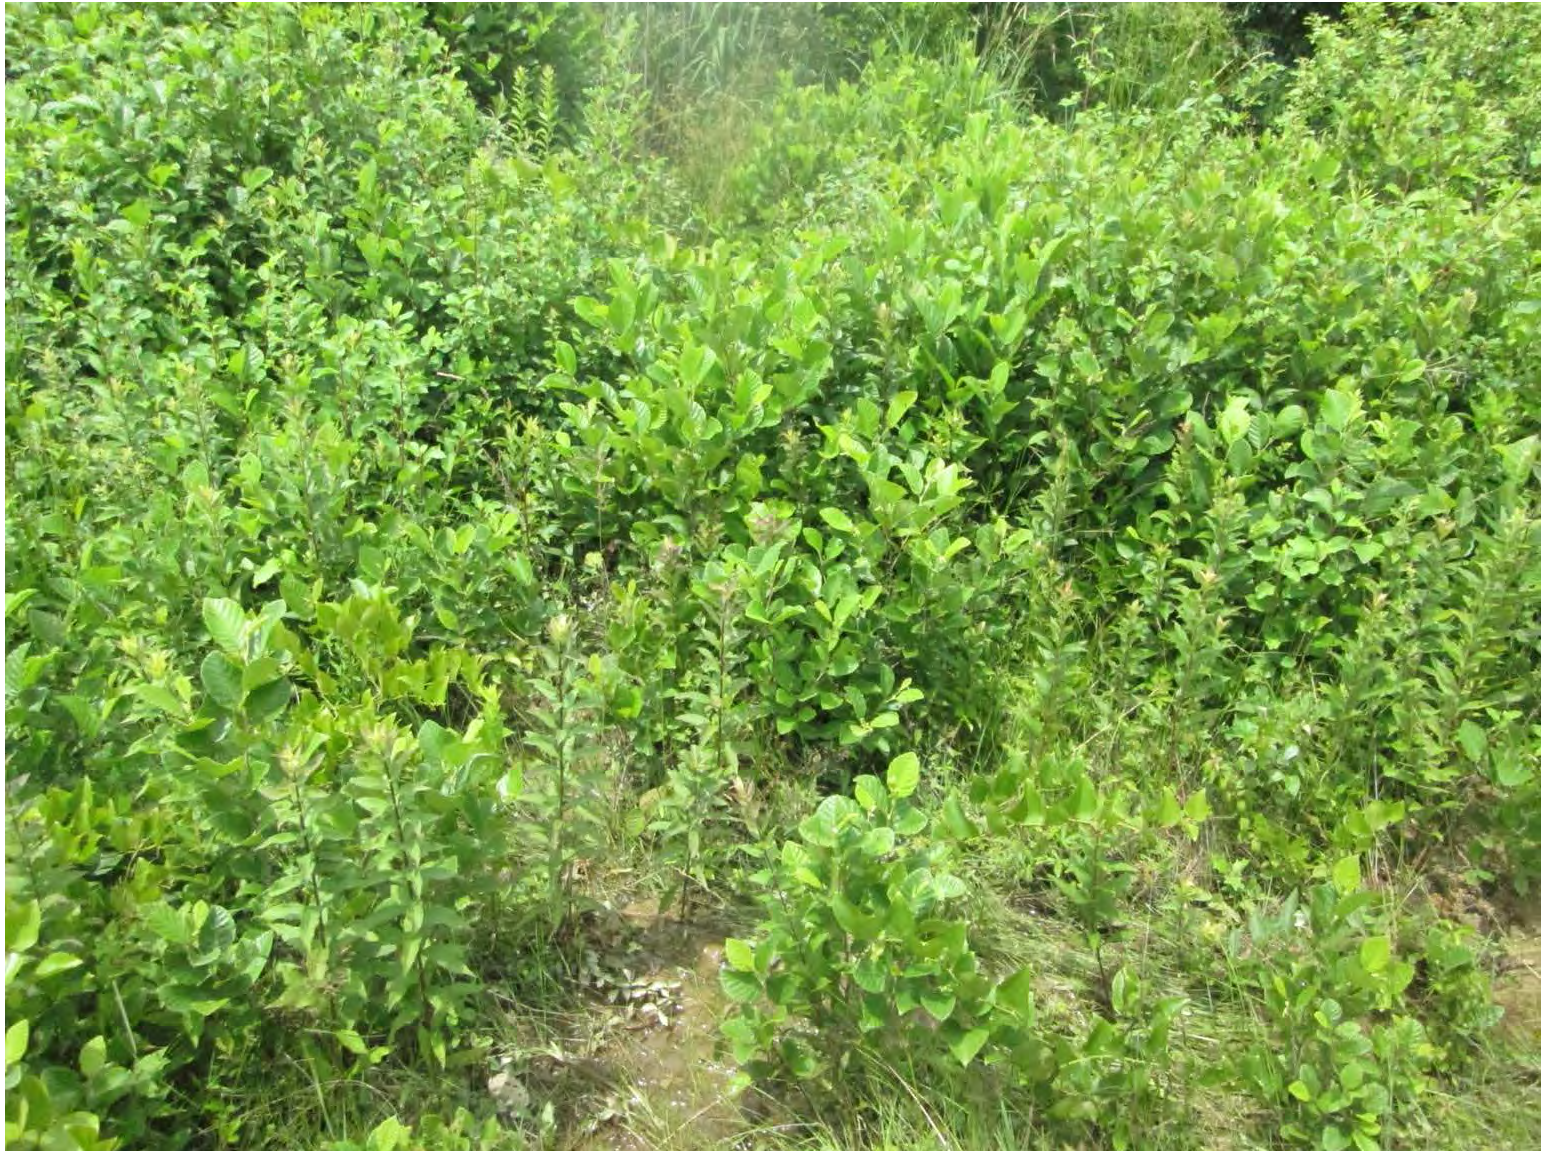
View of small release from catch basin at Runway 5 end on 7/17/14.

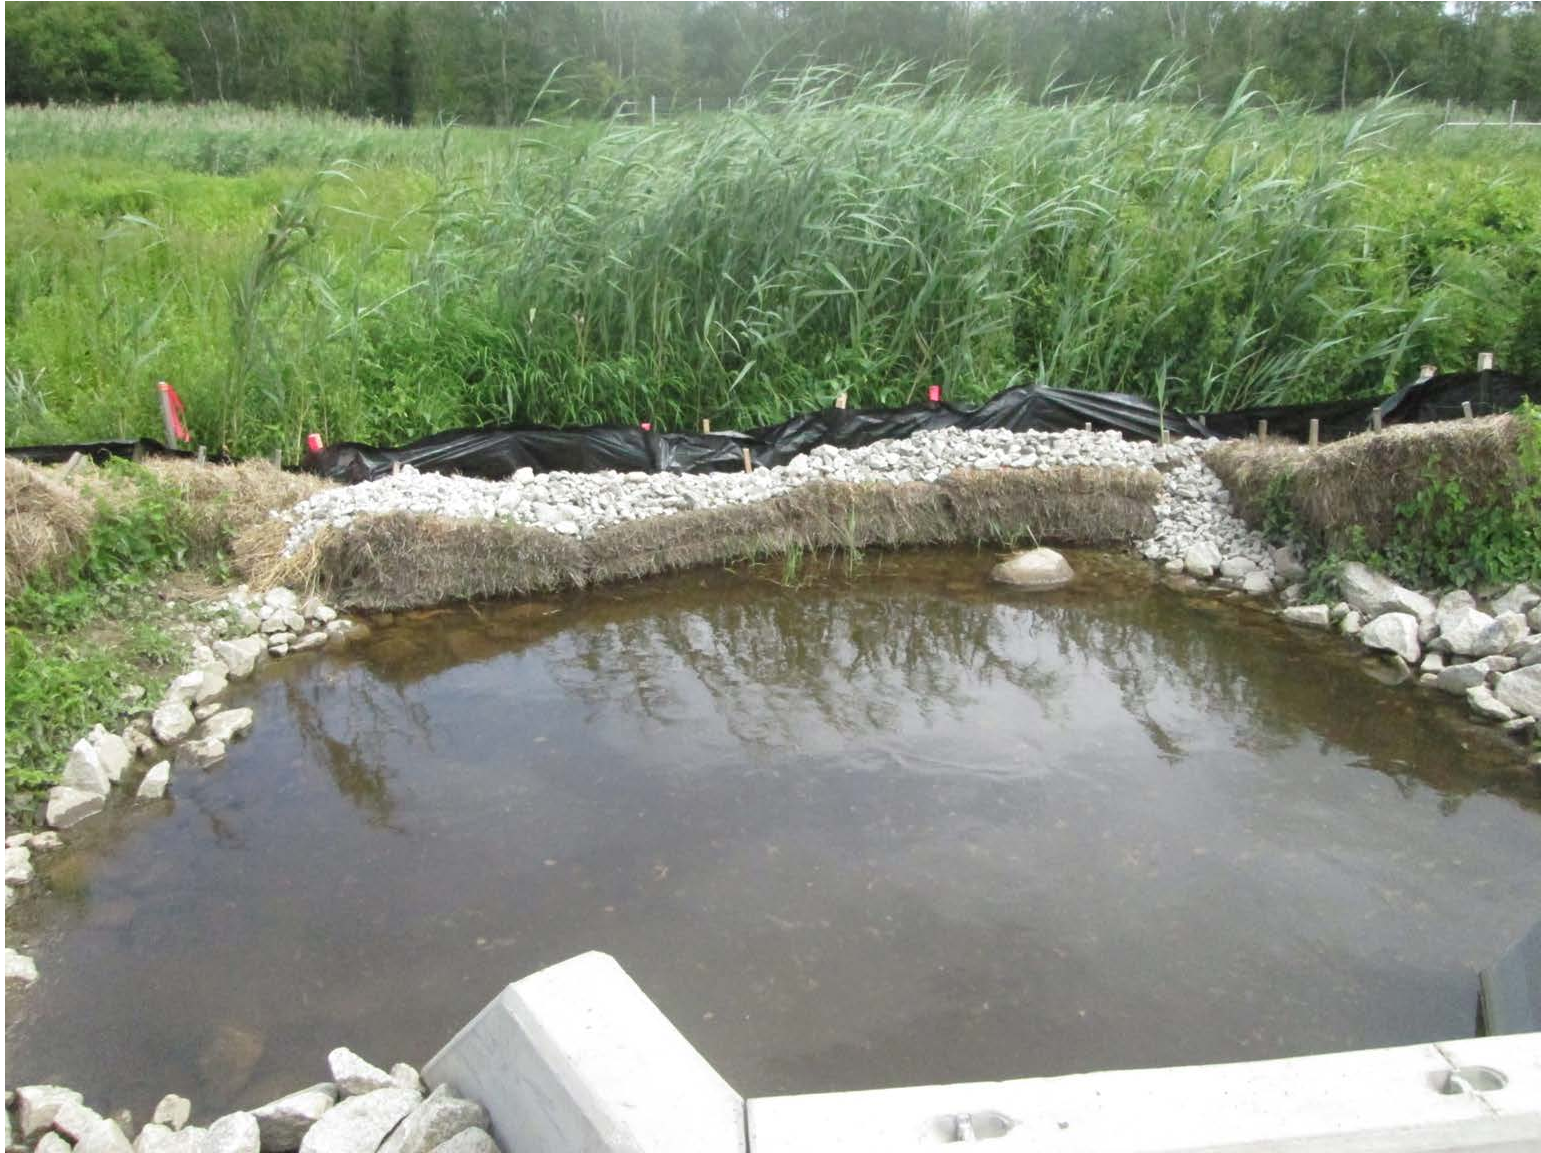
View of headwall by catch basin 11, area was armed. (7/24/14).

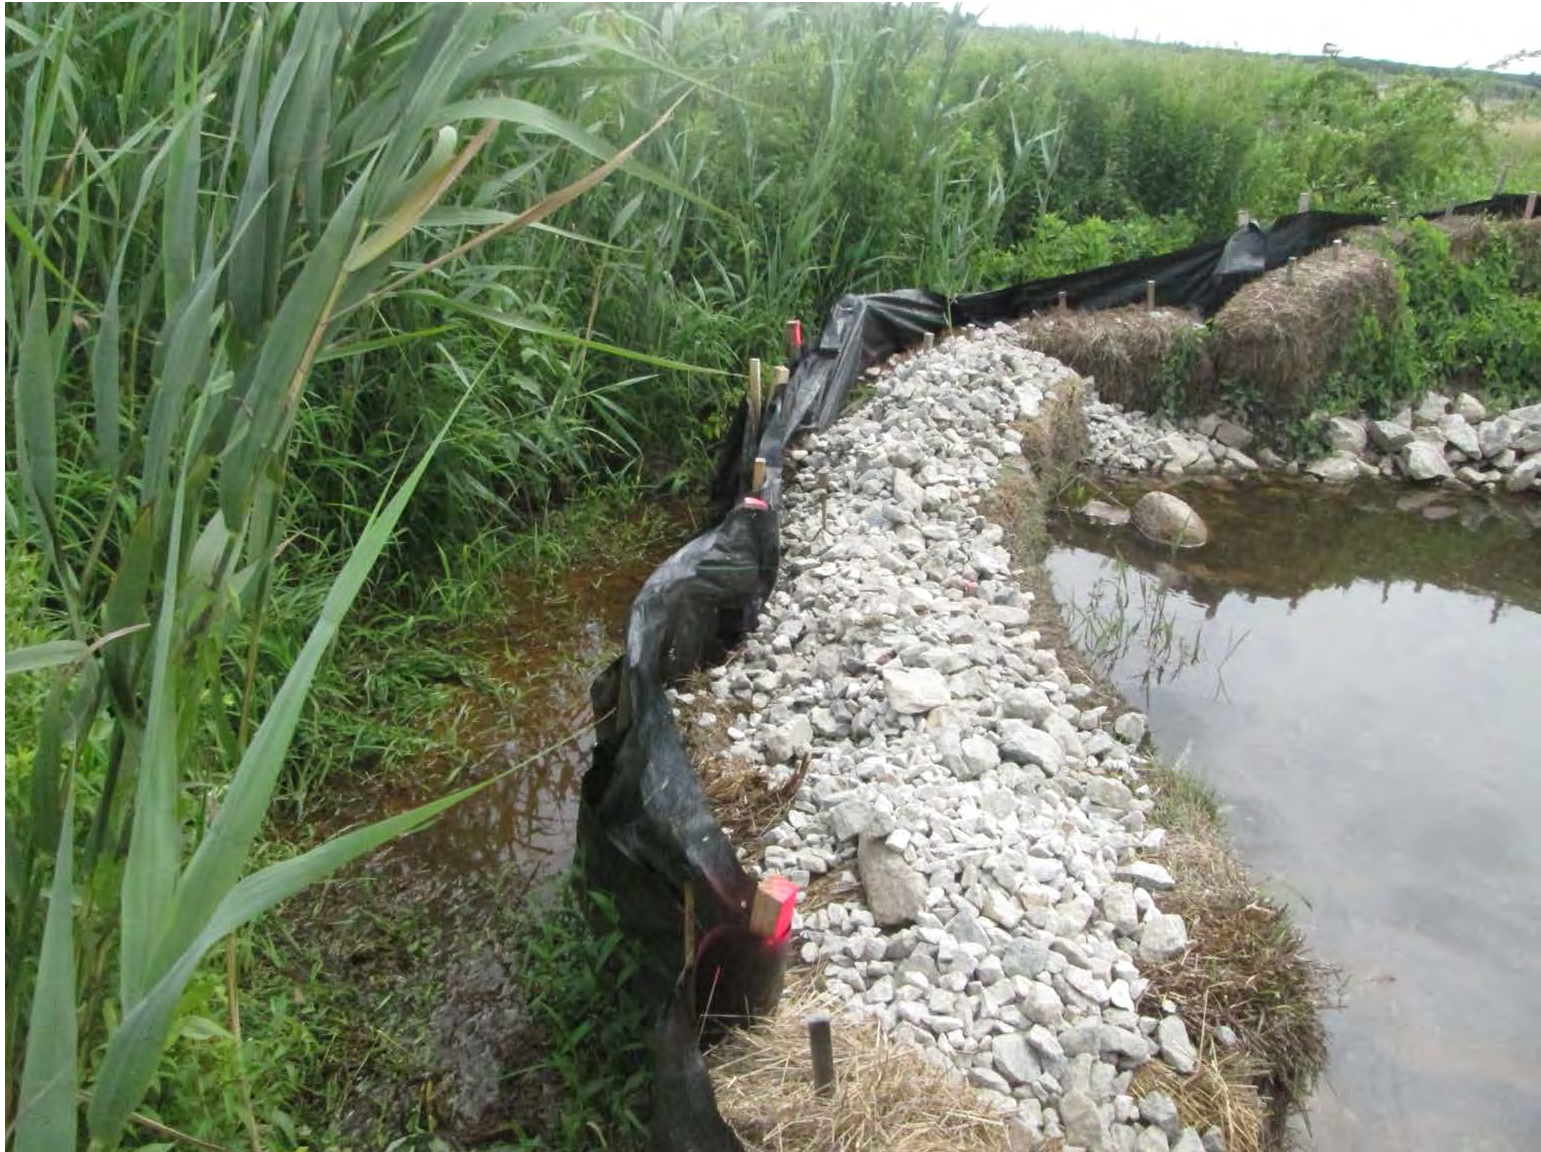
View of water beyond erosion controls. A small tear was noted and reported to the WS. (7/24/14).

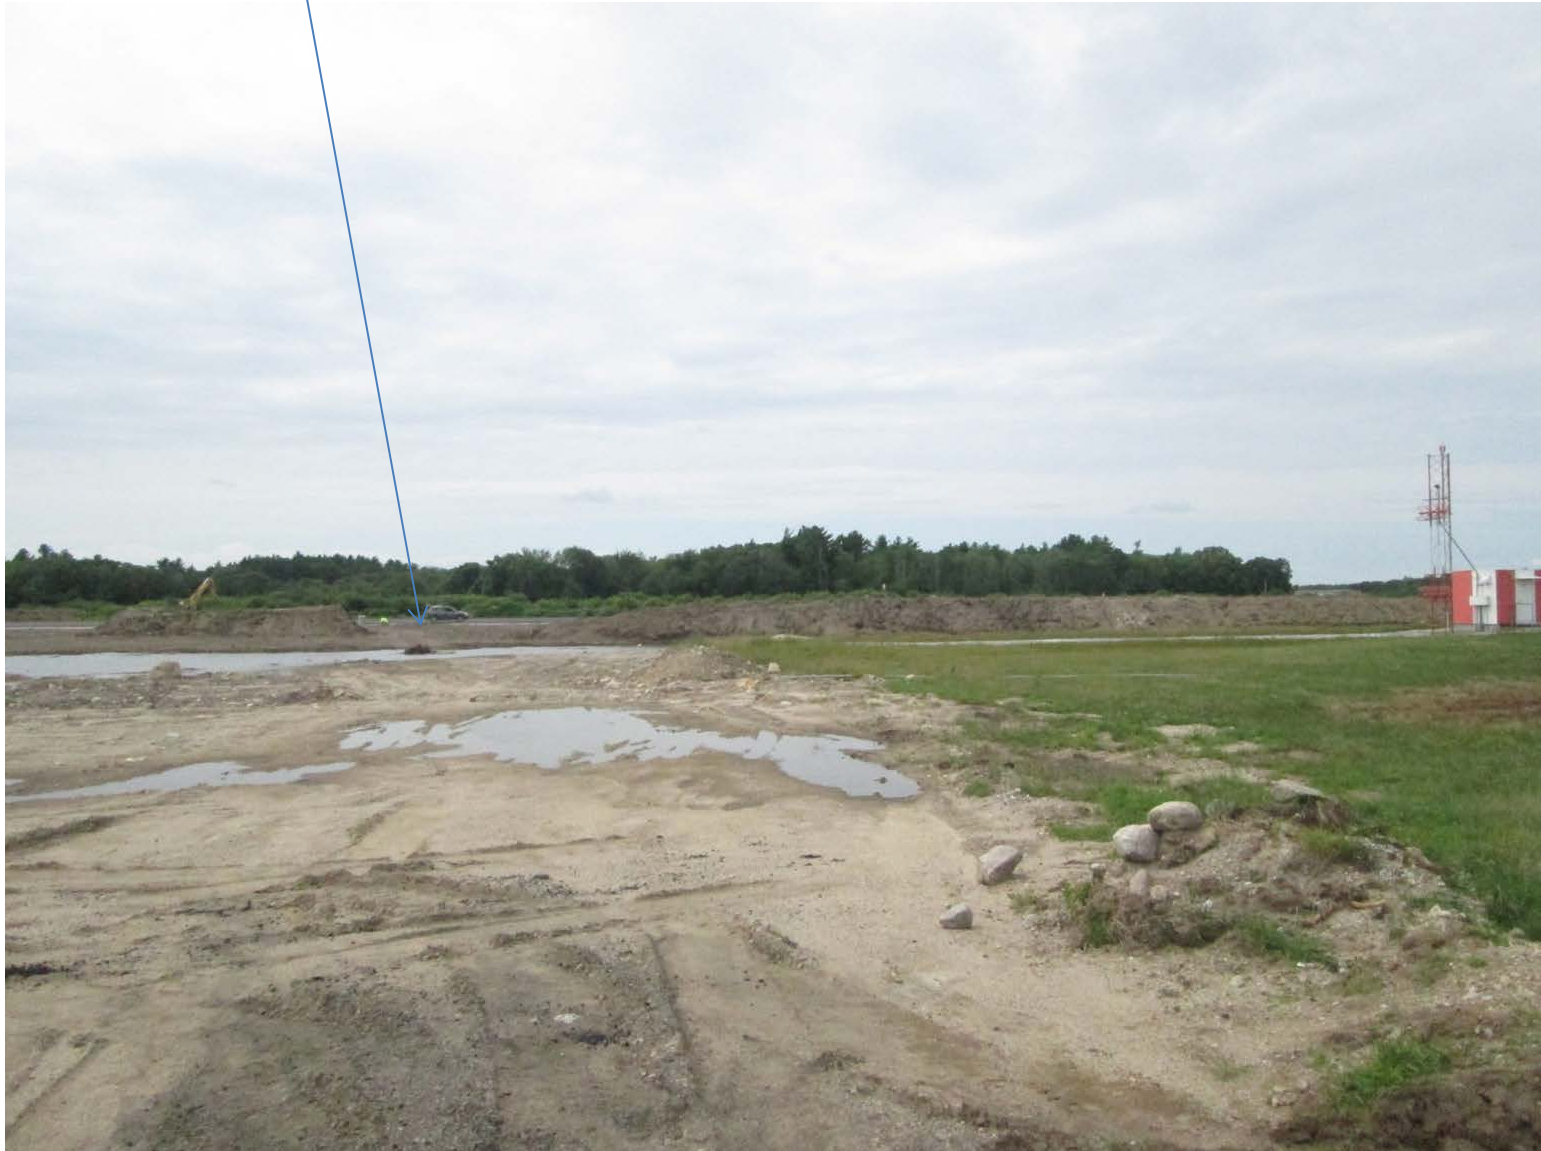
View of catch basin 11 on 7/24/14.

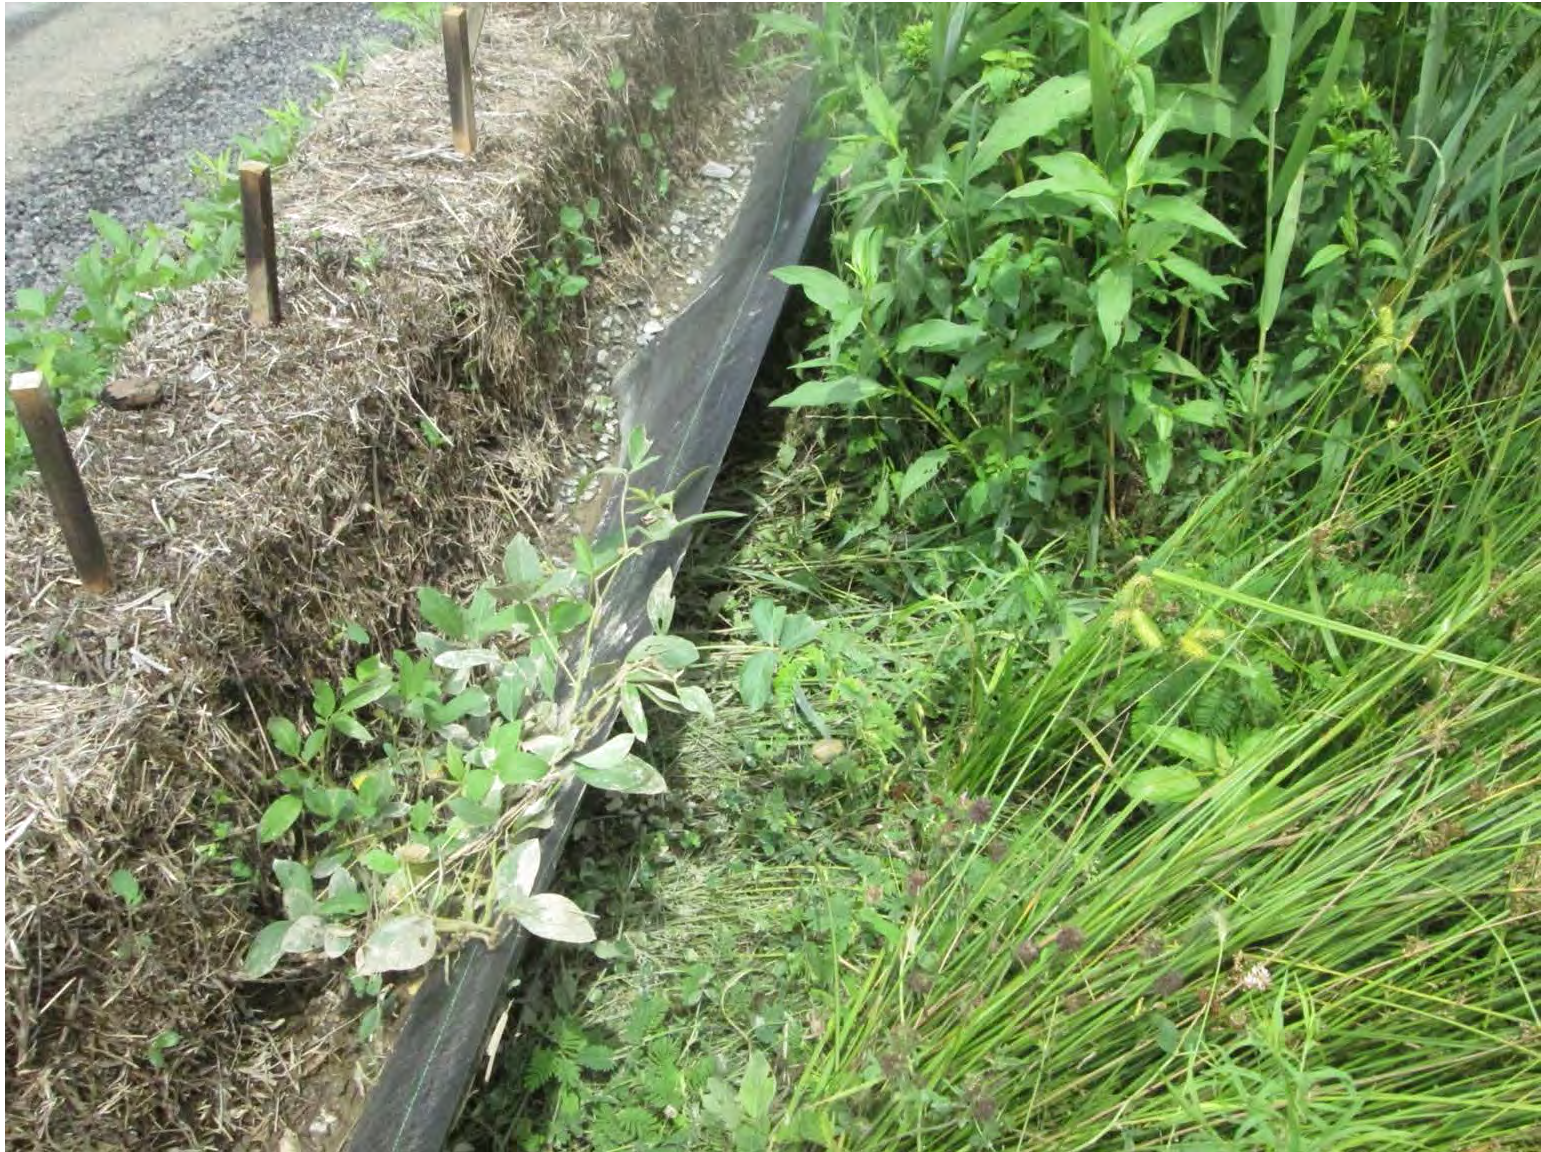
Example of erosion control matted down by water on 7/17/14. These erosion controls were repaired and restaked.

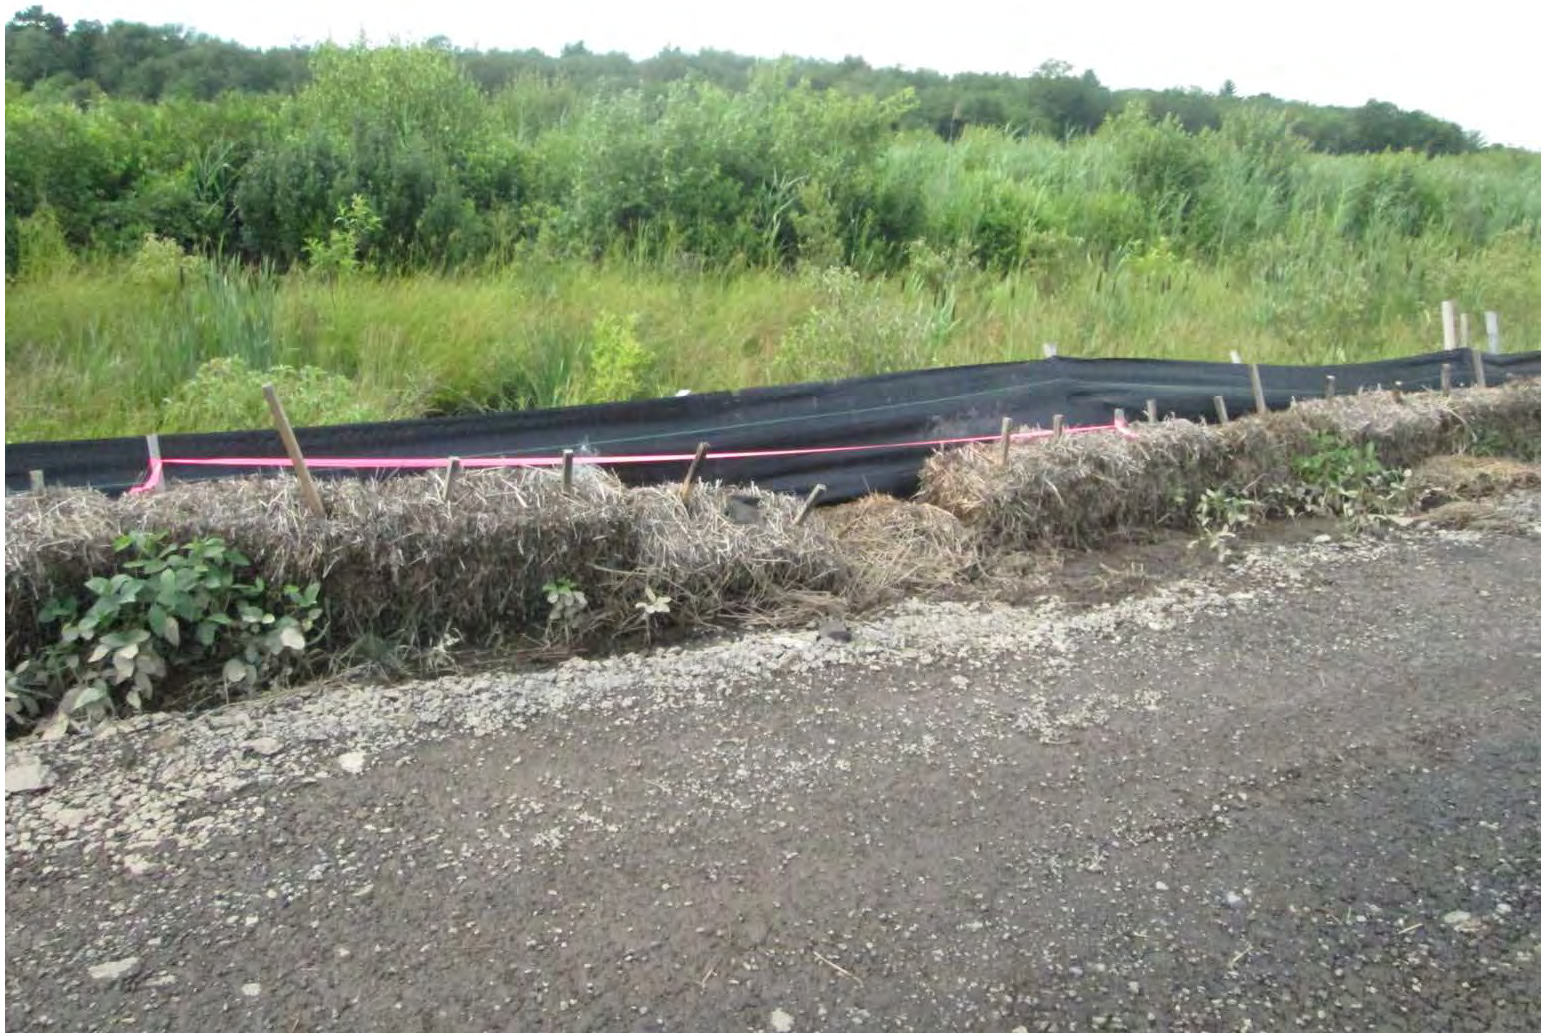
View of blow out from thunderstorm. On 7/17/14 it was obvious that the hay bale was not removed but compromised by the force of the water. Water tunneled through the two silt fences, laying one down and moving the other.

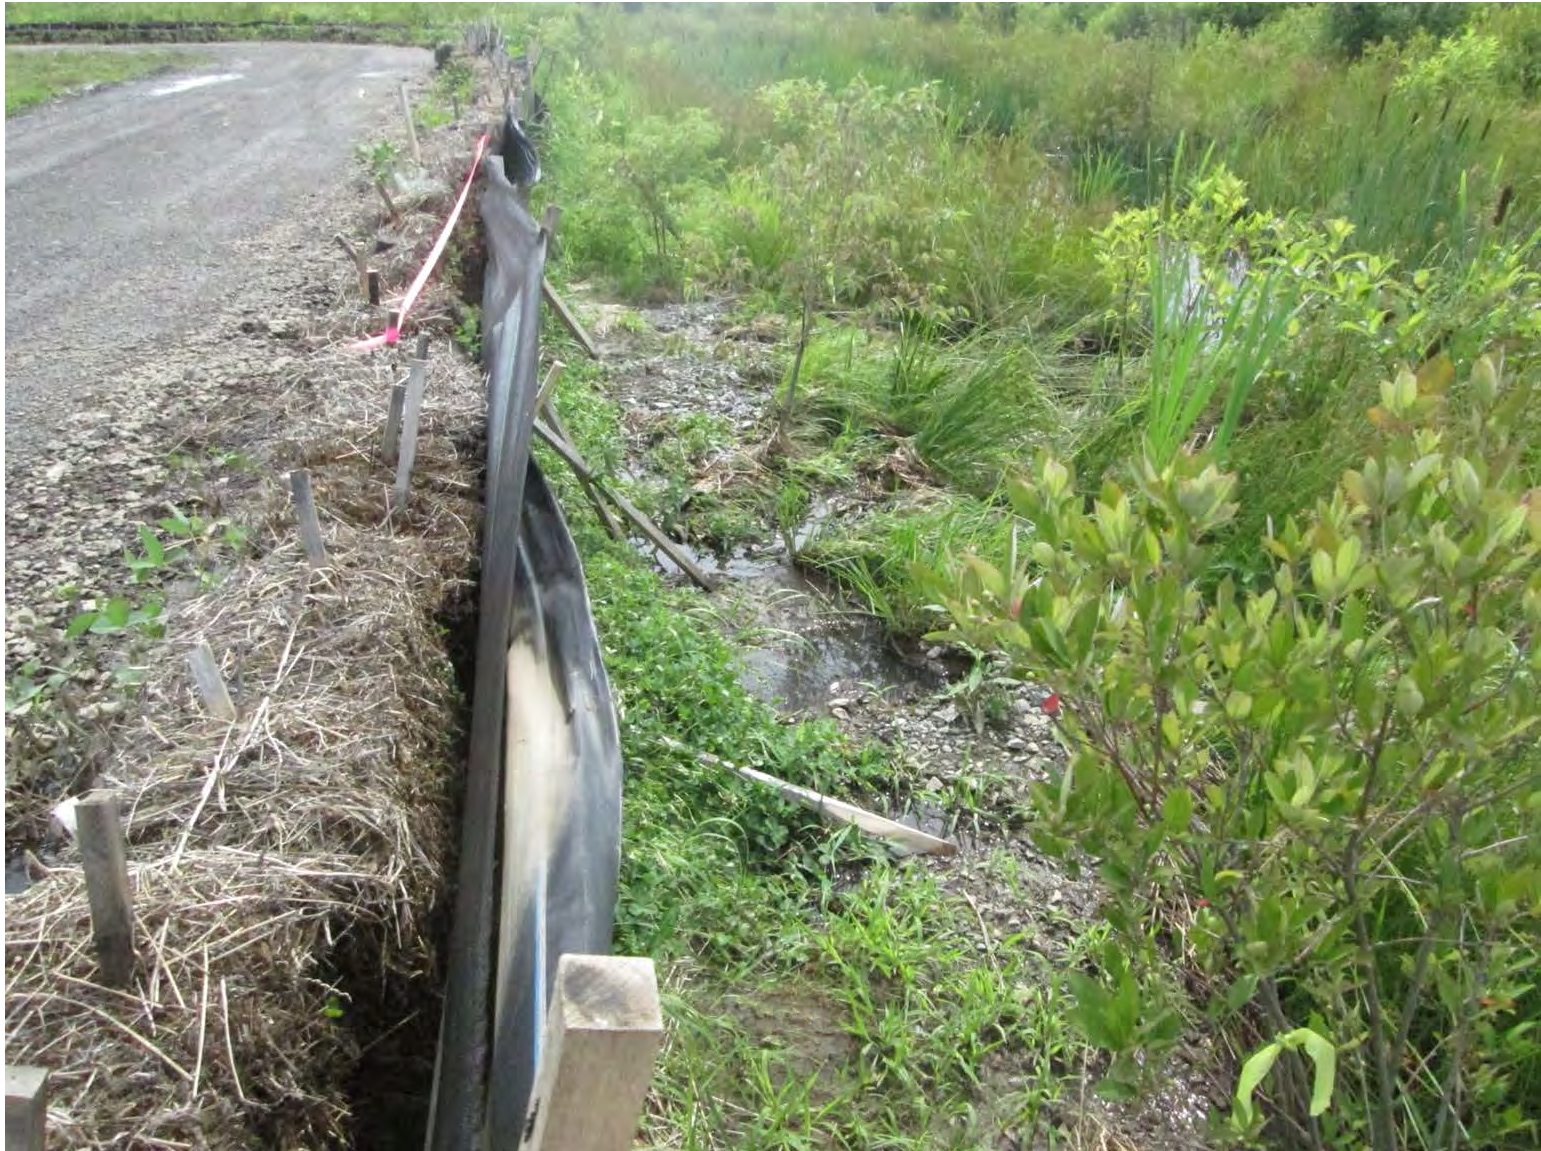
View of sediment and rock translocated into the west ditch restoration bank area and a small portion into the west ditch on 7/17/14.

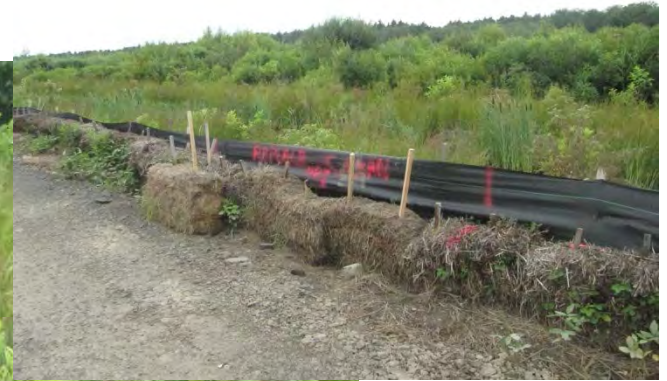
View of sediment that needs to be removed from the west ditch restoration area. 7/24/14. The WS reported that this area was fixed: silt fence toed in and sediment removed on 7/25/14.

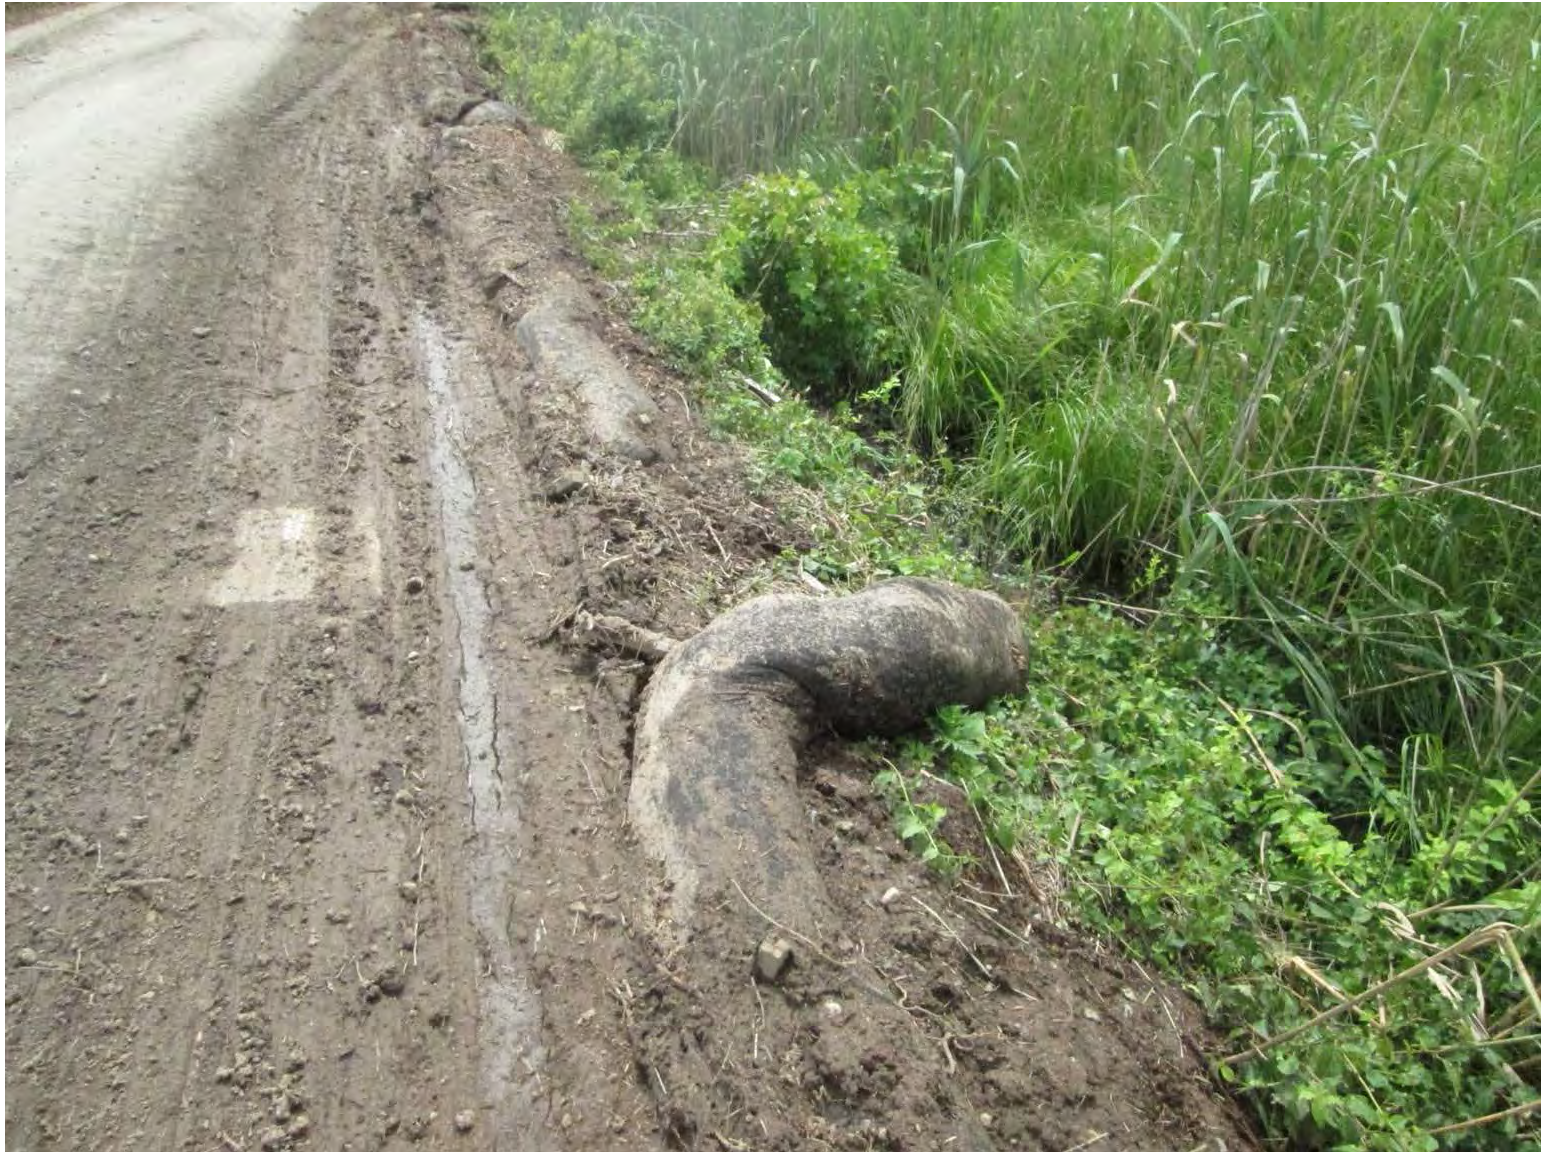
Work Area 1A – Tree Clearing in Dartmouth	<input checked="" type="checkbox"/> yes <input type="checkbox"/> no <input type="checkbox"/> n/a	By the end of the week of July 14 th , the ILS road had deteriorated. Compost tubes were dislodged or covered with sediment due to tree branches scraping the soil surface and creating some very local movement, and while no sediment had reached the adjacent wetlands it was possible that it could in the future. It had appeared that the operator was not driving down the center of the ILS road. As a result, Wagner Wood has modified their operations at the request of the WS. As a result of the ongoing deterioration of the ILS road shoulders the contractor is staging more, including cutting trees within the clearing area with a chainsaw. The contractor is now dragging smaller twitch loads and has added a skidder to remove large logs from the clearing area. The result is that there is a smaller twitch load footprint and less erosional force on the road. There is also strict enforcement that the operator

View of deteriorated compost tube on 7/17/14.

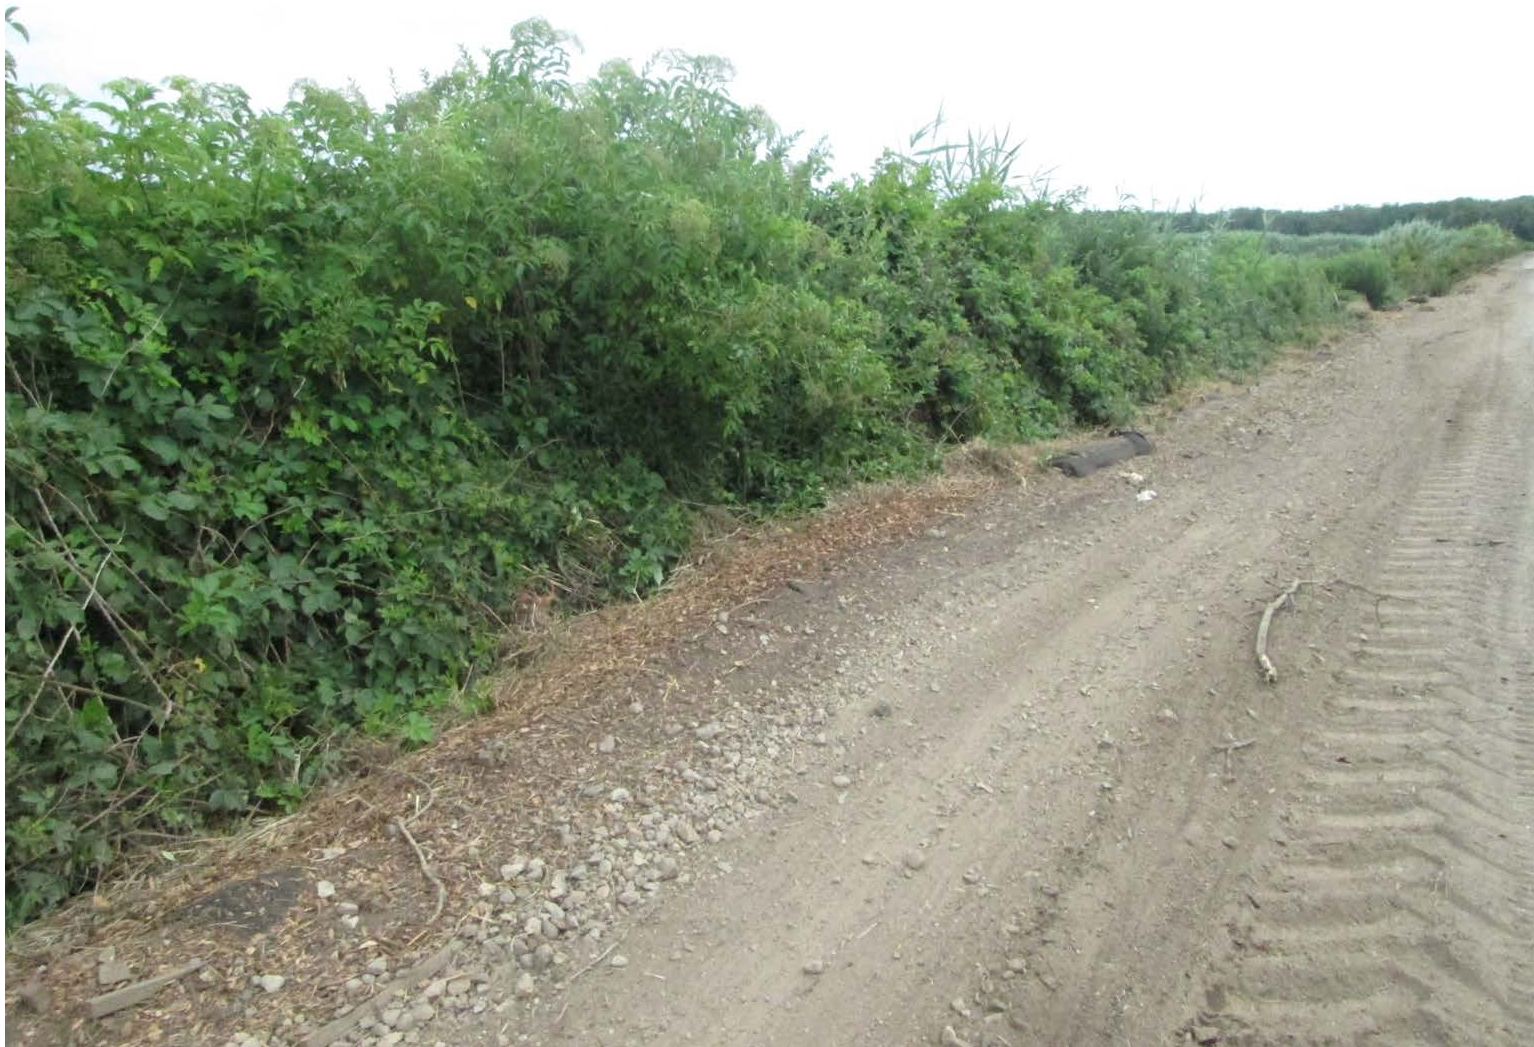
View of erosion control along the ILS road 7/24/14, wood chips and hay were added to discrete areas at time of inspection.

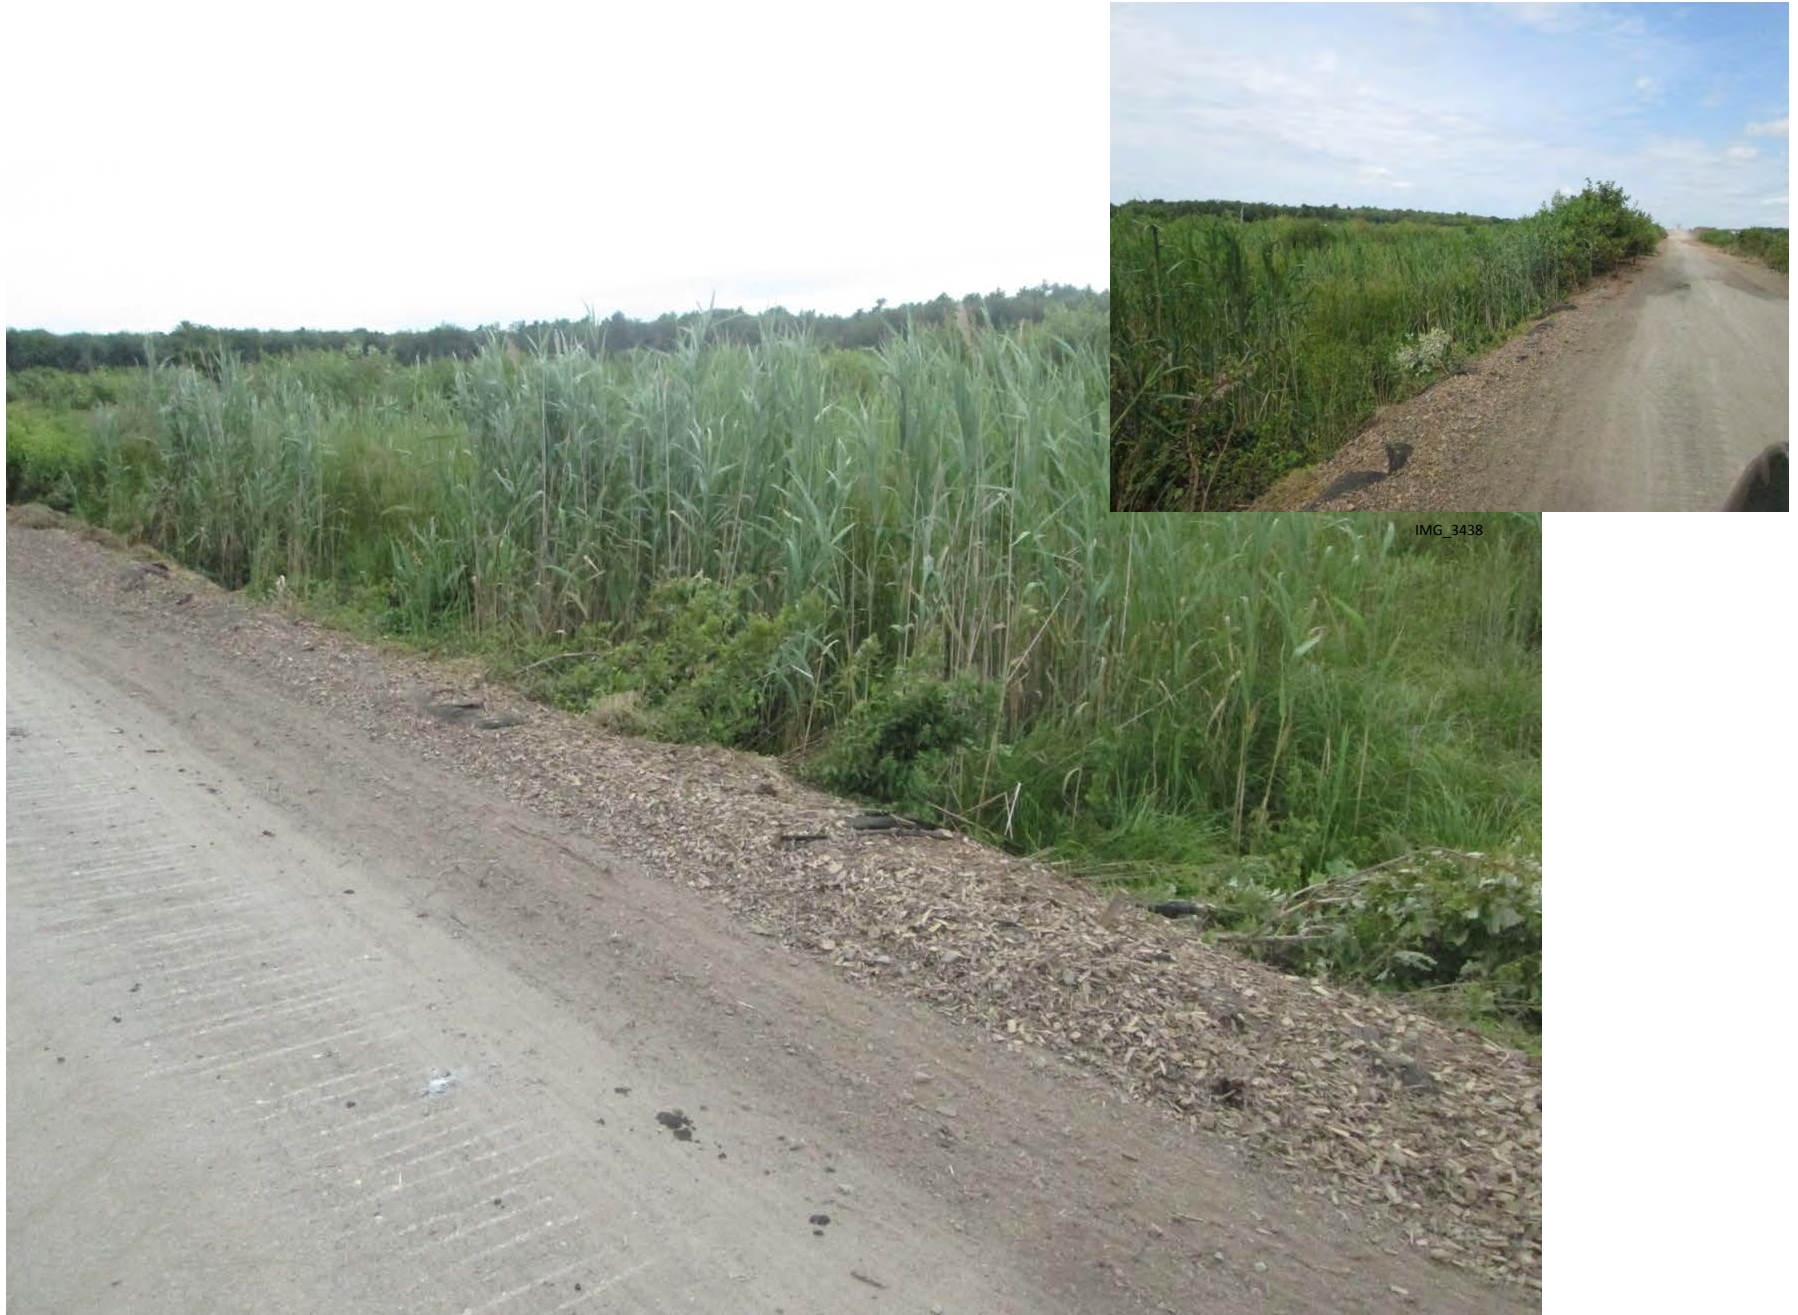
View of repaired ILS road with wood chips from 7/24/14.

Control Measure	Cleaning or Repair Needed	Comments/Recommendations from the EM
		<p>must drive down the center of the ILS road. The contractor repaired and restaked silt fence and hay bales along the ILS road. Logs are still being used to arm these controls. The contractor cleared excess sediment off the road has used wood chips and straw to arm and protect the compost tubes in the worst areas. More wood chips can be used to protect the compost tubes along the whole road. As of Friday 7/25/14, the contractor was working to arm the entire ILS road as directed by MassDEP and the Conservation Commission Agent (S. Porter). No sediment was noted in the adjacent wetlands. These sediment controls will be replaced prior to electrical trenching and earthwork. More timber mats were added to protect the West Ditch culvert.</p> <p>Tree clearing itself has been progressing smoothly. There is one feller buncher and three grappler machines to remove trees. Three pieces of equipment are moving trees to the processing area and fixing the timber mats as needed. The feller buncher on its own series of mats was clearing trees while one grappler was moving trees to the timber mat access road. One snag per acre has been identified and shored off at approximately 10-12 ft. One trailer of logs is removed from the site daily. Tree processing is ongoing.</p>

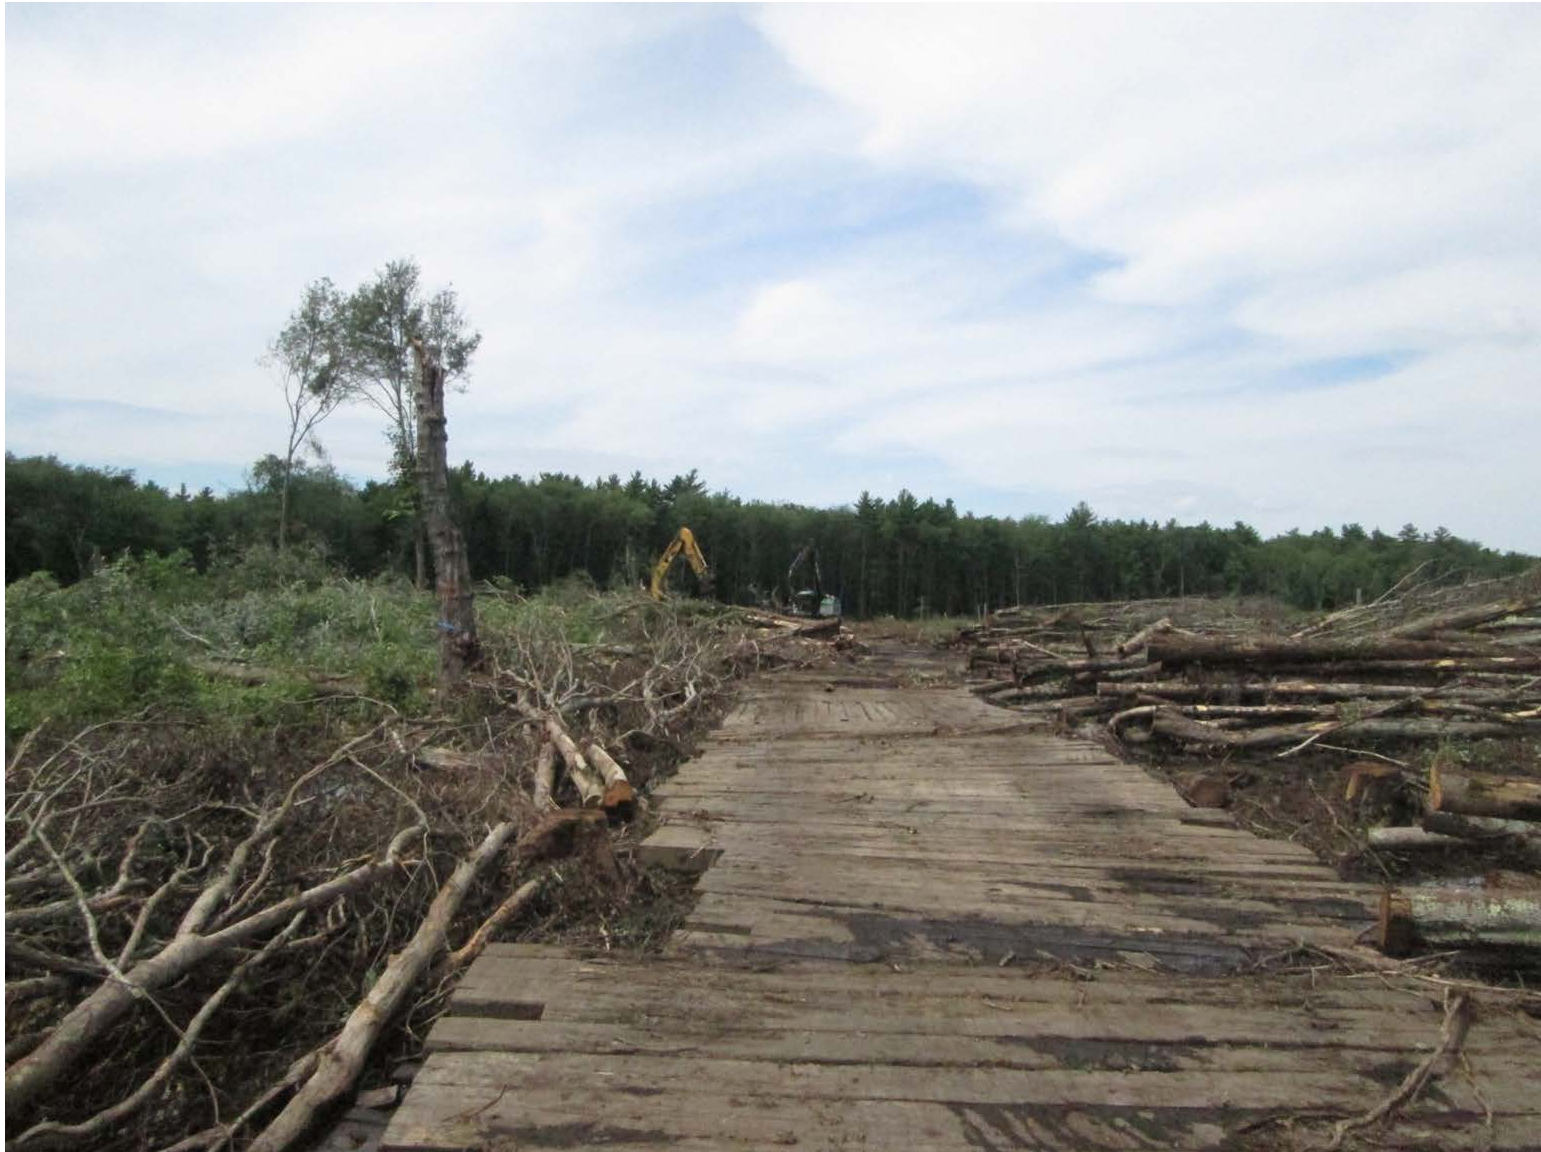
Tree clearing observed on 7/17/14.

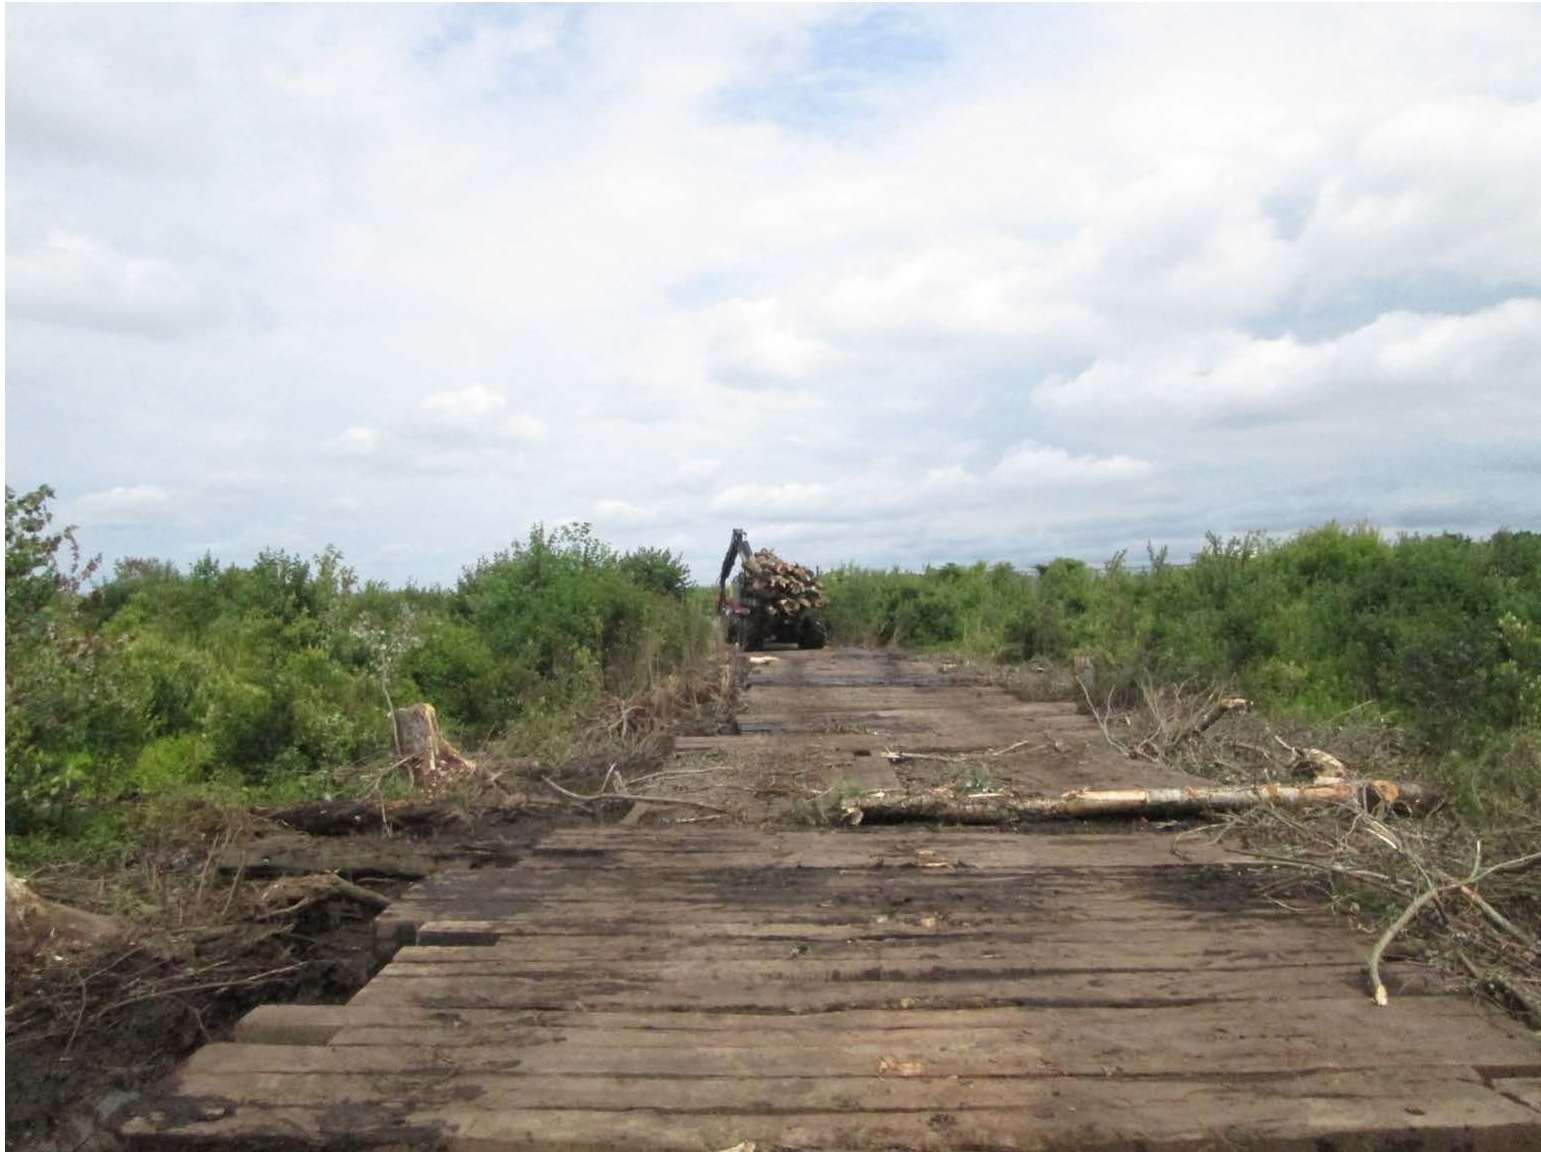
View of logs being removed from Dartmouth down the timber mat road on 7/24/14.
