**New Bedford Regional Airport
Runway Safety Improvements Project – Phase 4
Reconstruct, Mark, and Groove Runway 5-23
MassDEP File No. SE049-0635**

ENVIRONMENTAL MONITOR INSPECTION FORM

Date/ Time of Inspections: **7/17/14 (all day) and 7/24/14 (afternoon).**

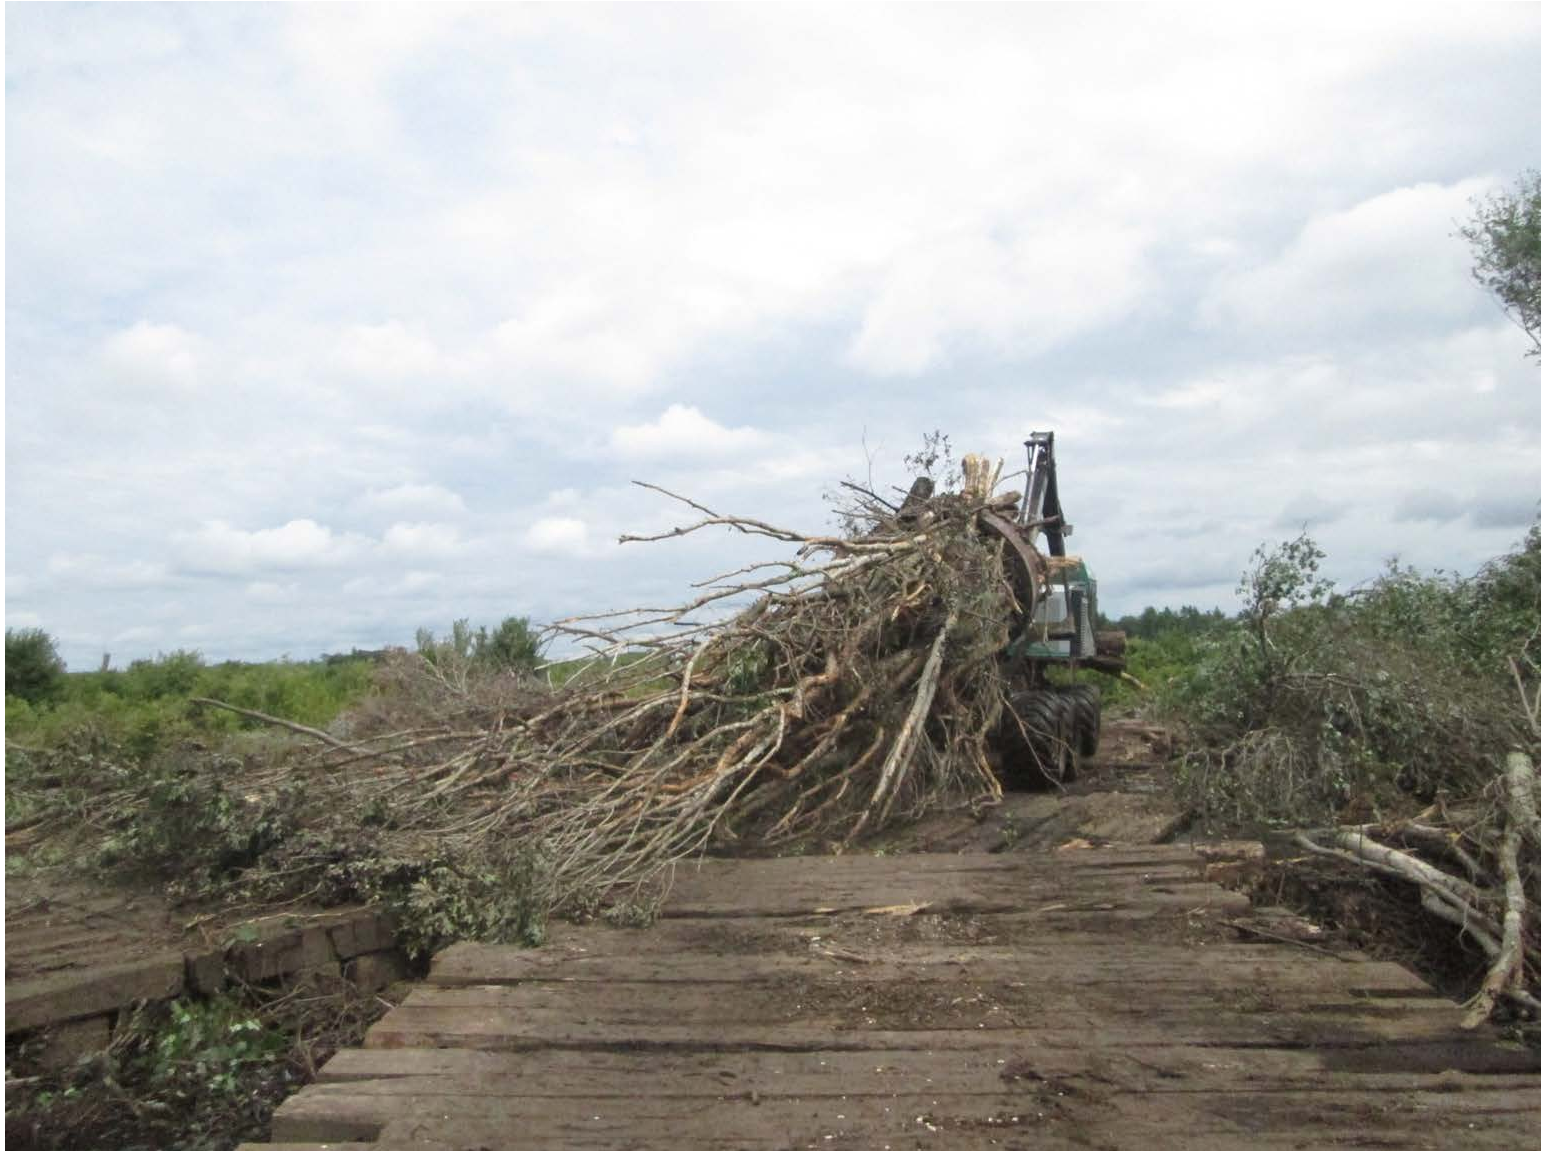
View of "twigs" being removed from Dartmouth 7/24/14.

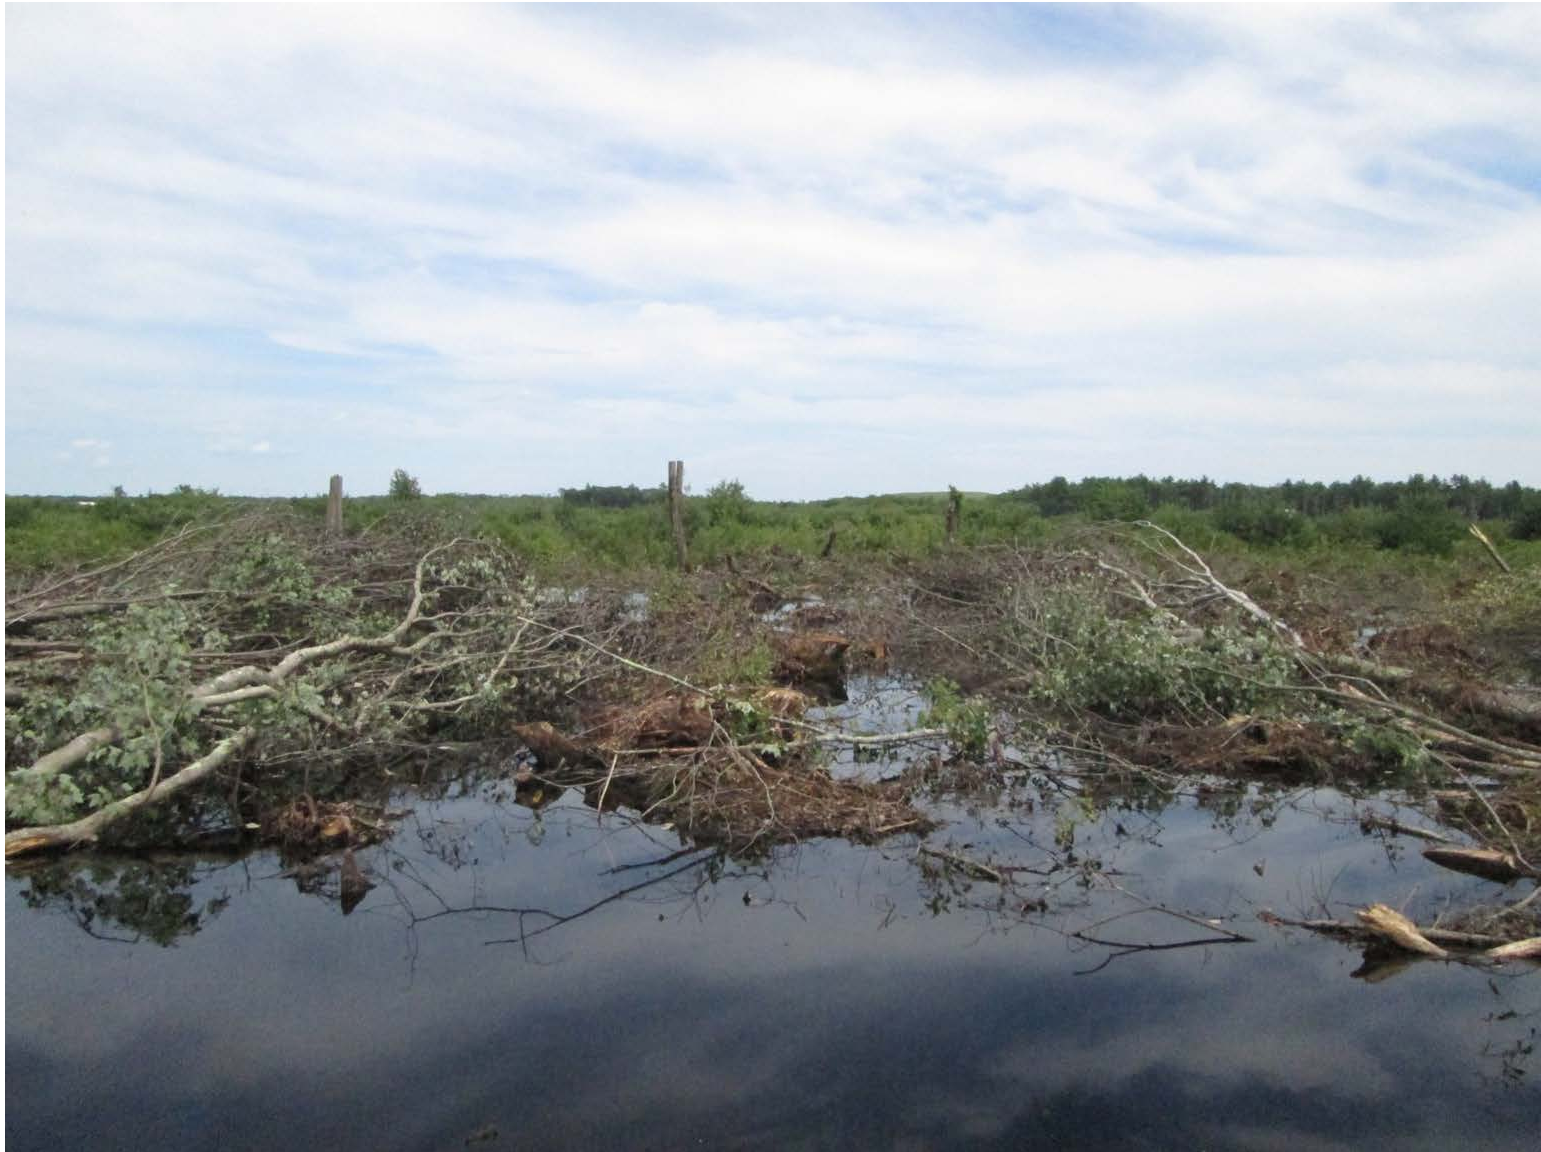
View of cleared area from 7/17/14.
