NEW BEDFORD REGIONAL AIRPORT  
RUNWAY 5-23 – PHASE 4

Reconstruct, Mark and Grove

Weekly Environmental Report

WEEK 12

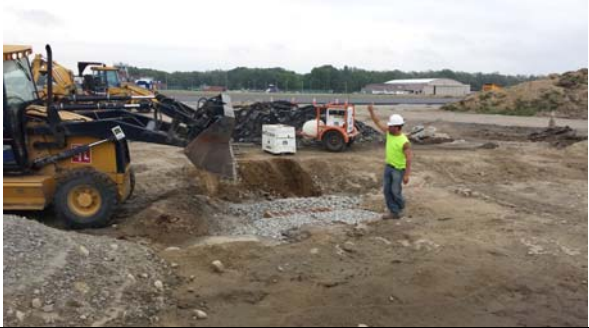
JM Fiske was on site a 7 AM - No clearing, no turtle sweeps in North Dartmouth section.	
Minimal crew during day. Preparation for 81-hour shutdown	
ETL added stone around a catch basin that will be used as a pump out chamber to discharge water to the RW5 end swale

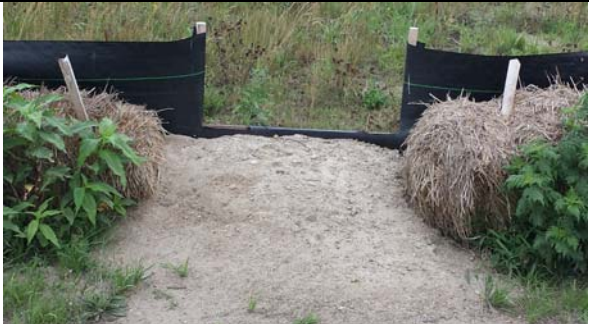
All turtle gates were re-inspected. Any turtle gate with a gap between the plywood and the earthen ramp was repaired.

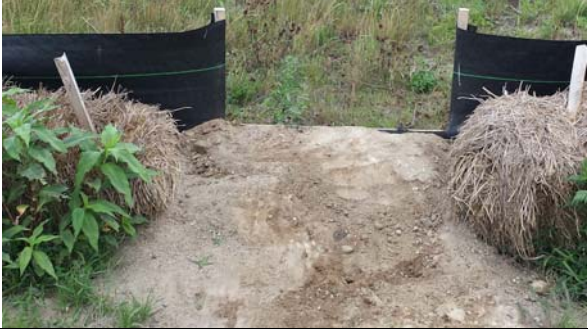
<p>A total of 6 of the 28 turtle gates were repaired by adding material to the ramp.</p>

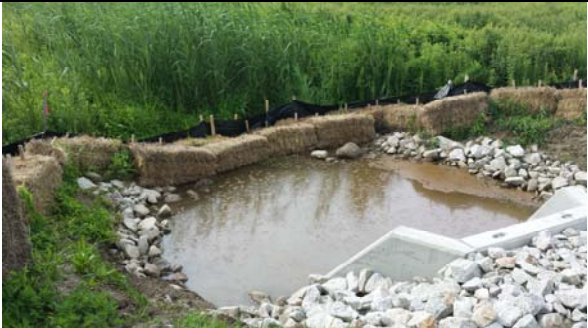
<p>All outlets were inspected to ensure silt fence and hay bales were in place in preparation of the 81-hour shut-down and the pending rain storms. This is the outlet from the area between taxiway A and RW5 runway. The cloudiness and sheen in the ponded water were investigated and appear to be organic in nature.</p>

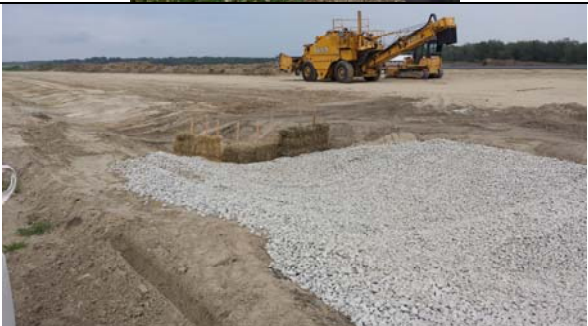
<p>All silt fence on the entire perimeter was inspected. No gaps in fences or hay bale barriers were observed.</p>	 
<p>A hay bale check dam was added above the stone apron installed at the end on the RW5 swale. Dewatering of the existing storm drain system to the swale began at 3:00PM</p>

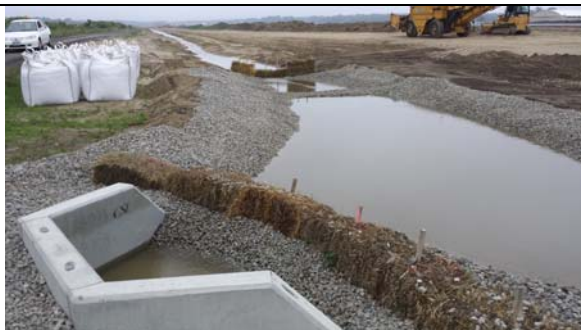
The swale and discharge were inspected after 7:00 PM and before the shutdown officially started. Water was clear and no turbid discharges were occurring.

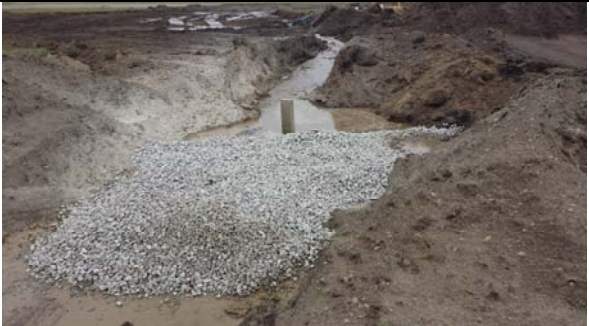
<p>An additional stone check dam was added on the RW23 end in the shutdown area to create a sediment trap and allow flows from the dewatering operation to continue to flow.</p>

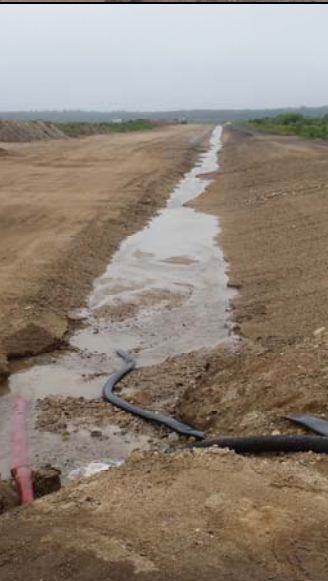
A photograph showing a stone check dam constructed across a ditch. The dam is made of numerous light-colored, irregularly shaped stones. Water is visible flowing over the dam from the background towards the foreground.
<p>View of the discharge into the RW5 swale at the upper end. Discharge water was continuously monitored and no turbid discharges were observed.</p>

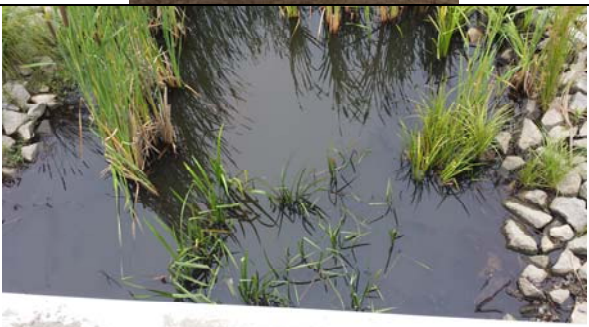
A photograph showing a long, straight discharge pipe or channel running through a dirt area. A line of water is flowing along the length of the pipe, which is surrounded by brown soil. The background shows a flat, open area under a cloudy sky.
<p>Water quality was also monitored in the west ditch as part of the verification of no degradation.</p>

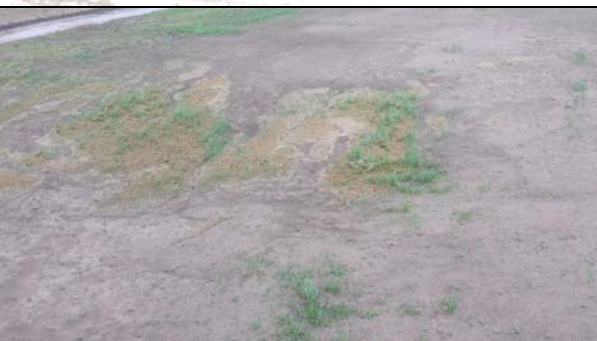
<p>Seed and mulch put down in the Taxiway B area by the hydro-seeder has been washed into clumps and will need to be re-done. Grass germination is evident after 10 days.</p>

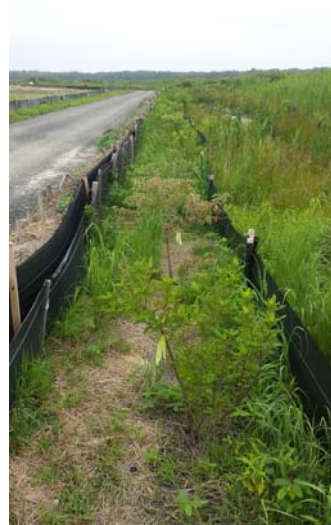
The west ditch buffer was inspected. Area is stable and all erosion control remained intact.

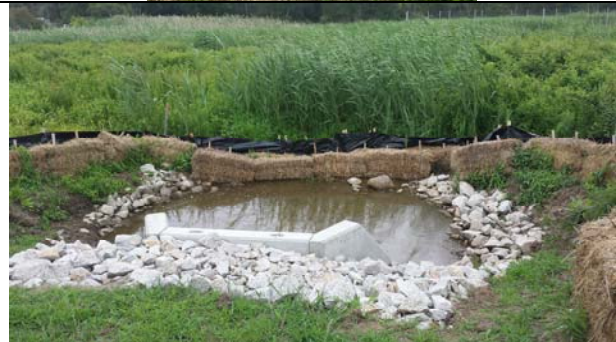
At the outfall by Taxiway A, a second row of silt fence was placed between the existing fence and the hay bales to fill any holes in the silt fence.

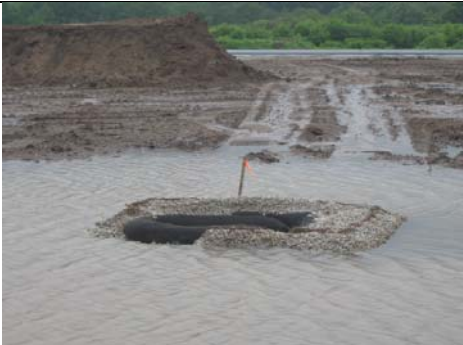
<p>CB-11 between Taxiway A &amp; RW5: The recently placed bmp was overtopped by overnight rains</p>

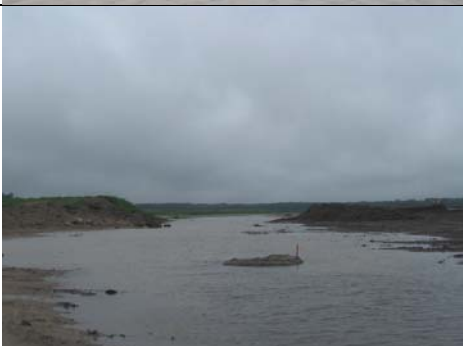
<p>The immediate area surrounding CB-11 between Taxiway A &amp; RW5: The bmp that was placed on 7/11/2014 although overtopped prevented the direct discharge of flowage to the Concrete Headwall situated on south side of Taxiway A.</p>

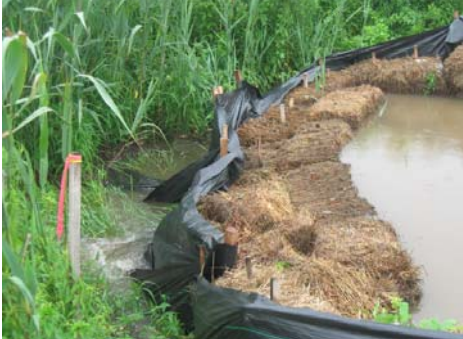
<p>The Concrete Headwall situated on south side of Taxiway A: Turbid flowage was noted w/an improvement in clarity after the silt fence/hay bale bmp once the rained slowed. JM Fiske will complete a closer investigation on 7/21/2014 for any accumulation of sediment at the perimeter of the adjacent wetland.</p>

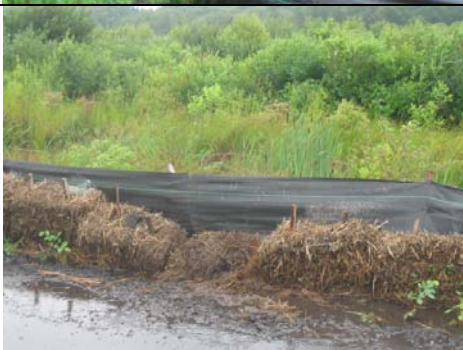
<p>West Ditch: A failure occurred here during the late morning of 7/16/2014. At this time a hay bale and section of silt fence was pushed over by surfacial flowage.</p>

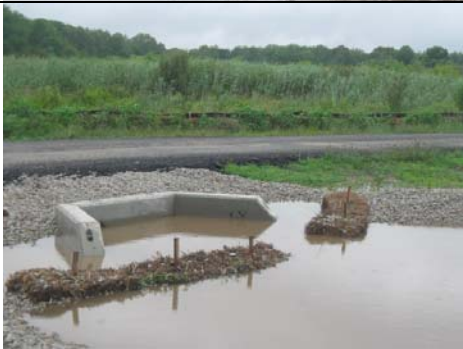
<p>Concrete Headwall - Inlet - North Side of RW 5 – Western End: A hay bale was dislodged here plugging the main inlet (at the time it could not be seen) and forcing a large percentage of the incoming flowage down along the access road towards the West Ditch.</p>

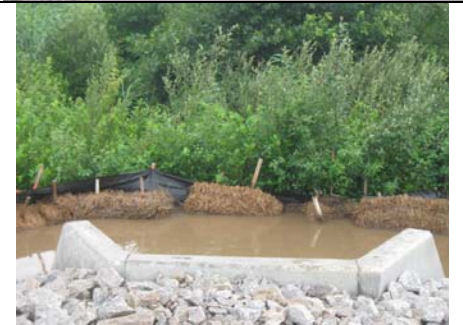
<p>Concrete Headwall - Outlet - North Side of RW 5 – Western End: The bmp at the outlet was compromised by the heavy flowage on 7/16/2014. Turbidity was again noted. Due to the blockage at the inlet, coarse sedimentation would have been limited.</p>

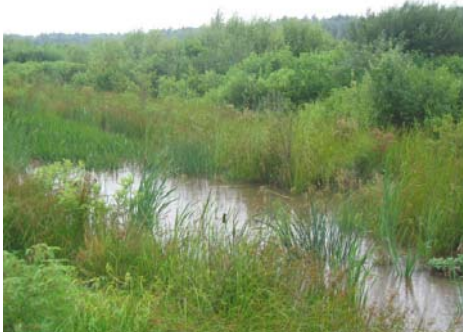
<p>The Wetland adjacent the Concrete Headwall - North Side of RW 5 – Western End: Turbidity was noted during the rain event.</p>

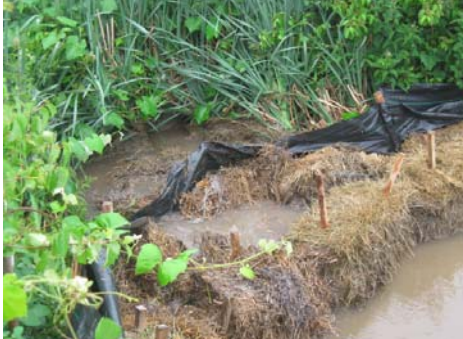
<p>Concrete Headwall - Outlet - North Side of RW 5 – Eastern End: This bmp was compromised by the volume of flowage. The respective silt fence and hay bales were both compromised. The 81 hour shut-down commitment at the center of the runways restrained a timely response to necessary erosion control measures.</p>

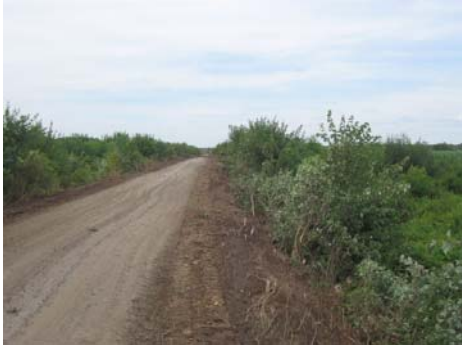
<p>The bmp's at the edge of the access road to and from the log yard have deteriorated from the twitching of logs. Sections of silt socks have been buried by soil or have been torn apart. Bmp measures need to added to prevent the movement of soils towards the wetlands.</p>

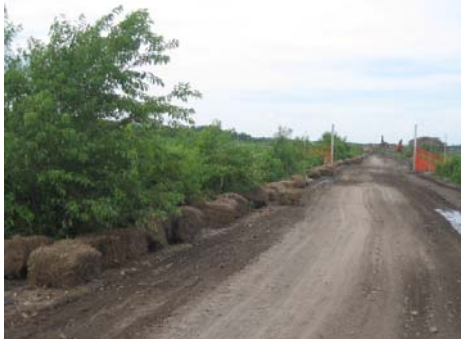
<p>Many of the hay bales that were placed at the edge of the access road to prevent the migration of soils need to be repositioned or replaced as needed. The width of the log twitches need to adjusted to minimize damage to the adjacent bmps.</p>

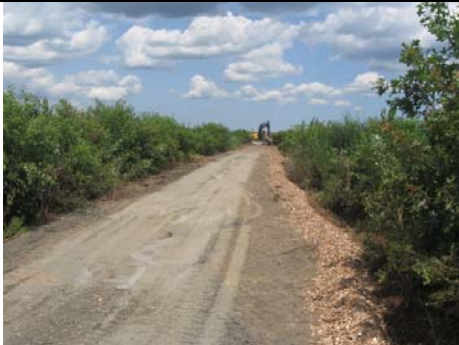
<p>The main access road down to the cut-over area was scraped clean, soils were peeled back from the existing socks (if intact), and a row of biomass chips were installed where socks were missing. Hay mulching was placed onto any exposed soil. A good start was made and the work will continue on 7/21/2014.</p>

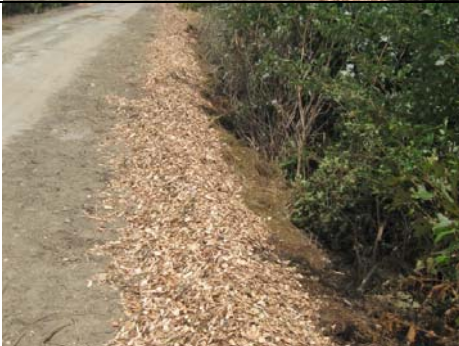
<p>This is a close-up of the row of chips that was installed along the log twitch road. It stands 6 to 8 inches tall. Excess soils between the pavement and row of chips were removed.</p>

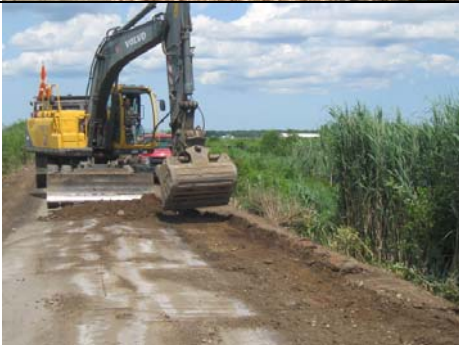
<p>This photo shows the excavator peeling back excess soils at an intact sock.</p>

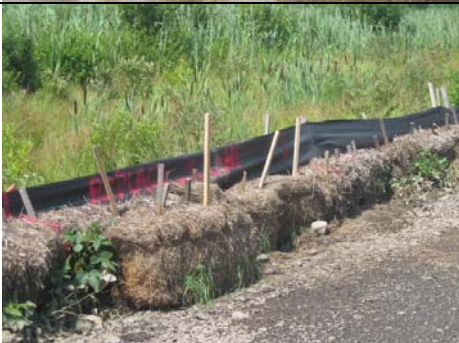
<p>West Ditch: Hay bales were re-installed. The silt fence at the back is still compromised. This needs to be toed-in properly and re-staked.</p>

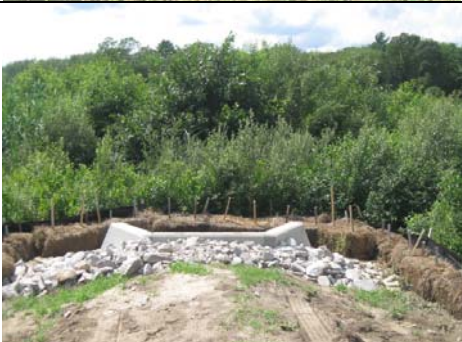
<p>Concrete Headwall - Outlet - North Side of RW 5 – Western End: An extra row of hay bales were installed here to provide some additional rigidity, however the silt fence still needs to be properly toed in.</p>

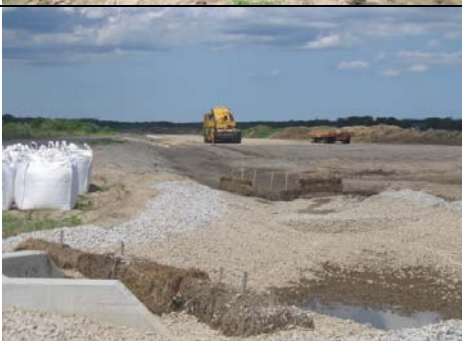
<p>Concrete Headwall - Inlet - North Side of RW 5 – Western End: A hay bale was removed from blocking the inlet and replaced again at the row of hay bales.</p>

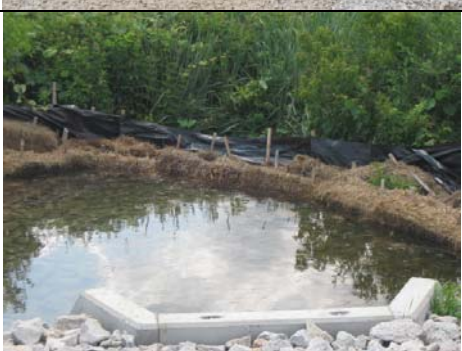
<p>Concrete Headwall - Outlet - North Side of RW 5 – Eastern End: an extra row of hay bales was added. The silt fence at the back still needs to be toed-in correctly. The standing water in the ponded area below the outletlowage was very clear.</p>

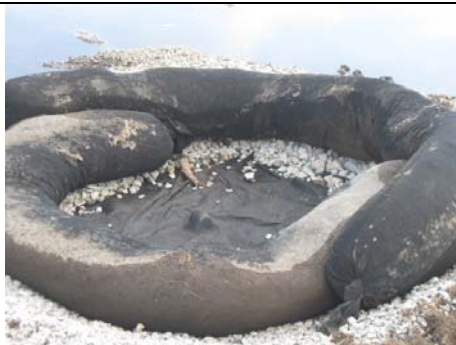
CB-11 between Taxiway A & RW5: Fabric was placed on the storm drain to back up flowage, to maximize infiltration in the area adjacent the storm drain and to prevent outflow flowage from reaching the Concrete Headwall situated on south side of Taxiway A.
