NEW BEDFORD REGIONAL AIRPORT  
RUNWAY 5-23 – PHASE 4

Reconstruct, Mark and Grove

Weekly Environmental Report

2014 May 19-23

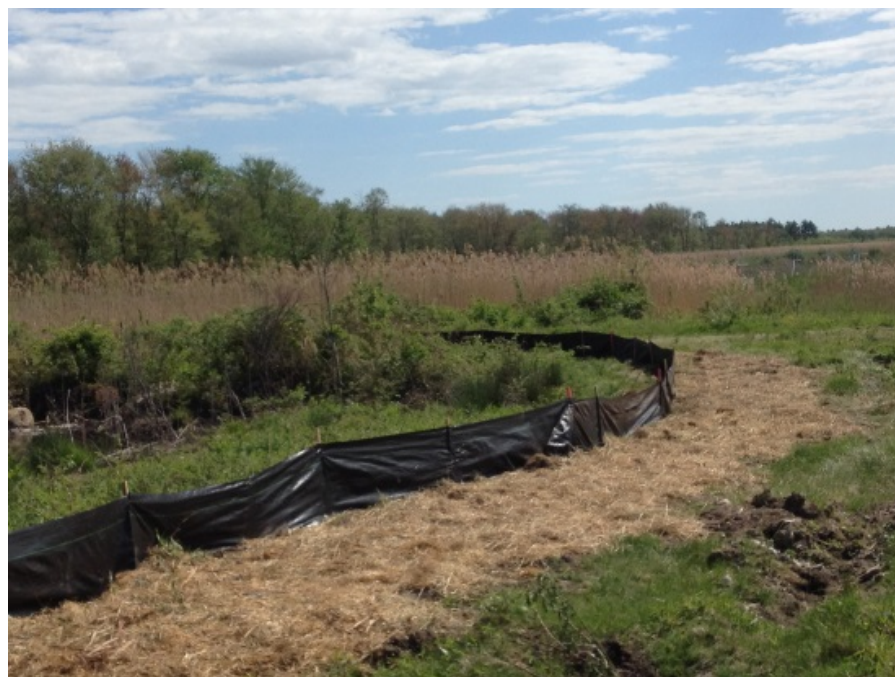
Photo 1: View of new turtle barrier around wetland near Colonial Hanger – south side of Runway 5.

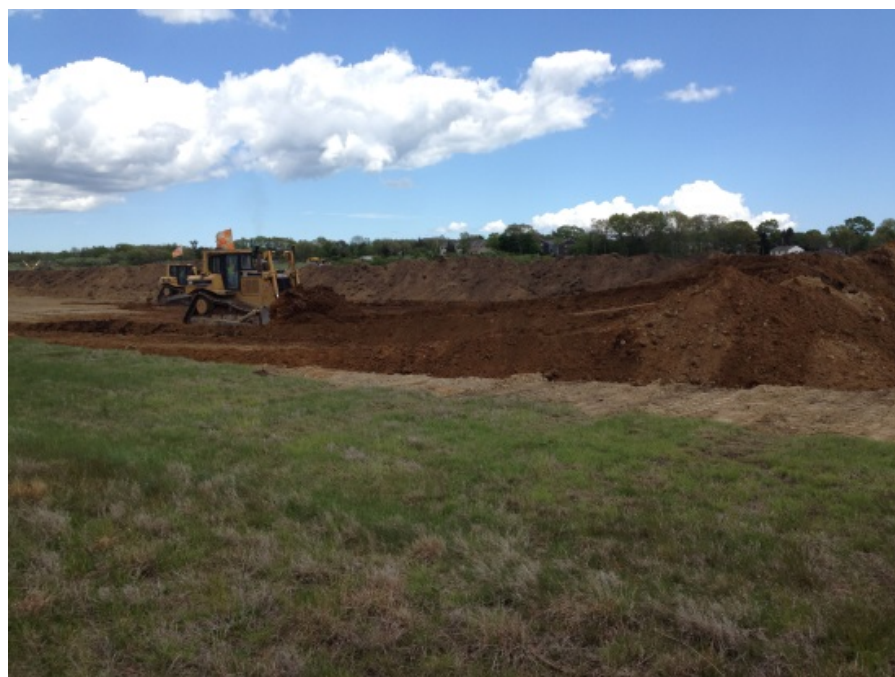
Photo 2: Stripping material off 23 end of runway.

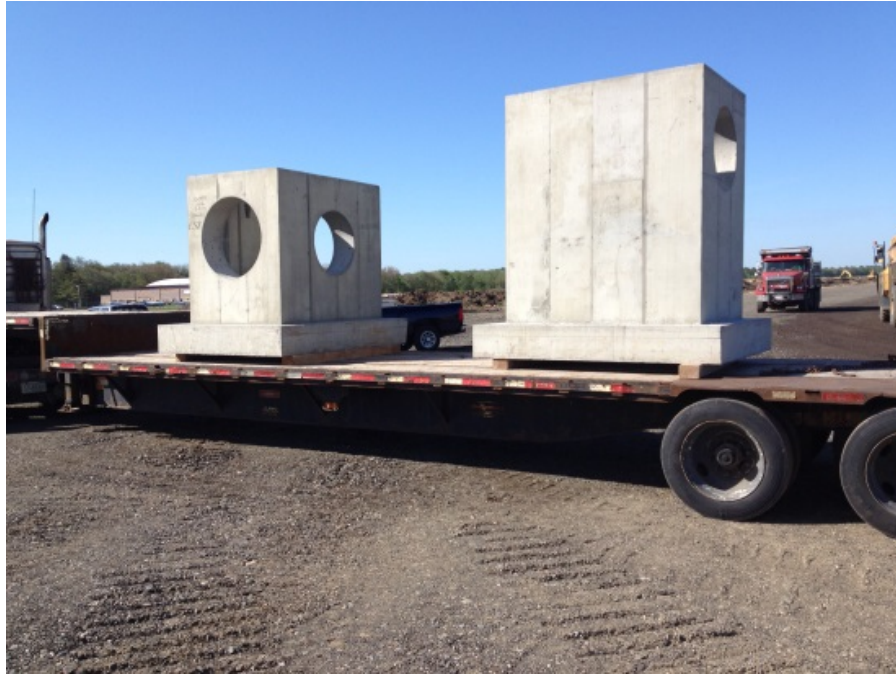
Photo 2: New drainage structures arrived on site this week.

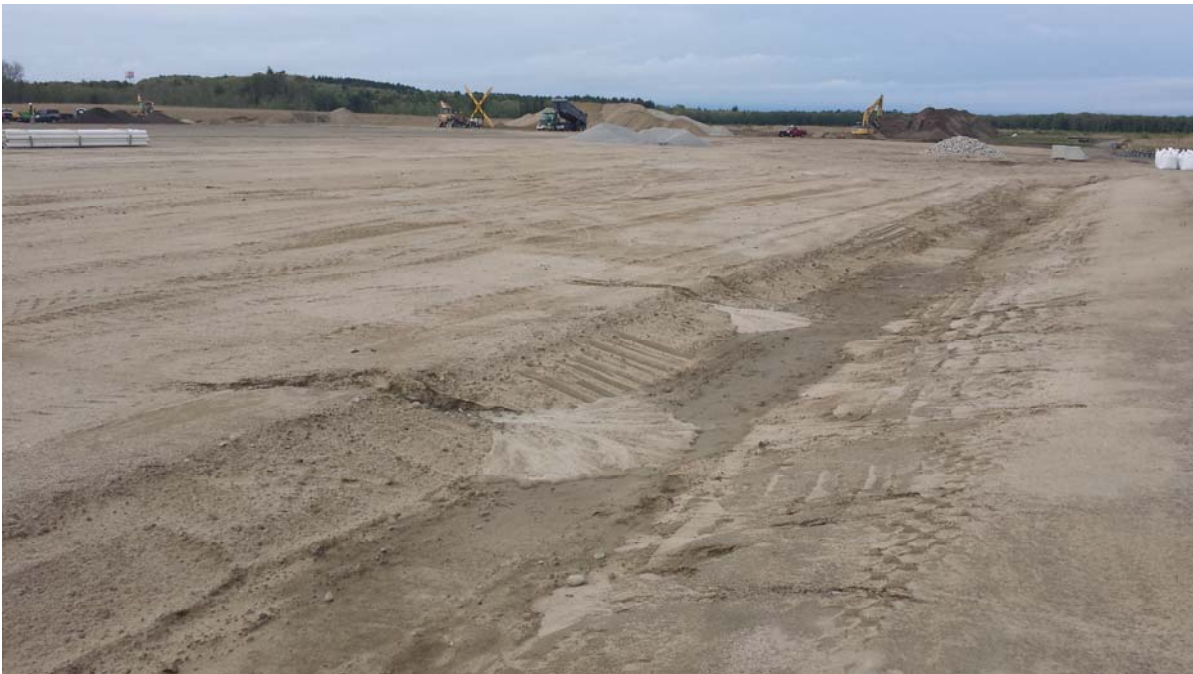
Photo 4: recently excavated swales at subgrade trapped stormwater runoff and prevented discharge to the access road and wetlands north of the 5 end of the runway.

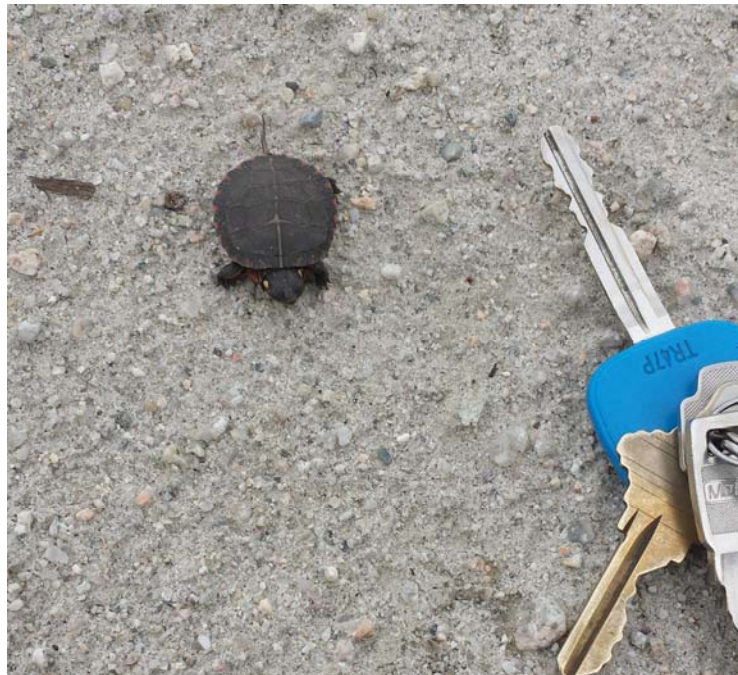
Photo 5: Turtle sweeps conducted daily have not identified any Eastern Box Turtles on site. This small painted turtle was found in Turtle Nesting Area 3. Oxbow is currently working on plan to identify one-way turtle gate locations now that the site is fully enclosed.

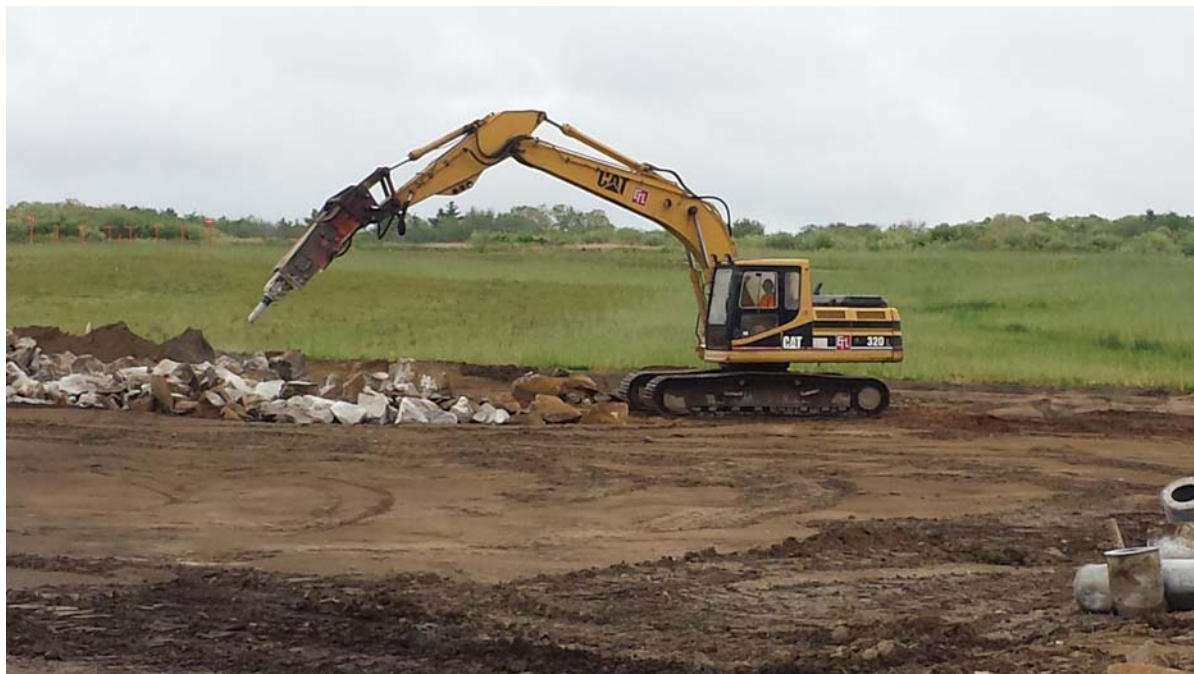
Photo 6: Hammering bedrock encountered at the 23 end pf the proposed runway extension.

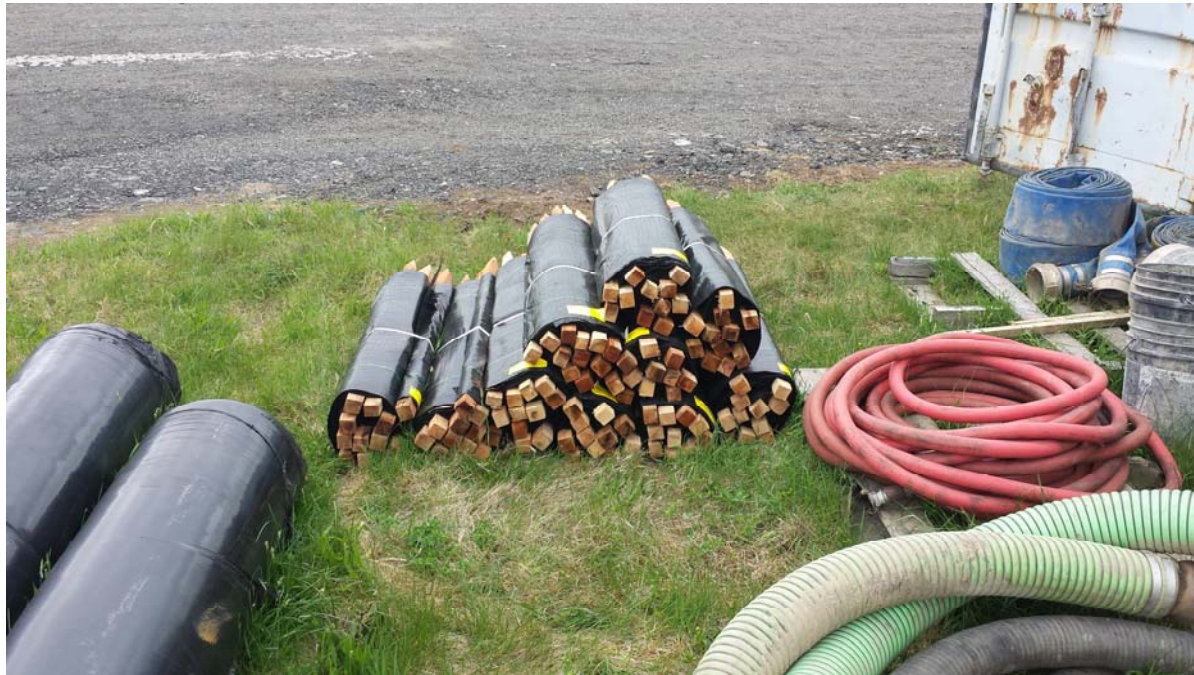
Photo 7 – View of stock pile of silt fence delivered to site on 5/23. The project currently has 10 rolls of silt fence on hand with a total length of 1,000 feet.

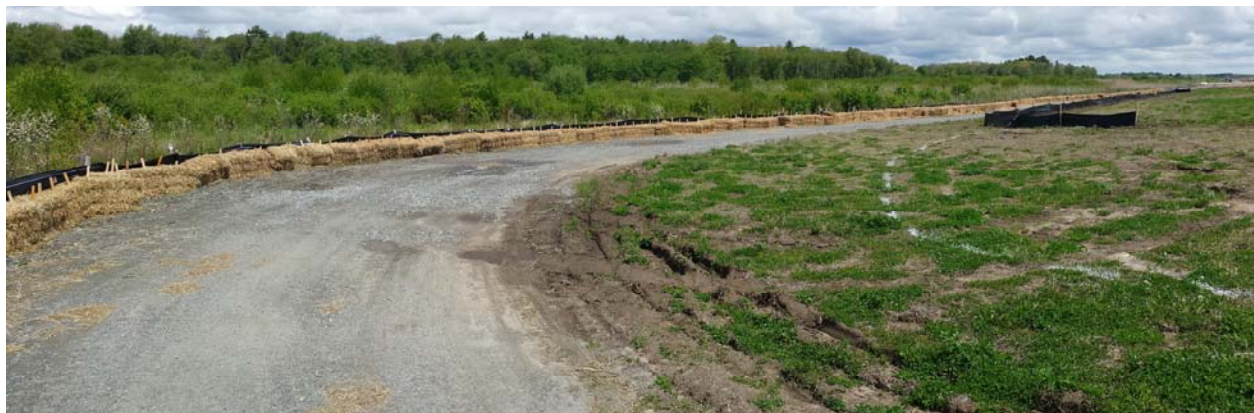
Photo 8: The west ditch area and access road were inspected during the Thursday storm event. No discharge was observed. Post storm inspections showed all fence installed by ET&L in compliance

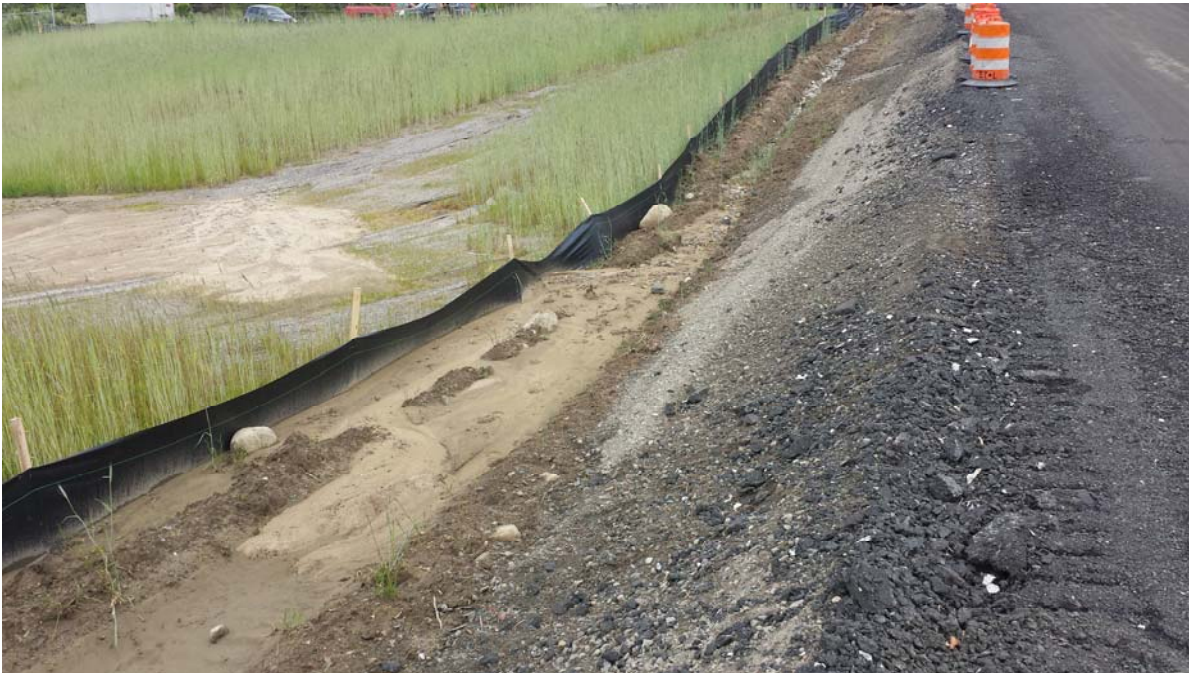
1. Area of silt fence with accumulated sediment that requires removal along the Old Plainville access road – OUTSTANDING.

Photo 9: Vie of accumulated sediment along access road off Old Plainville Road (23 end)

1. Area of silt fence with accumulated sediment that requires removal along the Old Plainville access road – SEDIMENT REMOVED - COMPLETED.

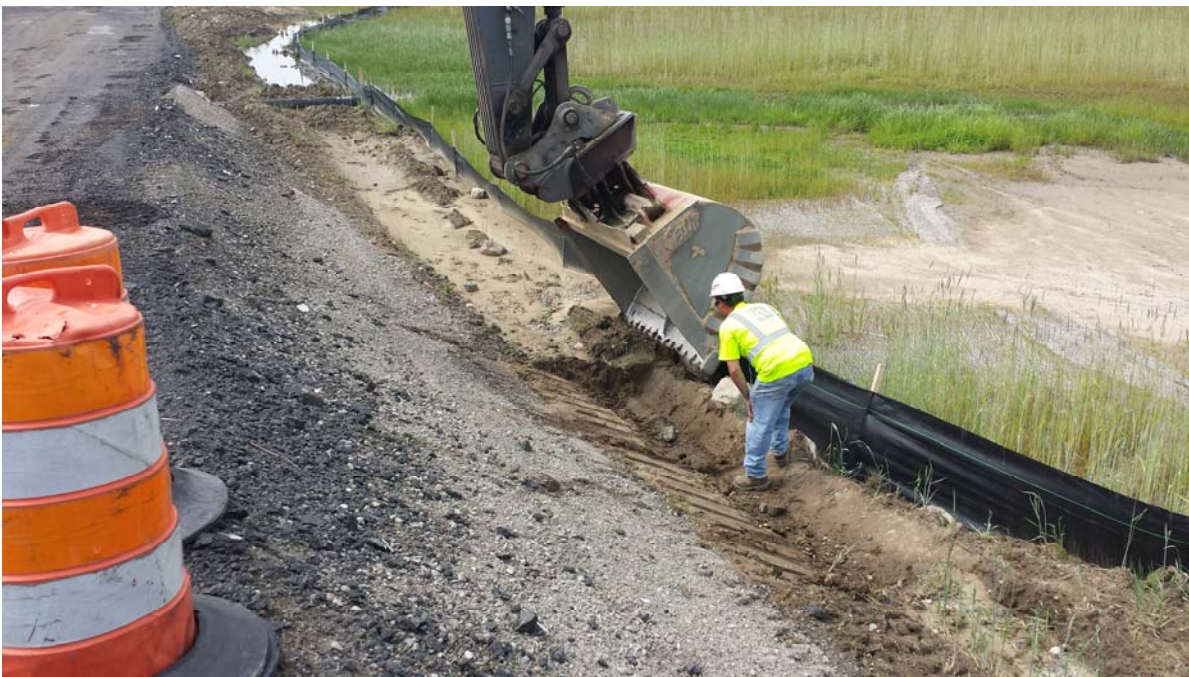
Photo 10: Sediment being removed from access road (23 End). Note sediment outside silt fence is erosion from previous phase/contractor and is outside the ET&L work zone. All sediment on photo is located in upland areas.
