Subject: Spring 2007 Cap Inspection
Keith Middle School
New Bedford, Massachusetts

SITE PHOTOGRAPHS
April 2007 Cap Inspection
Keith Middle School
New Bedford, Massachusetts

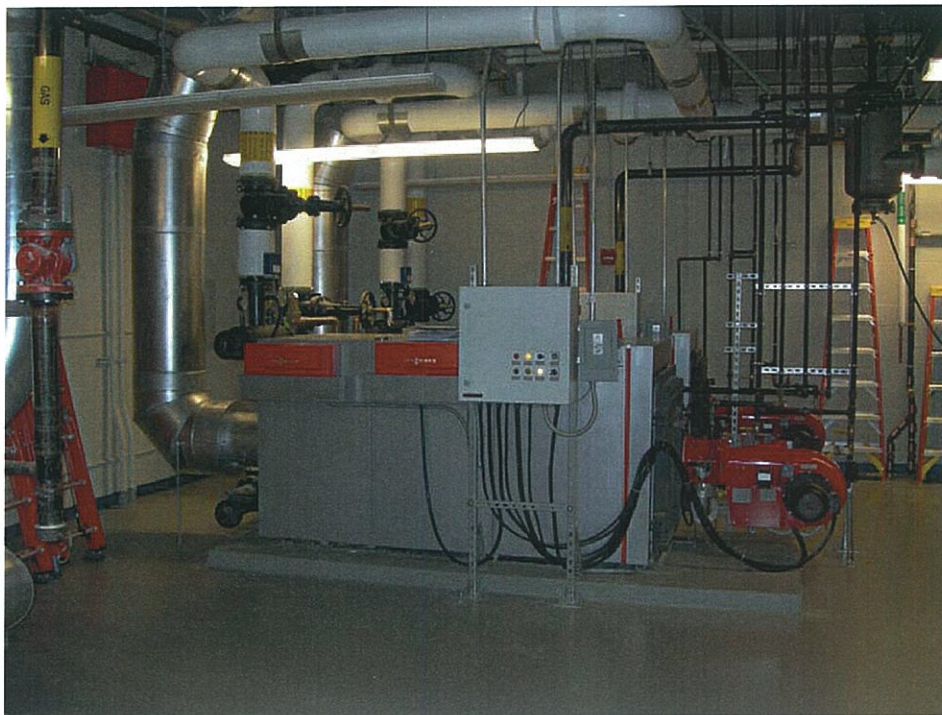
1) Boiler in Boiler Room.

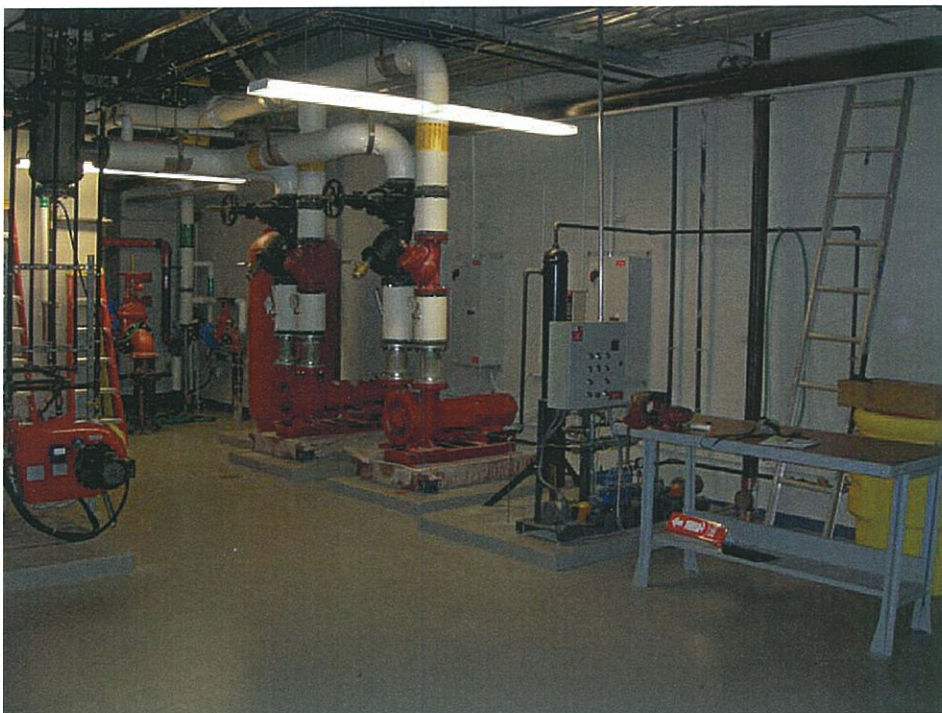
2) Boiler Room.

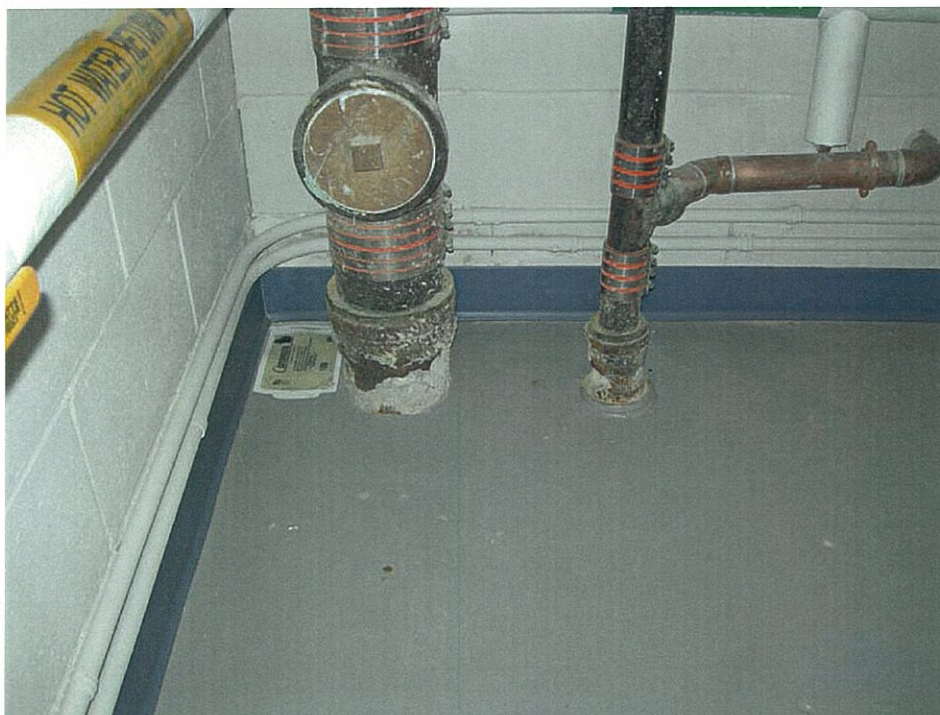
Photos 1-5two minor cracks, not open.
All pipe penetrations through
floor are tight.Rm 067 small crack in
between tile does not
appear to go through
floor. Photo 6Keith Middle School 4/17/07³

3) Pipe penetrations in Boiler Room.

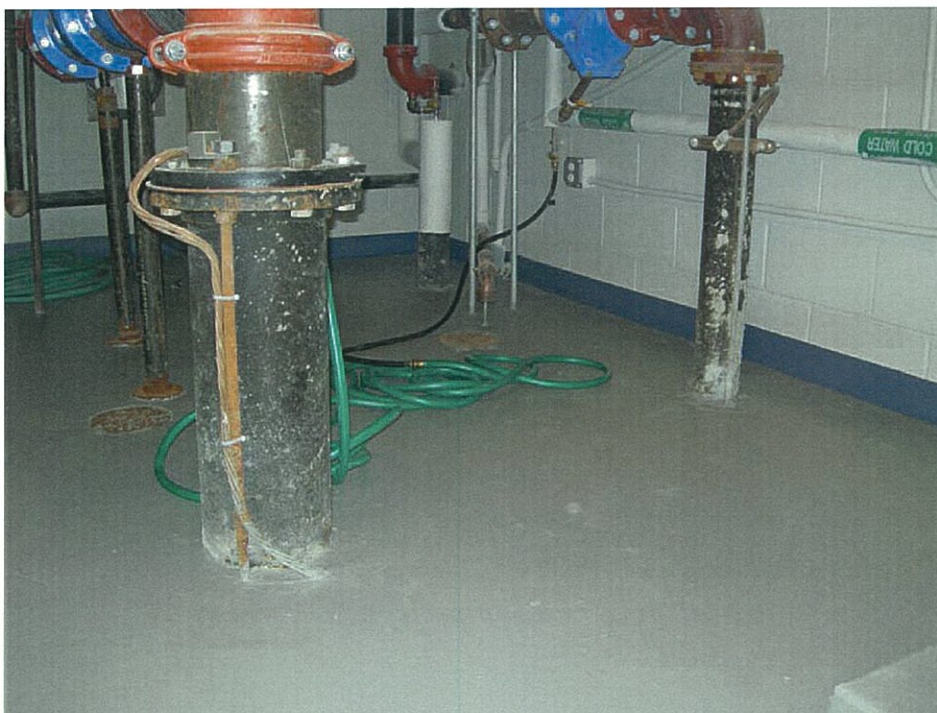
4) Other pipe penetrations in Boiler Room.

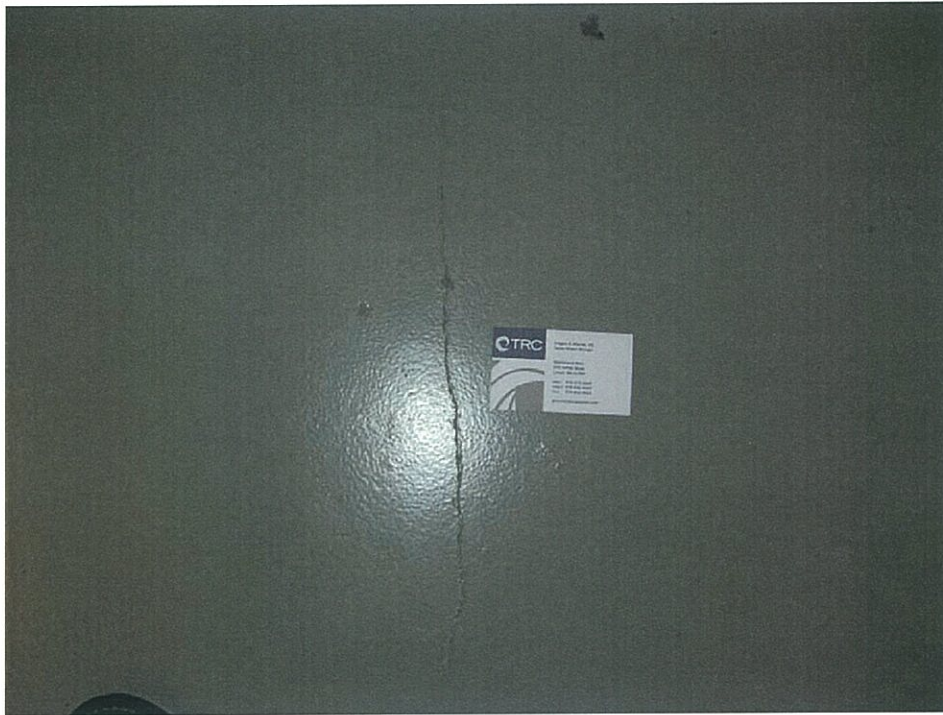
Two cracks in the boiler room floor were not open to expose the subgrade. Small cracks or separations between floor tiles did not appear to go through the concrete floor. A crack at the wall separating the kitchen from the cafeteria did not appear to go through the floor.

5) Crack in floor of Boiler Room.

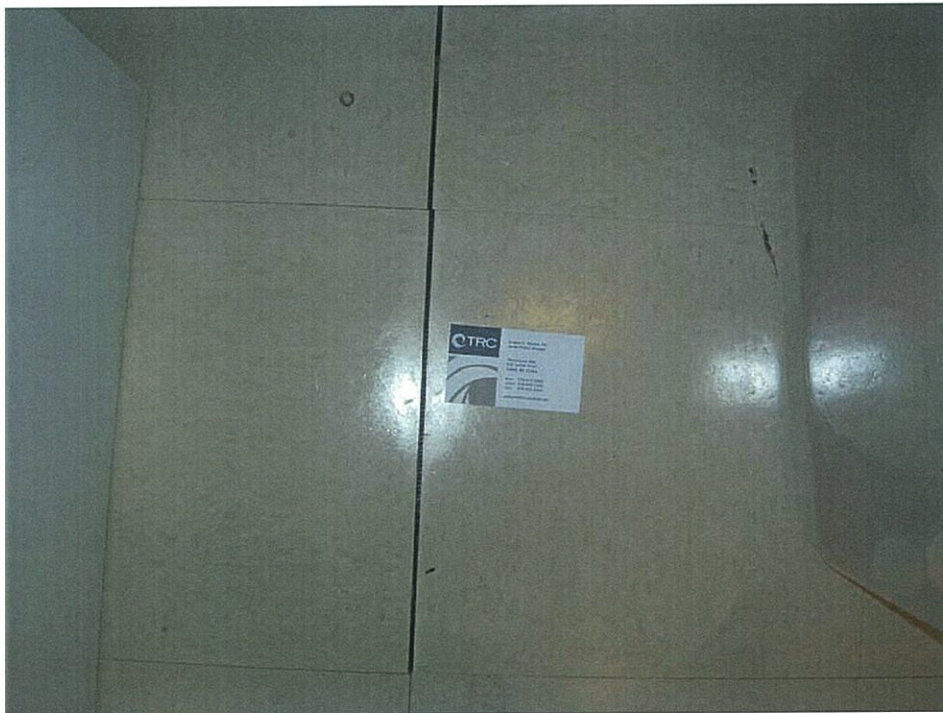
6) Separation between tiles in Room 067.

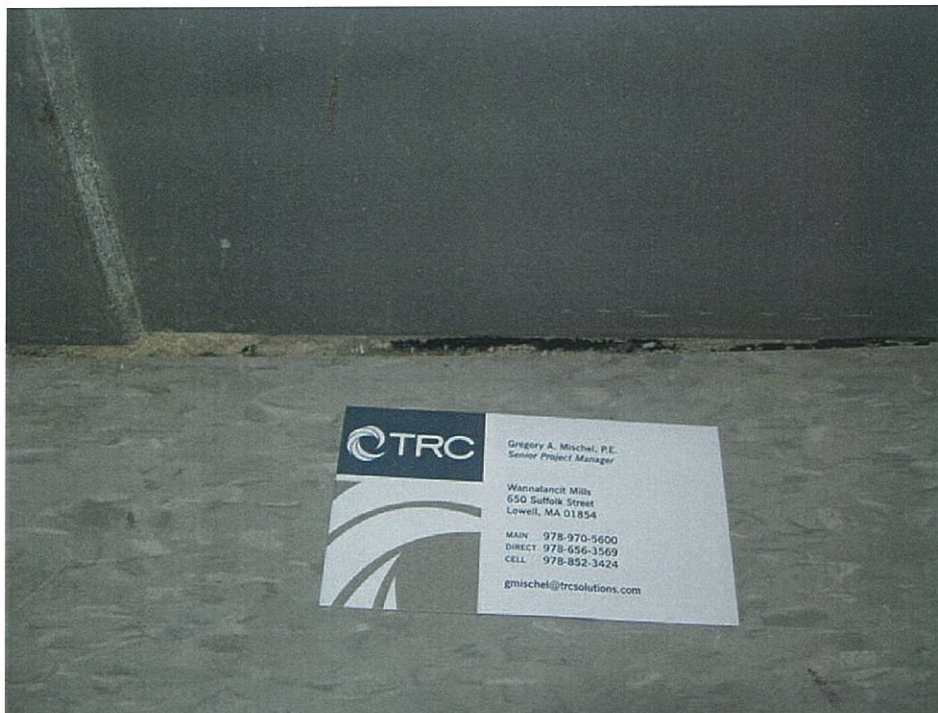
Photo 7 small crack in
north wall at Kitchen 060
entrance. Does not go thru floor.
No key for Kitchen

7) Crack at wall between Cafeteria and Kitchen.

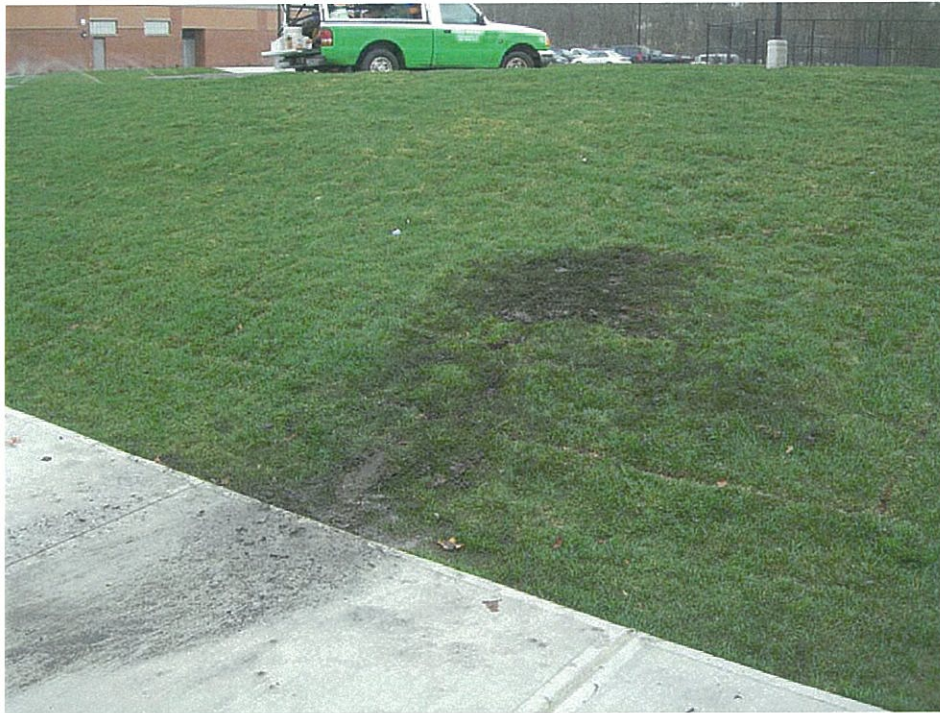
Keith Middle School 4/17/07⁵10:35 Soft wet area in grass near NE corner of property possible broken water line for sprinkler system.
"YardWorx" work crew on site testing system.

4. A small area of soft wet soil (approximately two feet in diameter) was observed in the grassy slope at the northeast corner of the property. A landscaping contractor was testing the sprinkler system in that area and the wet spot may have been related to the sprinkler system test. While the integrity of the cap has not been compromised at this time, this area should be monitored in the future to ensure that the wet area does not result in damage that could expose underlying cap layers.

15) Wet area near Northeast corner of property.

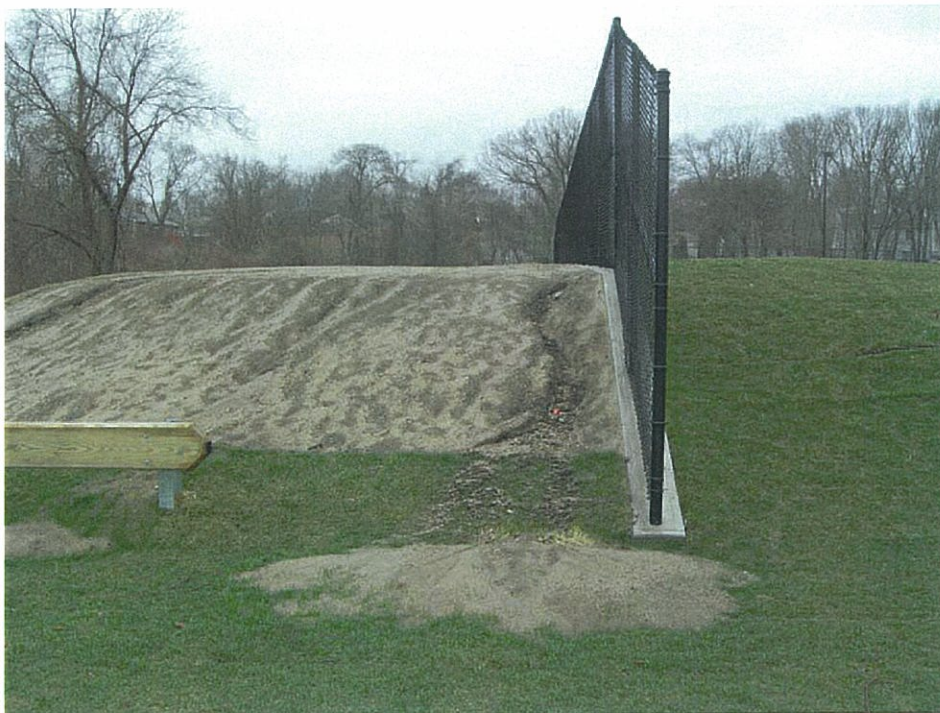
Photos 16 & 17 erosion at SE corner of property.
4" - 6" deep.Photo 18 erosion @ south slope
12 Erosion rills along South slopePhoto 19 Erosion @ SW corner
Photo 20 Top of slope, south end

1. The ground surface outside the fence at the south end of the school property is not vegetated, and as a result, 12 erosion rills have developed in the steep slope. The maximum depth of the erosion rills ranged between four and six inches.

16) Erosion at Southeast corner of property.

A design for the repair of the slope failure has been submitted to the City for review. Repair of the erosion rills is straight forward and would consist of filling in the rills with soil, planting grass seed and protecting the slope with mulch or erosion control mat until stabilizing vegetation is established. The soil on the south slope appeared to be low in organic material and some sort of soil amendment may be required to sustain vegetation. The slope at the culvert appears to be too steep to support the existing riprap. Larger riprap or a structural element such as a concrete headwall may be required to provide a stable culvert outlet.

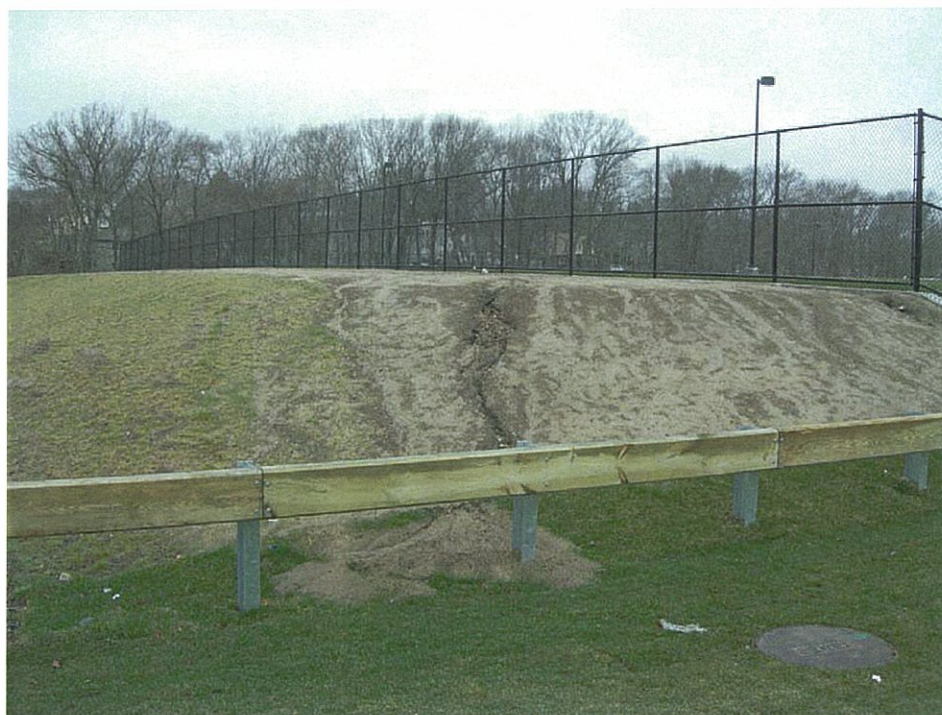
17) Additional erosion at Southeast corner.

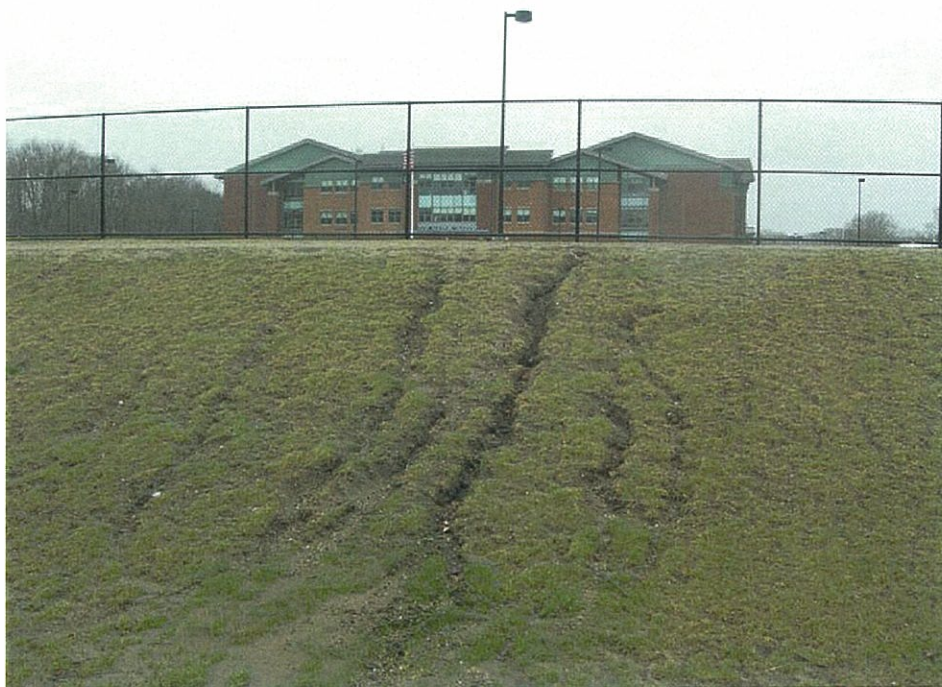
- Twelve erosion rills located on the steep slope at the south end of the Site property. Vegetation is also sparsely established in this location, leaving this area at risk of further erosion during significant weather events, (i.e., rain, wind).

18) Erosion on slope, Southern property line.

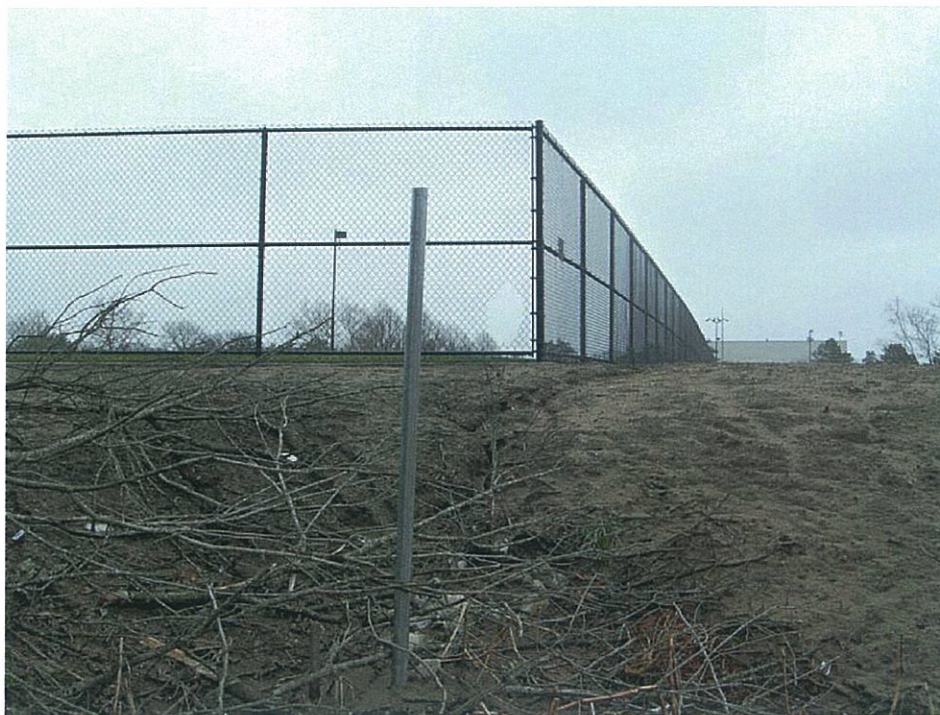
19) Erosion at Southwest corner of property.

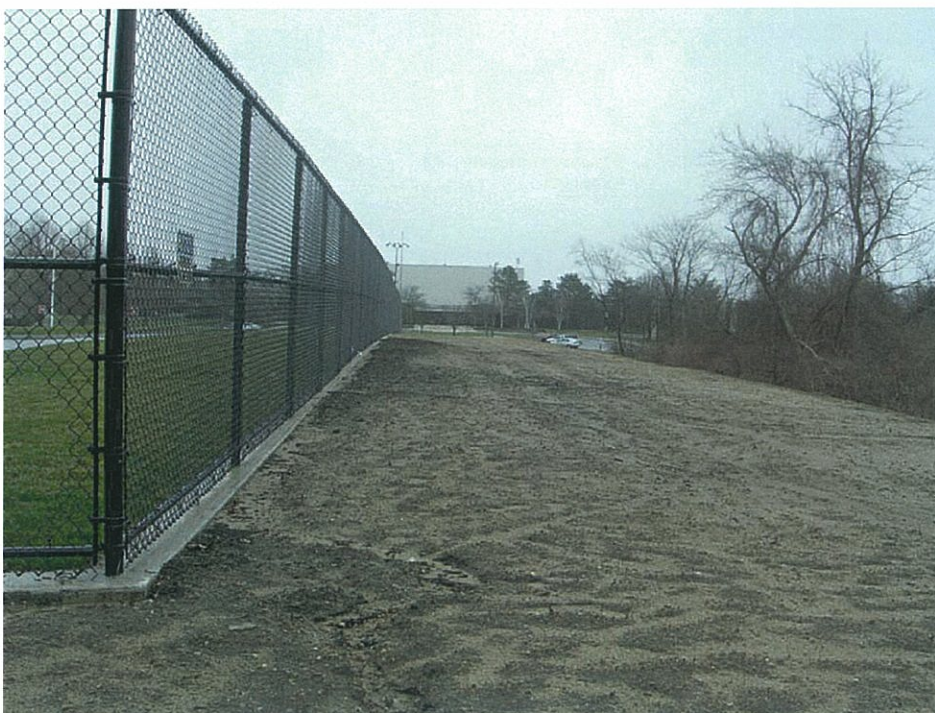
20) Unstabilized ground surface, Southern property line.

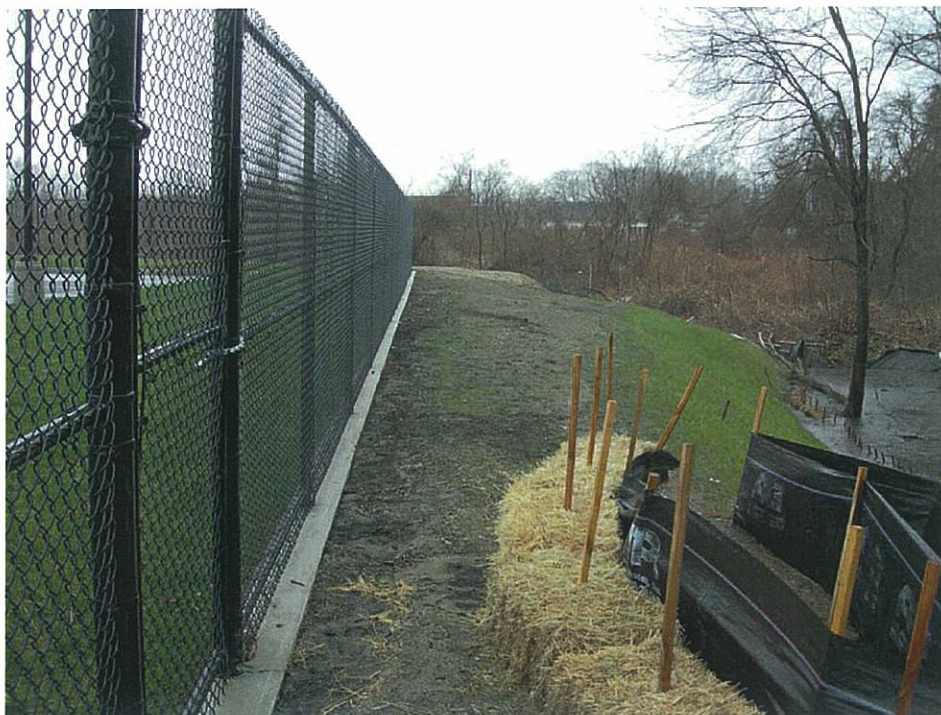
Poor vegetation along top of
slope to about the bike rack

21) Poor growth of vegetation at top of slope above slope failure.

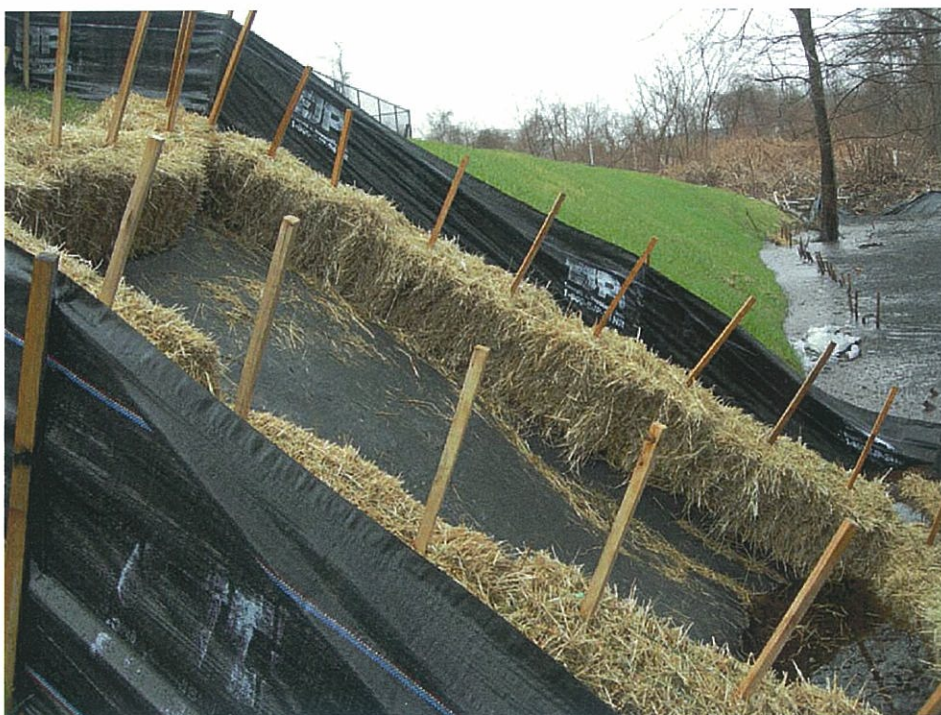
No further erosion ~~for~~
slumping observed at location
of failure.

2. In a separate area, a slope failure had developed in the steep slope between the wetland to the west and the southern parking lot to the east. A targeted inspection of the slope failure was conducted by TRC on April 10, 2007 after it was discovered on April 5, 2007. The slope failure measured approximately seven feet wide by eight feet tall and was located at the bottom of the steep slope. Only the top six-inch topsoil layer slumped exposing the clean granular fill soil layer below. A small three to four inch piece of the orange snow fence warning barrier was exposed. Contaminated soil was not exposed by the slope failure. Based on TRC's recommendations, a temporary repair was made the week ending April 13, 2007 which included two rows of hay bales and silt fence, and the placement of a geotextile filter fabric directly over the exposed soils. The hay bales, silt fence and geotextile filter fabric were all in good condition at the time of the inspection and no further slumping was observed. A permanent repair is required and is in the process of being designed.

22) Temporary slope failure repair.

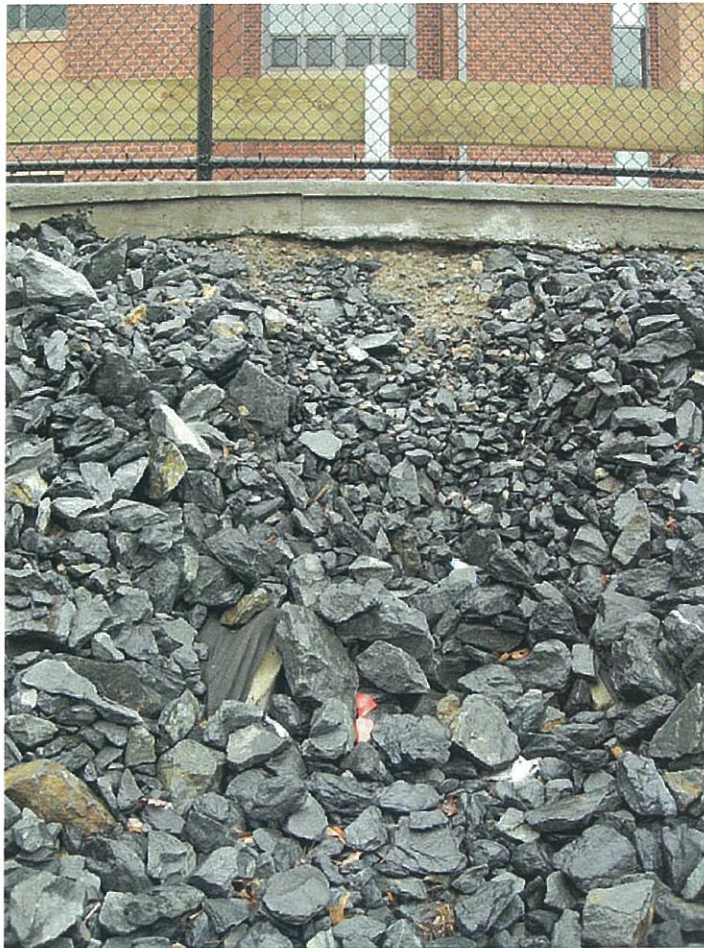
- Sloughing riprap stabilization stone that is undermining the concrete fence support at the top of the slope and filling the outlet of the storm water drainage culvert on the west side of the Site.

Photo 23 rip up falling
down slope covering outlet
of culvert and undermining
concrete fence support.
(fourth south of oil tank)

3. Riprap stabilization rock placed around the outlet of one of the storm water drainage culverts is falling down the slope and filling the end of the culvert. The outlet in question is the fourth outlet south of the above ground oil storage tank. The falling riprap has undermined the concrete fence support at the top of the slope and the deposited rock is impeding the flow of water from the culvert. The structural integrity of the fence may be compromised if the sloughing of the riprap continues. The cap soils beneath the riprap may also become exposed and susceptible to erosion.

- 23) Sloughing rip rap at culvert outlet. Note undermining of fence support and filled in culvert.**

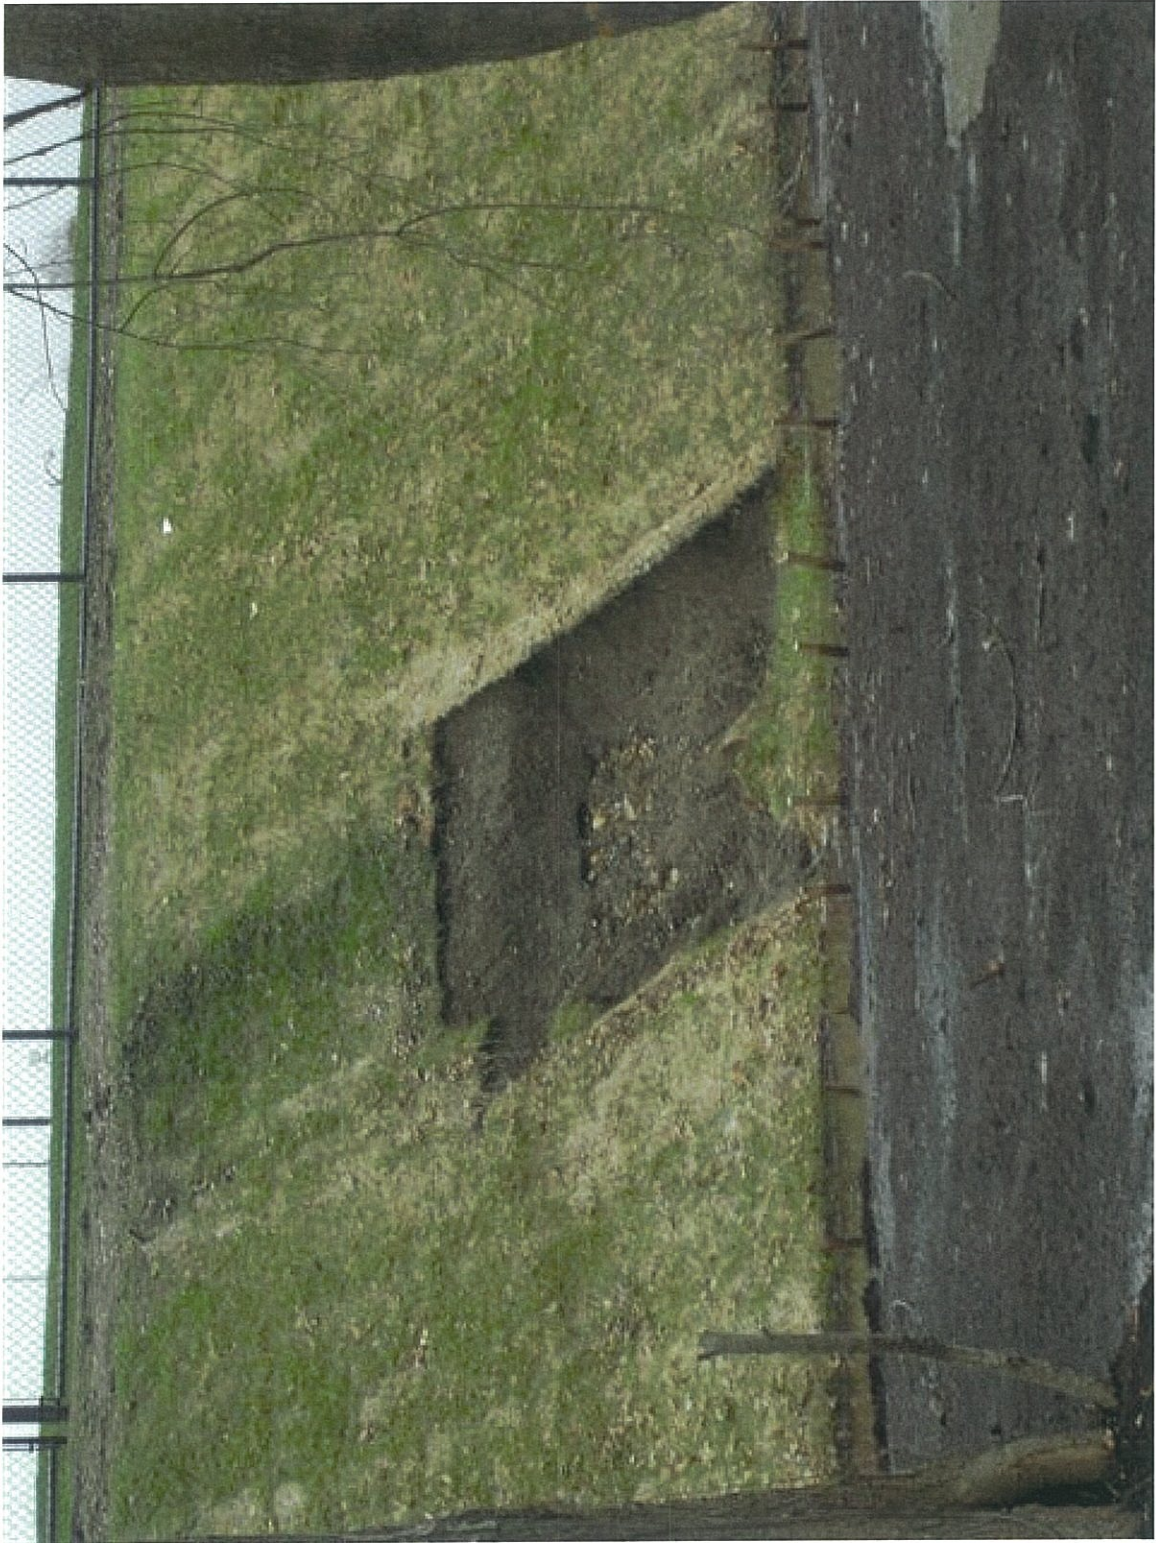
Slope Failure Photograph

- A slope failure located on the steep slope between the wetland to the west and the southern parking lot to the east. A photograph of the slope failure prior to the temporary repair is presented in Attachment 4. A small (approximately 3 to 4 inch) piece of the orange warning barrier was visible in the top left quadrant of the damaged area (when viewed from the wetland) during an initial damage inspection conducted on April 10, 2007. A temporary repair had been implemented at the time of the April 17, 2007 cap inspection by RC&D, Incorporated.
