Subject: April 2009 Cap Inspection  
Keith Middle School  
New Bedford, Massachusetts

**SITE PHOTOGRAPHS**  
**April 2009 Cap Inspection**  
**Keith Middle School**  
**New Bedford, Massachusetts**

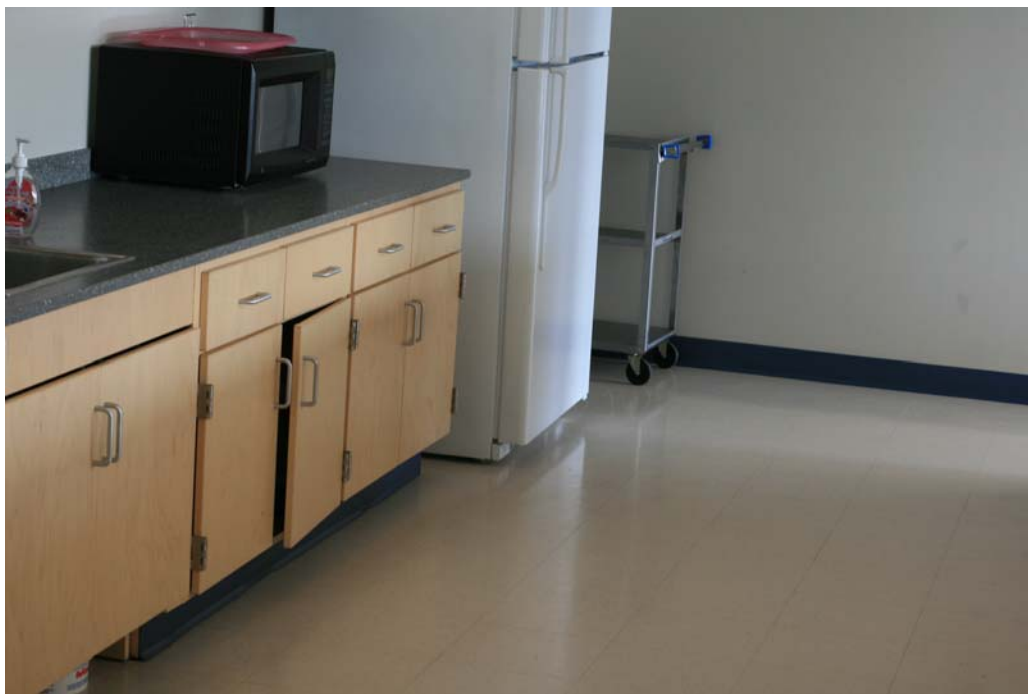
**1) Example of typical condition of interior flooring materials.**

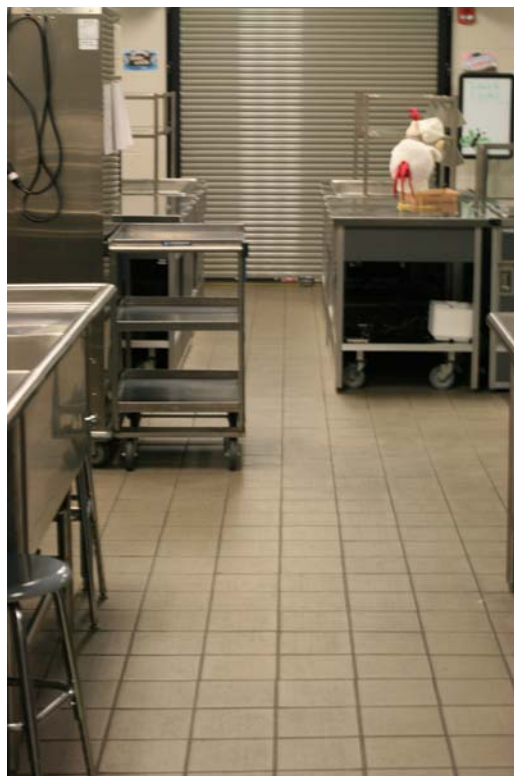
**2) Example of typical condition of interior flooring materials.**

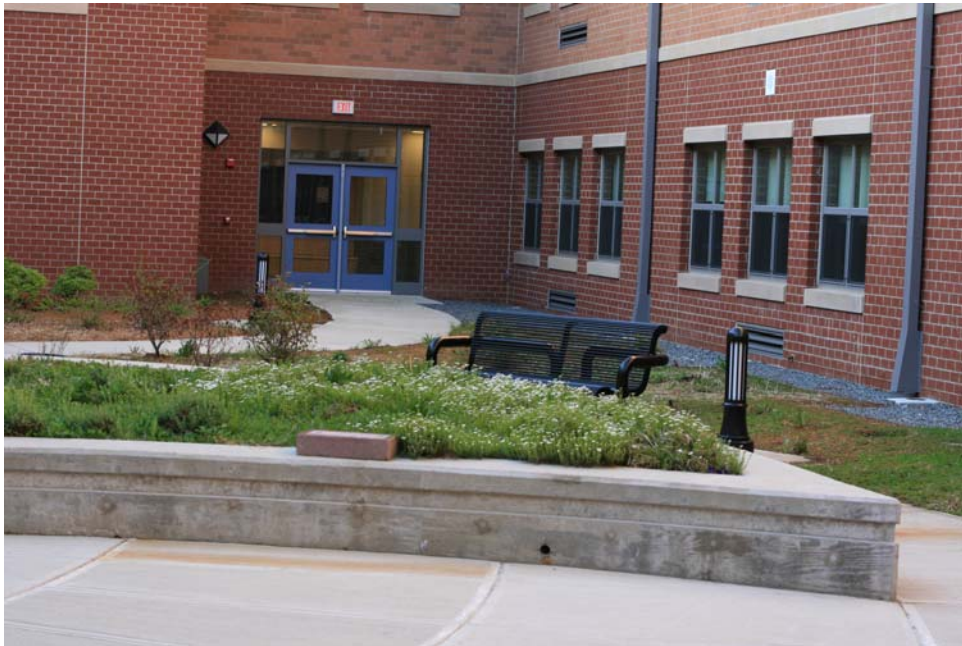
**3) Courtyard looking south.**

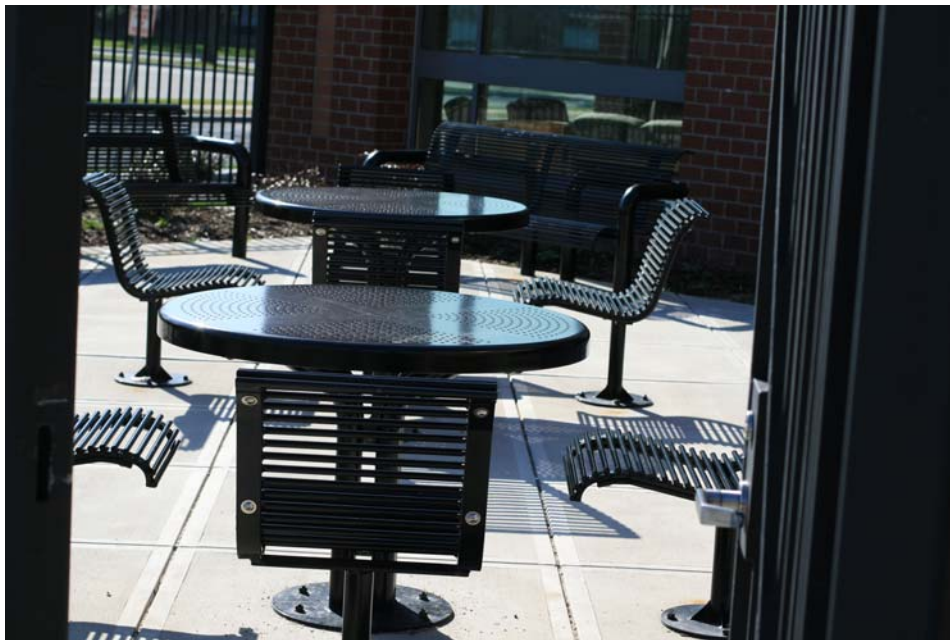
**4) Community Room/Faculty Lounge (014) courtyard facing southwest.**

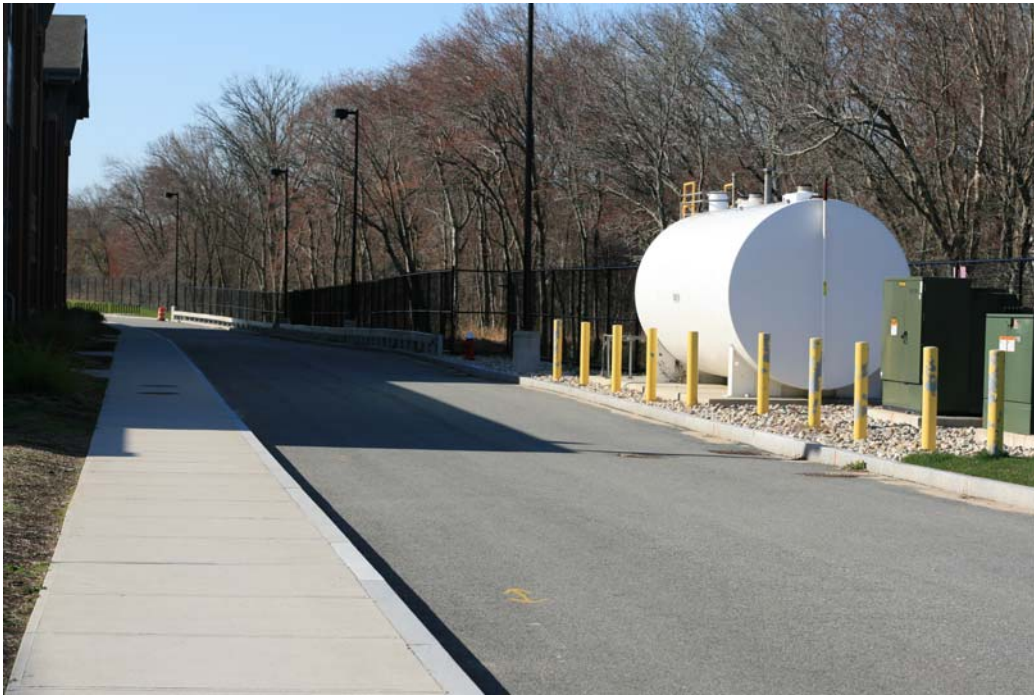
**5) Western side of the building facing south.**

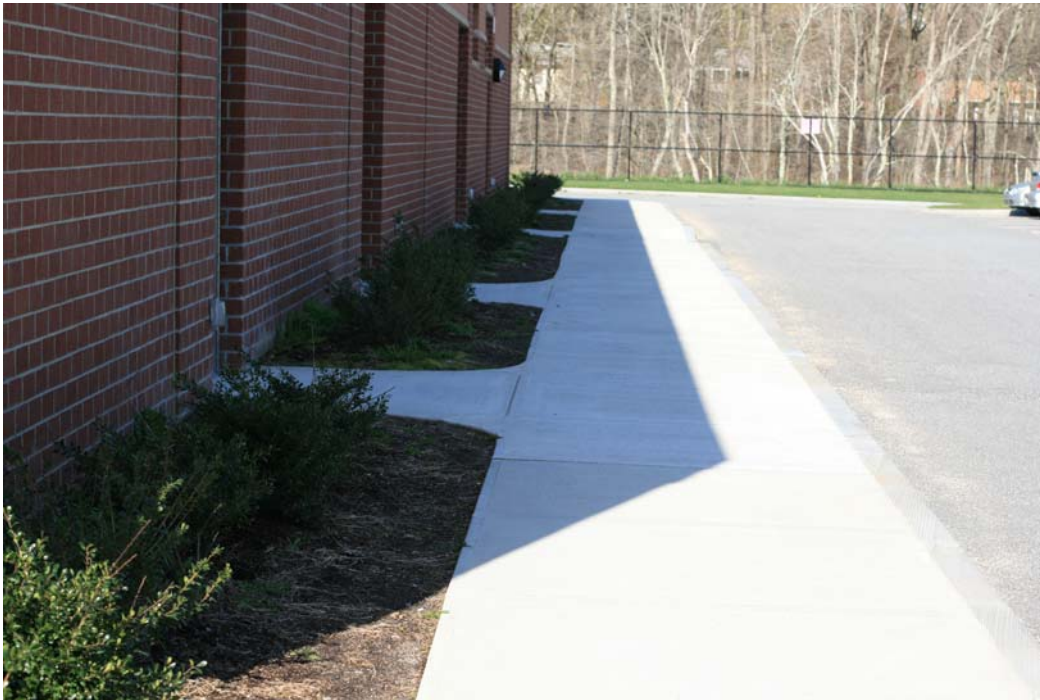
**6) Landscaping along the northern side of the building facing west.**

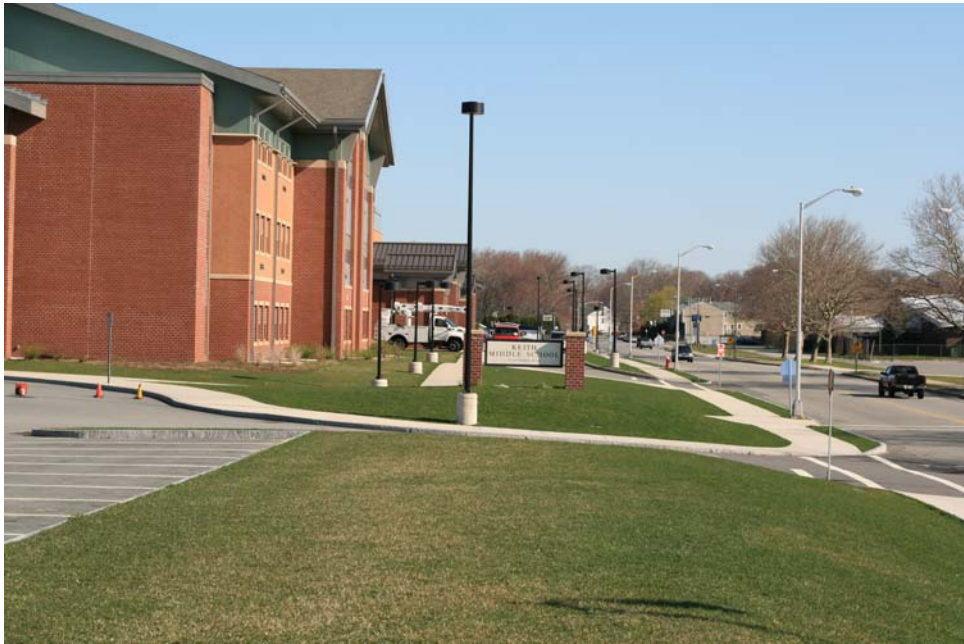
**7) Landscaping along the eastern side of the building facing north.**

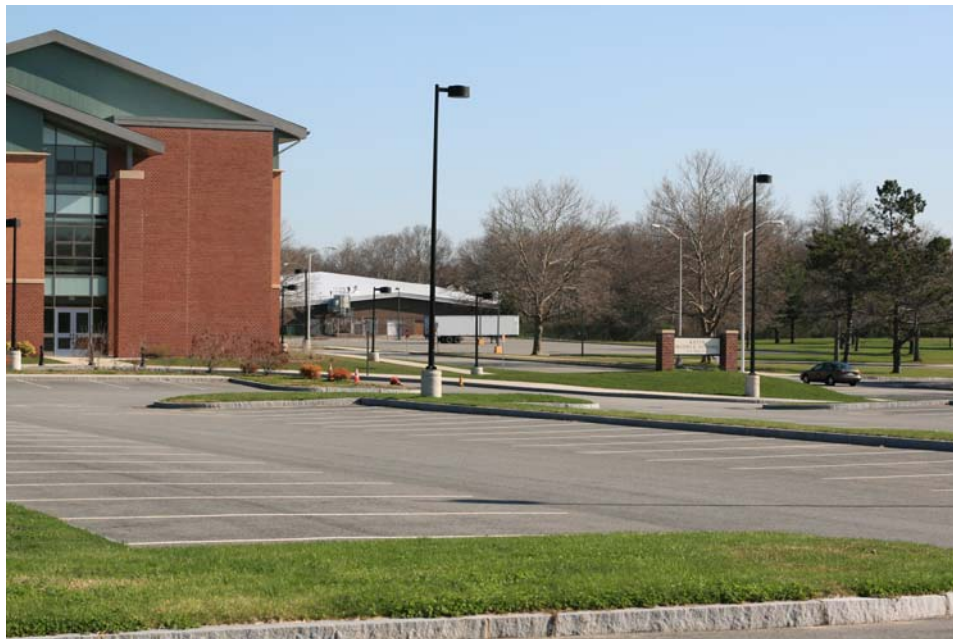
**8) Southern parking lot facing northeast.**

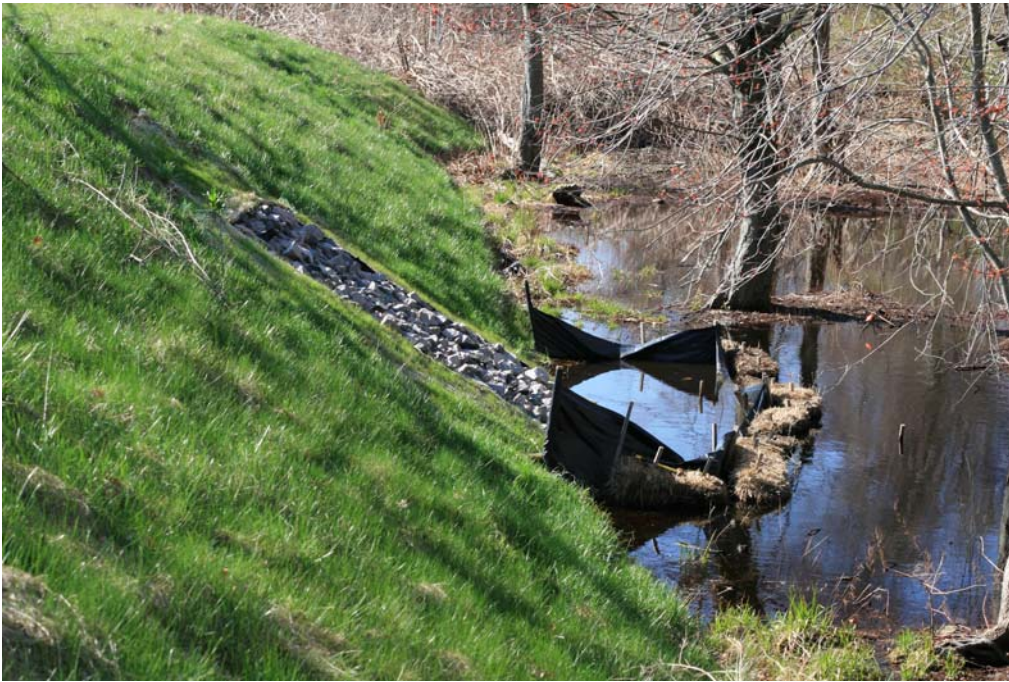
2. The repair to the slope failure between the wetland to the west and the southern parking lot to the east is currently functioning as intended. The hay bales and silt fence are still in place as shown in Photograph #9. The erosion control blankets are still visible. There is minor erosion shown in Photograph #10.

**9) Condition of slope repair in southwestern portion of cap facing south.**

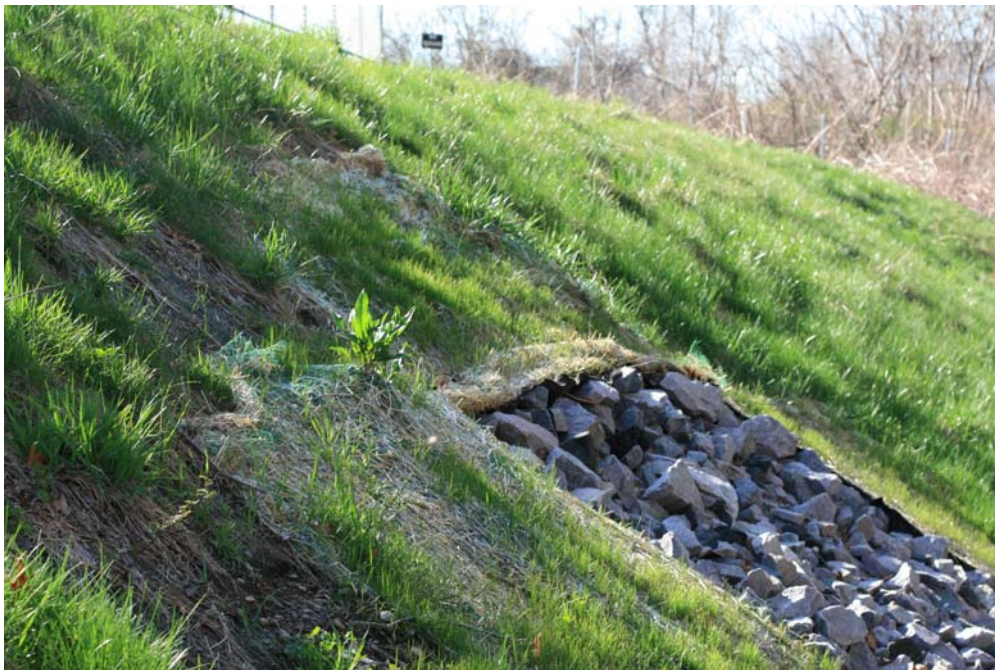
**10) Minor erosion adjacent to slope repair facing southeast.**

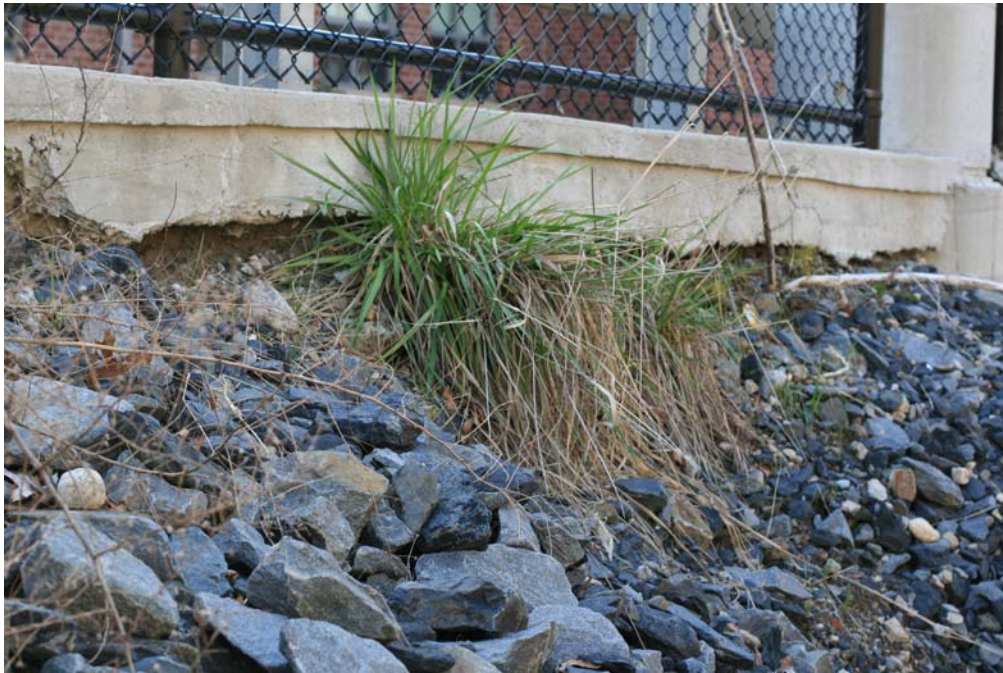
3. Riprap stabilization rock placed around the outlet of one of the storm water drainage culverts is falling down the slope and filling the end of the culvert. The outlet in question is the fourth outlet south of the above ground oil storage tank. The falling riprap undermined the concrete fence support at the top of the slope. See Photographs #11 through #13. Photograph #13 shows a crack in the concrete support of the fence along the top of slope. The structural integrity of the fence may be compromised if the sloughing of the riprap continues. The cap soils beneath the riprap may also become exposed and susceptible to erosion. The area appears stable at the moment. The extent of erosion seems similar to the conditions observed during the previous inspection. See inspection report letter dated November 24, 2008, Attachment 3, Photographs #11 and #12.

**11) Undercutting of fenceline at culvert outlet facing southeast.**

- Sloughing riprap stabilization stone that is undermining the concrete fence support at the top of the slope and filling the outlet of the storm water drainage culvert on the west side of the Site. Design and planning of a permanent solution is currently underway.

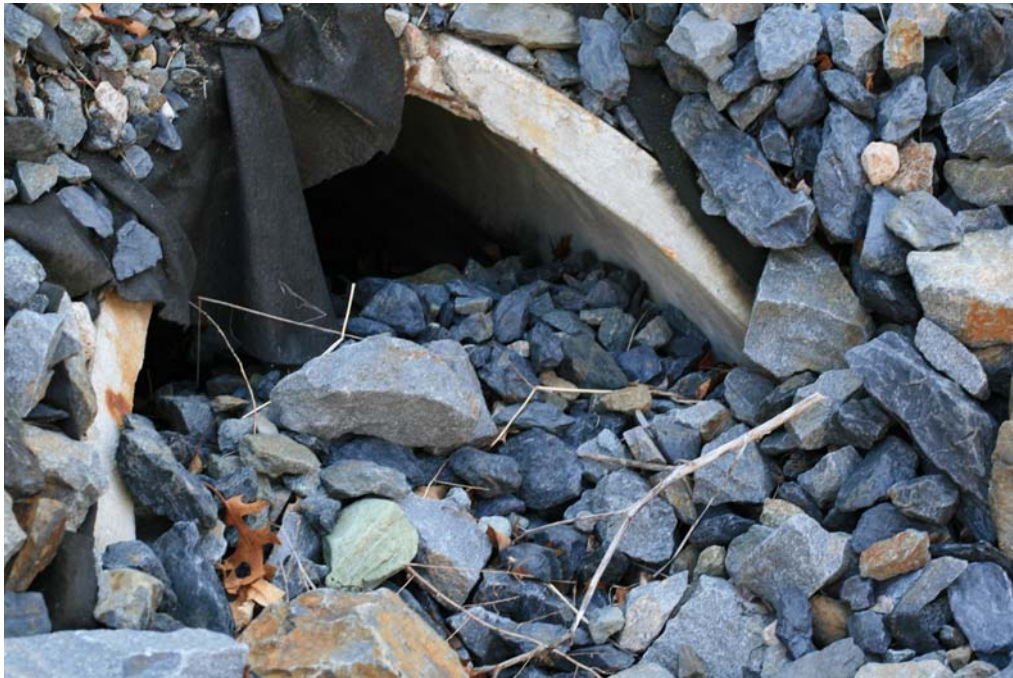
**12) Sloughing of riprap at culvert outfall facing southeast.**

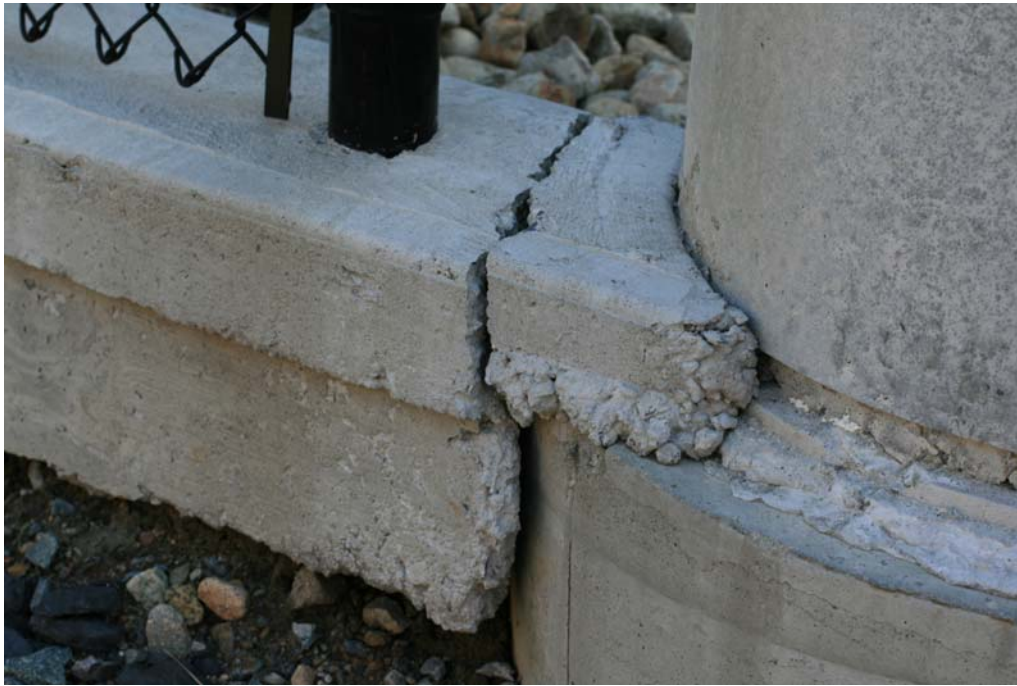
**13) Crack of concrete support at junction just south of riprap sloughing.**

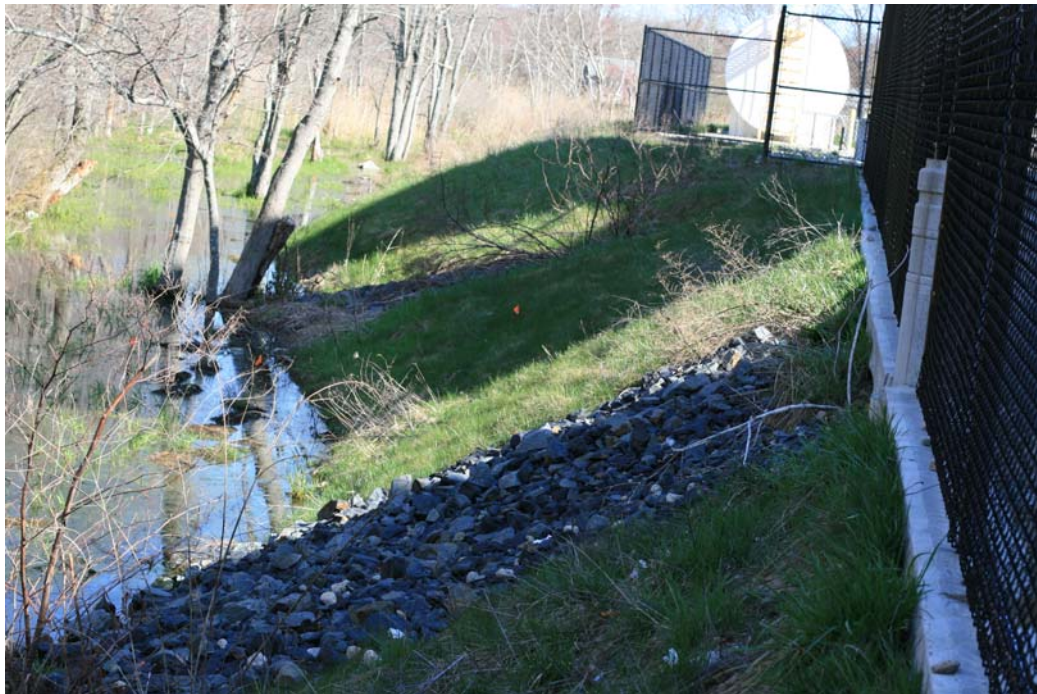
**14) Condition of vegetation in eastern portion of cap south of above ground tank.**

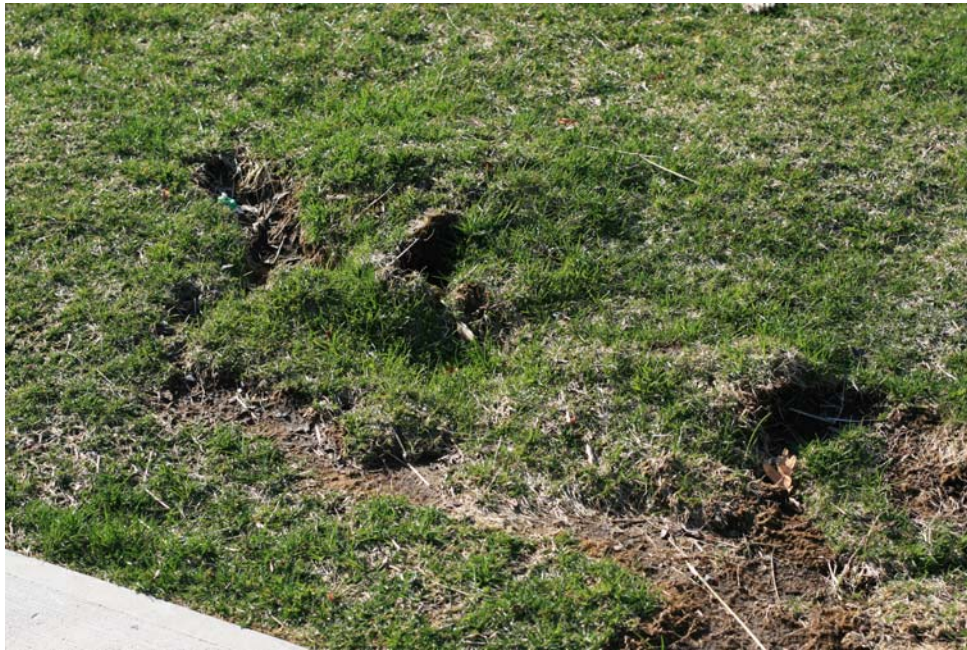
1. Overall, the landscaped areas surrounding the Keith Middle School (KMS) are in excellent condition and are well maintained. There were two minor divets in the landscaped areas that had depths greater than 1 inch. The first was located off the southwestern corner of the KMS building (approximately 30 feet), south of the first concrete walkway. See Photograph #15. The second was located against the front of the KMS building approximately 36 feet north of the main entrance. See Photograph #16.

**15) Minor divet in flat grassed area off the building's southwestern corner.**

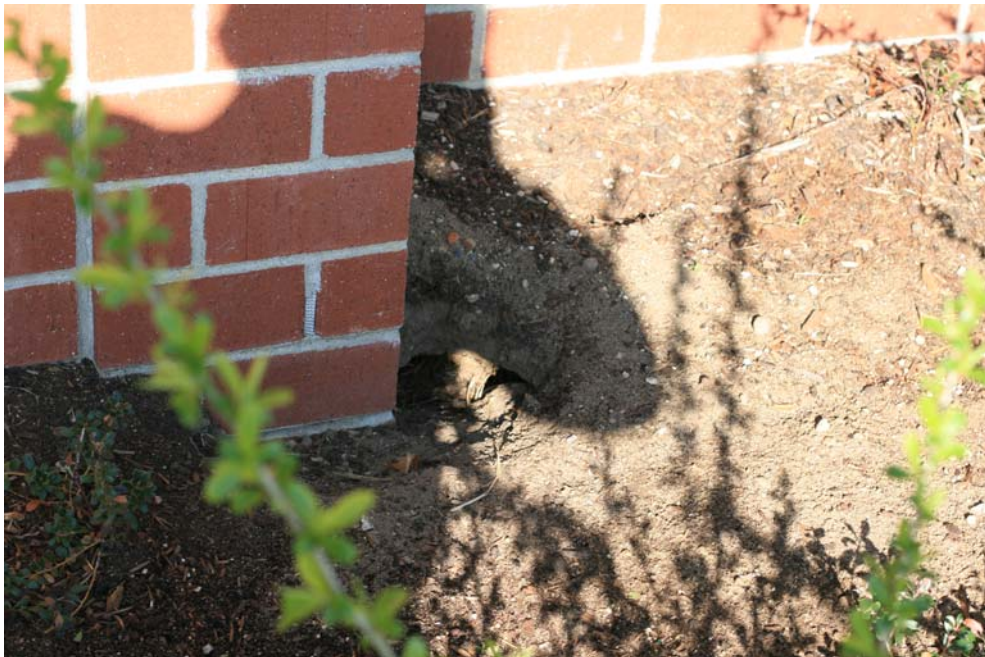
**16) Minor divet in landscaped area on the building's eastern face.**

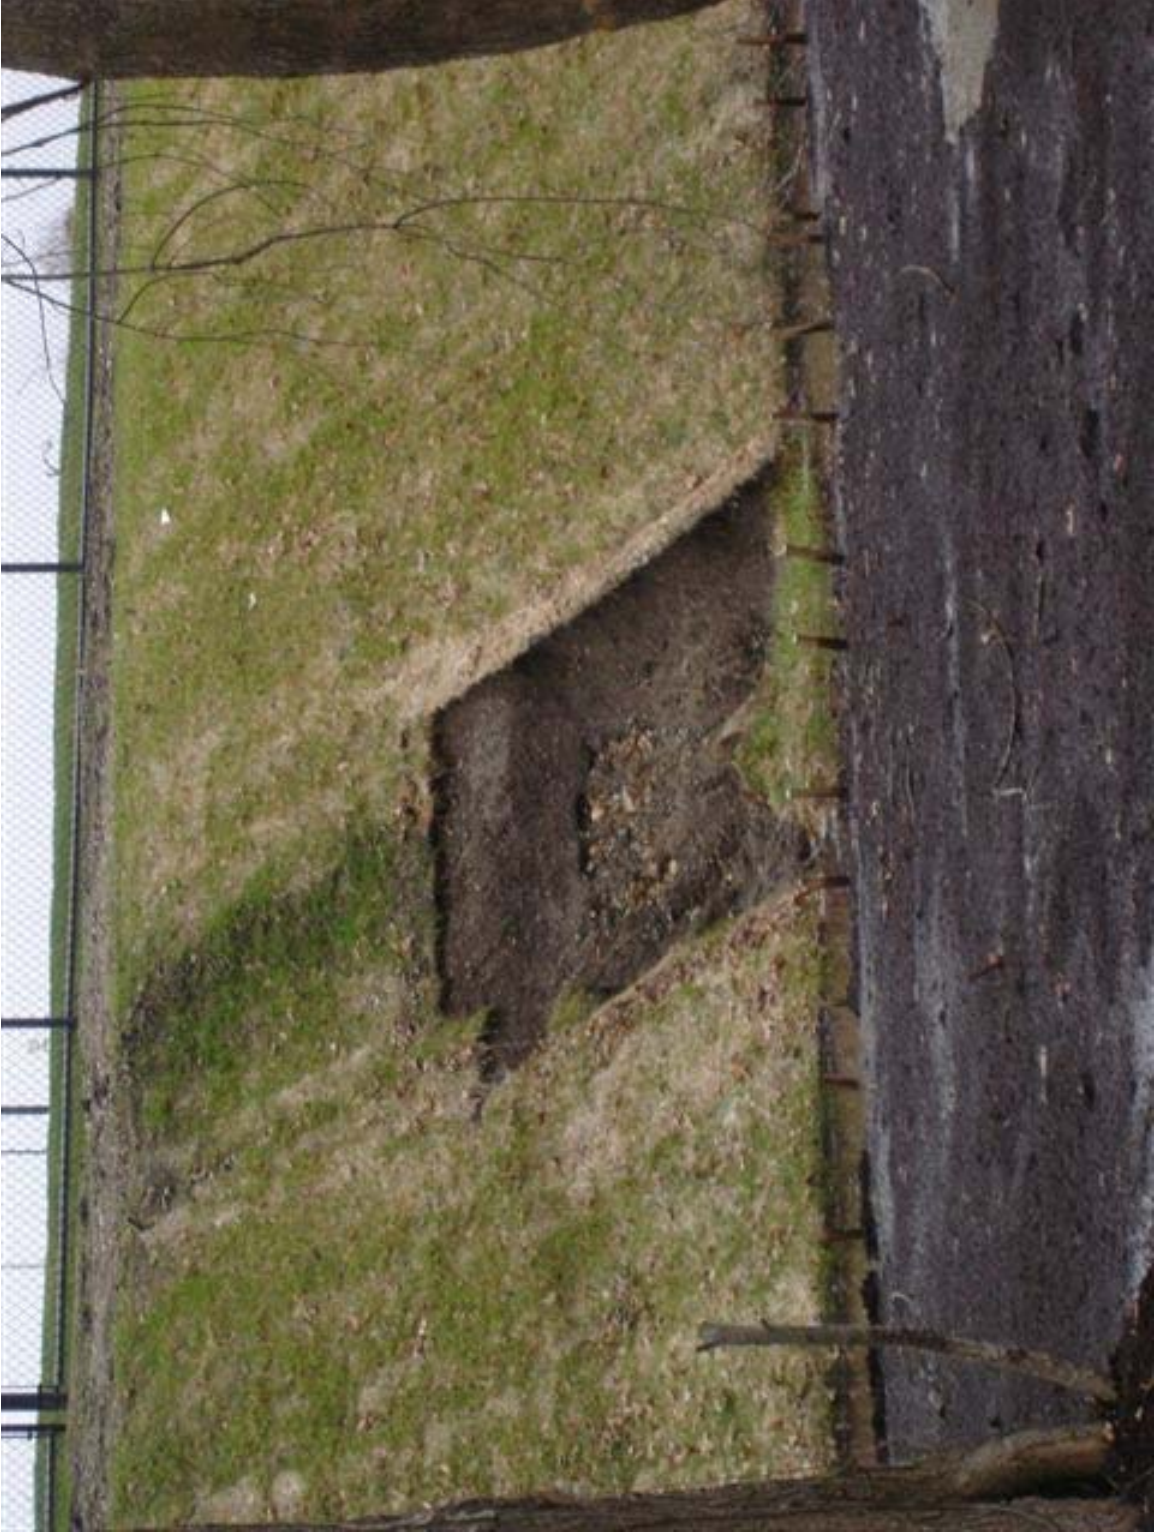
**Slope Failure Photograph**

- A shallow slope failure located on the steep slope between the wetland to the west and the southern parking lot to the east has been repaired. A photograph of the slope failure prior to the temporary repair is presented in Attachment 4. A permanent repair has been implemented and should not require additional work pending the reestablishment of vegetation around the repaired area.
