| File number: | 200220-4 | UNREGISTERED LAND | | |
| Owner: | CSY REALTY TRUST | REGISTERED LAND | | |

MORTGAGE INSPECTION PLAN
1091 TOBEY STREET, NEW BEDFORD, MA

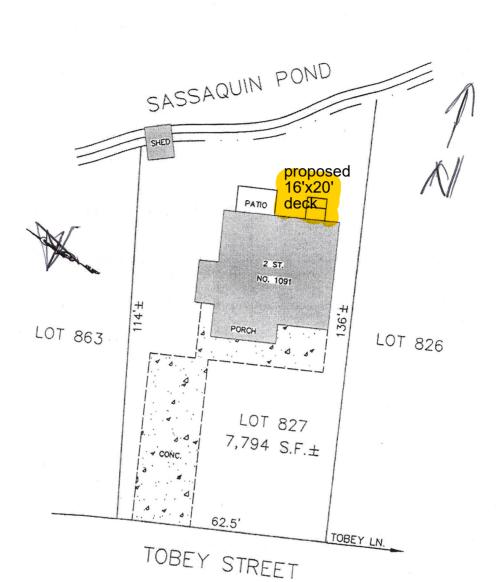
I CERTIFY TO THE ABOVE ATTORNEY, BANK,AND THEIR TITLE INSURANCE COMPANY THAT THE MAIN BUILDING, FOUNDATION OR DWELLING WAS IN COMPLIANCE WITH THE LOCAL ZONING BYLAWS IN EFFECT WHEN CONSTRUCTED (WITH RESPECT TO STRUCTURAL SETBACK REQUIREMENTS ONLY) OR IS EXEMPT FROM VIOLATION ENFORCEMENT ACTION UNDER MASS. GENERAL LAW TITLE VII, CHAPTER 40A, SECTION 7.

BY SCALE, THE DWELLING SHOWN HERE DOES NOT FALL WITHIN A SPECIAL FLOOD HAZARD ZONE AS DELINEATED ON A MAP OF COMMUNITY # 25005C377F AS ZONE X DATED 07/07/2009 BY THE NATIONAL FLOOD INSURANCE PROGRAM.
