Structural Inspection North Terminal, New Bedford, MA Report of Findings

New Bedford Harbor Development Commission
52 Fisherman's Wharf, New Bedford, MA

cleengineering

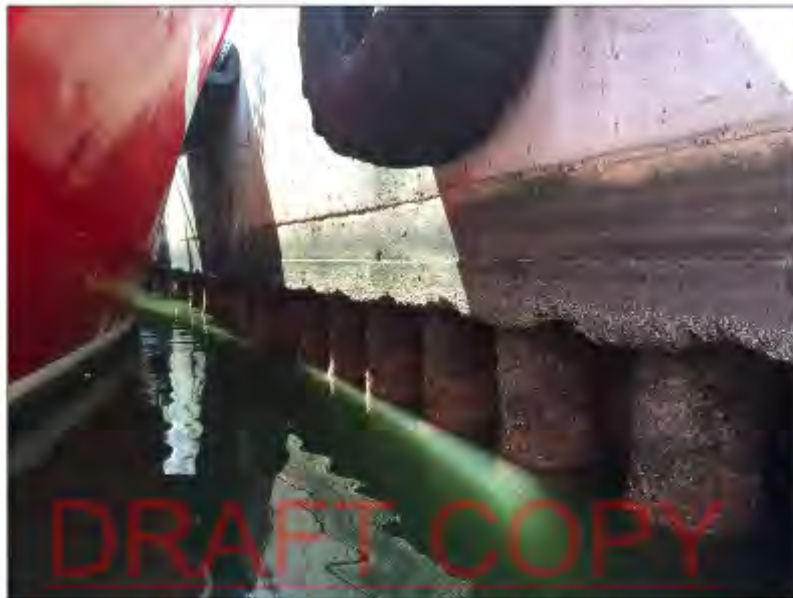
The Maritime International Terminal (Pier) is approximately 478 linear feet and is used for access to fishing vessel berths, for support of the buildings on site, and general storage. No record plans or plans indicating date of construction were located (aerials indicated pre-1971 construction date). The structure consists of a large concrete deck supported by concrete encased timber piles. The piles are driven along a grid line only along the seaward face, piles behind the face are located in an almost random arrangement. Due to the non linear arrangement of the piles and the very close spacing (only 18 to 24 inches clear space is typical), inspection of this site was not possible. The few piles inspected exhibited signs of reduced section area due to marine borer damage.

Photograph 1: Typical pile layout along fender line

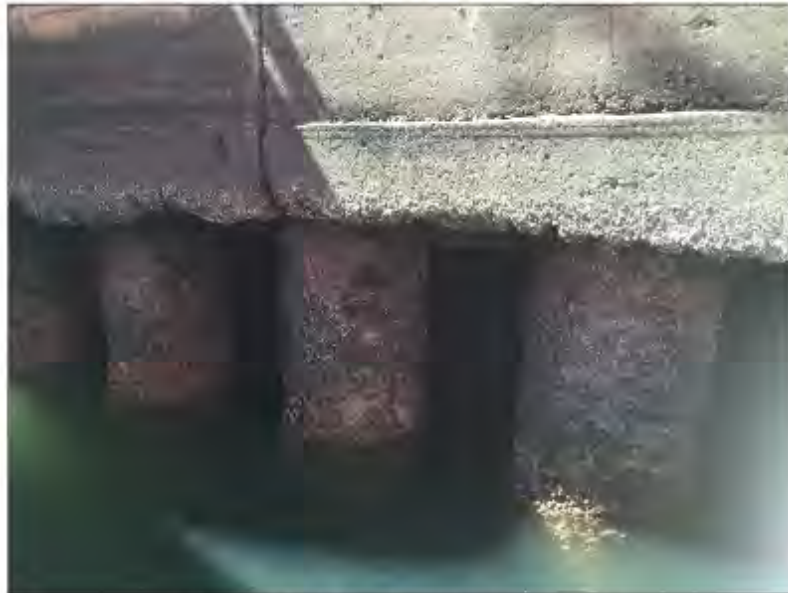
Photograph 2: Typical close spacing of piles

The pier along Parcel 1 likely contains hundreds of piles supporting both the concrete cap and the terminal buildings above. These piles comprised of concrete encased timber are susceptible at or near the mudline to marine borer attack. Assuming this condition has existed for nearly 50-years an inspection focused just on this Parcel should be completed immediately.

Given that the concrete jackets at this site extend almost the full length of the piles it may be possible to extend the service life of the structure significantly by extending the jackets into the mudline. The efficacy of this repair cannot be determined until an inspection is completed.

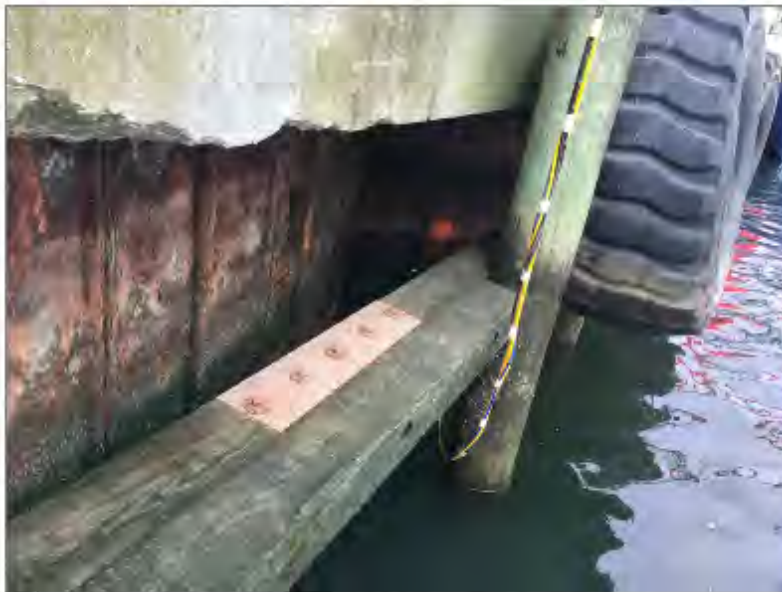
Photograph 3: Typical bulkhead/fender construction

The steel sheet pile cells are of varying diameters and extend from the mud line directly into the concrete cap. The flat steel sheets which comprise the cells exhibit signs of heavy corrosion with pitting of the steel and no evidence of a previous coating. However, relatively few holes were located during the underwater inspection (two - 24 in² at Cell 3, and one 300 in² at Cell 8). Conduit located at various locations along the steel cells may indicate that an impressed current system was once installed at the site but no such system is currently in operation.

The timber fender system is in fair condition with the piles still showing evidence of their preservative treatment. The bolting hardware retains a crisp profile with minor deterioration and the bolting holes have not been expanded beyond their original size (through friction or marine borers). The tire fenders are typical for an industrial site of this type and although not an engineered solution, they appear to perform adequately as contact of the timber system with a vessel appears to be infrequent. A galvanized channel protects the concrete cap from friction damage from the tire anchor cables.

Overall the bulkhead is in *Fair* condition with no load restrictions but significant deterioration. The presence of heavy deterioration and holes in the sheet pile cells indicate that the bulkhead is approaching the end of its service life. However in the near term (beyond the next inspection interval) should the parcel's use remain as it is today, patching of the three located holes is the only structural repair which is recommended at this time. It may be possible to extend the life of the system with the installation of a cathodic protection system. An analysis of the current condition and connectivity of the structure should be performed to assess the cost/benefit.

- Cathodic protection analysis
- Design of bulkhead patching repairs

- Perform bulkhead patching repairs
- Routine inspection in 2021

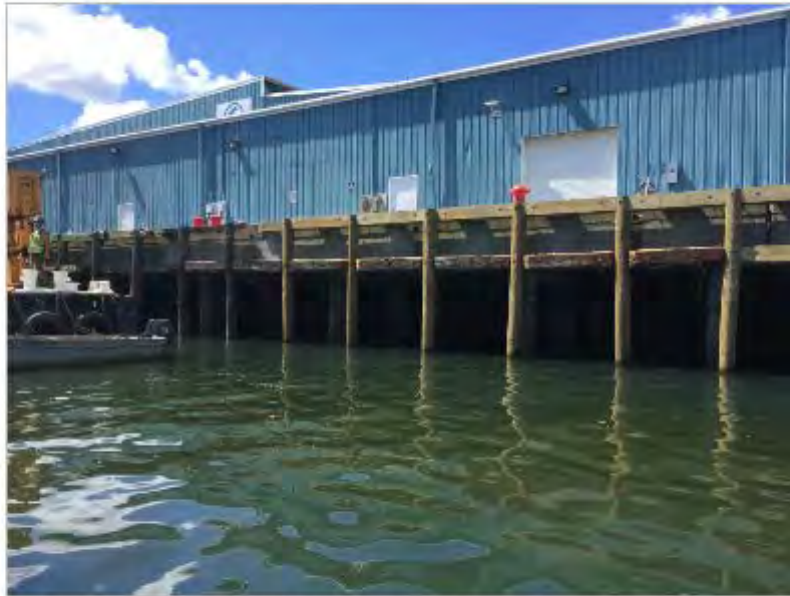
Photograph 4: Replaced timber fender along Seawatch parcel

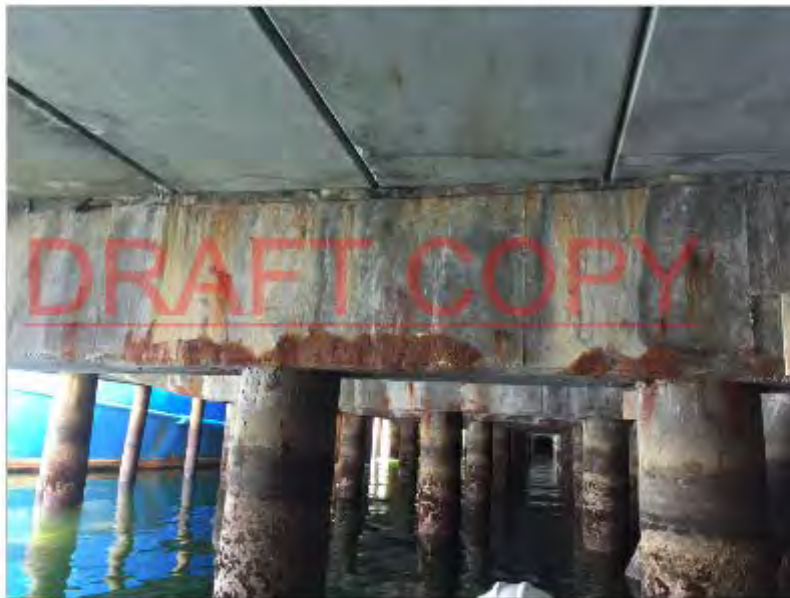
Photograph 5: Typical below deck view of pier construction/condition

The concrete deck and pile caps have localized areas of spalling and corrosion of the steel reinforcement consistent with the age of the structure. Spalling or loss of concrete was not extensive enough to determine reinforcement diameter or spacing.

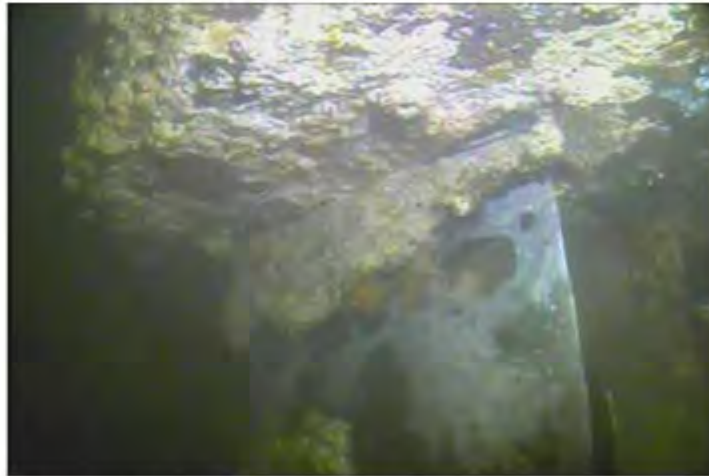
Photograph 7: Bent 16 Pile C2 - Bottom of concrete jacket visible

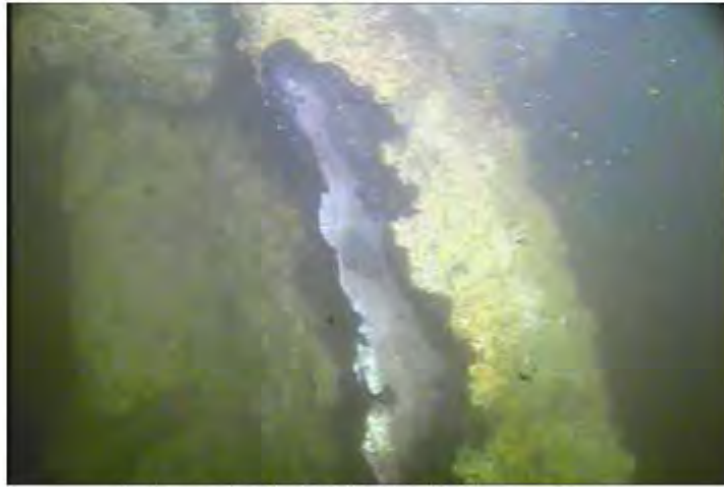
Photograph 9: Bent 16 Pile 16.3 2 - flange edge

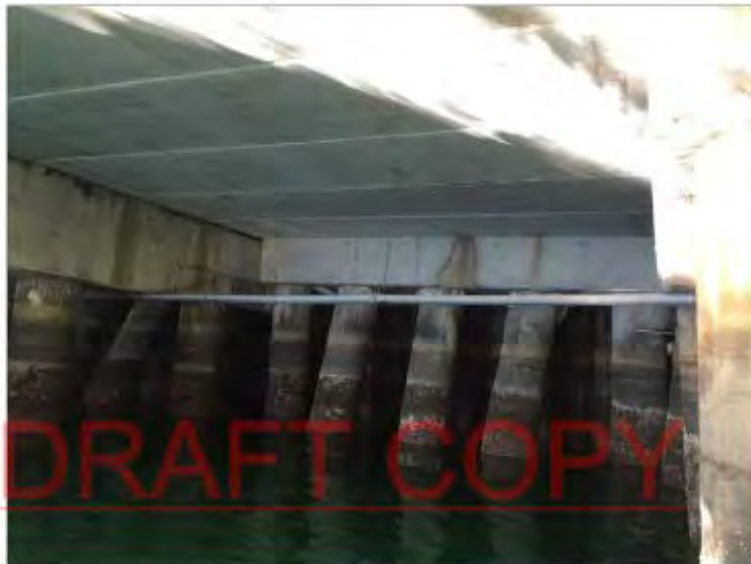
Photograph 10: Typical batter pile construction against bulkhead

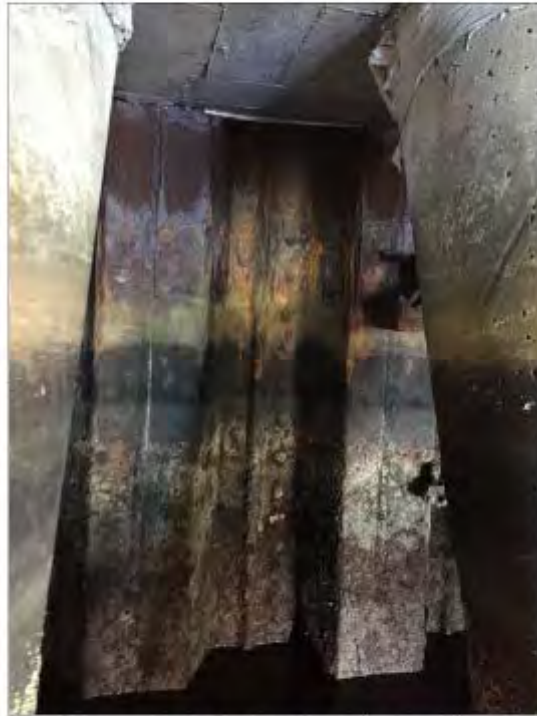
The steel bulkhead was found to be deteriorated especially at the northern end of the project site (see Photograph 11). Large holes (6 ft x 2 ft and 6 ft x 4 ft) were observed at the northern end of Parcel 10. Evidence of a tie back anchor system were found intermittently along the entire length (see Photograph 12). It is not clear if these anchor systems are original or were retrofitted at a later date.

Photograph 11: Typical Sheet Pile Condition

The large holes in the bulkhead at the northern end of the project site are permitting loss of fill through the bulkhead possibly undermining the area immediately landward of the pier. Continued loss of fill presents the possibility of a collapse due to loading by vehicles, product, etc.

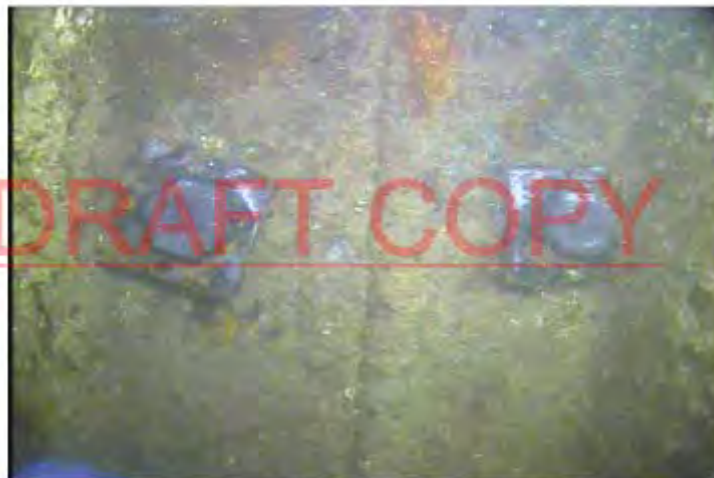
Photograph 12: Tieback bolts through bulkhead

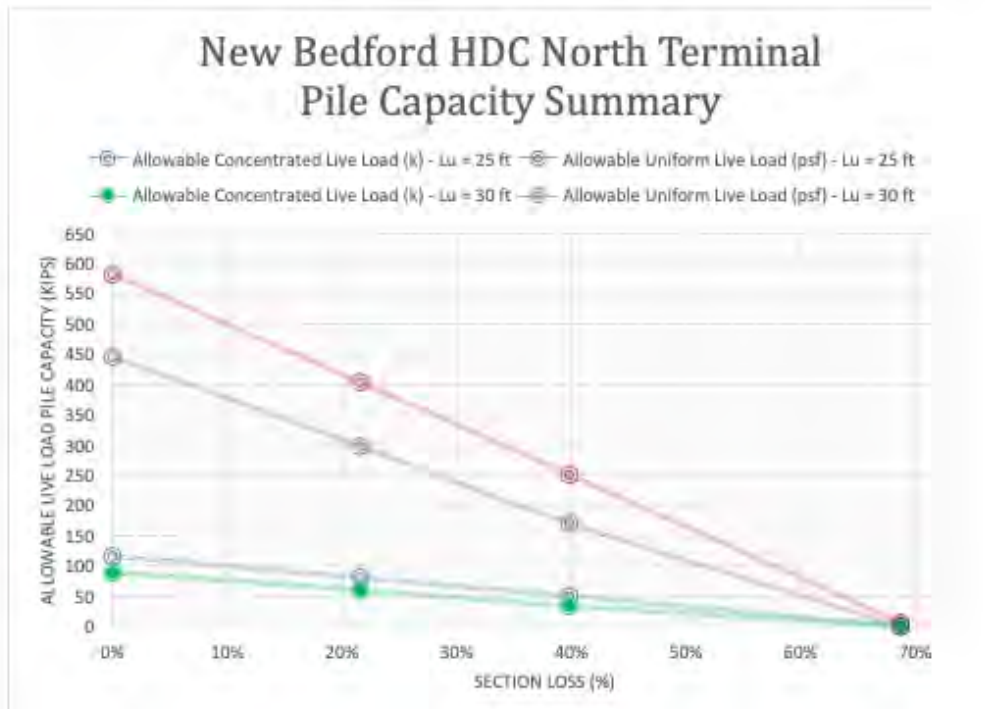
Figure 6: Section loss vs. Allowable Live Load

CLE performed structural calculations using estimates of original pile thicknesses and lengths to determine the approximate capacity of the structure at the time of construction. As shown in Attachment B it is estimated that the pier began its service life with an approximately 400 psf deck load capacity. Given that some piles were observed to be completely deteriorated and most were found to have only 50% or less of their original section remaining, the structure is considered to be in *Poor* condition. In its current condition the allowable loading must be significantly reduced from the original 400 psf. Based on a structural analysis of the piles, all piles which are below 0.217 inches in web/flange thickness have an allowable capacity less than 100 psf. Piles with thickness less than 0.153 may fail due to overstressing and have no remaining live load capacity. The pile condition plan provided in Attachment A indicates that the vast majority of the piles in which the marine growth was removed were found to be in severe condition with significant section loss. Those piles not assigned a color were not cleaned of marine growth, and can be assumed to be of similar condition to those which were cleaned. Until further inspections can be conducted, the capacity of the pier must be limited to 100 psf.

It is recommended that an inspection of 100% of the plumb piles be performed as soon as possible to determine if areas of pier may have additional or less capacity than 100 psf.
