## PROJECT EVALUATION

RE New Bedford Whaling Museum  
Bourne and Wood Buildings

Project No. 18118

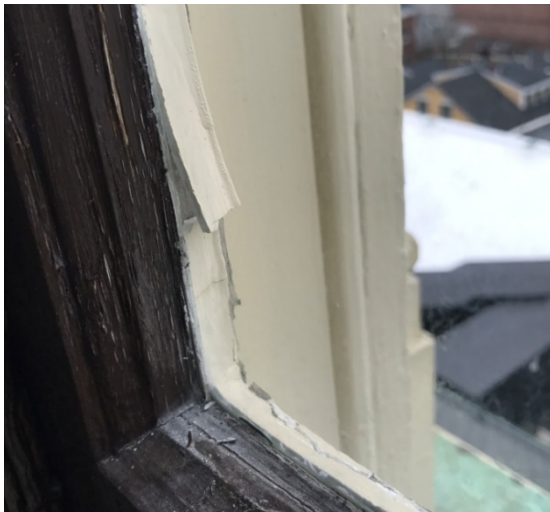
Bourne Building, Cupola: deteriorated exterior sealant

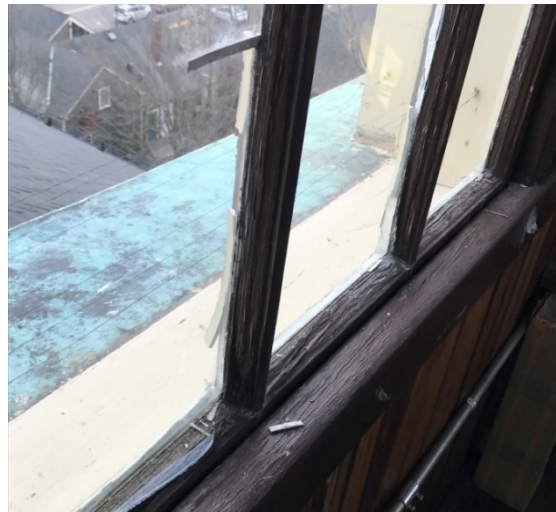
Bourne Building, Cupola: deteriorated exterior sealant

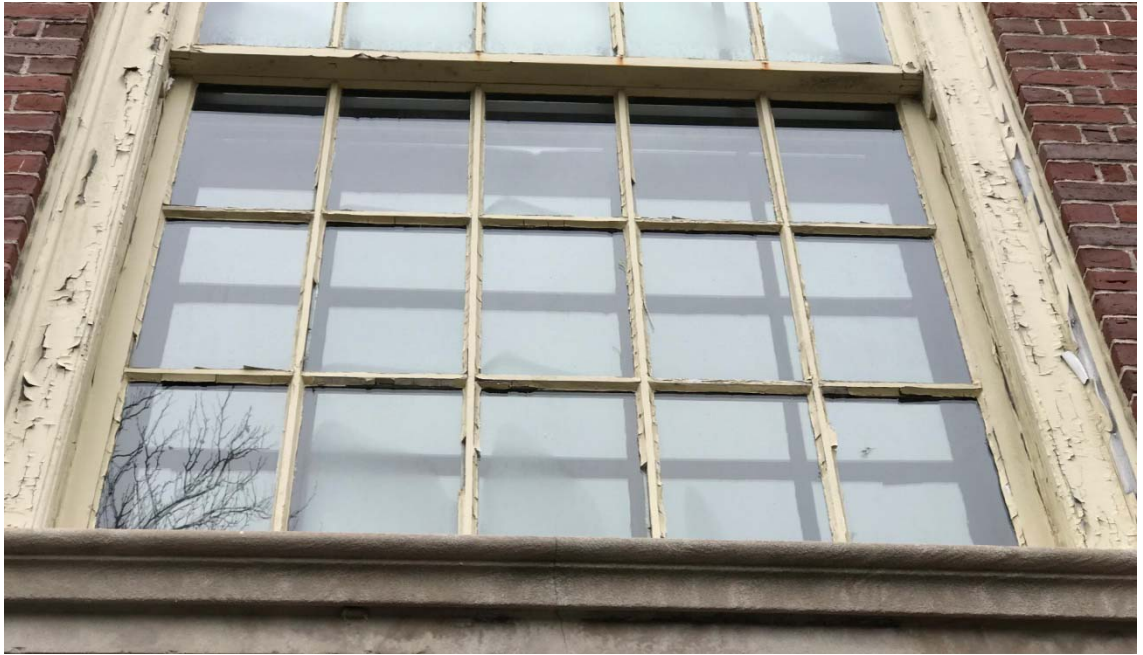
Bourne Building: typical window sash with deteriorated sealant (as well as peeling paint at sash frame and casings)

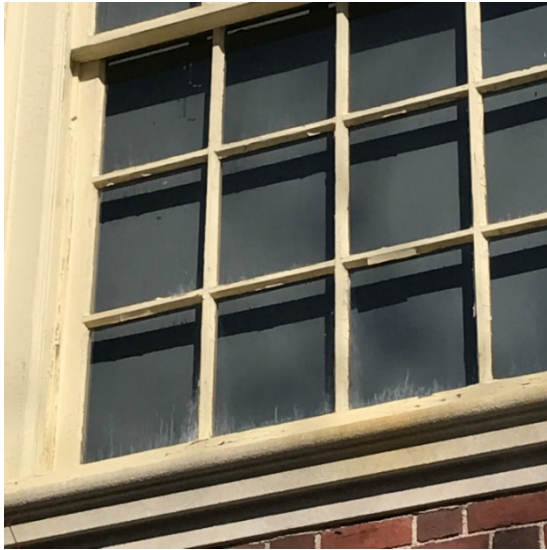
Wood Building: sealant (glazing compound) falling out of place at edges of window panes

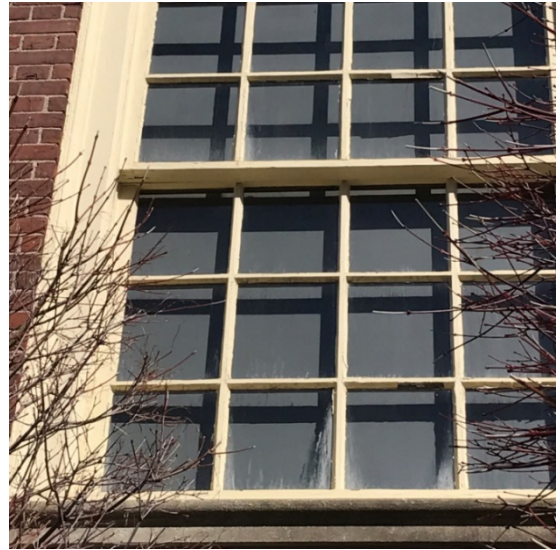
Wood Building: sealant (glazing compound) falling out of place at edges of window panes

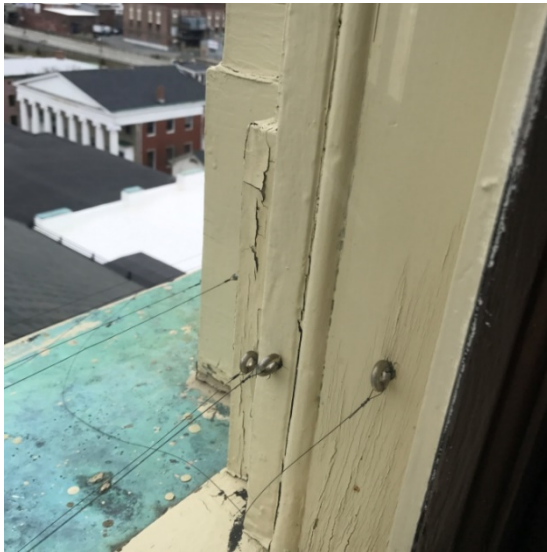
Bourne Building, Cupola: cracked and blistering paint at window jamb and casing

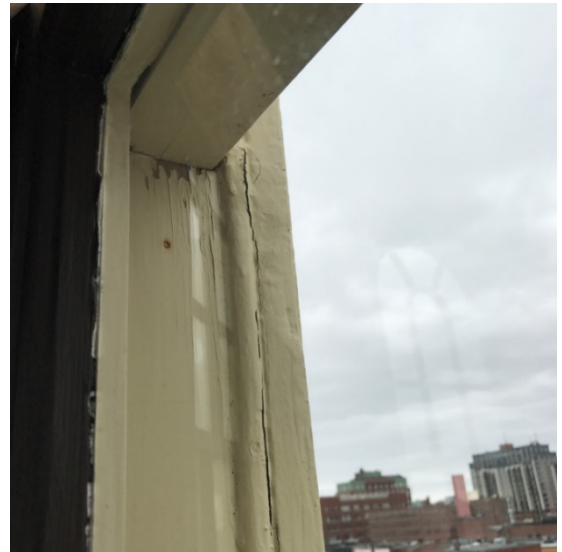
Bourne Building, Cupola: cracked and blistering paint at window jamb, head and casing

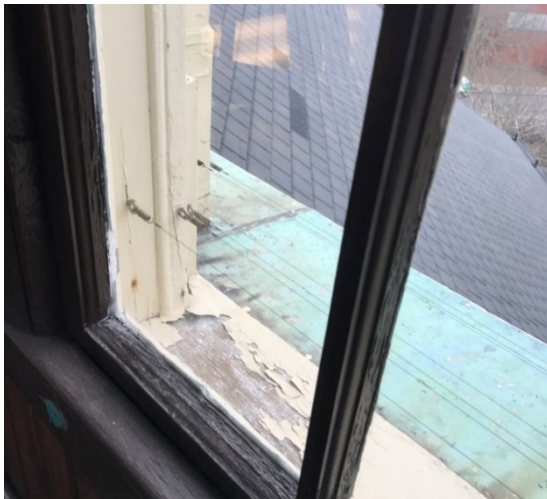
Bourne Building, Cupola: flaking paint at window sill.

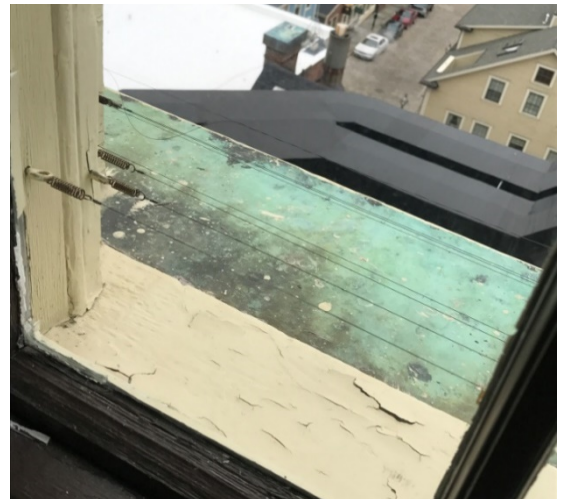
Bourne Building, Cupola: cracked paint at window sill

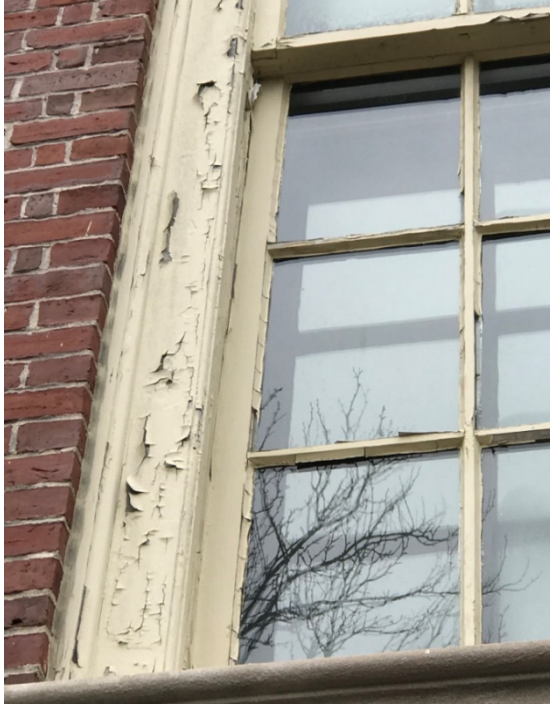
Bourne Building: peeling paint at window casing

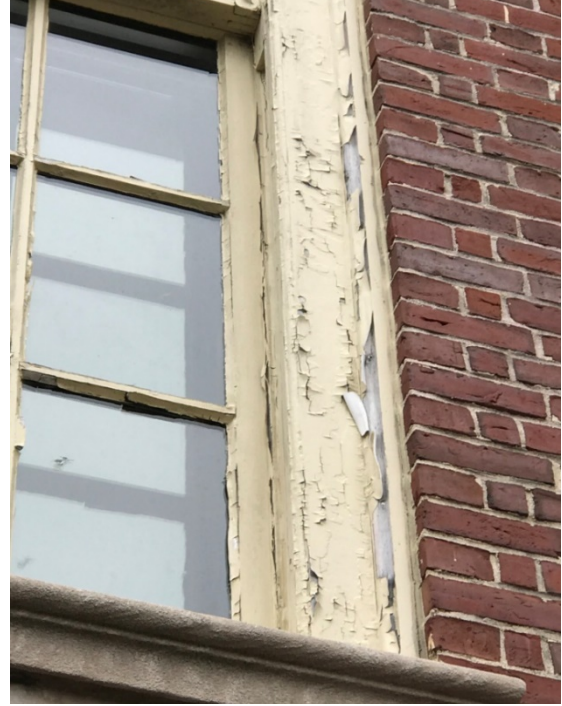
Bourne Building: peeling paint at window casing

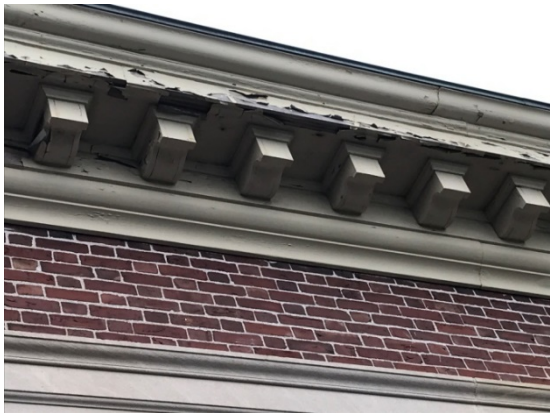
Bourne Building: peeling paint at cornice

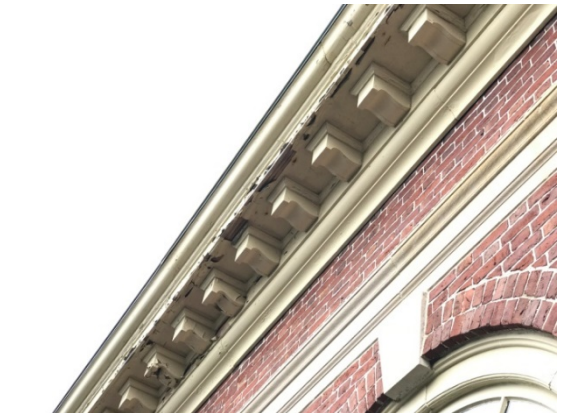
Bourne Building: peeling paint at cornice and possibly damaged bracket(s)

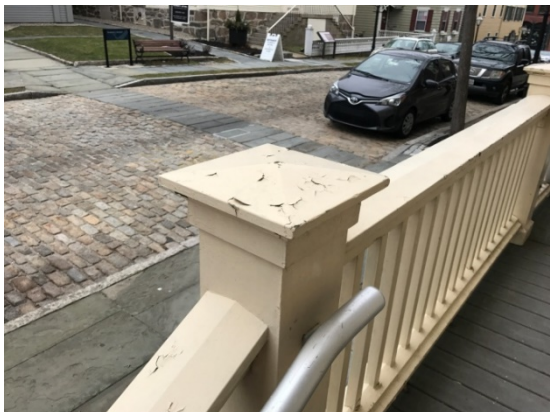
Bourne Building, Ramp: peeling paint at wood guard rail

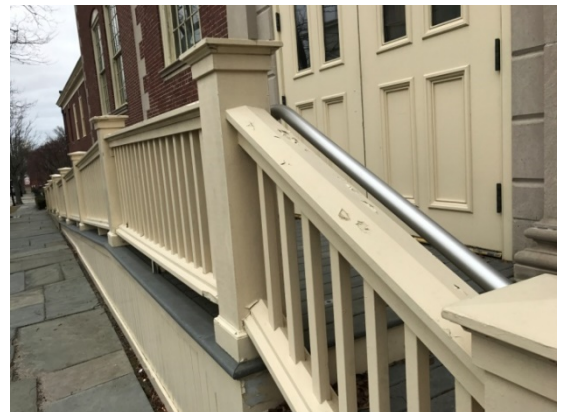
Bourne Building, Ramp: peeling paint at wood guard rail

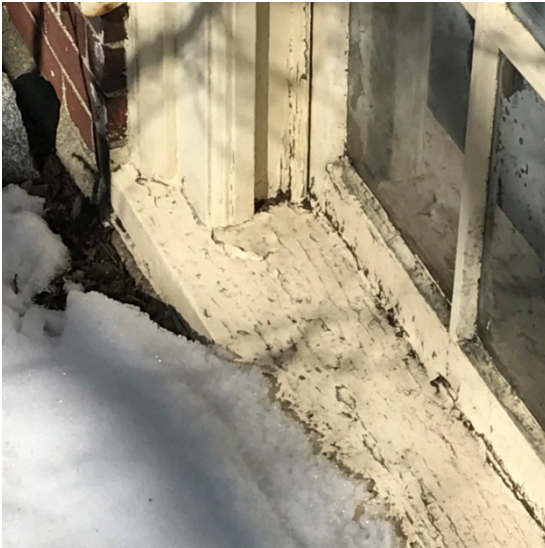
Wood Building: wood trim in need of repainting and possibly repair of the trim itself

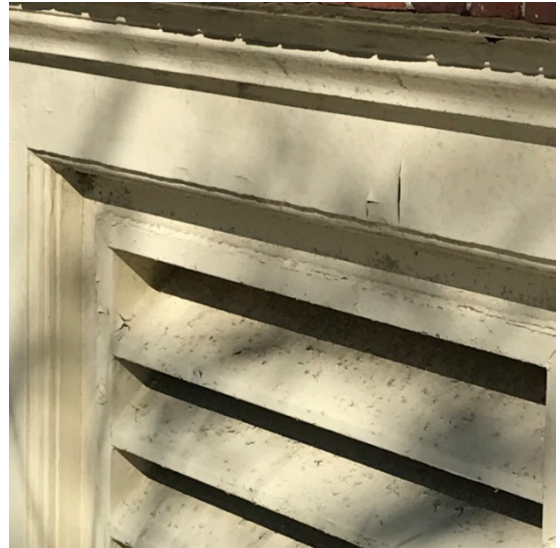
Wood Building: wood trim in need of repainting

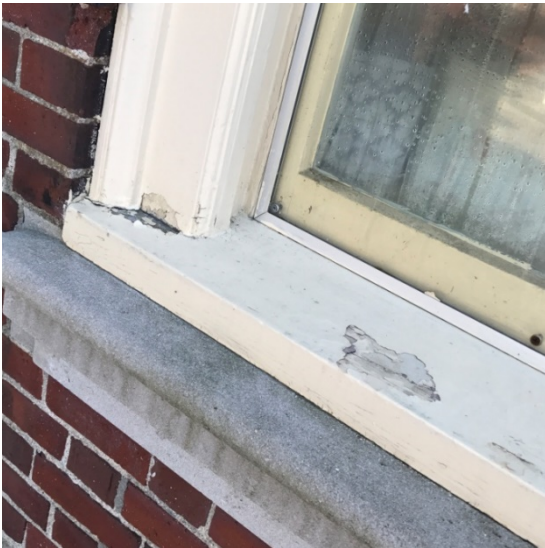
Wood Building: flaking paint at window trim and sill

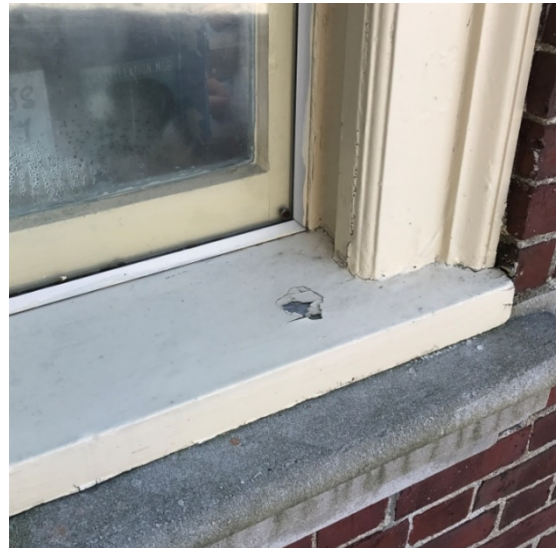
Wood Building: flaking paint at window trim and sill

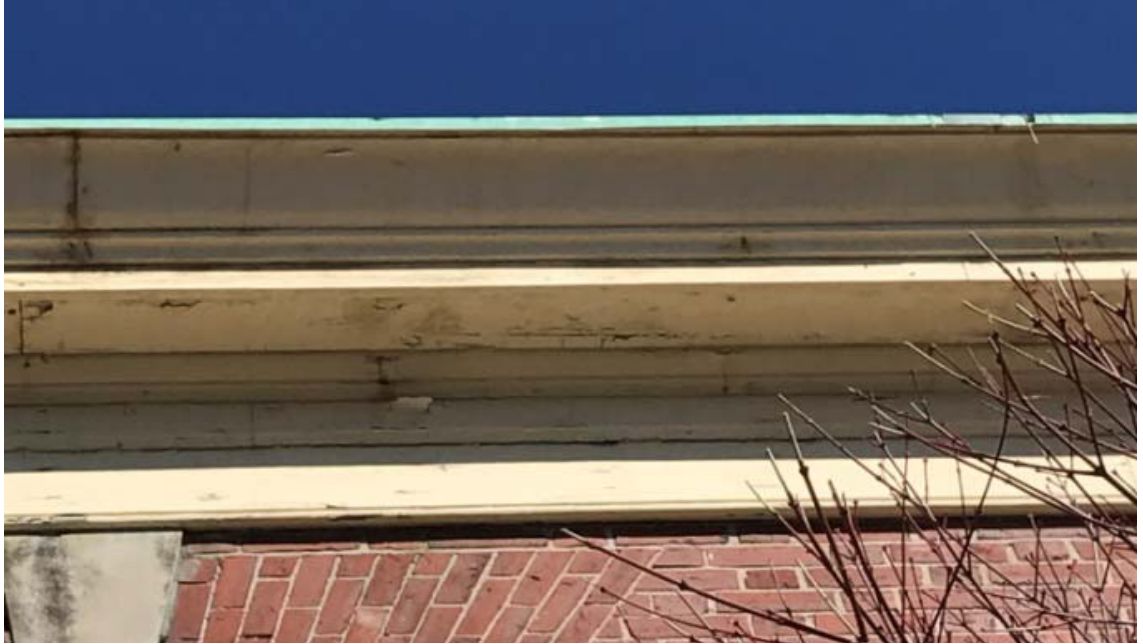
Wood Building: peeling paint at wood soffit, frieze and gutter

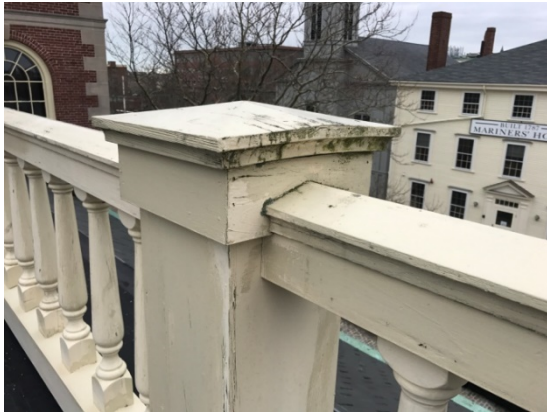
Wood Building, Baluster: baluster post and cap exhibiting signs of decay/deterioration

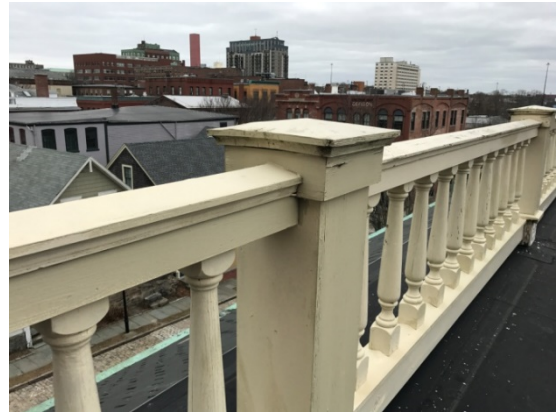
Wood Building, Baluster: baluster post and cap exhibiting signs of decay/deterioration

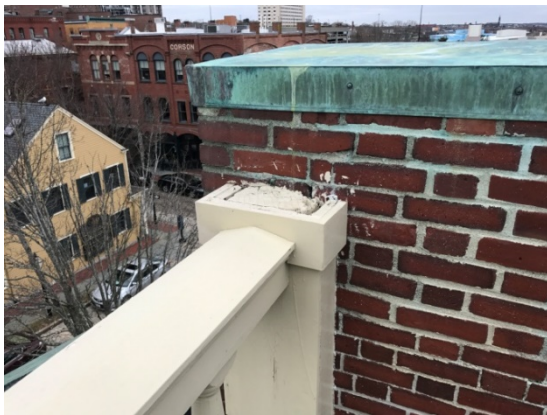
Wood Building, Baluster: missing baluster engaged post with missing cap

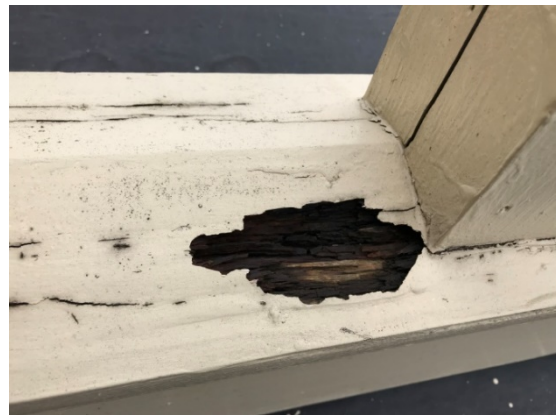
Wood Building, Baluster: deterioration at bottom rail of baluster

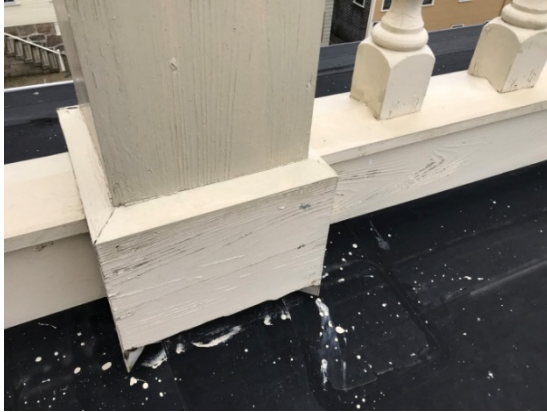
Wood Building, Baluster, missing piece at bottom of baluster post base trim

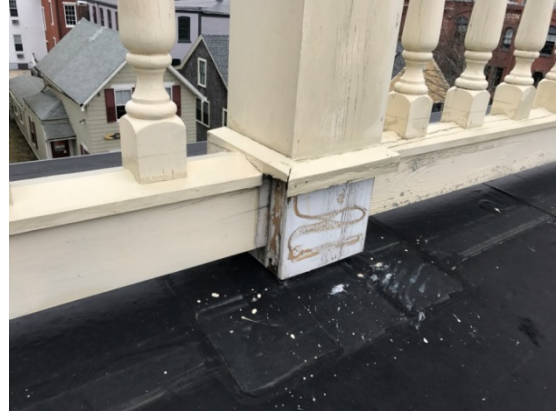
Wood Building, Baluster: missing pieces at baluster post base trim

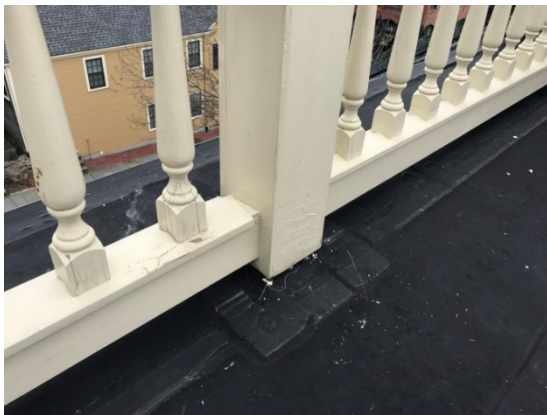
Wood Building, Baluster: entirely missing baluster post base trim
