### HISTORICAL COMMISSION MEMO

**Date:** April 29, 2021  
**To:** NBHC  
**From:** Anne Louro  
**RE:** Case #2021.08 - 117 Union Street

SE Project NBDC-221-01  
Existing Conditions Assessment  
121, 117 & 115 Union Street  
7 North 2<sup>nd</sup> Street  
New Bedford, MA

Schlick Engineering, LLC (SE) is pleased to submit this Existing Conditions Assessment letter for the referenced project located in New Bedford, MA. Our services were retained to perform an existing conditions assessment on the building referenced above and indicate any structural deficiencies.

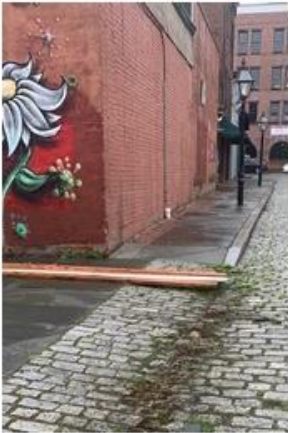
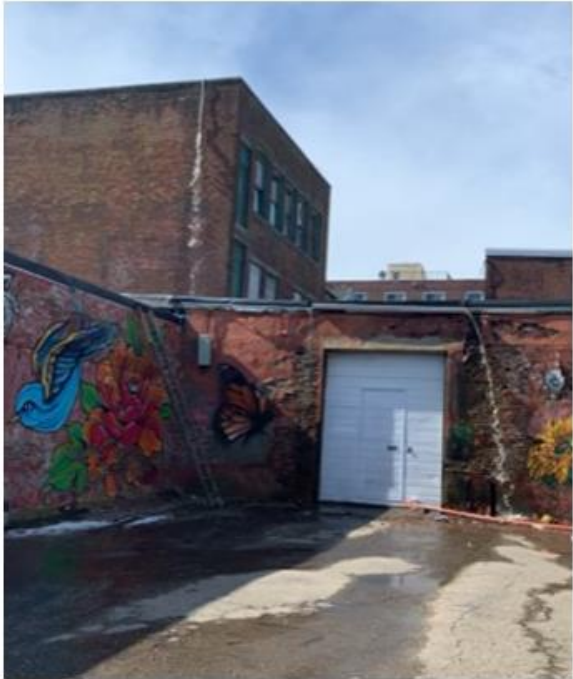
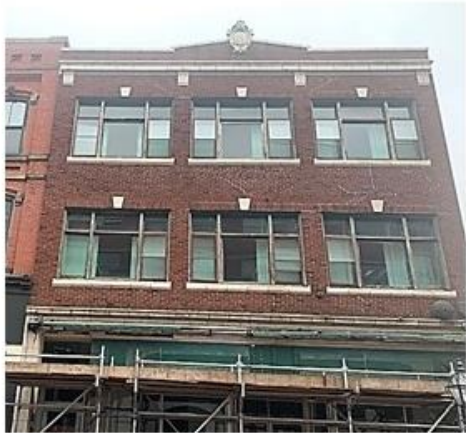
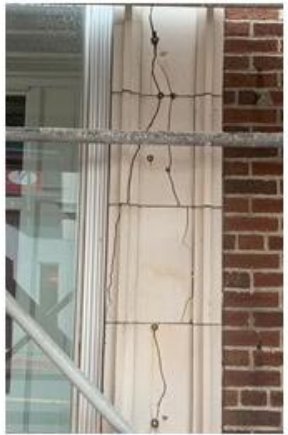
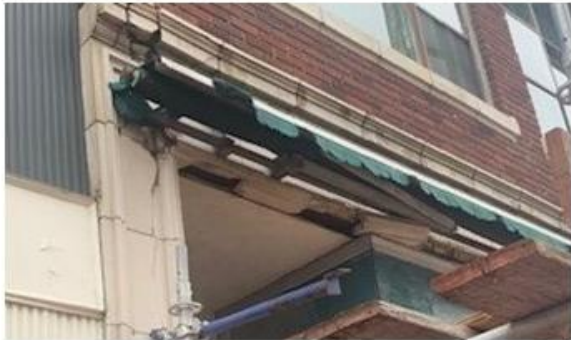
Façade Conditions and Water Drainage

**MOBY DICK BUILDING:** In the past few months water infiltration on the roof and within the basement of the Moby Dick Building has been an issue, with the water compromising the brick and terra- cotta façade. The property owner has been pumping water off the roof and from the basement. The water may be infiltrating behind the masonry façade, weakening its attachment. There are areas of terra cotta separating from the façade.

- ***The NBHC should require qualifications of the masonry contractor, seek specifications for repair/ replacement, and an approved field mock-up.***

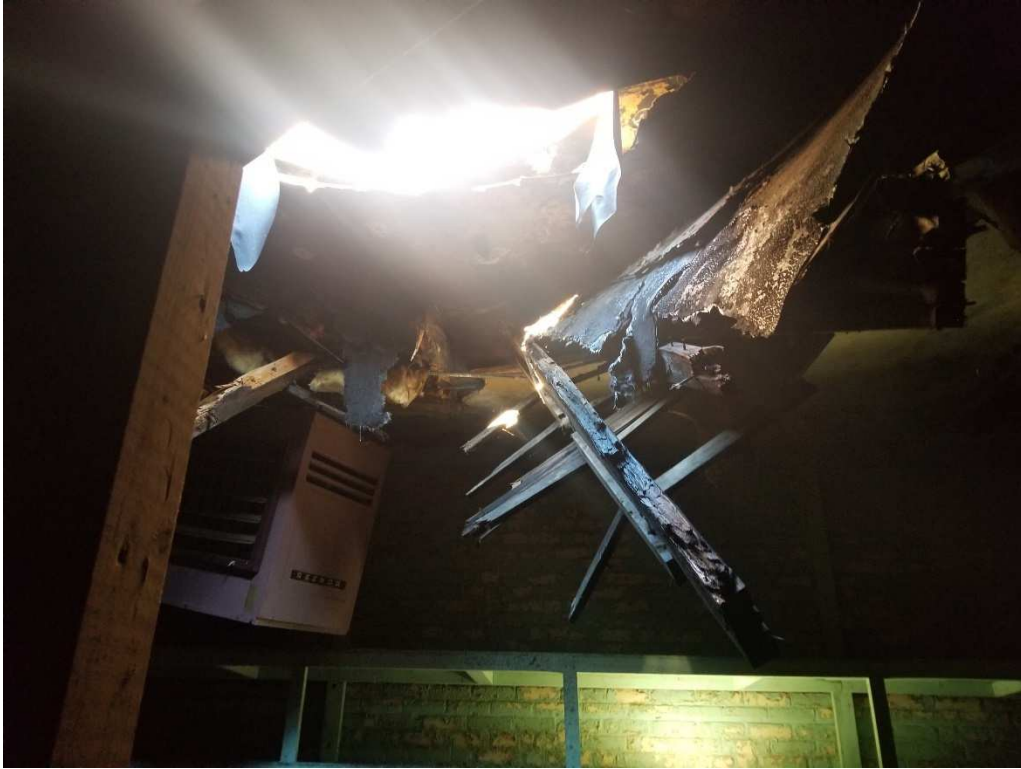
1. The roof framing at the back of the building has collapsed (Photo #1). ***The roof is adjacent to the 3-story building, which causes drifting on to the lower roof. The roof appears to be deteriorated, which is caused by water intrusion thru the roofing membrane. It appears the combination of deteriorated wood framing an overstressing from snow drifting has cause the roof to collapse.***
2. The steel framing and wood framing is severely deteriorated at the front façade of the building (Photo #2 & 3). ***The severe deterioration is causing the entire front façade to pull away from the building approximately 1" (Photo #4, 5 & 6) and will ultimately fall onto the pedestrian sidewalk.***
3. The interior steel girders and columns are severely deteriorated (Photo #7 & 8). ***The deteriorated steel may become overstressed, causing the ceiling to collapse.***

**Photo #1 – Roof collapse at the back of the building adjacent to the 3-Story Building.**

- Buildings 121 Union Street, 117 Union Street, 115 Union Street and 7 North 2<sup>nd</sup> Street should be demolished before the deterioration progresses further and causes harm to the public. The existing adjacent buildings should be reviewed and shored as necessary during the demolition process.
- The masonry façade on the 3-story building should be repointed and retrofitted by a professional mason.

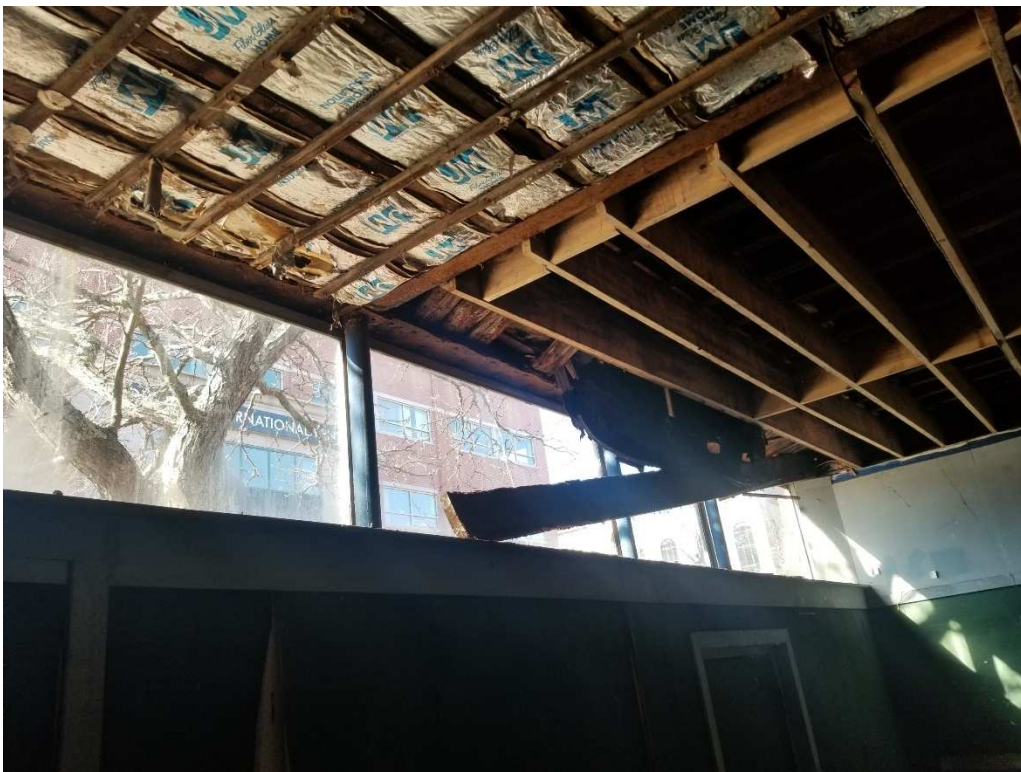
**Photo #2 – Steel girder, perimeter steel lintel assembly and wood framing deteriorated at front façade.**

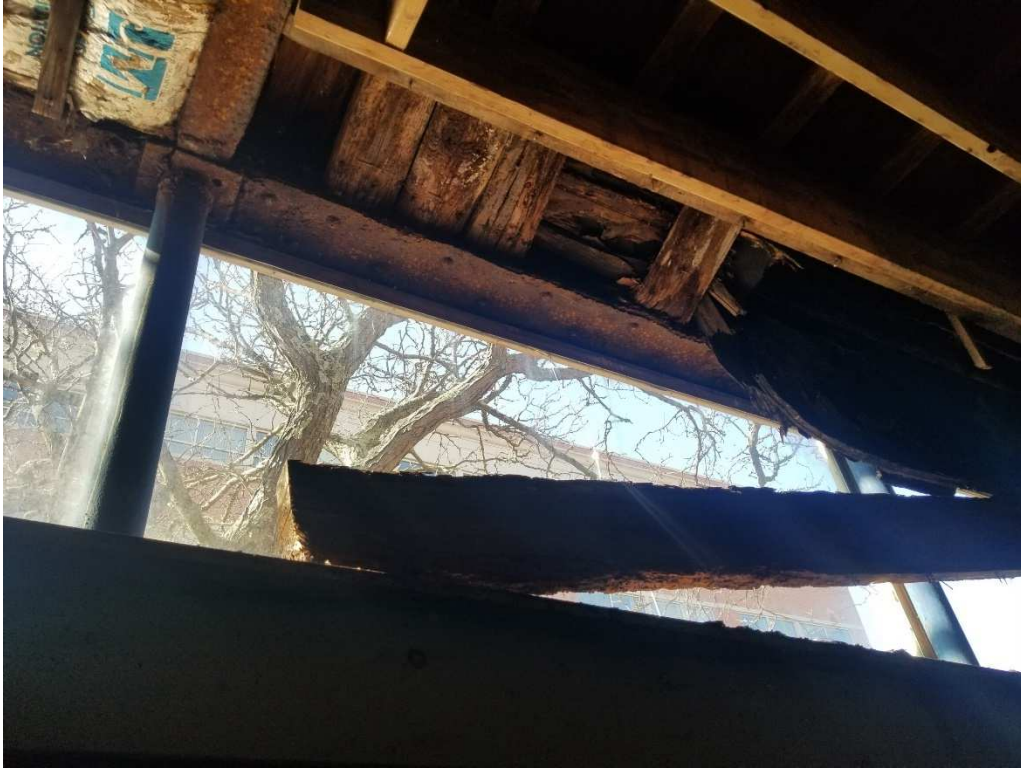
**Photo #3 – Steel girder, perimeter steel lintel assembly and wood framing deteriorated at front façade.**

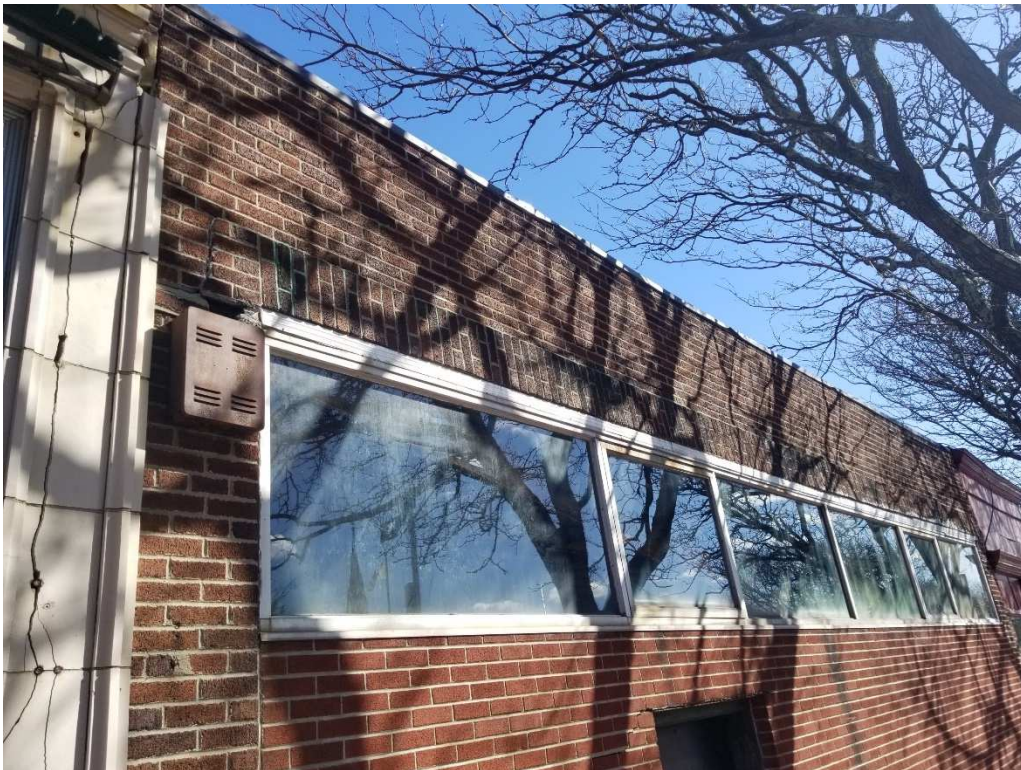
**Photo #4 – Front façade pulling away from the building at the failed lintel assembly.**

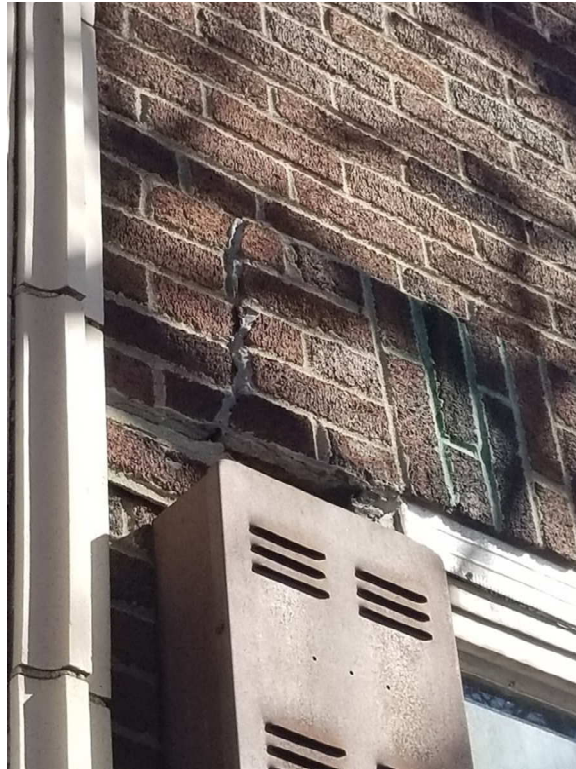
**Photo #5 – Façade pulled away from the building approximately 1”.**

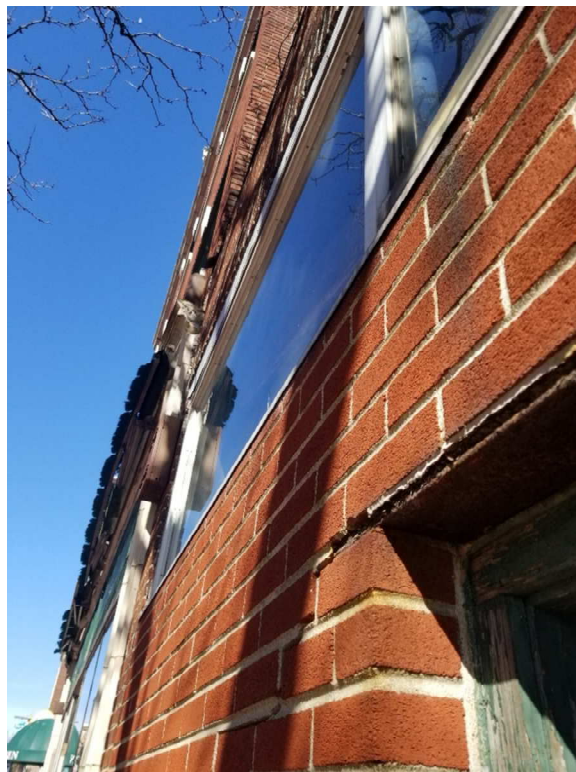
**Photo #6 – Façade pulled away from the door lintel approximately 1”.**

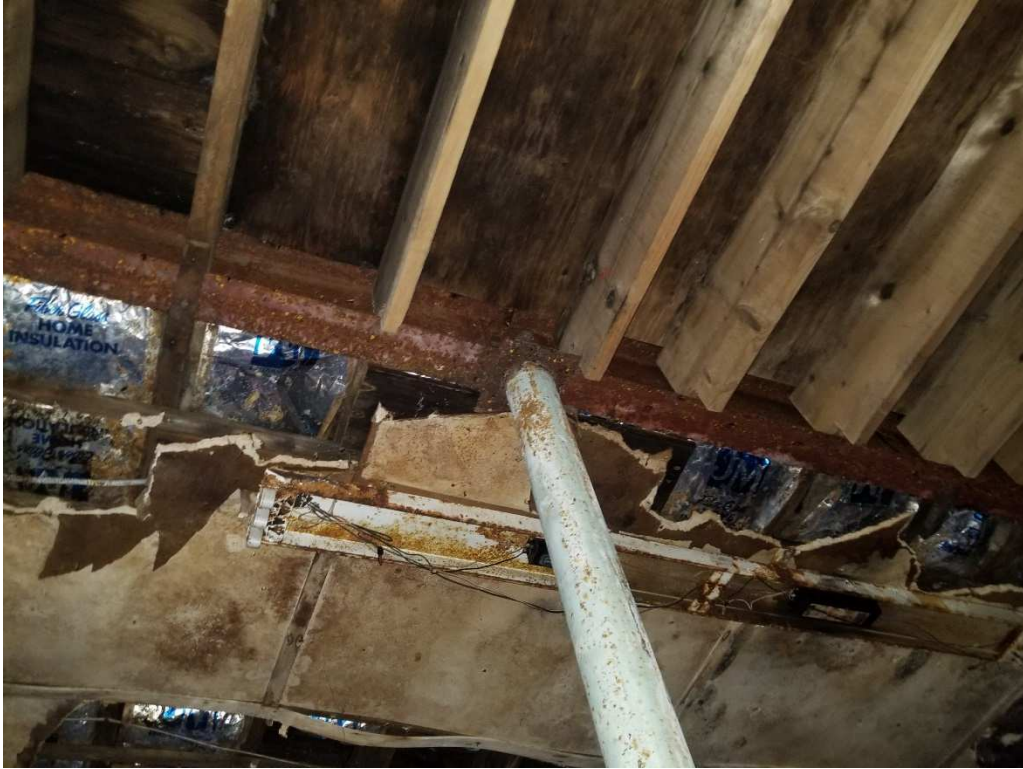
**Photo #7 – Steel girders and columns severely deteriorated.**

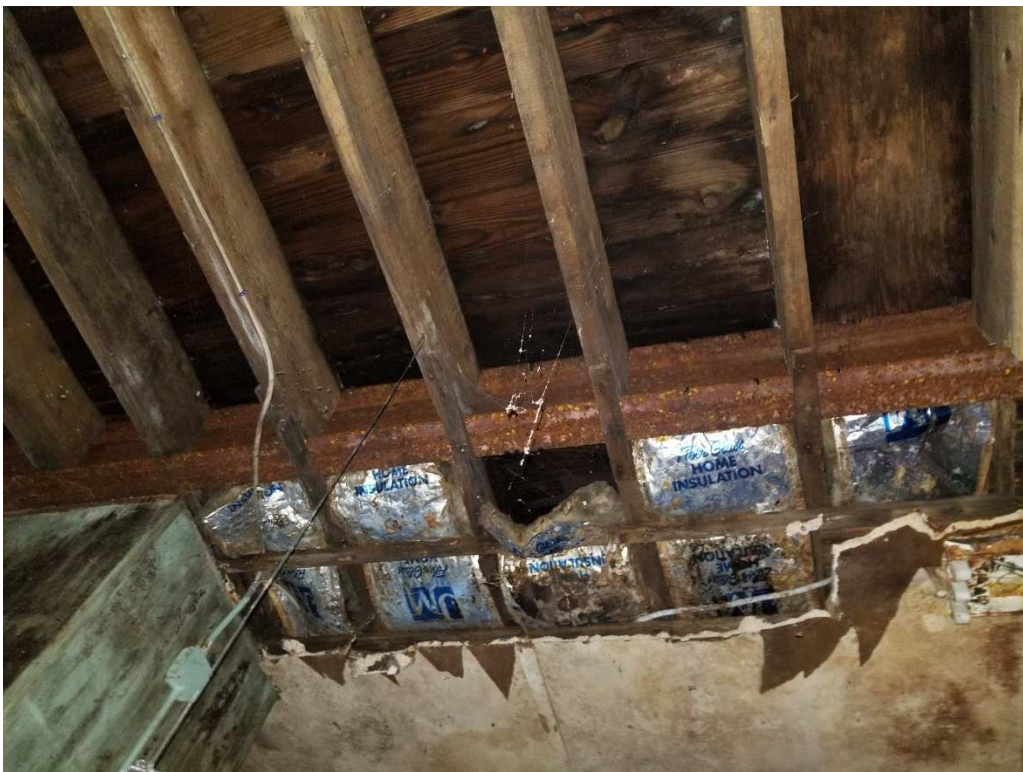
**Photo #8 – Severe deterioration of the steel framing.**

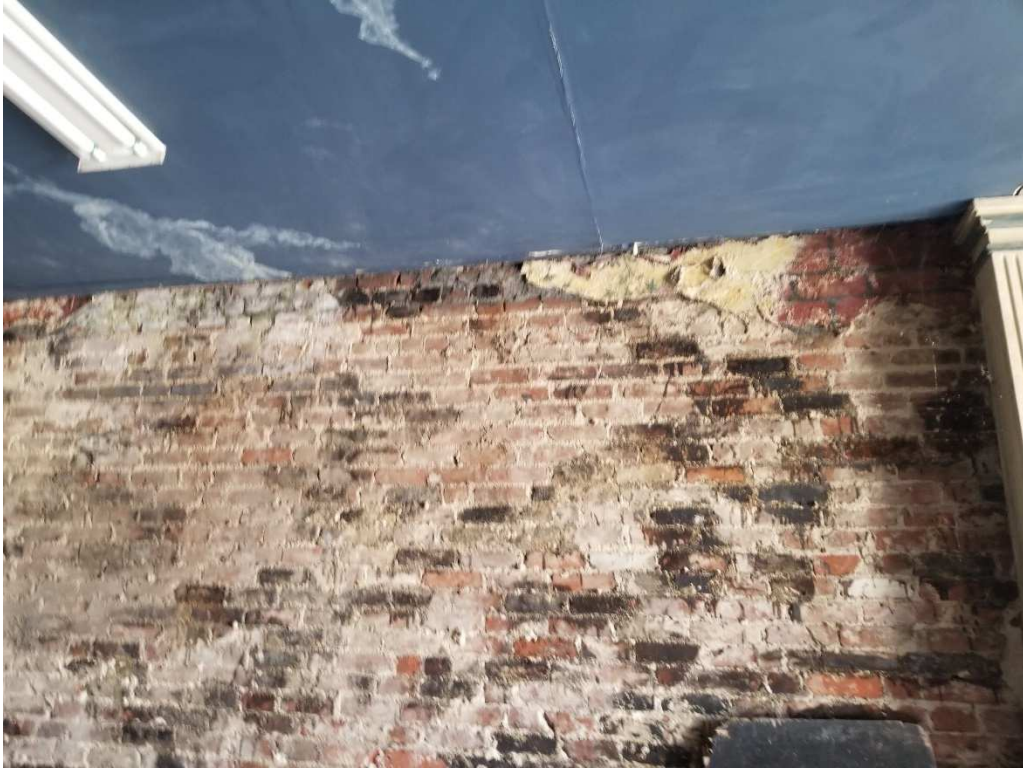
1. The back wall and ceiling showed signs of water intrusion (Photo #9). **The water intrusion is most likely deteriorating the concealed wood framing, which would cause a roof collapse. The mortar is deteriorated and adversely affecting the structural integrity of the bearing wall.**
2. The lintel assembly is failing at the front and side of the building. The masonry wall is pulling away from the structure at the front of the building (Photo #10, 11, 12 & 13). The lintels are excessively deflecting, and the masonry has diagonal cracks coming from the failing lintels (Photo #14, 15 & 16). **The failing lintel assembly is causing the perimeter masonry walls to become unstable and detached, which will ultimately fall onto the pedestrian sidewalk.**

**Photo #9 – Water intrusion at the back wall.**

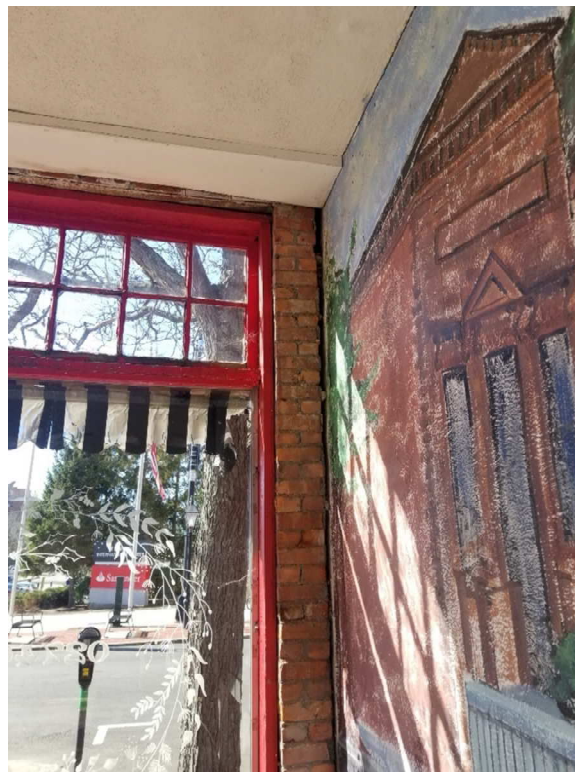
**Photo #10 – The front façade is pulling away from the structure.**

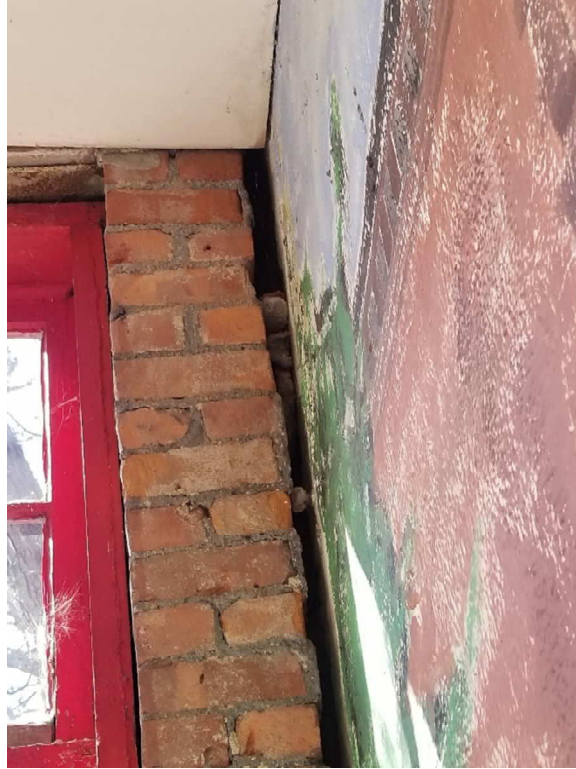
**Photo #11 – Daylight can be seen from the masonry pulling away from the structure.**

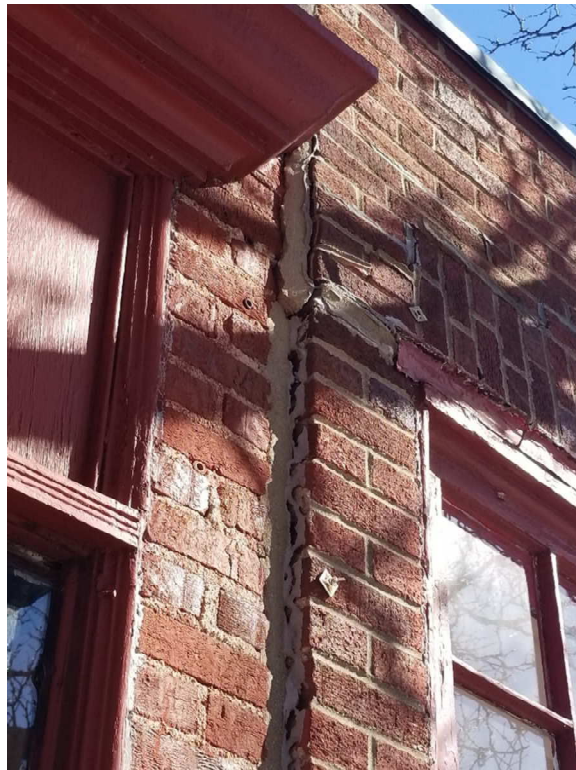
**Photo #12 – Masonry wall pulling away from the front of the structure approximately 2".**

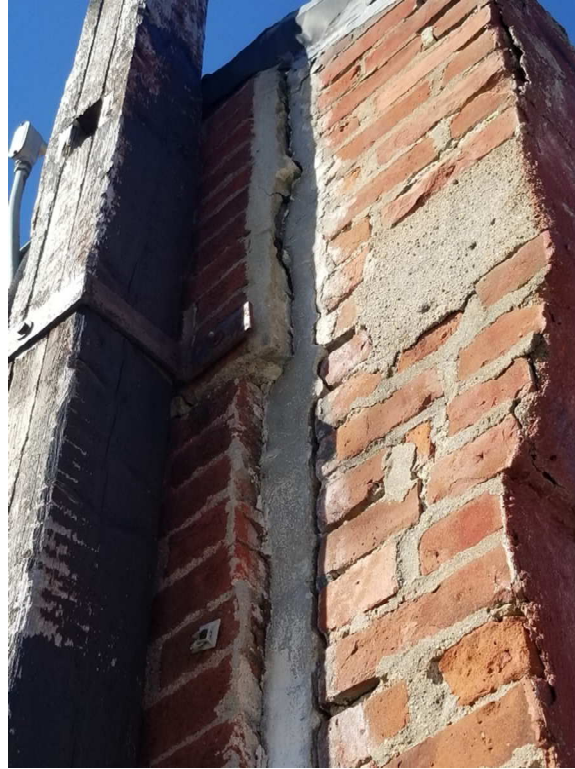
**Photo #13 – Masonry wall pulling away from the back of the structure approximately 2”.**

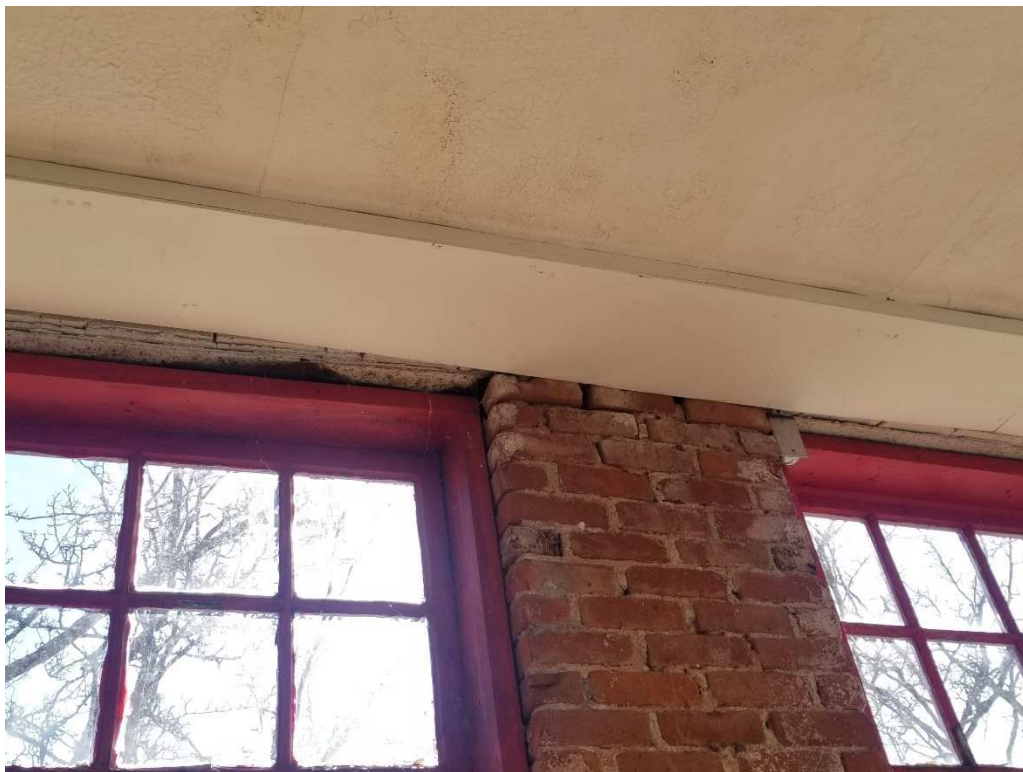
**Photo #14 – Lintels excessively deflecting and the masonry deteriorated at the supports.**

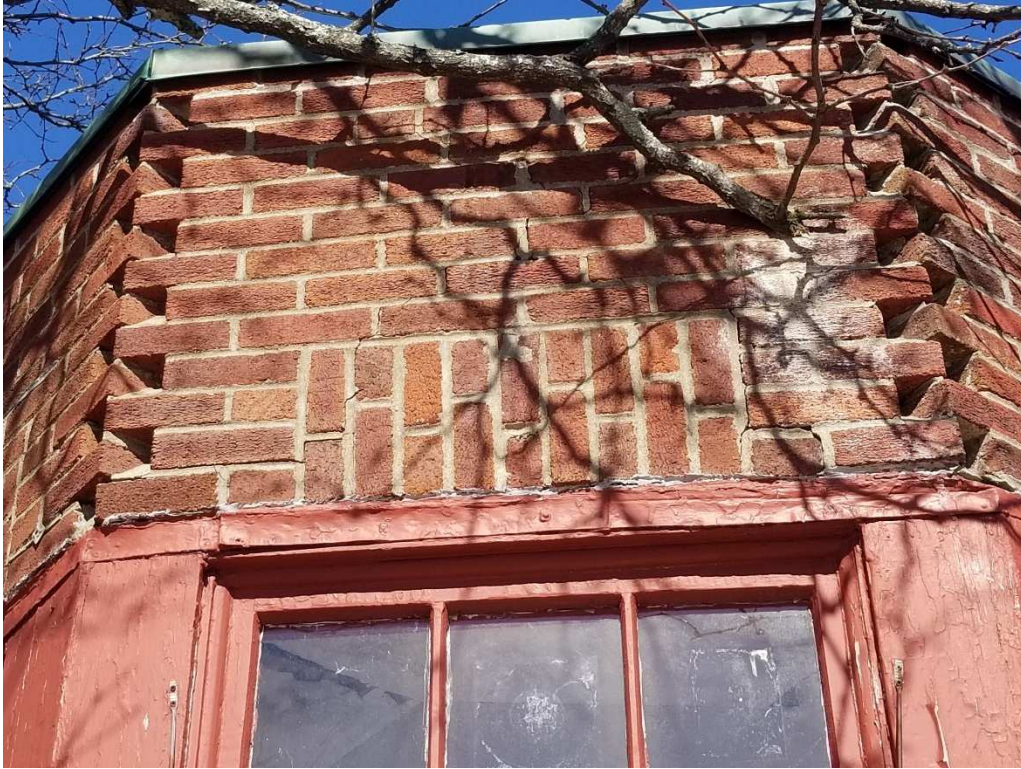
**Photo #15 – Diagonal cracking above front lintel assembly.**

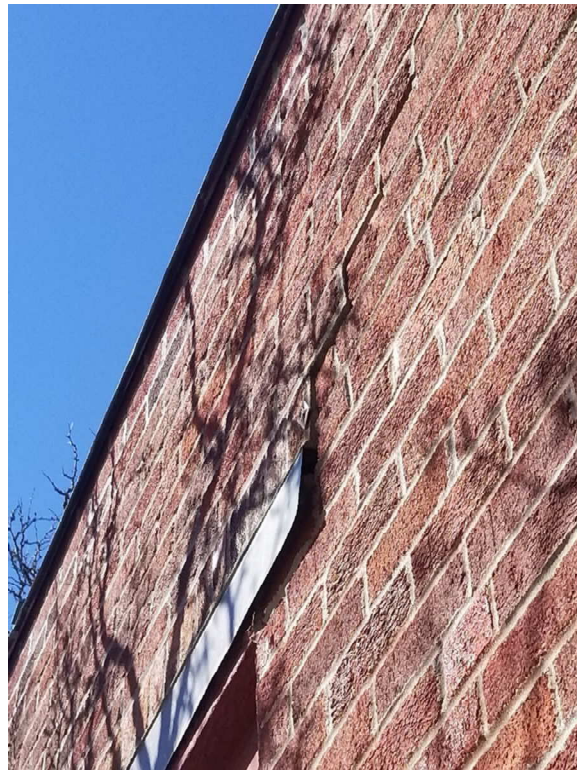
**Photo #16 – Diagonal cracking and pulling away from the structure at the side lintel assembly.**

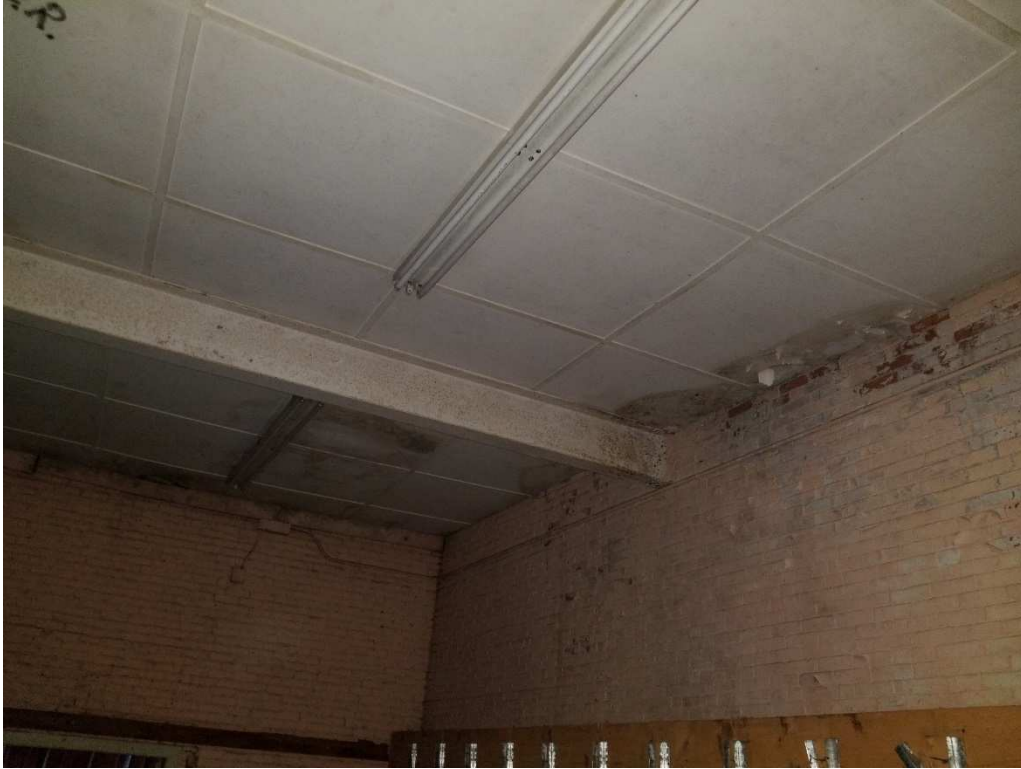
1. Water intrusion on the roof at the front and back of the building (Photo #17 & 18). **The water intrusion is most likely deteriorating the concealed wood framing, which would cause a roof collapse.**
2. The side wall has a deteriorated gutter, with no downspouts, and water has been eroding the mortar of the masonry bearing wall (Photo #19). The location of the deteriorated masonry wall is supporting a steel beam (Photo #20). **The deteriorated masonry wall is spalling and has lost the structural integrity to support the steel beam, which will ultimately cause the roof to collapse.**

**Photo #17 – Water intrusion at the front of the building, adjacent to 121 Union street.**

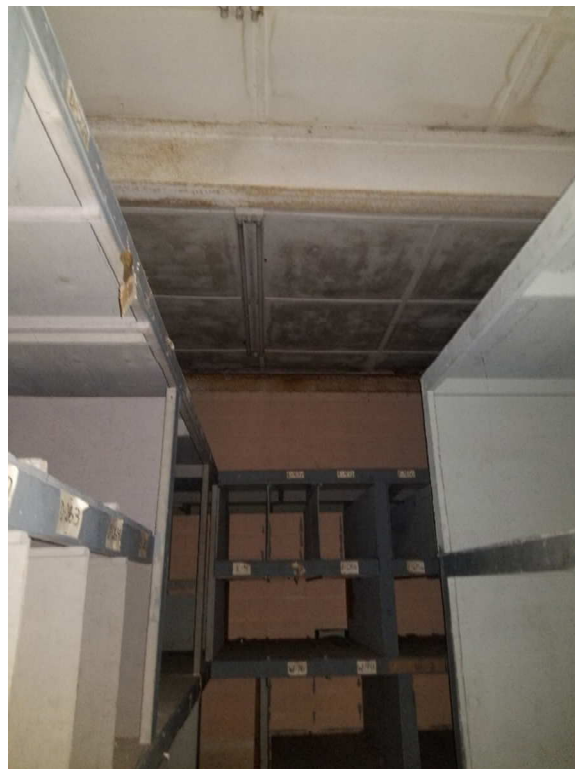
**Photo #18 – Water intrusion at the back of the building.**

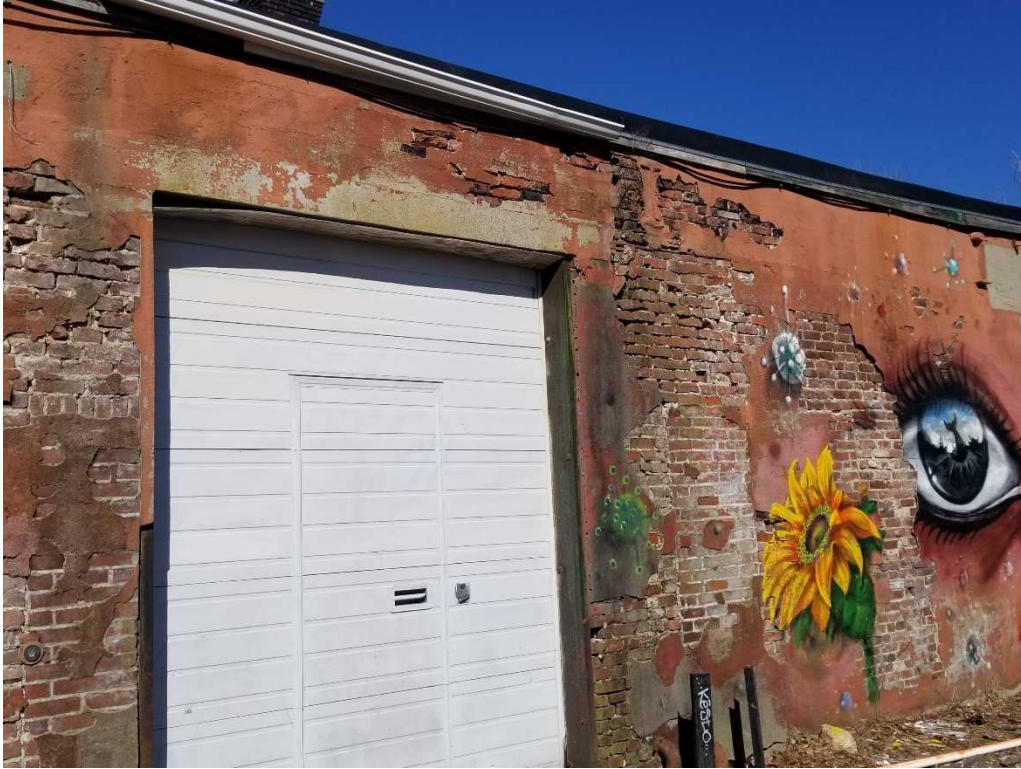
**Photo #19 – Gutter above overhead door with no downspout.**

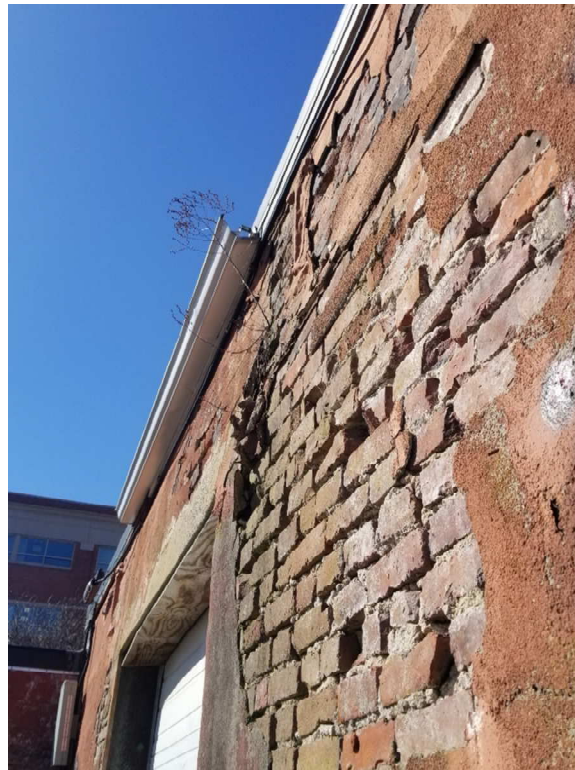
**Photo #20 – Water eroded the mortar directly below a beam and causing wall instability at the support.**

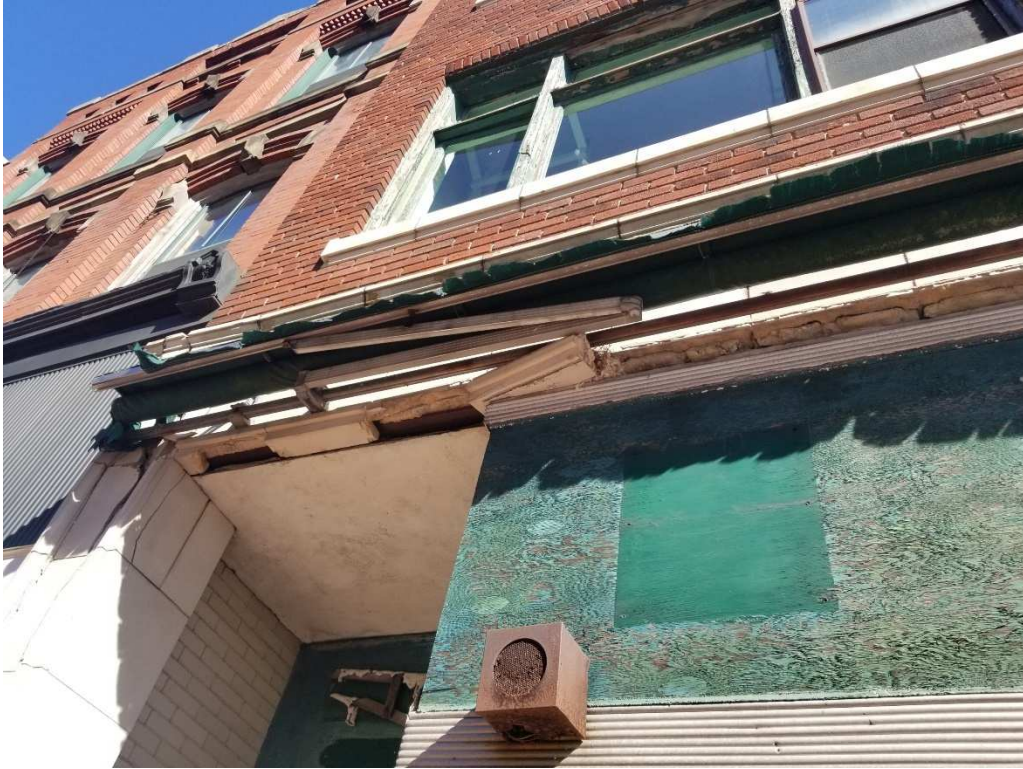
1. We did not perform an inspection of the 3-story building adjacent to 121 Union Street, but we noticed that the masonry band along the front façade is severely deteriorated and spalling (Photo #21 & 22). **The deteriorated masonry is spalling onto the pedestrian sidewalk.**
2. We walked thru the 3-Story building to get access to the 7 North 2<sup>nd</sup> Street building. We noticed that the back room, single story portion at the back of the building, showed signs of deterioration and the ceiling was collapsing adjacent to the masonry stack (Photo #23). **The entire roof shows signs of water damage and it appears this roof is severely deteriorated and starting to collapse.**

**Photo #21 – Masonry band is deteriorated and spalling off the building.**

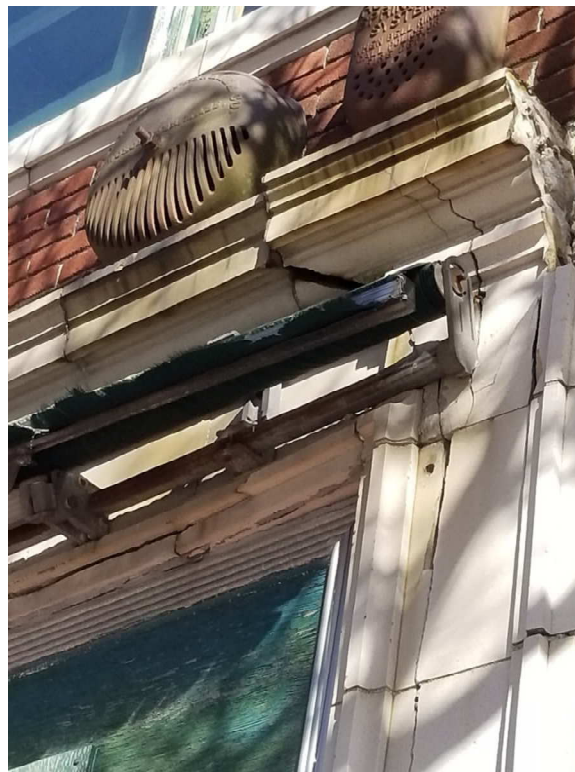
**Photo #22 – Masonry band is deteriorated and spalling off the building.**

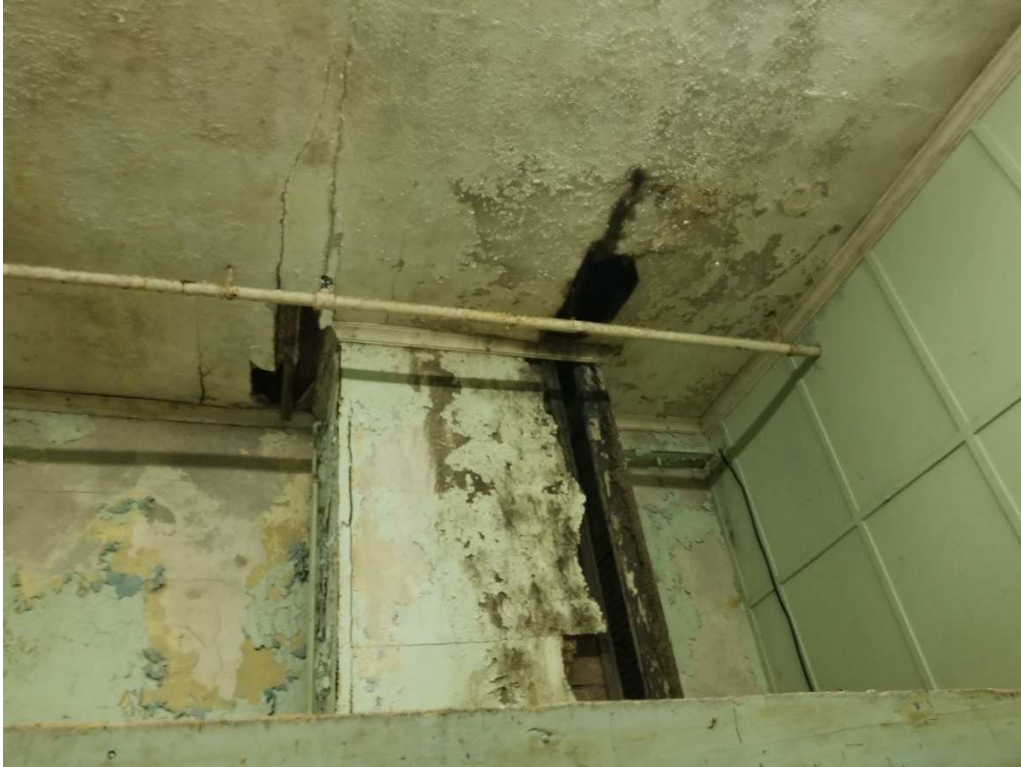
**Photo #23 – The wood framing is deteriorated and starting to collapse.**

- The single-story building, at the back of the 3-story building, should be demolished or shored up if it is to be retrofitted in the future.

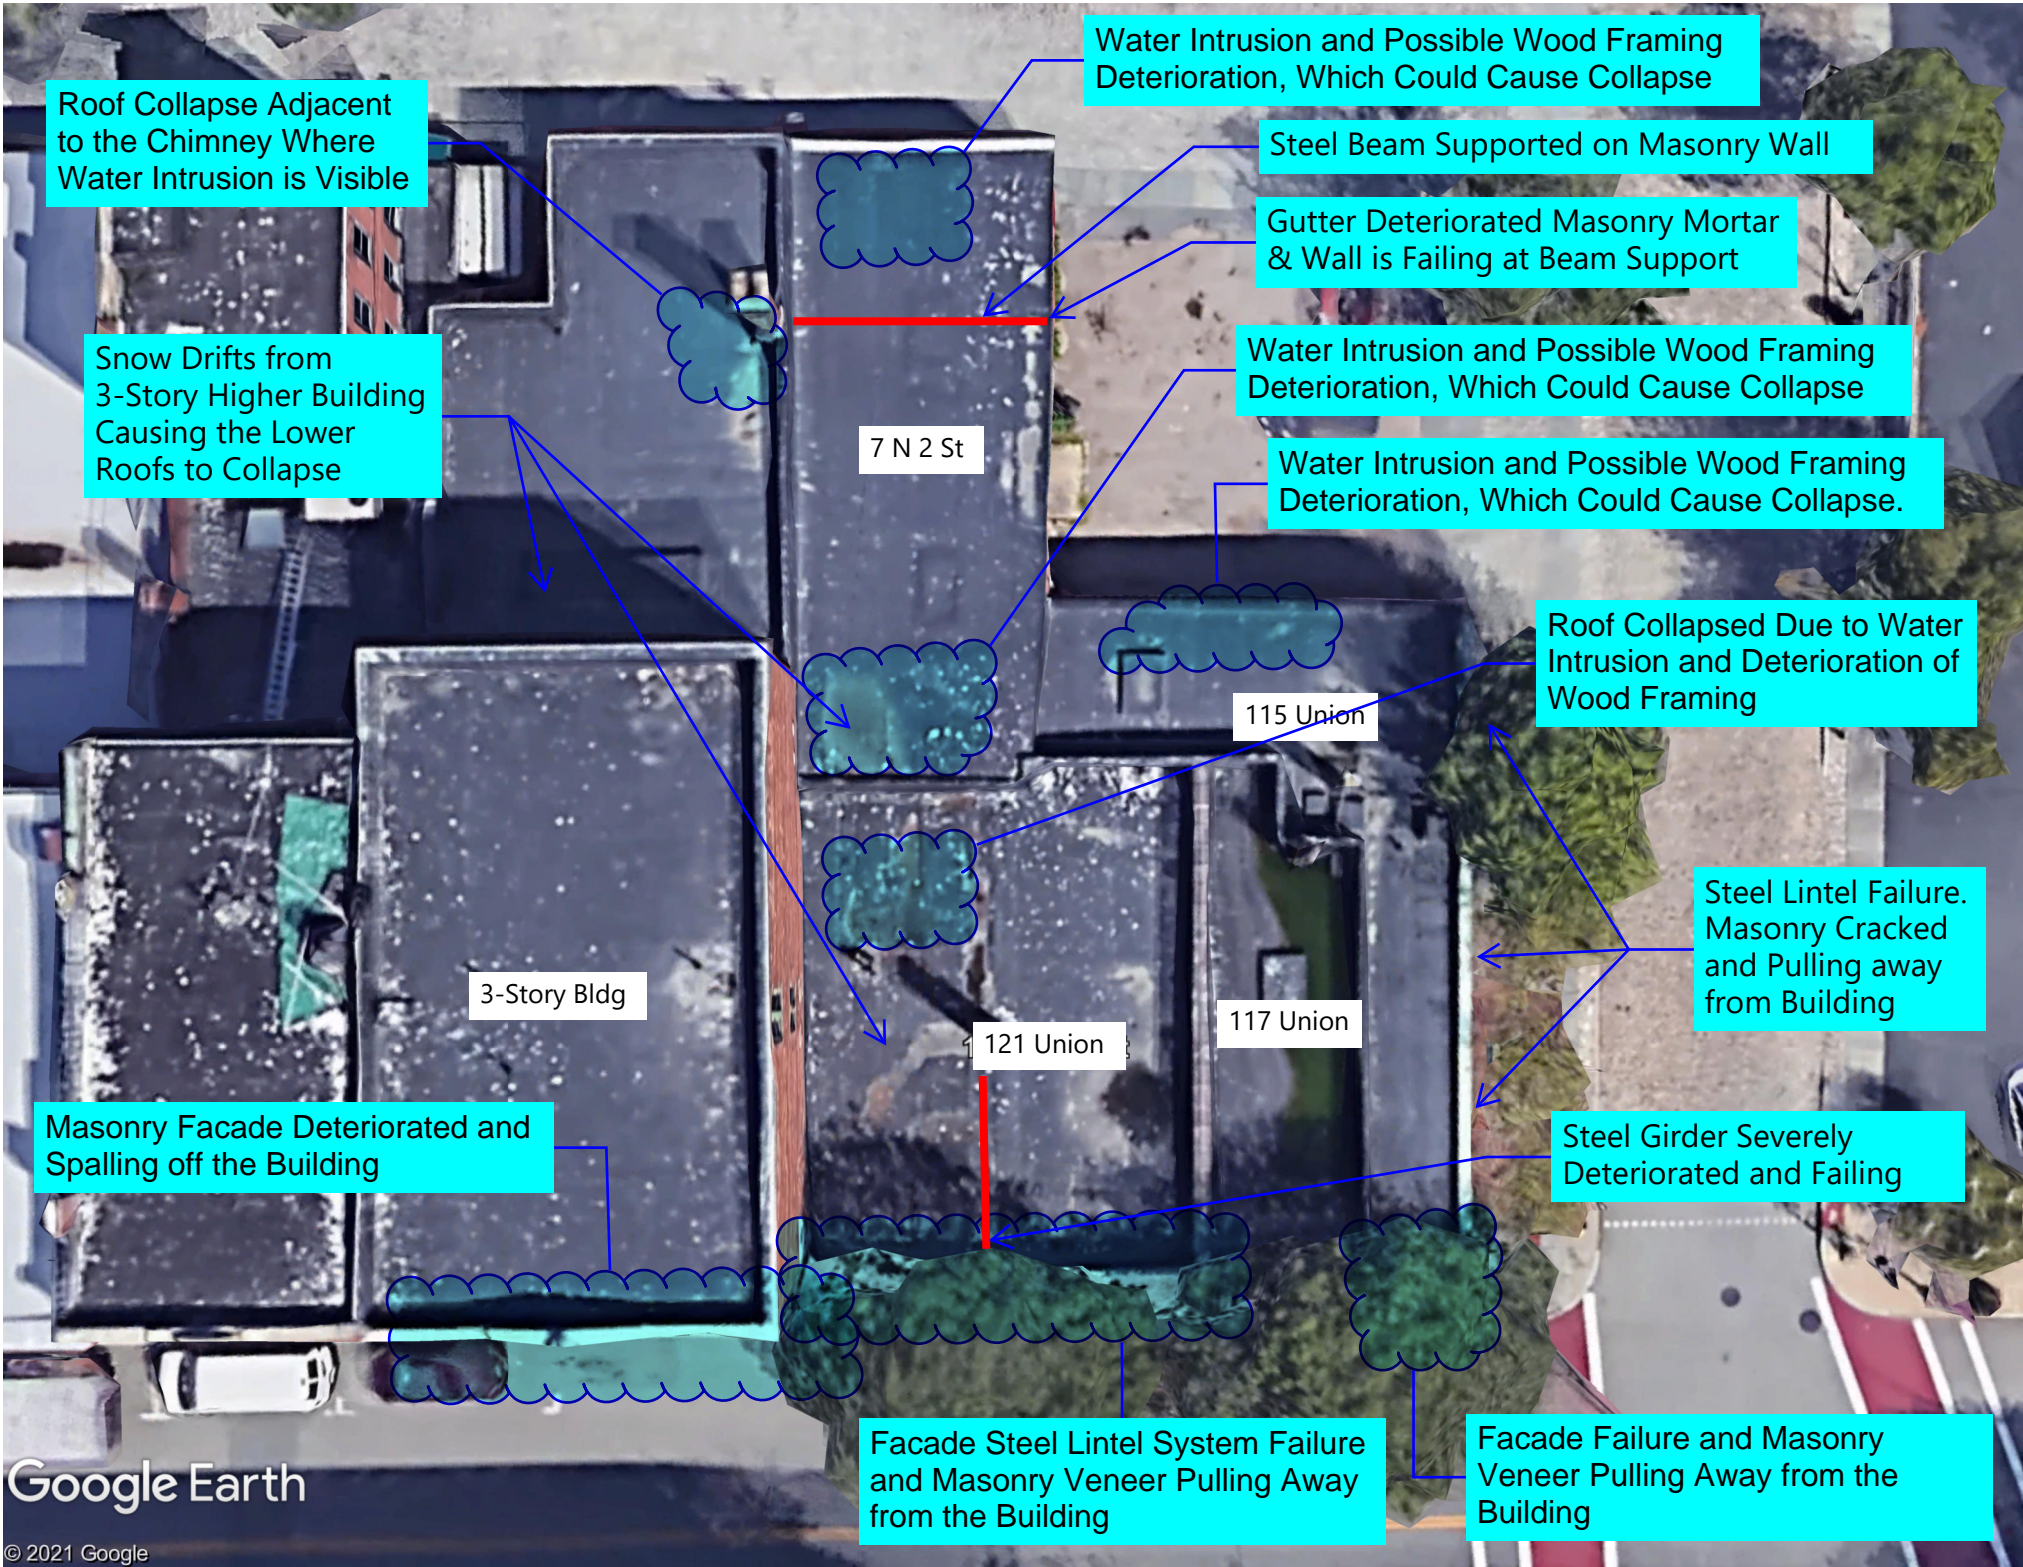
Roof Collapse Adjacent to the Chimney Where Water Intrusion is Visible

Water Intrusion and Possible Wood Framing Deterioration, Which Could Cause Collapse

Gutter Deteriorated Masonry Mortar & Wall is Failing at Beam Support

Snow Drifts from 3-Story Higher Building Causing the Lower Roofs to Collapse

Roof Collapsed Due to Water Intrusion and Deterioration of Wood Framing

Steel Lintel Failure. Masonry Cracked and Pulling away from Building

Steel Girder Severely Deteriorated and Failing

Masonry Facade Deteriorated and Spalling off the Building

Facade Steel Lintel System Failure and Masonry Veneer Pulling Away from the Building

Facade Failure and Masonry Veneer Pulling Away from the Building
