NEW BEDFORD COMMUNITY PRESERVATION COMMITTEE

COMMUNITY PRESERVATION ACT PROJECT APPLICATION FY24

PROJECT TITLE	Completion of Mansard, Dormers, Cornice Restoration		WARD	5
PROJECT LOCATION	427 County Street, New Bedford			
LEGAL PROPERTY OWNER OF RECORD	James Arnold Mansion, Inc.			
CPA PROGRAM CATEGORY (Select relevant categories for your project)	<input type="checkbox"/> OPEN SPACE		<input checked="" type="checkbox"/> HISTORIC RESOURCE	
	<input type="checkbox"/> RECREATION		<input type="checkbox"/> HOUSING	
ESTIMATED START DATE	1 July 2024	ESTIMATED COMPLETION DATE	31 October 2024	
ONE SENTENCE DESCRIPTION OF PROJECT	Completion of Mansard, Dormers, and Cornice Restoration begun with NB CPC FY23 Funding.

Mansard Replacements and Dormer / Cornice Repairs – Part 2

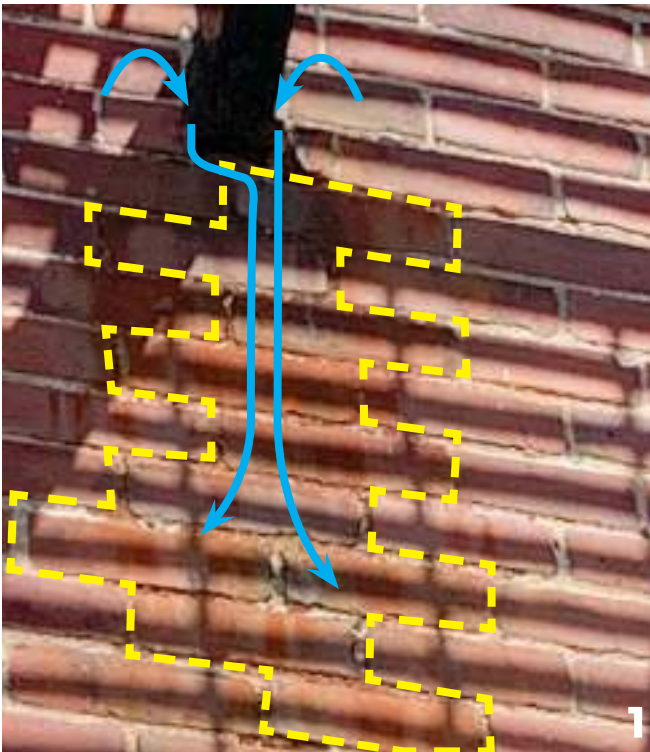
All three fire escape assemblies throughout the building have caused long-term distress on the related **brick masonry**. Areas of brick around the mounting locations of steel fire escapes have faced severe deterioration, largely the result of poor execution but also exacerbated by deferred maintenance.

Treatment of the deficiencies wrought by fire escapes will involve close coordination of modifications to or replacement of the fire escapes (currently being addressed by Fire Escape Engineers) and selective rebuilding of brick masonry. Existing bricks should be salvaged and reused where possible, and a mortar closely matching the original (that is, original to whichever portion of the building is being addressed) should be selected by a qualified preservation specialist.

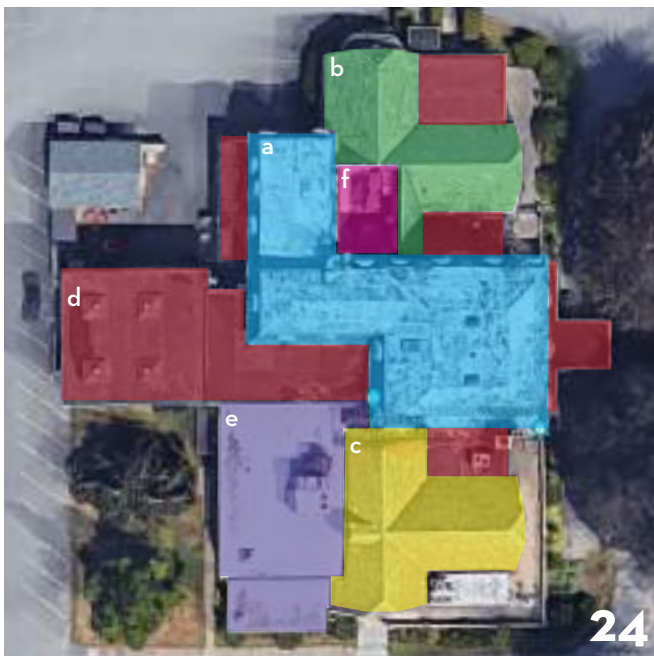
Each of the James Arnold Mansion's distinct 'parts' is capped by a unique roof. Various roof types have been utilized at the building; as such, the following observations and recommendations apply broadly to each roof type, of which there are six: (a) the slate mansards capping the original building and ell (dating to the 1870s); the slate clipped gable over both the (b) north (1920s with later repairs) and (c) south additions (1920s, replaced later); (d) flat membrane roofs over the squash courts, between the original house and flanking additions, and over the terrace (2021); (e) the flat membrane roof over the dining room and sunroom (date unknown); and (f) the second floor courtyard area in which all horizontal faces are surfaced with EPDM (2018) and vertical faces are surfaced with standing seam copper (1920s).

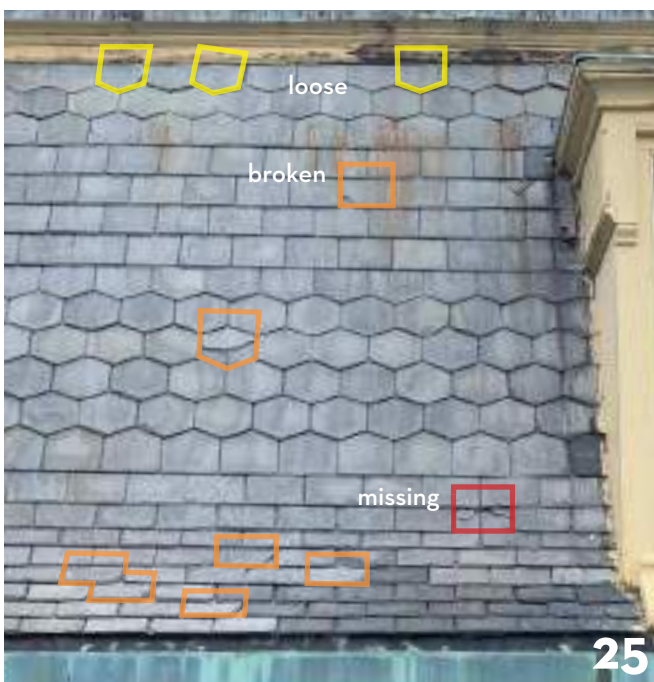
The mansards are in 'moderate' condition because there are some loose and missing slates (Img. 25). During site investigation, some fallen slates were discovered on the fire escape and in gutters at the north and west elevations. Further observation suggests that no more than 5% of slates are loose or missing, mostly at intersections of the roof and dormers or otherwise adjacent to copper assemblies. While this condition is not dire in the short term as far as its potential to allow water into the building, it is a life safety issue: falling slates could seriously harm passersby below. *Loose slates should be secured with new nails and missing slates should be replaced in-kind.*

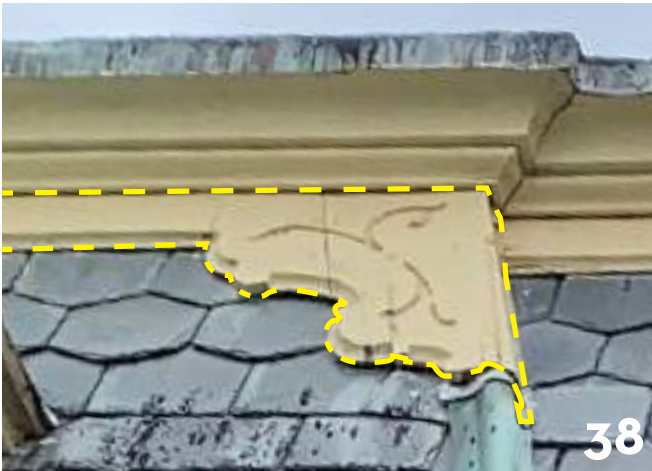
As previously discussed, copper gutter liners generally appear to be in good condition. However, the same cannot be said of the wood gutters below, which show signs of deterioration, which is severe in some places (such as at the east elevation of the main house and adjacent areas of the porch). What is more: the decorative dentils ‘supporting’ the cornice from below face a high degree of exposure and can easily become loose and fall (Img. 37). It is evident that several have been lost already, which – much like falling slates – is a life safety issue. *Missing dentils should be replaced with new wood dentils, fabricated to closely match the existing. All existing dentils should be inspected to ensure that they are properly secured to the cornice and any loose members should be re-secured.*

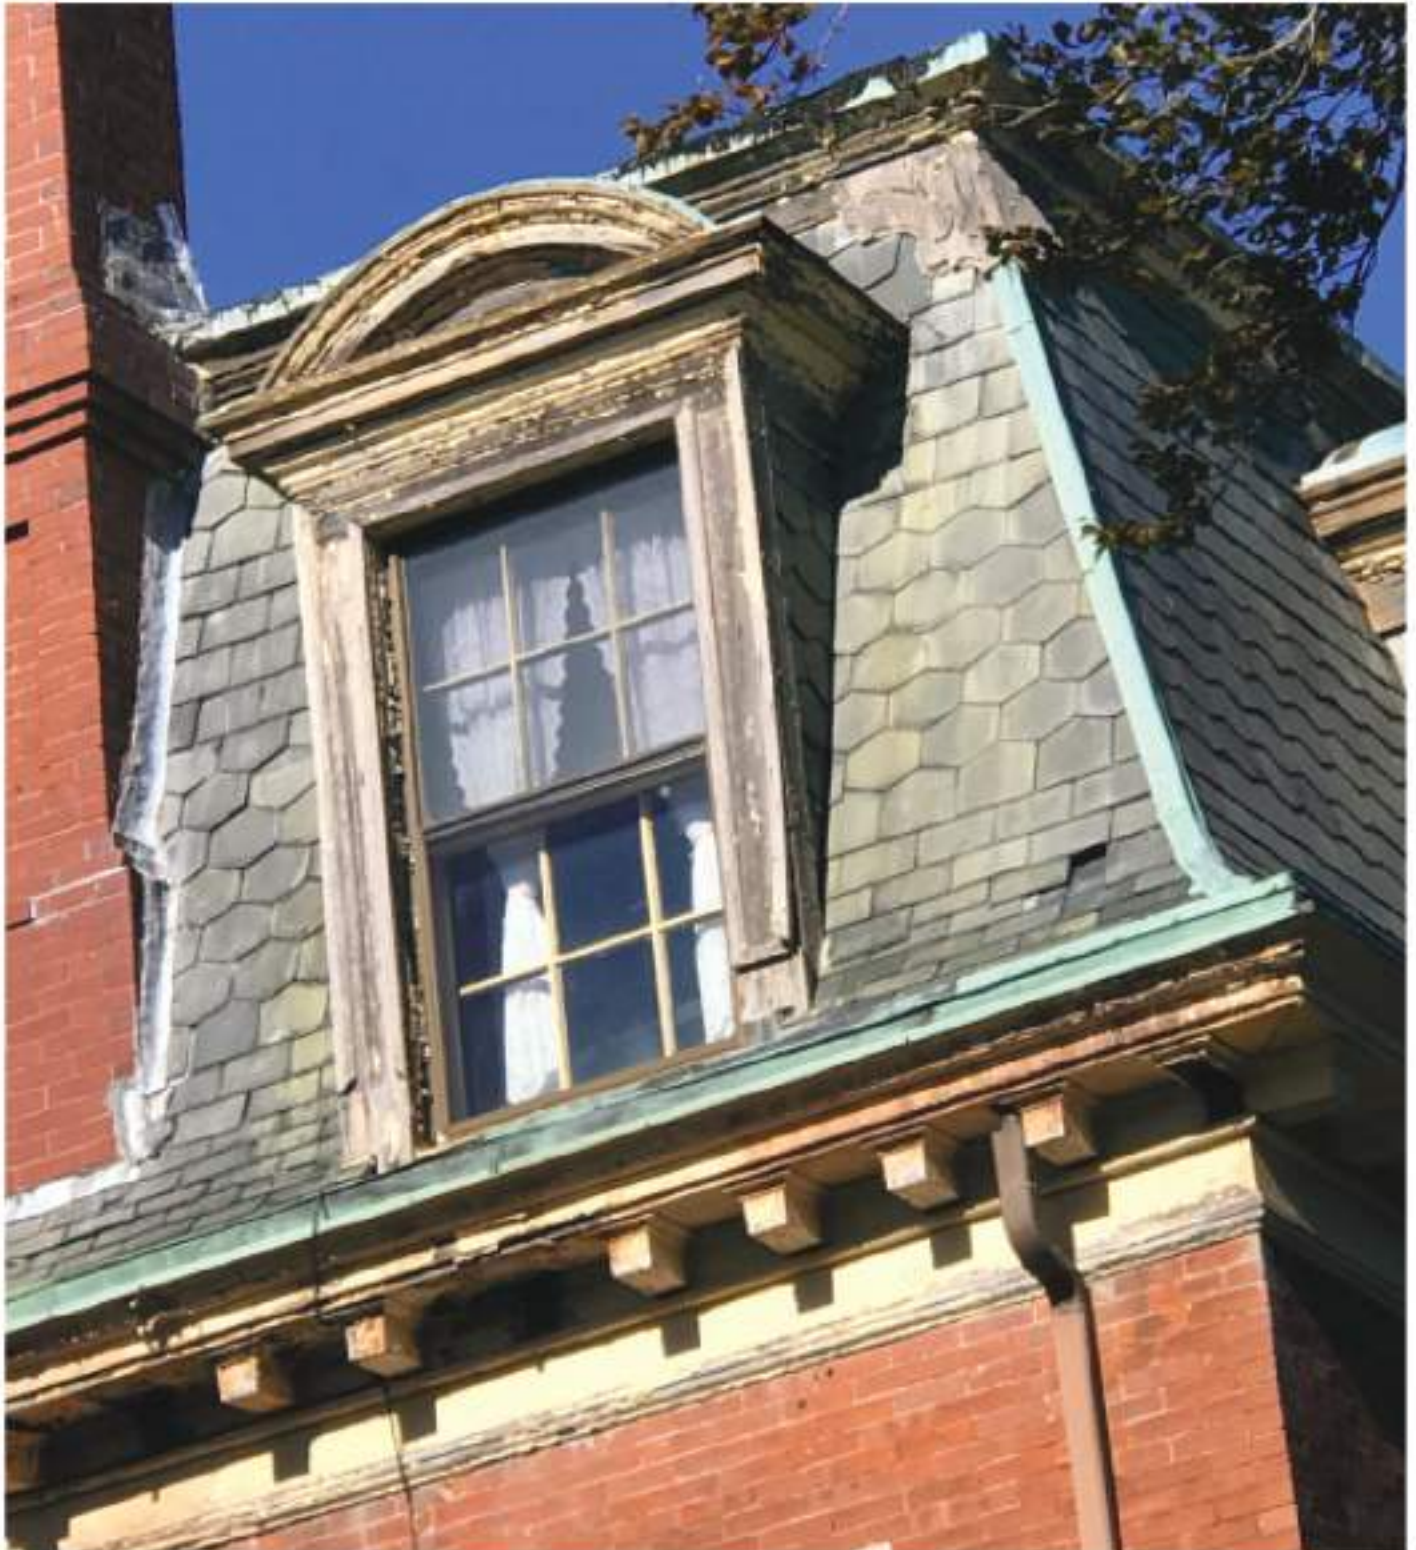
Slate, Millwork, Cornice, Dentils, Copper Flashing - they all need attention and treatment.

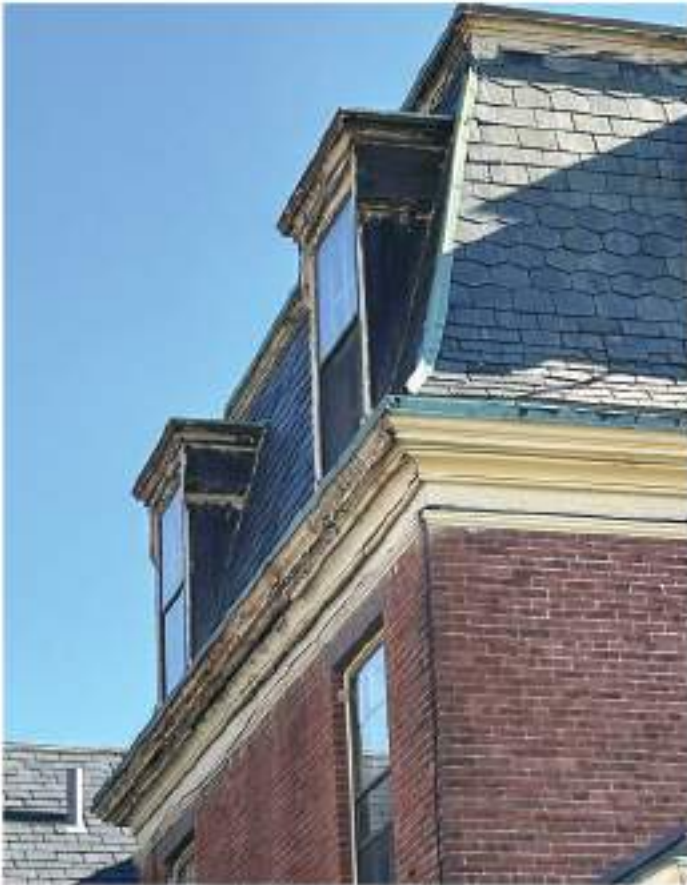
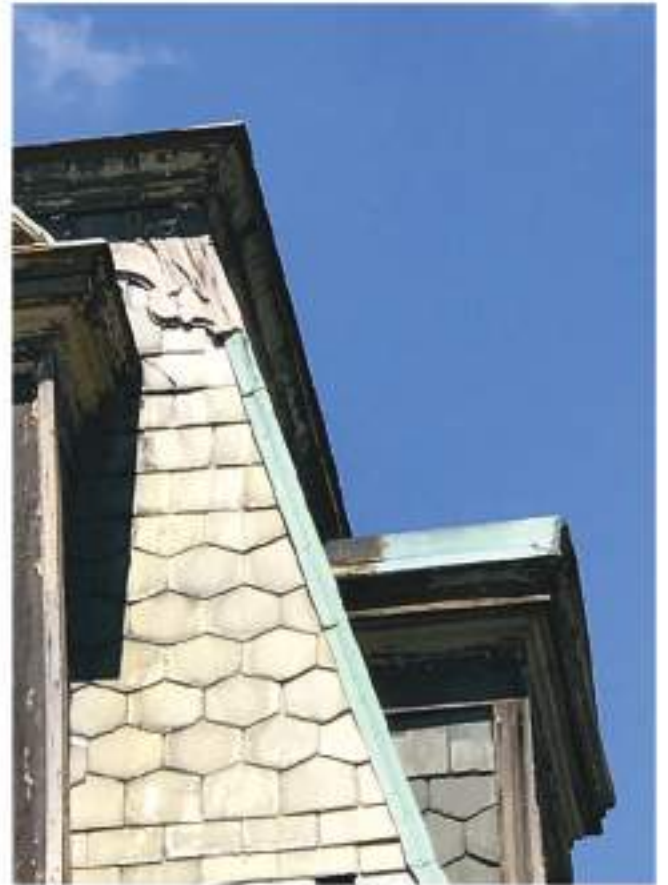
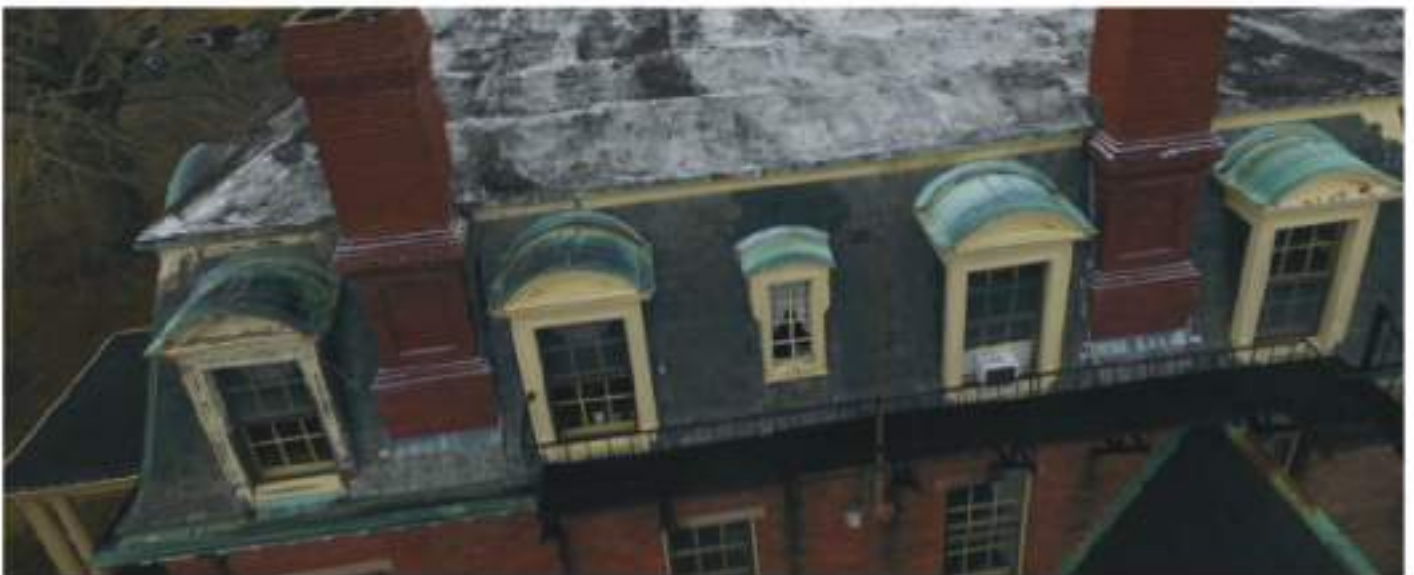
Slate tiles to be replaced, Dormer millwork to be stabilized/replaced and painted, Copper hoods to be replaced.
