AS-BUILT SEPTEMBER 9, 2016

DEPARTMENT OF PUBLIC INFRASTRUCTURE

Howard Avenue Pump Station Map 116 Lot 99 99 River Road, New Bedford MA 02745

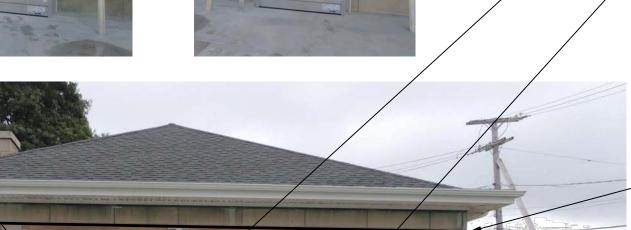
WEST ELEVATION

REPLACEMENT COMPLETE WITH HEAVY DUTY FLOOD-PROOF HATCH AND **HARDWARE**

MAIN ENTRY DOOR REPLACED WITH NEW FIBERGLASS FLOOD-RESISTANT DOOR AND NEW ALUMINUM STOP LOG SYSTEM

EACH WINDOW HAS BEEN COMPLETELY BLOCKED WITH IN-FILL MASONRY ON THE INTERIOR SIDE IN LIEU OF EXTERIOR FLANGED INSERTS.

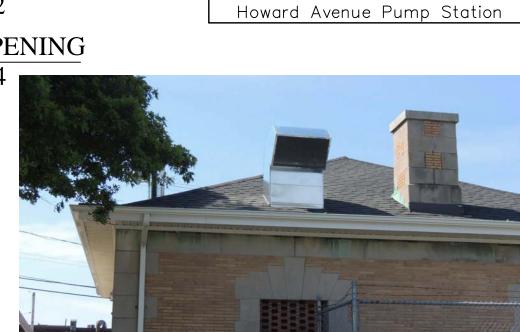
GRATE ELIMINATED AND PIT FILLED AND CAPPED IN **CONJUNCTION WITH** VENTING **RE-CONFIGURATION**

SCREEN ROOM DOOR REPLACED WITH NEW FIBERGLASS FLOOD-RESISTANT DOOR

EACH WINDOW HAS BEEN COMPLETELY BLOCKED WITH IN-FILL MASONRY ON THE INTERIOR SIDE IN LIEU OF EXTERIOR FLANGED INSERTS

NEW HVAC NON-POWERED BUILDING **INTAKE DUCT**

RELOCATE DIESEL FUEL TANK SETTING BOTTOM

OF TANK TO ABOVE ELEVATION 19.03. RELOCATE

AND REFURBISH FUEL PLUMBING BETWEEN TANK

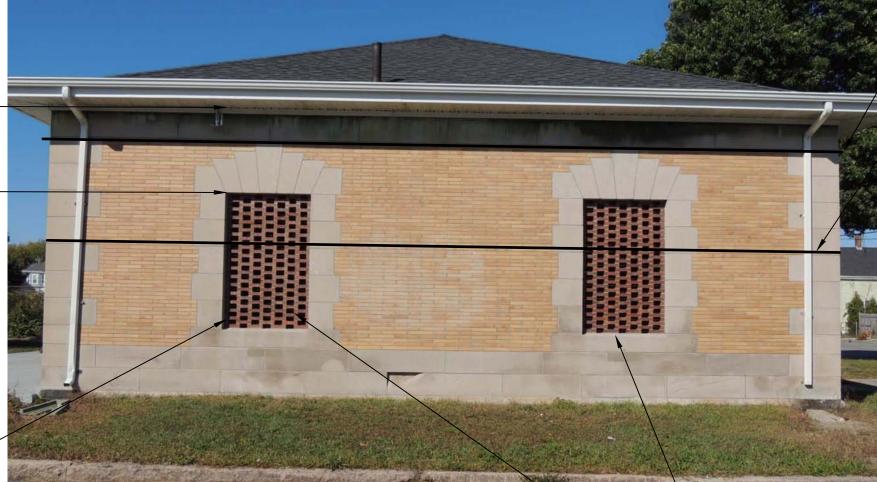
TYPICAL WINDOW

INTERIOR MASONRY INFILL
