PHOTOGRAPHS OF MOBY DICK CHANDLER - PHASE 2

117 Union St. – Phase 2 – Rehabilitation of the "Moby Dick" Building
Application for Certificate of Appropriateness
New Bedfod Historical Commission

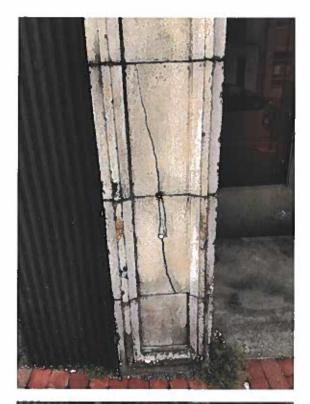
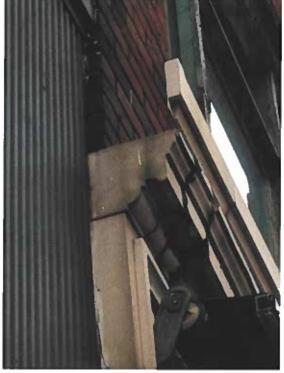
**DETERIORATED TERRA COTTA**

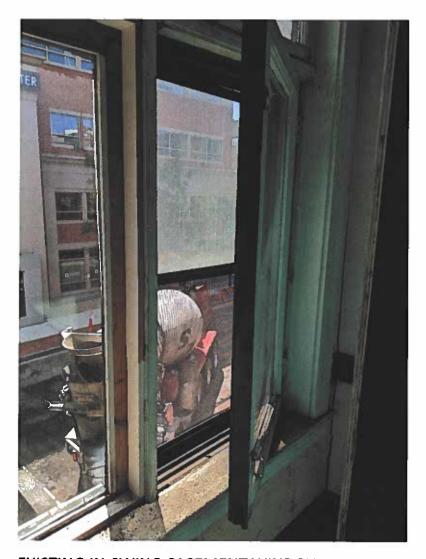
**EXISTING IN-SWING CASEMENT WINDOW**
