CITY OF NEW BEDFORD
COMMUNITY PRESERVATION ACT FY26
PROJECT APPLICATION

PROJECT INFORMATION			
PROJECT TITLE	Arnold Mansion - Millwork Repairs and Paint		WARD 5
PROJECT LOCATION	427 County Street, New Bedford, MA 02740		
LEGAL PROPERTY OWNER OF RECORD	James Arnold Mansion, Inc.		
CPA PROGRAM CATEGORY <i>(Select relevant categories for your project)</i>	<input type="checkbox"/> OPEN SPACE	<input checked="" type="checkbox"/> HISTORIC RESOURCE	
	<input type="checkbox"/> RECREATION	<input type="checkbox"/> HOUSING	
ESTIMATED START DATE	1 July 2026	ESTIMATED COMPLETION DATE	31 December 2026

JAMES ARNOLD MANSION

CONDITIONS ASSESSMENT & TREATMENT RECOMMENDATIONS

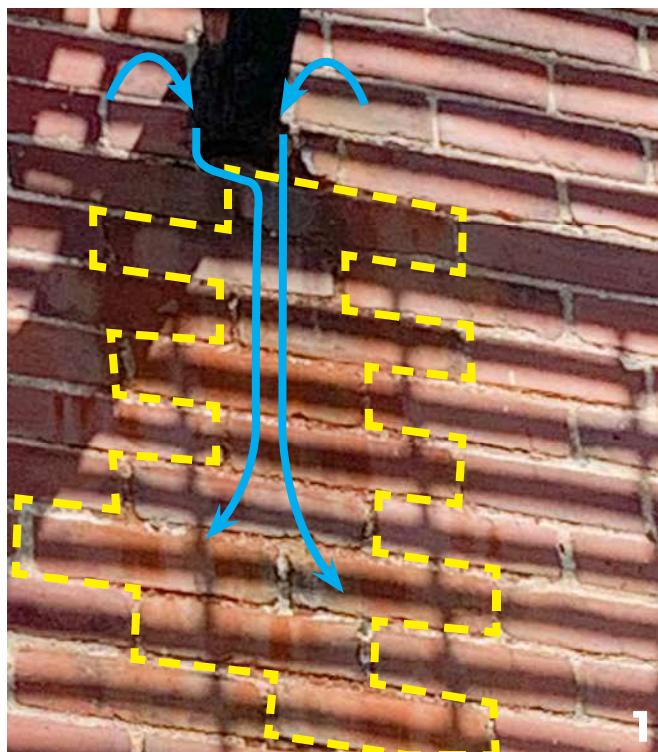
1

Masonry deficiencies are often among the most pressing concerns at the building envelope, as their unchecked development can lead to leaks and structural problems. Here, masonry issues are pervasive and have been exacerbated by poorly maintained fire escapes throughout.

Treatment of the deficiencies wrought by fire escapes will involve close coordination of modifications to or replacement of the fire escapes (currently being addressed by Fire Escape Engineers) and selective rebuilding of brick masonry. Existing bricks should be salvaged and reused where possible, and a mortar closely matching the original (that is, original to whichever portion of the building is being addressed) should be selected by a qualified preservation specialist.

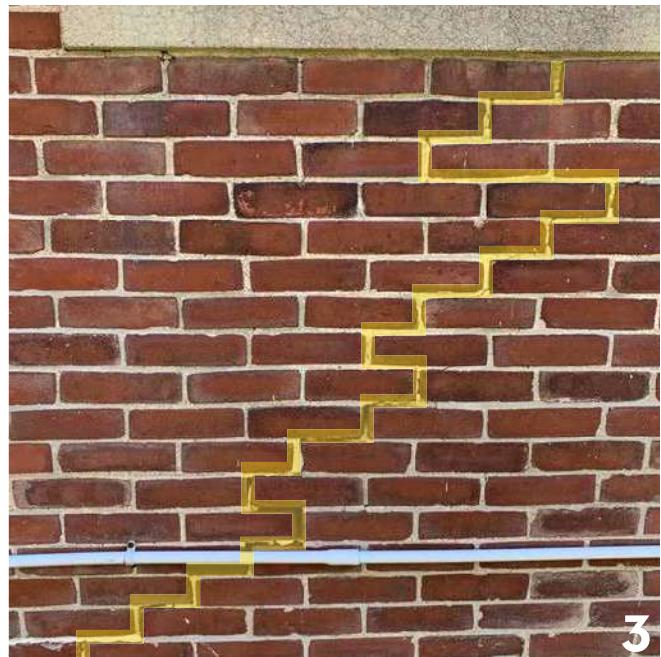
3

As previously mentioned, a wide variety of materials have been employed for window lintels and sills. In some cases, as seen in Img. 3, movement of natural and cast stone lintels and sills has caused cracking in the brick masonry. However, other less visible windows, such as those accessing the basement at the 1924 addition at the west elevation, have steel lintels. The condition of these structural members will be addressed in further detail as part of a later subsection of this narrative, but the fact that they have rusted — in some cases severely — related to the surrounding brick masonry. As can be observed in Img. 5, these steel lintels extend several inches past the inner

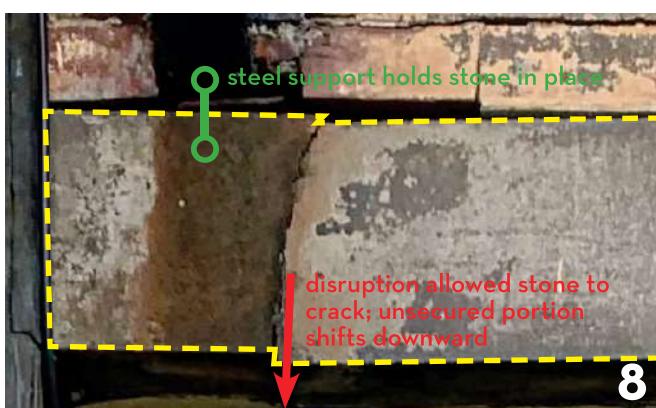
8

The most pressing issue with natural stone is structural cracking. In many cases, cracks run through both the lintel and sill (Img. 7), a result of either (a) the window sagging or (b) related structural cracking in the brick masonry, such as that described on the previous page (see Img. 8). Treatment of stone lintels should be undertaken as part of a larger masonry project. That is, during repointing and or rebuilding of the surrounding brick masonry.

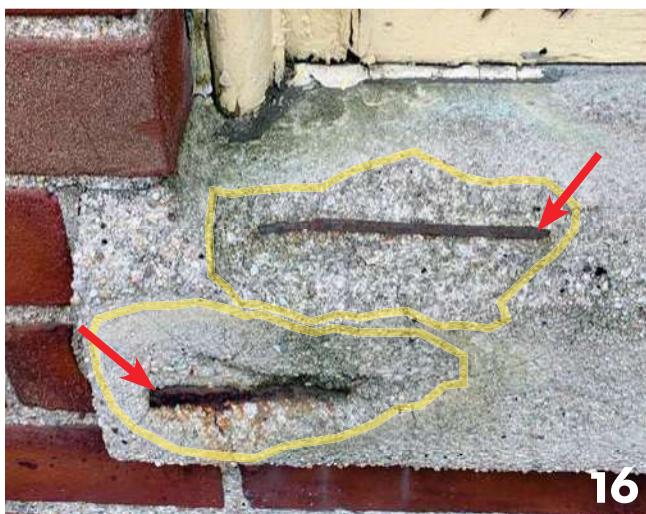
16

Precast concrete and cast stone are today often marketed as more durable alternatives to natural stone, but the current state of the precast members seems to suggest the opposite. Here, breakage occurs differently: the natural stone tends to crack from tensile forces whereas precast tends to spall. An example of this can be observed at the west elevation of the one-story kitchen addition (Img. 15), where the outer and lower faces of a precast lintel have crumbled, exposing the steel rebar embedded therein. This is the result of the material becoming saturated with moisture that then freezes and thaws to cause small, internal cracks. A similar condition can be seen at precast lintels and sills throughout the building, such as at the east elevation (Img. 16).

REPLACE ALL PRECAST LINTELS AND SILLS IN-KIND. POINT W/ MORTAR TO MATCH EXISTING
IF NECESSARY

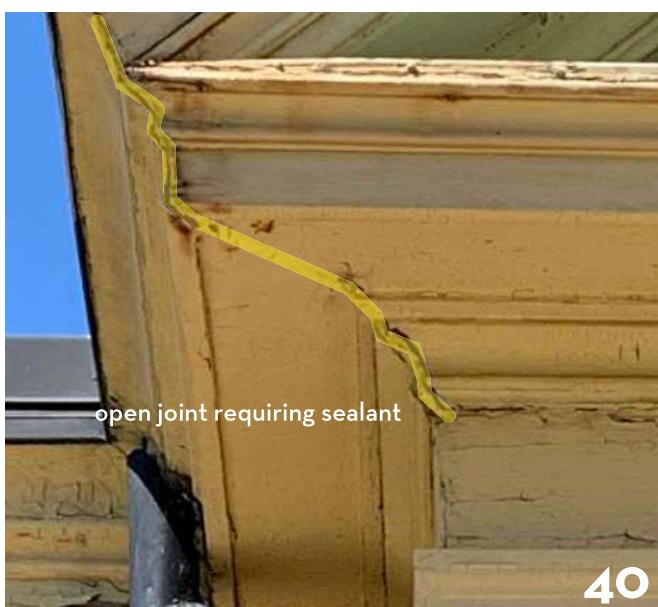
The mansards' upper cornice has faced a similar degree of damage, though it notably has less parts to come loose and/or fall. Corner moldings are an exception. They vary in condition; most have retained crisp edges and show minimal damage (Img. 38) while some are broken and splintered, the result of deferred maintenance and wind exposure. *Corner moldings showing any degree of damage should be removed and replaced with wood moldings, once again, fabricated to closely match the existing.*

The above recommendations apply to lower 1920s cornices, which generally appear to be in good condition, aside from some joints that should be caulked (Img. 40).
