NOTICE OF INTENT

SITE PLAN

ASSESSORS MAP 134 LOT 5 100 DUCHAINE BOULEVARD NEW BEDFORD, MA 02745

TIM CUSSON
PARALLEL PRODUCTS OF NEW ENGLAND
100 DUCHAINE BOULEVARD
NEW BEDFORD, MA 02745

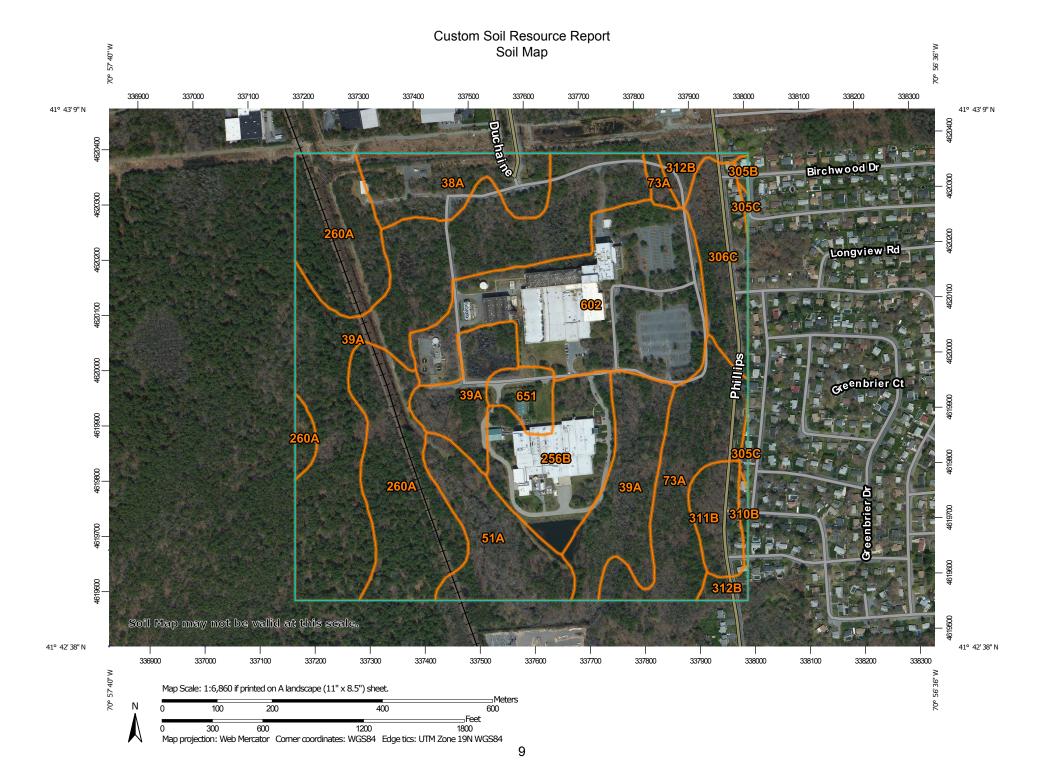
Soil Map

The soil map section includes the soil map for the defined area of interest, a list of soil map units on the map and extent of each map unit, and cartographic symbols displayed on the map. Also presented are various metadata about data used to produce the map, and a description of each soil map unit.

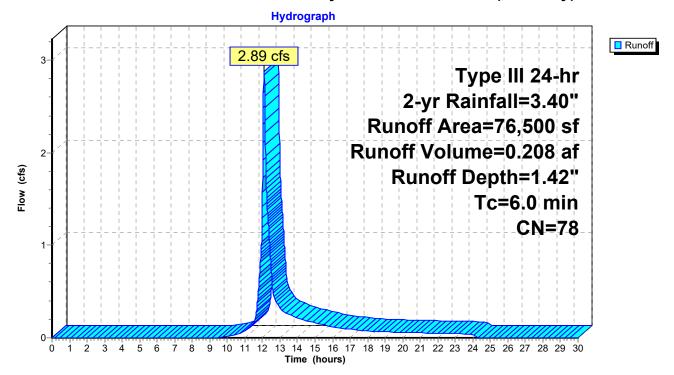
Subcatchment S-1: Tributary to Detention Basin (Westerly)

Area (sf)	CN	Description	Description						
	9,910	49	50-75% Gra	50-75% Grass cover, Fair, HSG A						
*	11,940	98	Roadway aı	Roadway and Concrete						
	6,700	98	Water Surfa	Water Surface						
	47,950	76	Gravel road	Gravel roads, HSG A						
	76,500	78	Weighted A	Weighted Average						
	57,860		75.63% Per	vious Area	a a constant of the constant o					
	18,640		24.37% Imp	ervious Are	rea					
	Tc Length			Capacity	Description					
(r	min) (feet	(ft/	ft) (ft/sec)	(cfs)						
	6.0				Direct Entry, Min. Tc

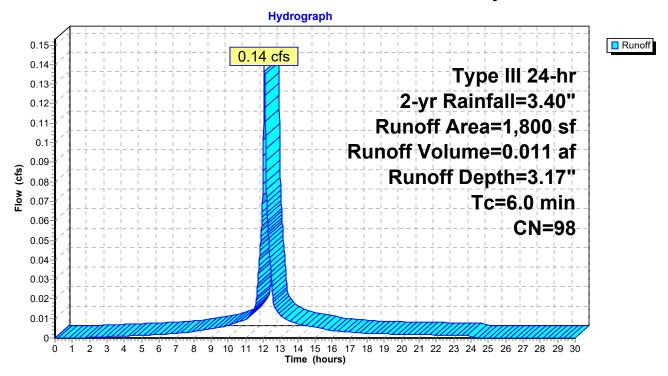
Subcatchment S-2: Off Site Runoff to Westerly BVW

_	Α	rea (sf)	CN [Description					
*		1,800	98 F	Roadway/Concrete					
		1,800	1	00.00% Im	pervious A	vrea			
	Тс	Length	Slope	Velocity	Capacity	Description			
_	(min)	(feet)	(ft/ft)	(ft/sec)	(cfs)				
	6.0					Direct Entry, Min. Tc

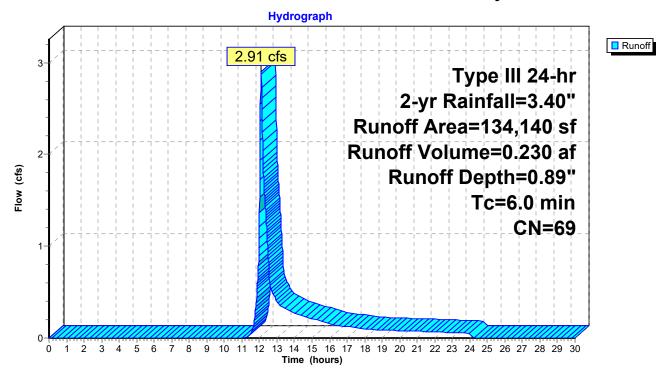
Subcatchment S-3: Off Site Runoff to Northerly BVW

_	Area	(sf) CN	N D	Description						
	50,9	990 43	3 W	Woods/grass comb., Fair, HSG A						
*	46,8	300 98	3 C	Concrete Pad, HSG A						
_	36,3	350 68	3 <	<50% Grass cover, Poor, HSG A						
134,140 69 Weighted Average										
	87,3	340		•	vious Area					
	46,8	300	34	4.89% Imp	ervious Are	ea				
	Tc Lei	ngth Sl	lope	Velocity	Capacity	Description				
_	(min) (f	eet) ((ft/ft)	(ft/sec)	(cfs)					
	6.0					Direct Entry	v. Min. Tc

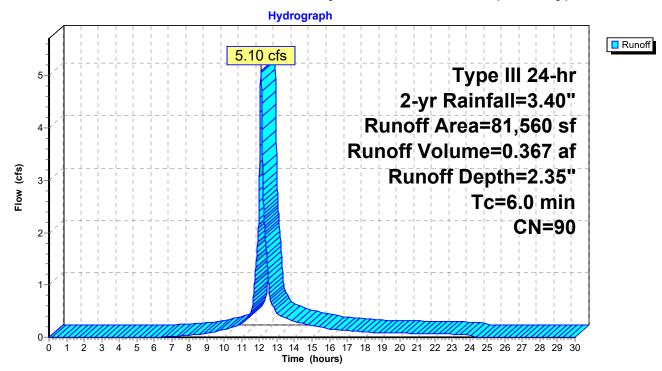
Subcatchment S-4: Tributary to Detention Basin (Easterly)

_	Α	rea (sf)	CN	Description						
		12,950	49	50-75% Grass cover, Fair, HSG A						
*		68,610	98	Roadway and Concrete						
		81,560 12,950 68,610		Weighted A 15.88% Per 34.12% Imp	vious Area					
_	Tc (min)	Length (feet)	Slope (ft/ft)	,	Capacity (cfs)	Description				
	6.0					Direct Entry, Min. Tc

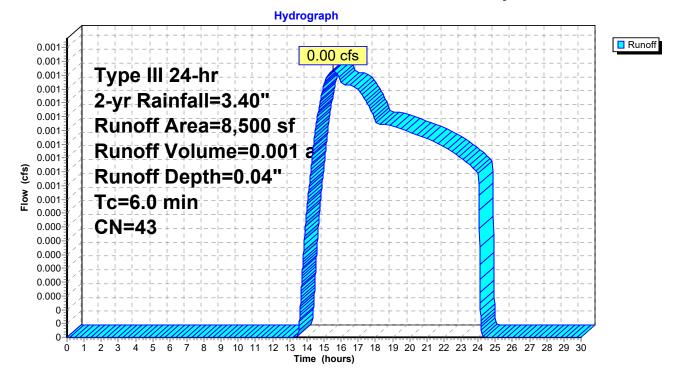
Subcatchment S-5: Off Site Runoff to Southerly BVW

Α	rea (sf)	CN	Description							
		7,920	39	>75% Grass cover, Good, HSG A							
*		580	98	Walkways,	Walkways, HSG A						
		8,500	43	Weighted A	Veighted Average						
		7,920		93.18% Pervious Area							
		580		6.82% Impe	6.82% Impervious Area						
	Тс	Length	Slope	e Velocity	Capacity	Description					
	(min)	(feet)	(ft/ft	t) (ft/sec) (cfs)							
	6.0					Direct Entry, Min. Tc

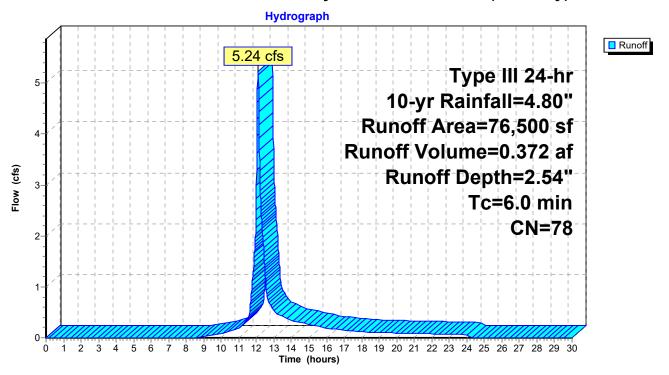
Subcatchment S-1: Tributary to Detention Basin (Westerly)

Area (sf)	CN	Description	Description						
	9,910	49	50-75% Gra	50-75% Grass cover, Fair, HSG A						
*	11,940	98	Roadway an	Roadway and Concrete						
	6,700	98	Water Surface	Water Surface						
	47,950	76	Gravel roads	Gravel roads, HSG A						
	76,500	78	Weighted Av	Weighted Average						
	57,860		75.63% Perv	/ious Area						
	18,640		24.37% Imp	ervious Are	ea					
	Tc Length	Slop	,	Capacity	Description					
(n	nin) (feet)	(ft/1	t) (ft/sec)	(cfs)						
	6.0				Direct Entry, Min. Tc
