Expanded Environmental Notification Form West Beach

New Bedford, MA

March 2019

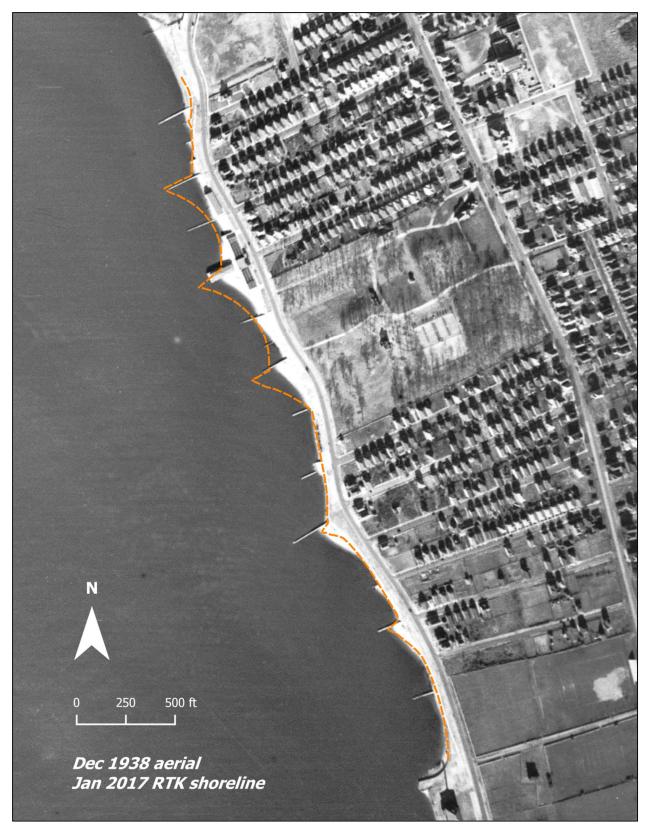
Figure 1.3 Aerial photograph from 1938 with the approximate shoreline from January 2017 shown in orange.

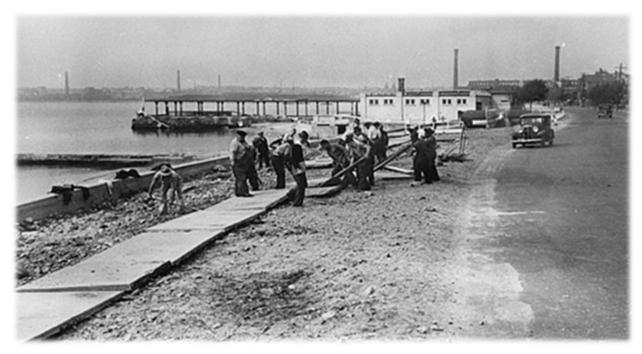
Figure 1.4 Damage to the area landward of the West Rodney French Boulevard seawall as a result of the September 1938 Hurricane (source: Spinner Publications, New Bedford, MA, www.spinnerpub.com).

During the 1938 Hurricane, substantial damage occurred throughout New Bedford and the shoreline area of Clarks Cove was not spared. Figure 1.4 and Figure 1.5 are photographs showing the condition of the West Rodney French Boulevard area after the

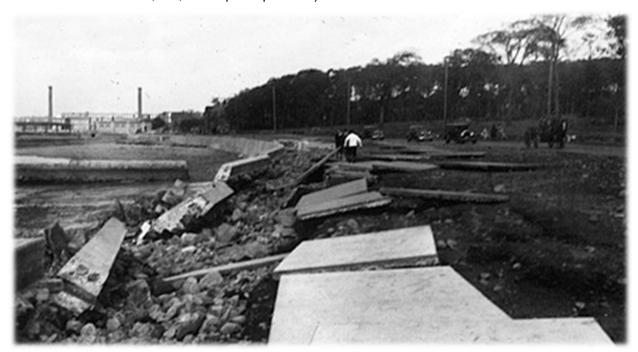
Figure 1.5 Portion of the West Rodney French Boulevard seawall failure that occurred as a result of the September 1938 Hurricane (source: Spinner Publications, New Bedford, MA, www.spinnerpub.com).

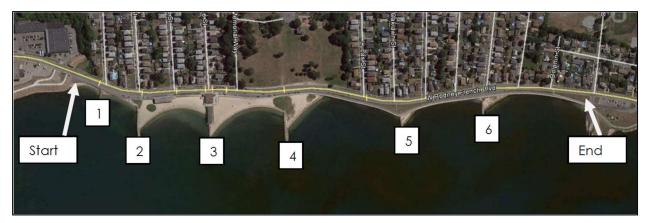
Figure 2.2 Location of Existing Stone Groins within Project Inspection Limits.

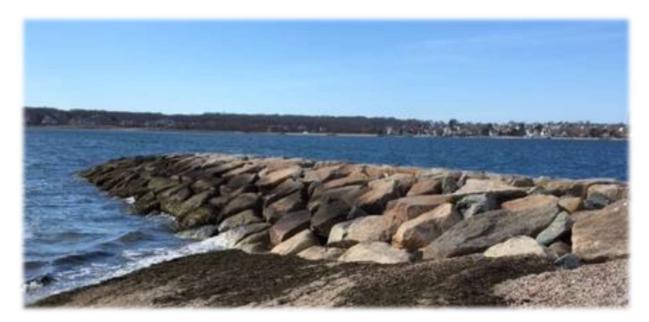
Figure 2.3. Typical groin condition at West Beach.

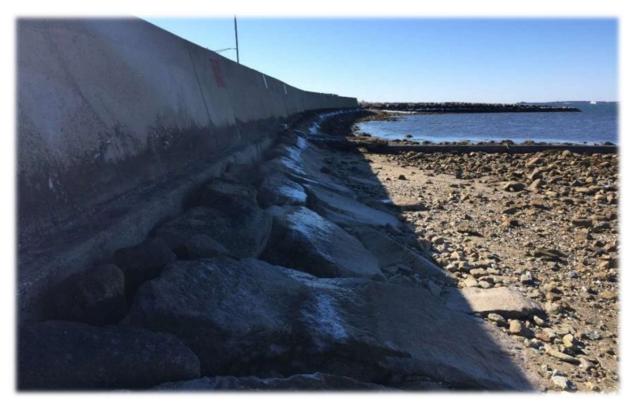
Figure 2.5 Typical Good condition of the seawall along the south side (B rated structure).

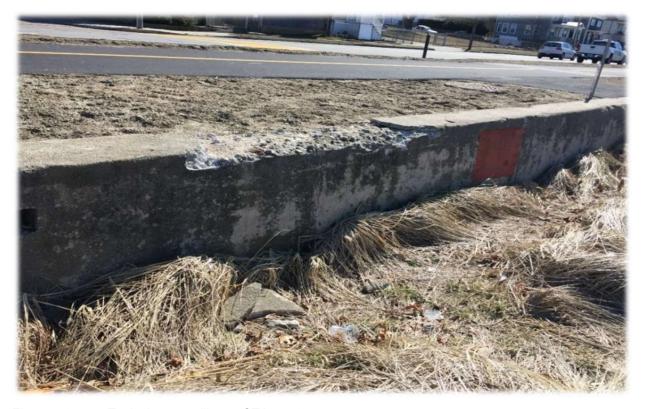
Figure 2.6 Typical cap spalling at STA 5+00.

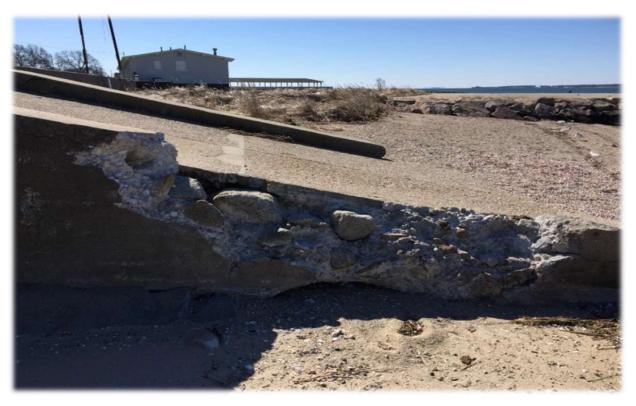
Figure 2.7 Ramp heavy spalling STA 4+75.

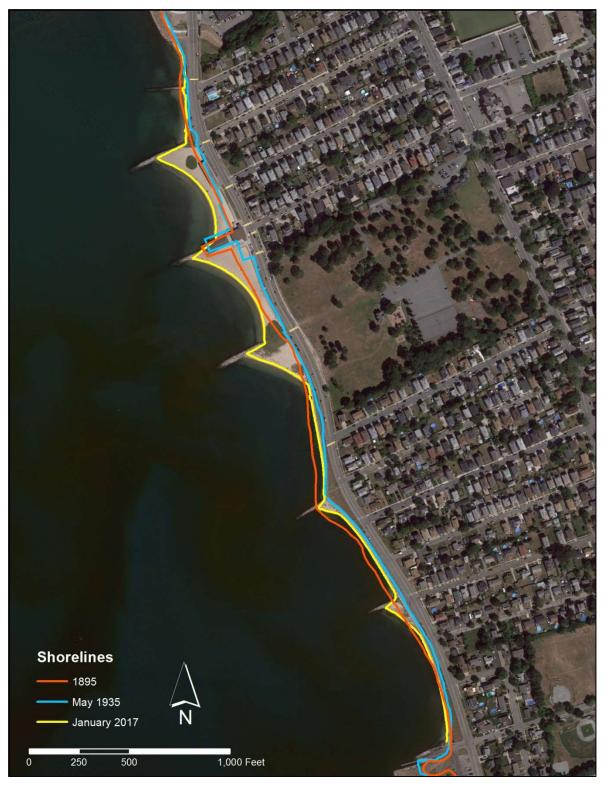
Figure 2.9 Shorelines from 1895, 1935, and 2017, where the shorelines from 1895 and 1935 were derived from the MCZM shoreline database and the 2017 shoreline position was surveyed using RTK-GPS equipment.

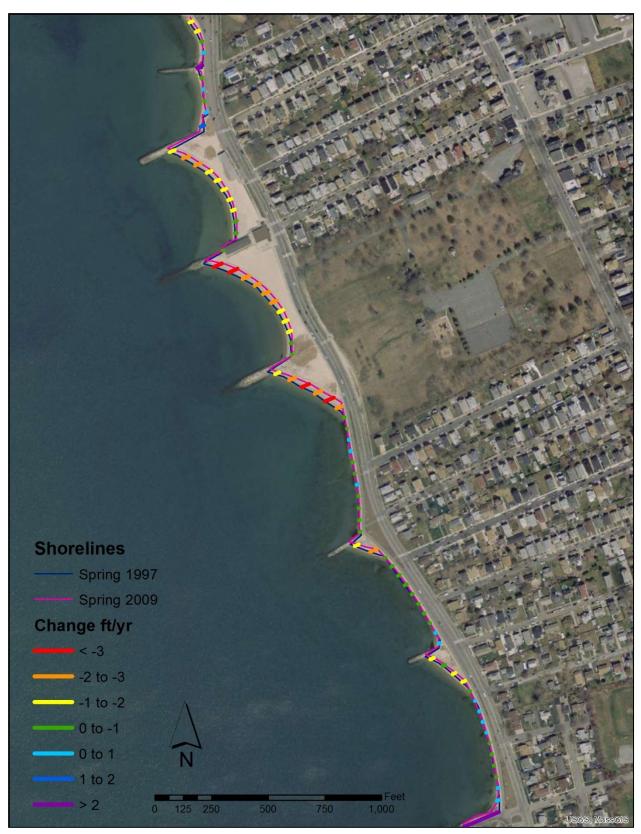
Figure 2.10 Historical shoreline change for West Rodney French Boulevard shoreline from 1997 to 2009.

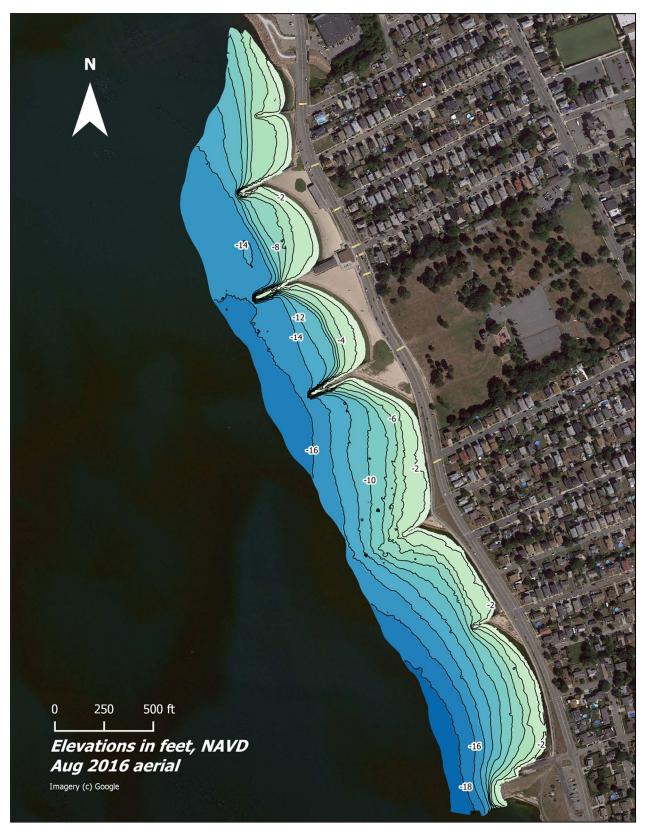
Figure 2.11 Bathymetric contour data from 2017 multi-beam survey.

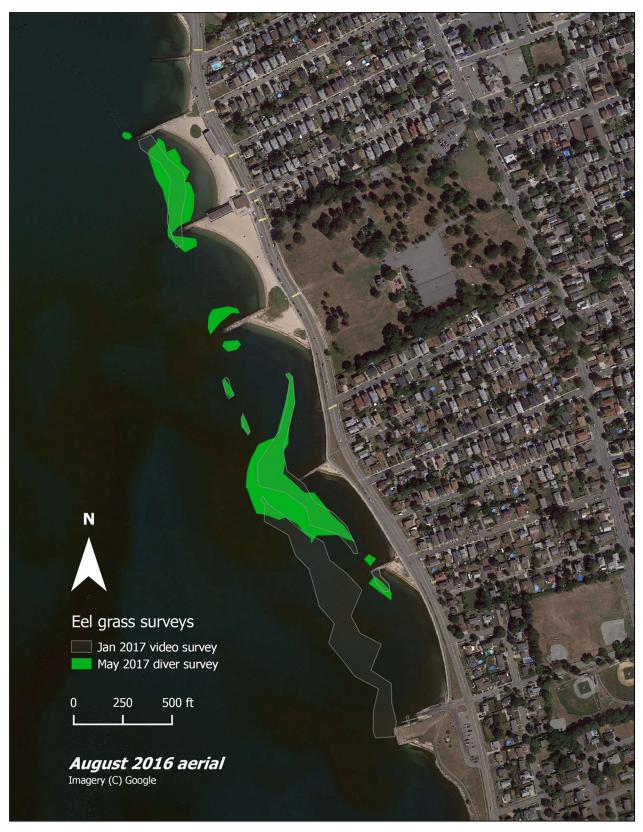
Figure 2.12 Eelgrass coverage based upon results of January 2017 reconnaissance video survey by CLE, Inc. and in-season May 2017 diver survey by Stantec.

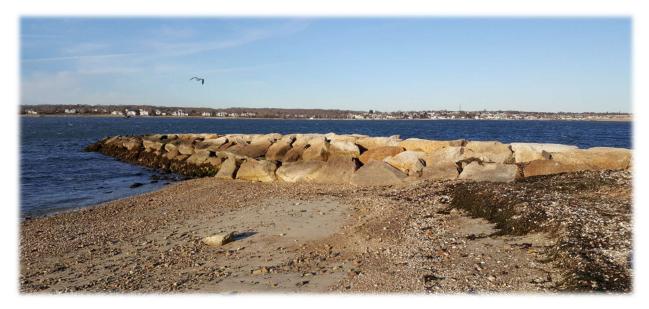
Figure 4.10 View of the Oaklawn Street groin, looking northwest (Jan 2017).

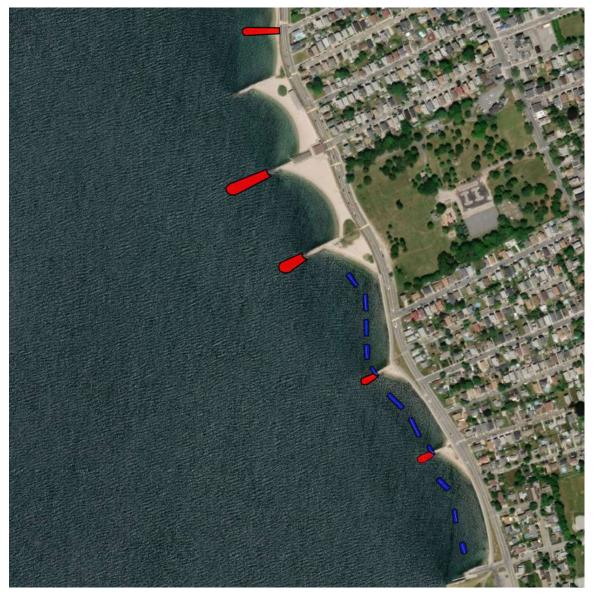
Figure 4.16 Aerial photo of the existing structure footprint (shaded in red) to be traded for the new T-head structures (shaded in blue).

Repositioned groins. The footprint area of reshaped groins at Aquidneck and Oaklawn Street will be reduced by a small amount, as the groin tips will be repositioned into shallower water and; therefore, their bases would not be as wide as they presently are constructed, given the same crest elevation and side slopes. Like the removed groin sections north of the nourishment area, for the portion of the groins tips that are repositioned, material will be removed to the level of the surrounding ocean bottom. Any remaining material that is embedded below that level will be left as rocky substrate. This is intended to mitigate for any potential loss of man-derived coarse cobble- and boulder-sized material that may presently serve as nearshore fisheries habitat. The existing manderived material in the intertidal and nearshore areas will be covered by the planned beach nourishment. The footprint of the relocated groin tips together is 2,480 square feet. The combined structure footprint planned for removal is 25.577 square feet.

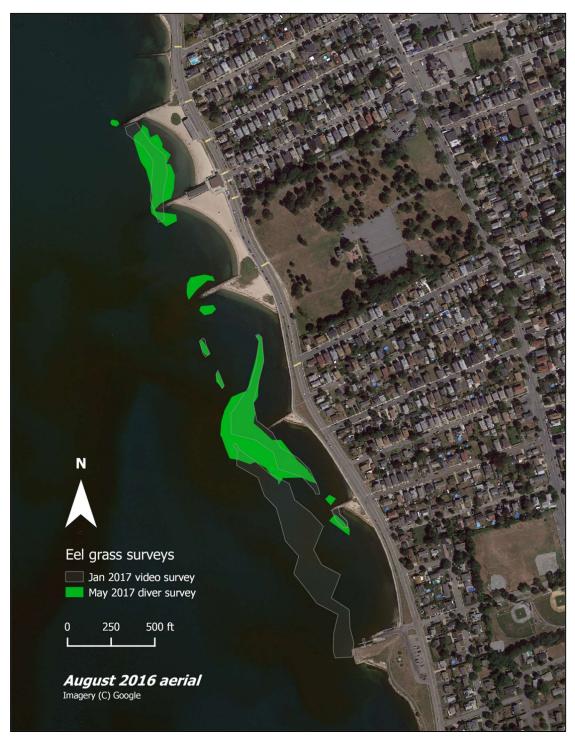
Stantec Eelgrass Assessment Results May 25, 2017 with CLE Eelgrass Video Assessment Results (January 2017). Figure 5.3

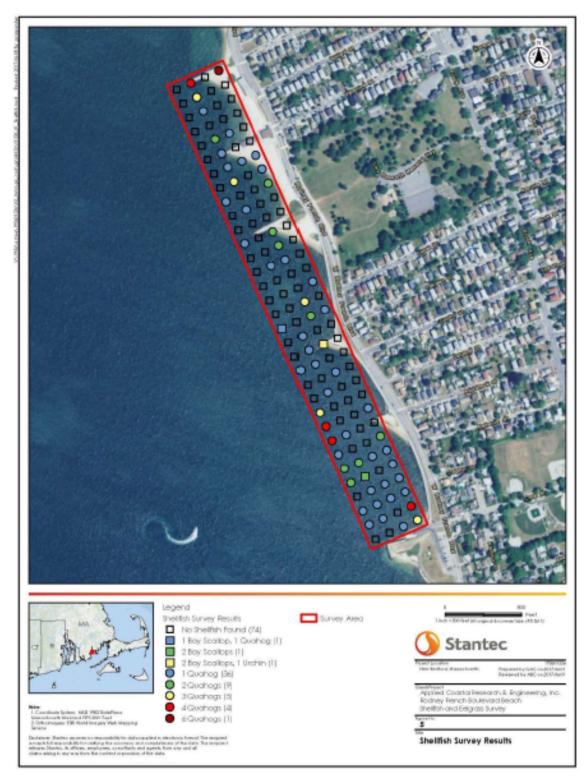
Figure 5.4 Stantec Shellfish Locations and Results, May 26, 2017.

The majority of the study area within Clarks Cove is shown to be suitable for quahogs. Additionally, there are small areas designated as suitable for bay scallops, razor clams and American oysters between Hazelwood Park and the boat ramp. Figure 5.6 depicts MADMF shellfish growing areas. This information was also acquired as geospatial data via the MassGIS OLIVER Online Mapping Tool. Clarks Cove is mapped as conditionally approved for shellfish growing and the City of New Bedford seeds the area with quahogs. This area can be open to City of New Bedford shellfishing subject to water and sediment quality. The area is conditionally approved for shellfish growing by MADMF and is considered suitable for quahogs, bay scallops, oysters, and razor clams within Clarks Cove.

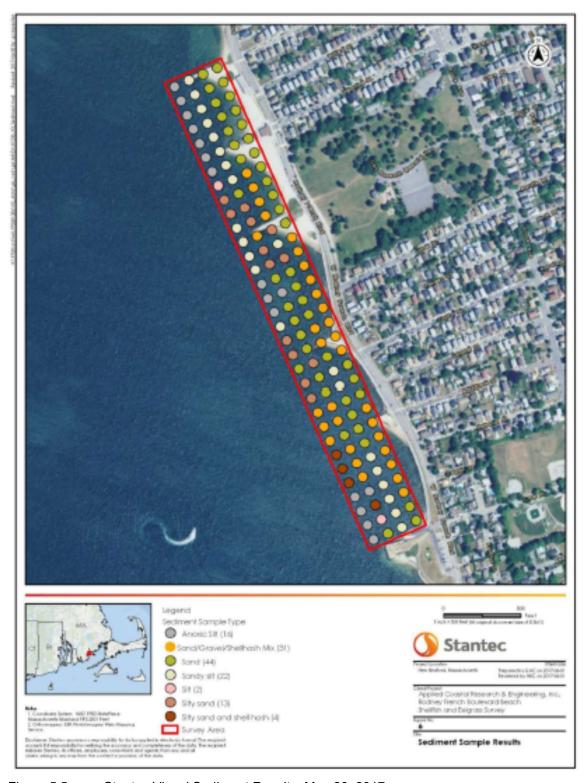
Figure 5.5 Stantec Visual Sediment Results, May 26, 2017.

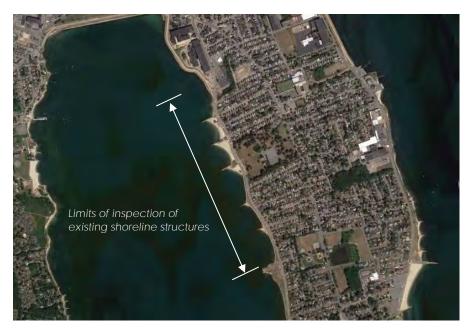
Figure 1: Limits of shoreline inspection of coastal structures along West Rodney French Boulevard.

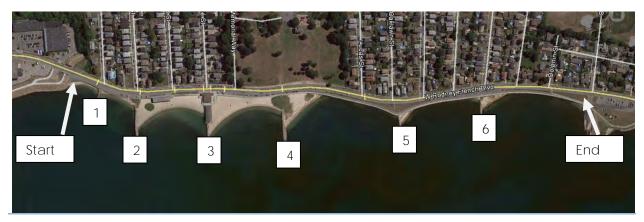
bathhouse facility and appears to be the only groin which does not extend to West Rodney French Boulevard itself.

Figure 2: Location of Existing Stone Groins within Project Inspection Limits

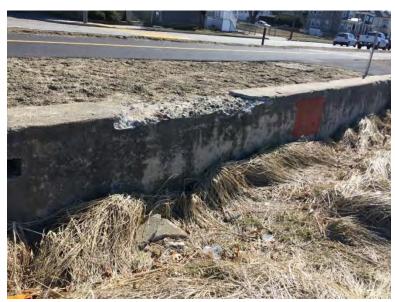
Photograph 2: Typical cap spalling at STA 5+00

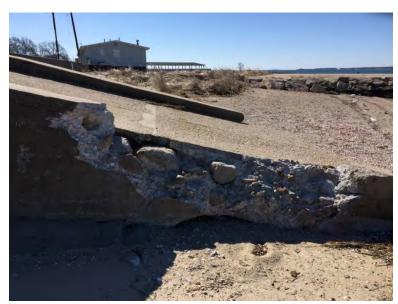
Photograph 3: Ramp heavy spalling STA 4+75

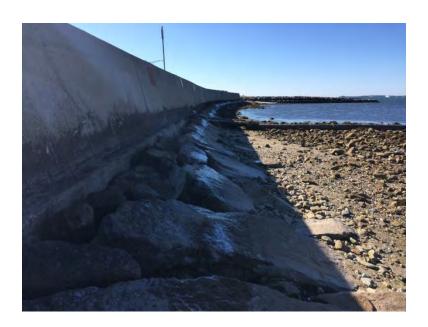
Photograph 4: Typical Good condition along the south side (B rated structure)

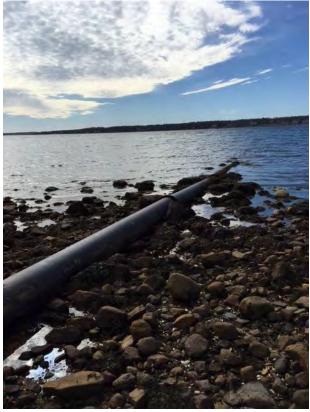
Photograph 5: Existing cast iron outfall pipe.

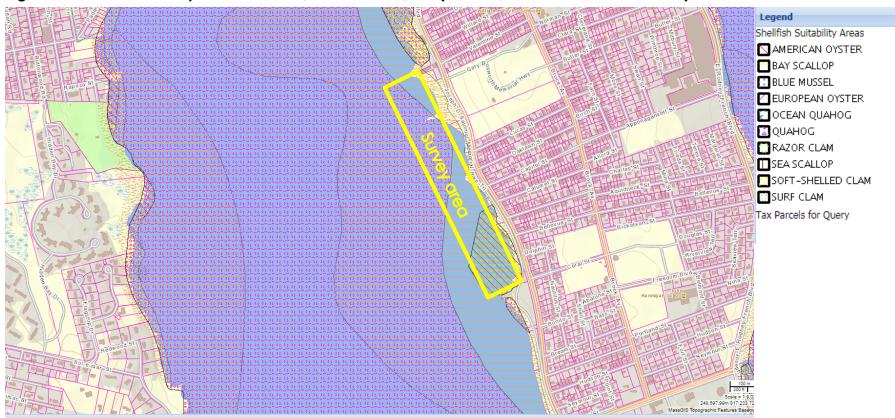
Figure 3. Shellfish growing areas in Clarks Cove, New Bedford, MA (MADMF, data retrieved June 2017). Yellow box represents surveyed area.

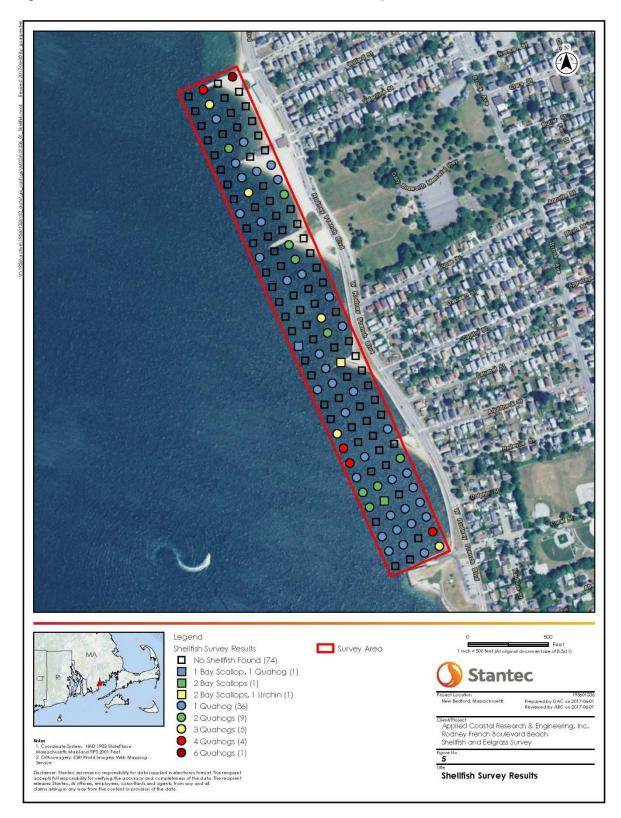
Figure 6. Stantec Visual Sediment Results, May 26, 2017.
