# Expanded Environmental Notification Form West Beach

New Bedford, MA

June 2018

Applied Coastal Research and Engineering, Inc.  
766 Falmouth Road, Suite A1  
Mashpee, Massachusetts 02649

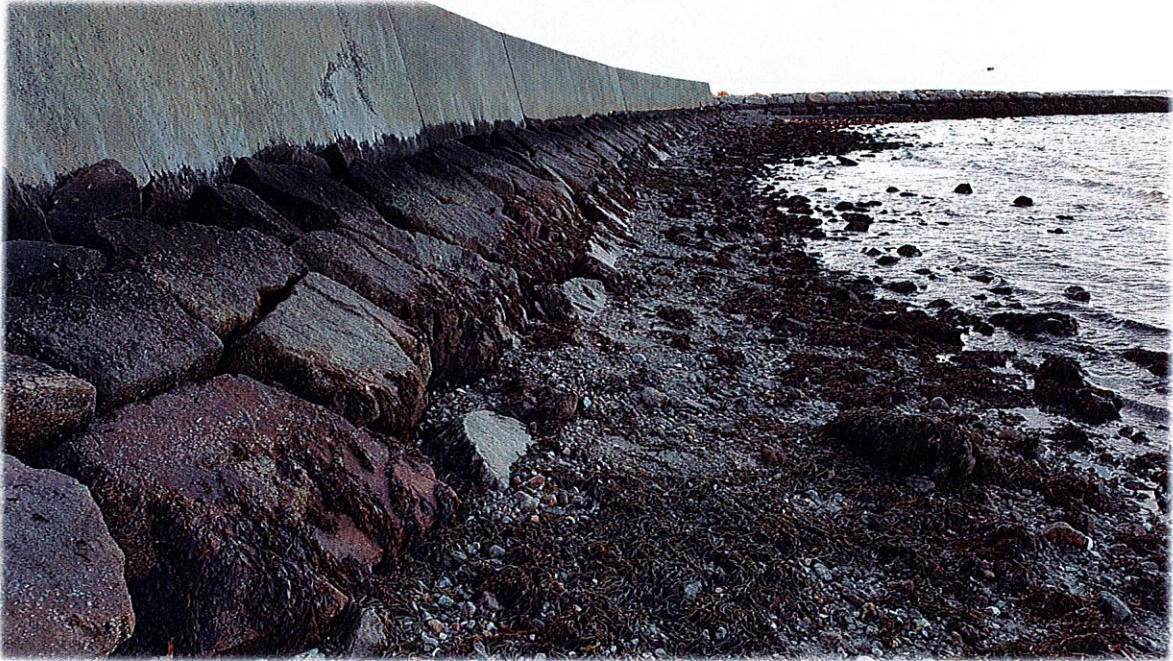
Figure 1.2 Photographs of West Rodney French Boulevard seawall taken January 2017

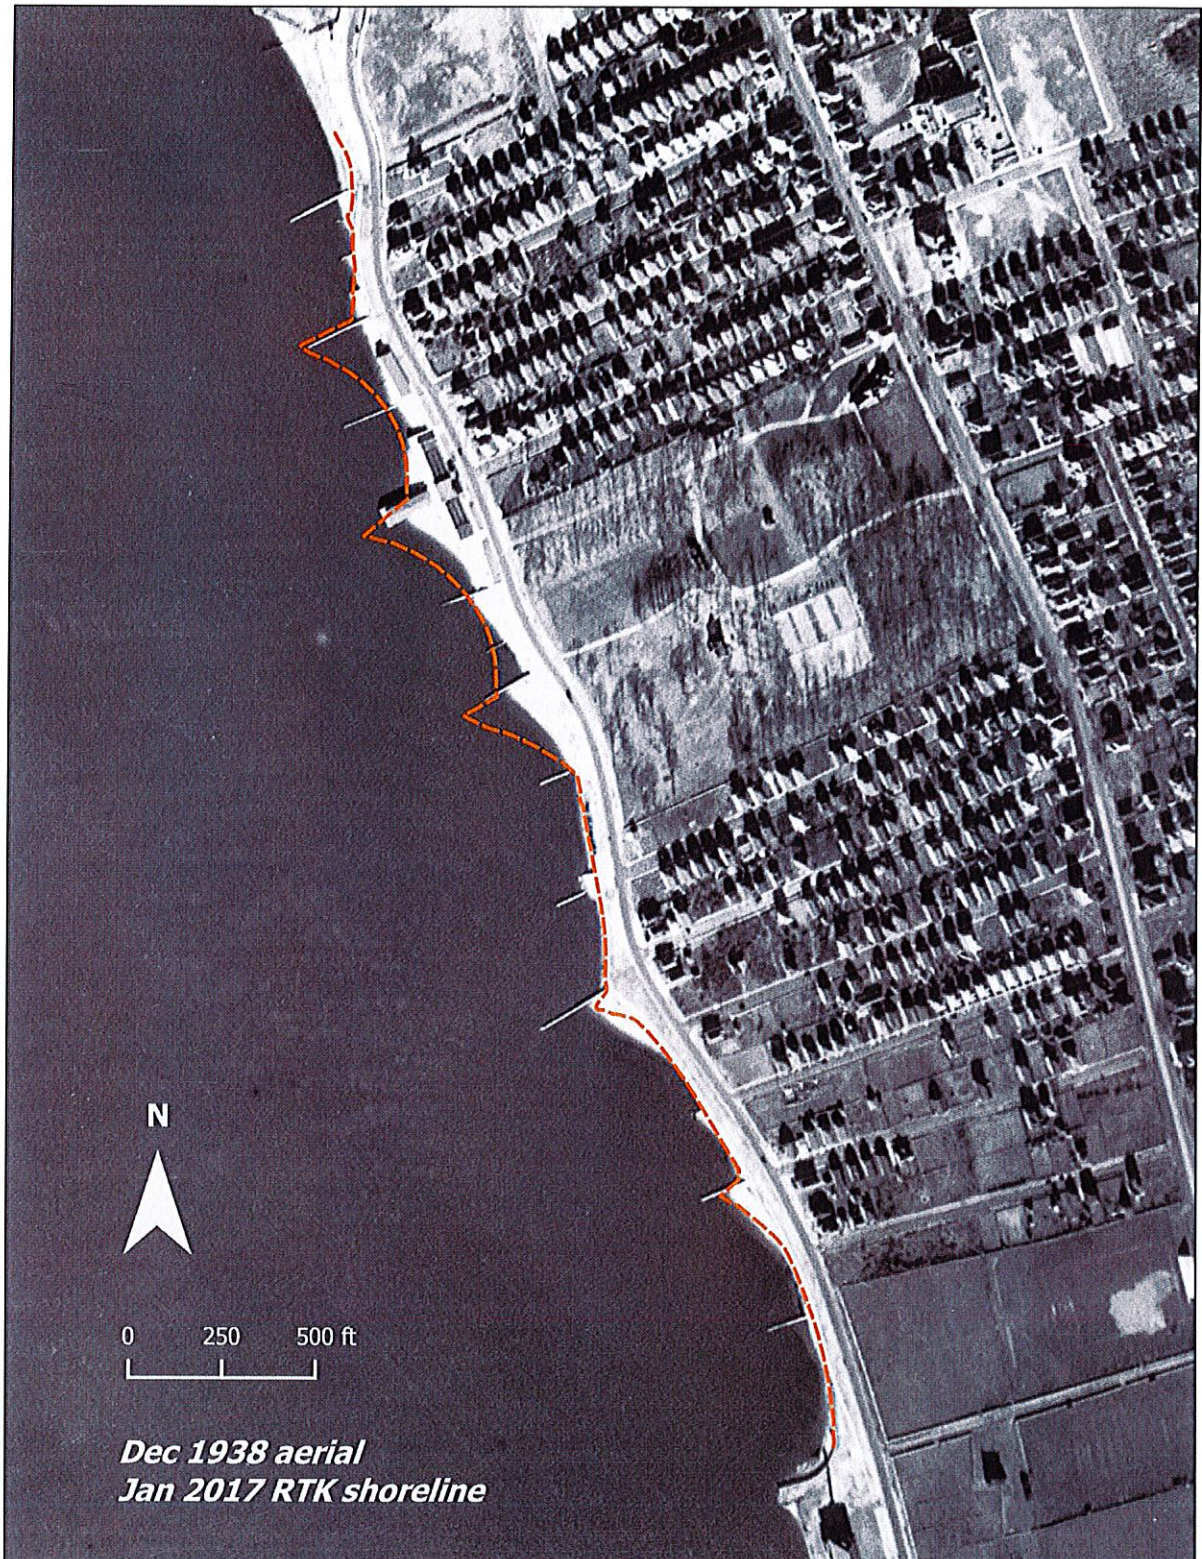
Figure 1.3 Aerial photograph from 1938 with the approximate shoreline from January 2017 shown in orange.

A historical analysis of shoreline changes to the West Rodney French Boulevard shoreline was assembled to assist in evaluating alternatives. The earliest documented shoreline position from the MCZM database is from 1895. Aerial imagery from 1938 provides insight in the shoreline position relative to the seawall (Figure 1.3), prior to nourishments placed in 1958 and 1977. The West Rodney French Boulevard shoreline has experienced modest erosion of the shoreline in areas that have been not protected by these two nourishments. While this beach erosion has not been severe when reviewing

shoreline change rates since 1938 (See Figure 1.3), lowering of the beach over time has led to the need for revetment protection along the face of the exposed seawall sections.

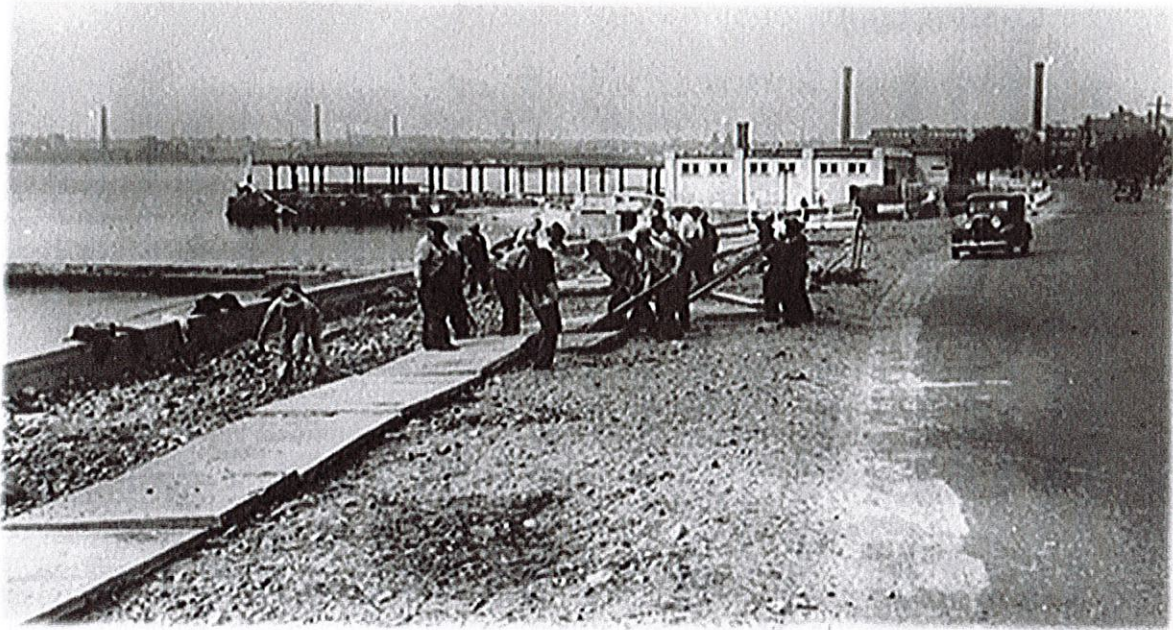
Figure 1.4 Damage to the area landward of the West Rodney French Boulevard seawall as a result of the September 1938 Hurricane (source: Spinner Publications, New Bedford, MA, [www.spinnerpub.com](http://www.spinnerpub.com)).

During the 1938 Hurricane, substantial damage occurred throughout New Bedford and the shoreline area of Clarks Cove was not spared. Figure 1.4 and Figure 1.5 are photographs showing the condition of the West Rodney French Boulevard area after the

storm. Under storm conditions, portions of the seawall failed and upland adjacent to the seawall was substantially scoured. During the peak of the storm, water levels greatly exceeded the low elevation of the seawall and roadway, which limited the damaging effects of waves at the point of maximum water levels.

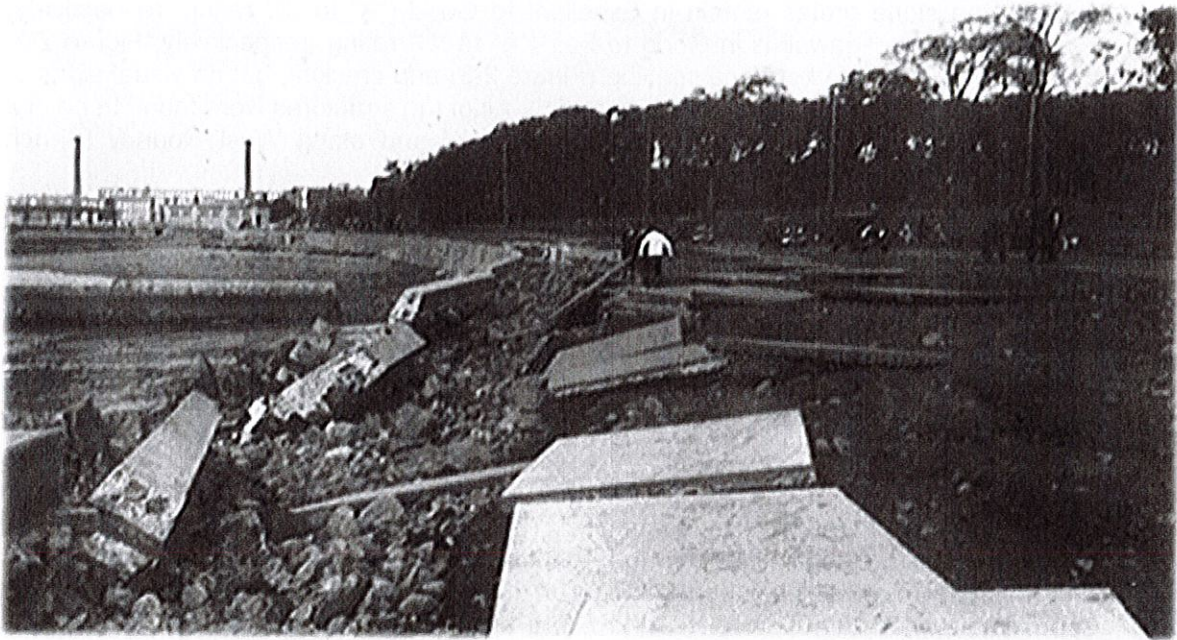
Figure 1.5 Portion of the West Rodney French Boulevard seawall failure that occurred as a result of the September 1938 Hurricane (source: Spinner Publications, New Bedford, MA, [www.spinnerpub.com](http://www.spinnerpub.com)).

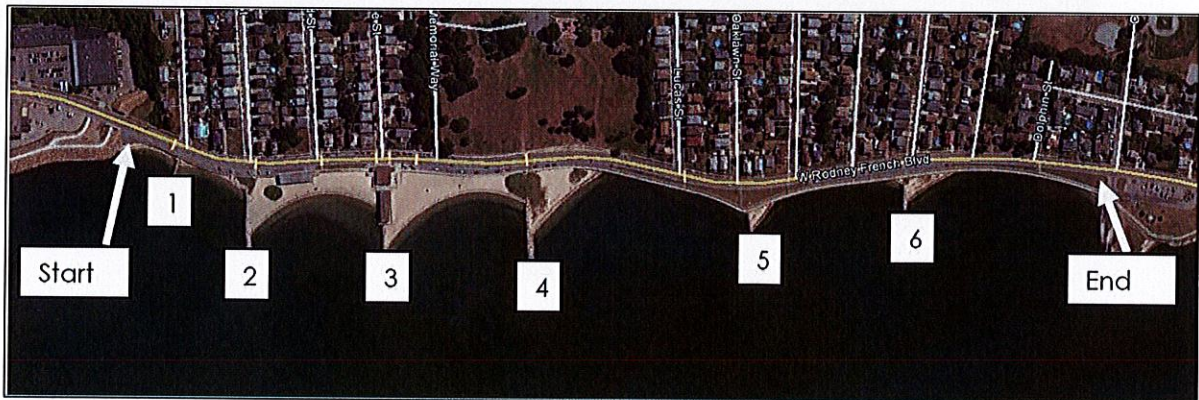
Figure 2.2 Location of Existing Stone Groins within Project Inspection Limits.

The project area includes a total of six (6) stone groins as shown in Figure 2.2. The groins are constructed similarly of 3 to 5 foot diameter stone with 1H:1V side slopes and a 6 to 10 foot wide level bench (Figure 2.3). The structures vary in length from approximately 175 to 400 linear feet (LF). The exact date of construction of the groins is not known, however, they are visible in an aerial photograph from 1945. Groin No. 4 was extended both in 1958 and 1978. The existing groin structures presently appear to have maintained their original slopes and lengths with few signs of displacement, settling, or scour. Groin No. 3 extends from the end of the bathhouse facility and appears to be the only groin which does not extend to West Rodney French Boulevard itself.

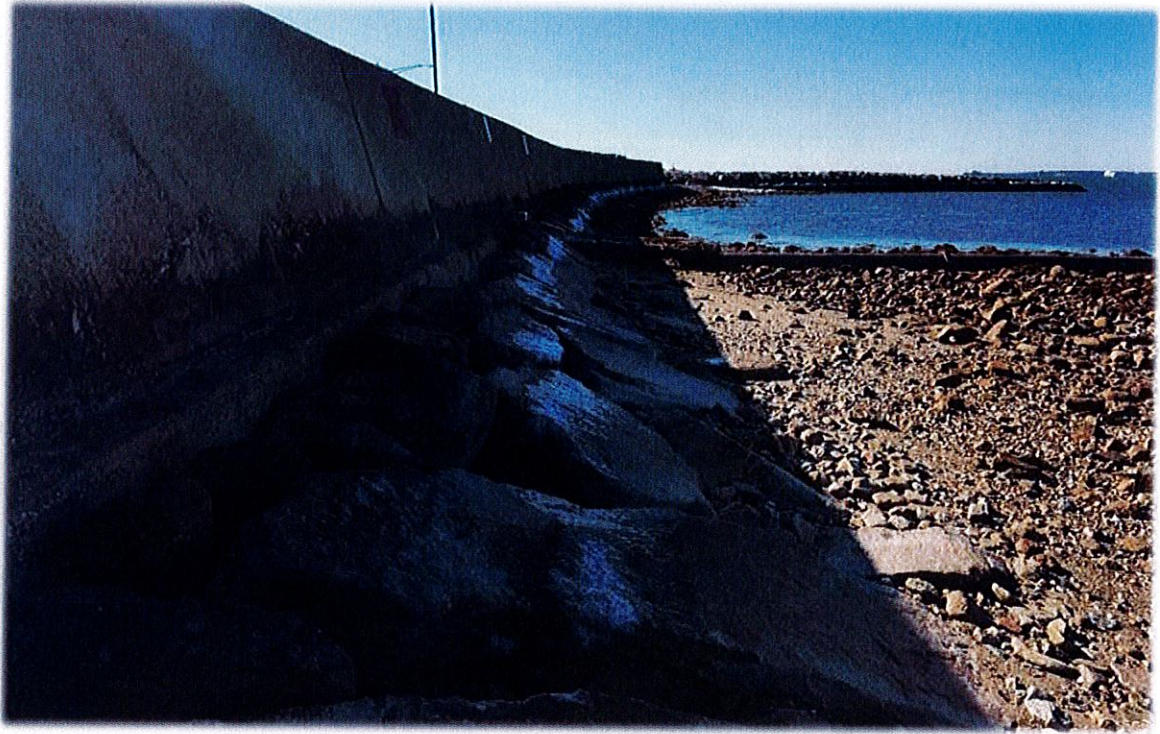
Figure 2.5 Typical Good condition of the seawall along the south side (B rated structure).

As shown in Table 2.2 below, the overall condition of the full length of the seawall varied from Good to Fair ("B" or "C" rating, respectively). Wall Section 1.1 remains in Good ("B" rating) condition including the exposed toe stone (Figure 2.5). The conditions observed along Wall Sections 1.2 and 1.3, however, are considered to be Fair ("C" rating) as there are presently visual signs of deterioration, cracking, spalling, etc. (Figure 2.6). Despite these observations, all wall sections still adequately provide flood protection; however, their ability to be reused in the future as a core structure for an elevated wall or to be repaired rather than replaced has been reduced. Sealing the existing cracks and grouting the surface spalls could significantly extend the life of the wall. Provided these measures are implemented within the next 5 years, it is viable that all wall sections could be raised for future sea level rise without a complete reconstructive effort. In addition, it is noted that the existing access ramp located at STA 4+75 exhibits severe deterioration along the wingwalls, and the structures' low elevation presents a risk due to low crest elevation (see Figure 2.7). An evaluation with respect to need for the ramp should be performed before implementing any repairs. The crest elevation of the seawall is shown to vary between 10.0 and 10.8 feet MLW, as shown in Figure 2.4.

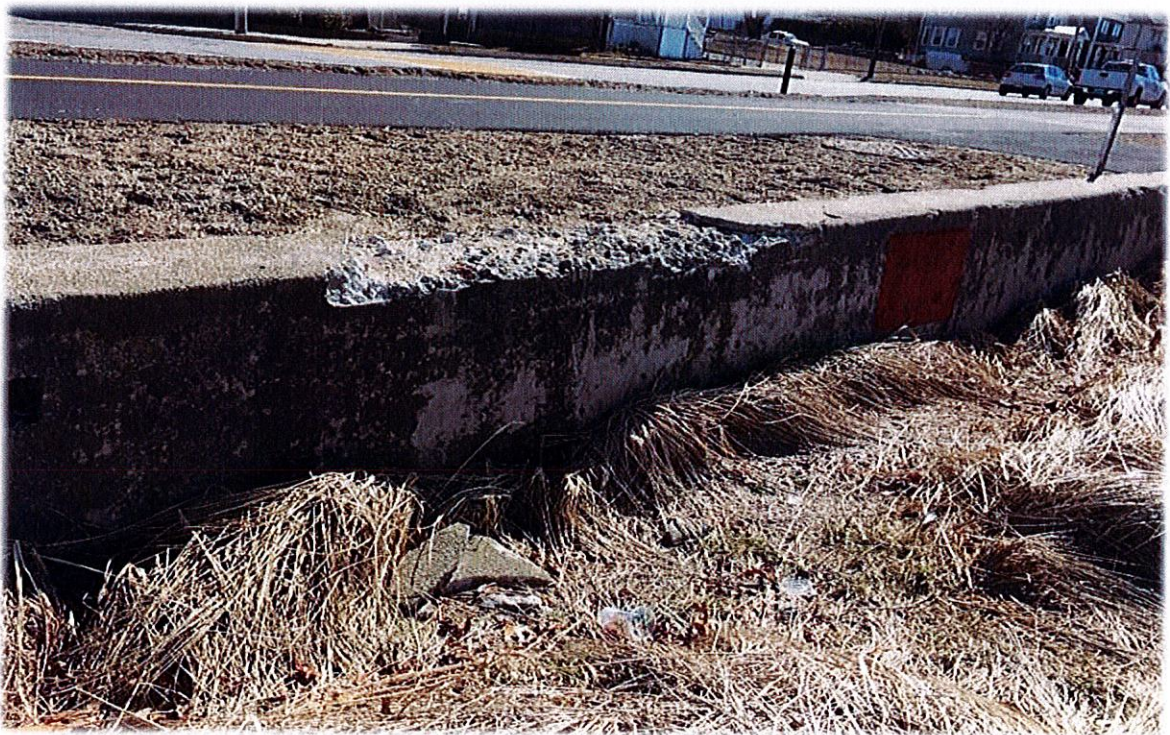
Figure 2.6 Typical cap spalling at STA 5+00.

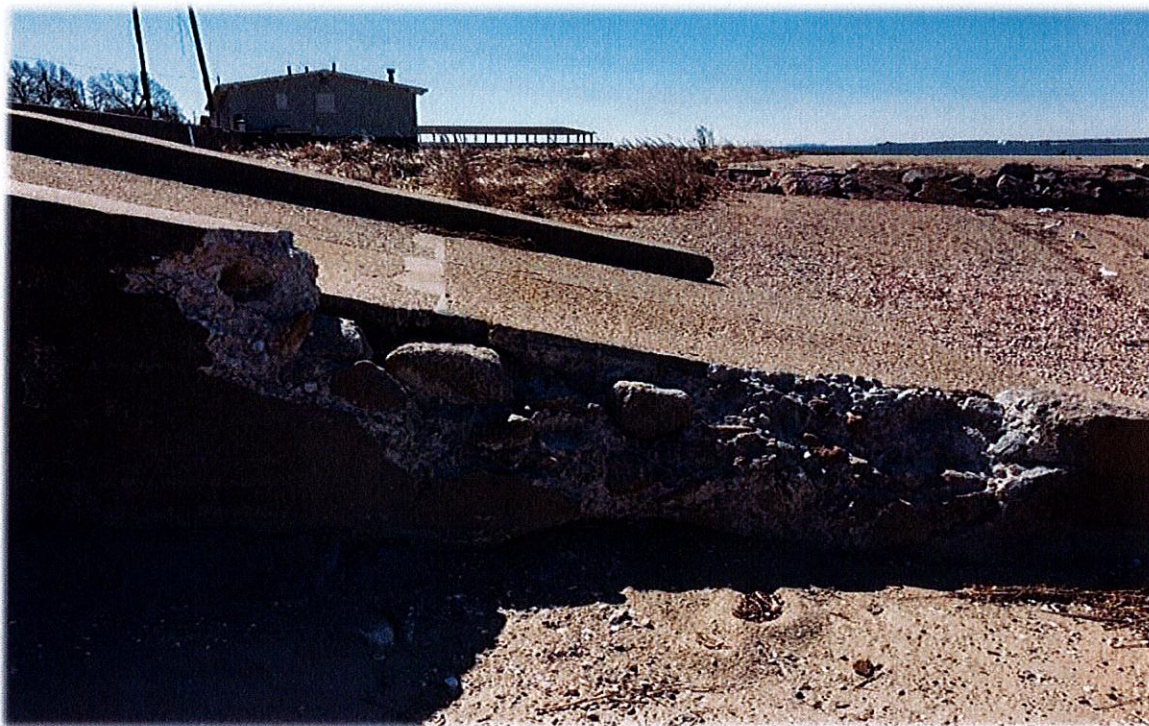
Figure 2.7 Ramp heavy spalling STA 4+75.

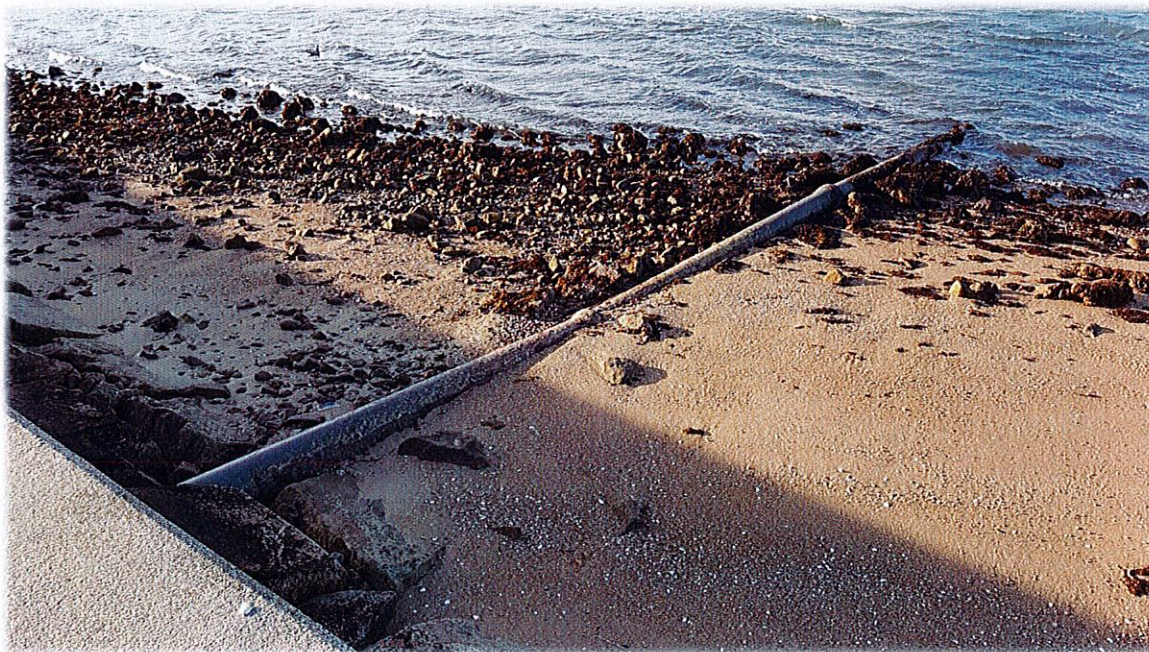
Figure 2.8 Existing cast iron outfall pipe.

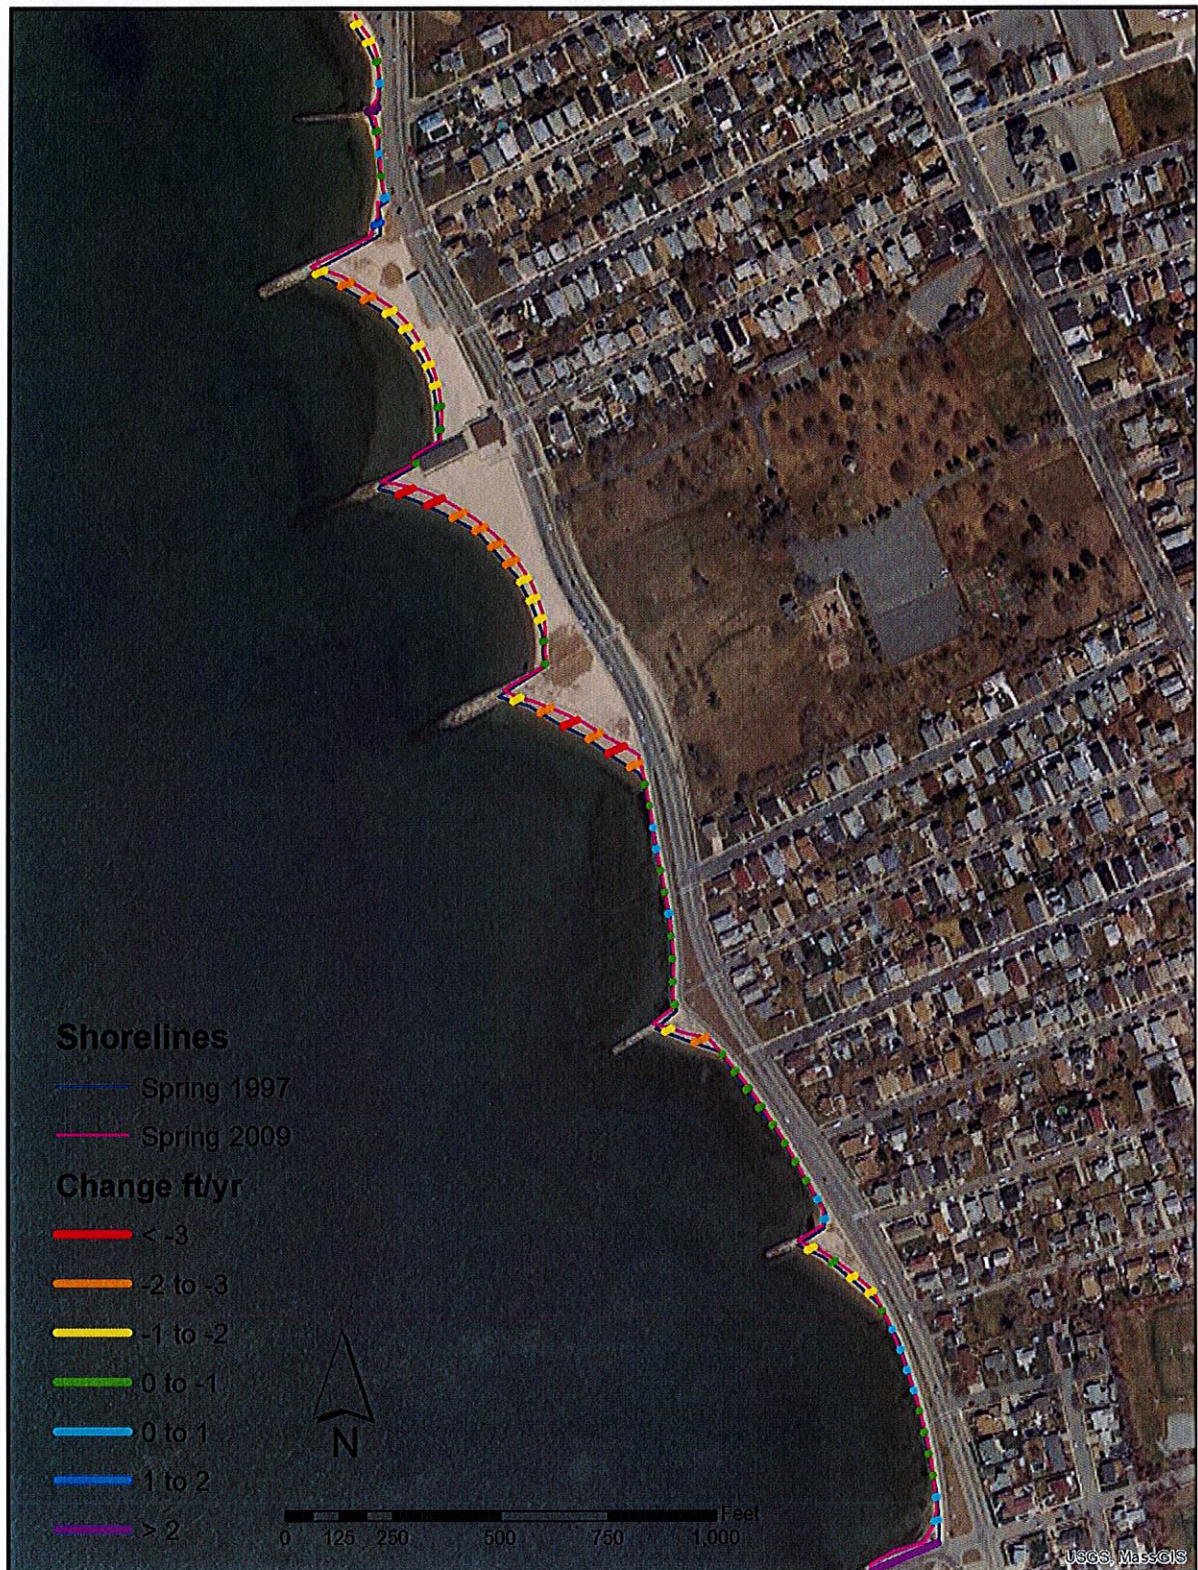
Figure 2.10 Historical shoreline change for West Rodney French Boulevard shoreline from 1997 to 2009.

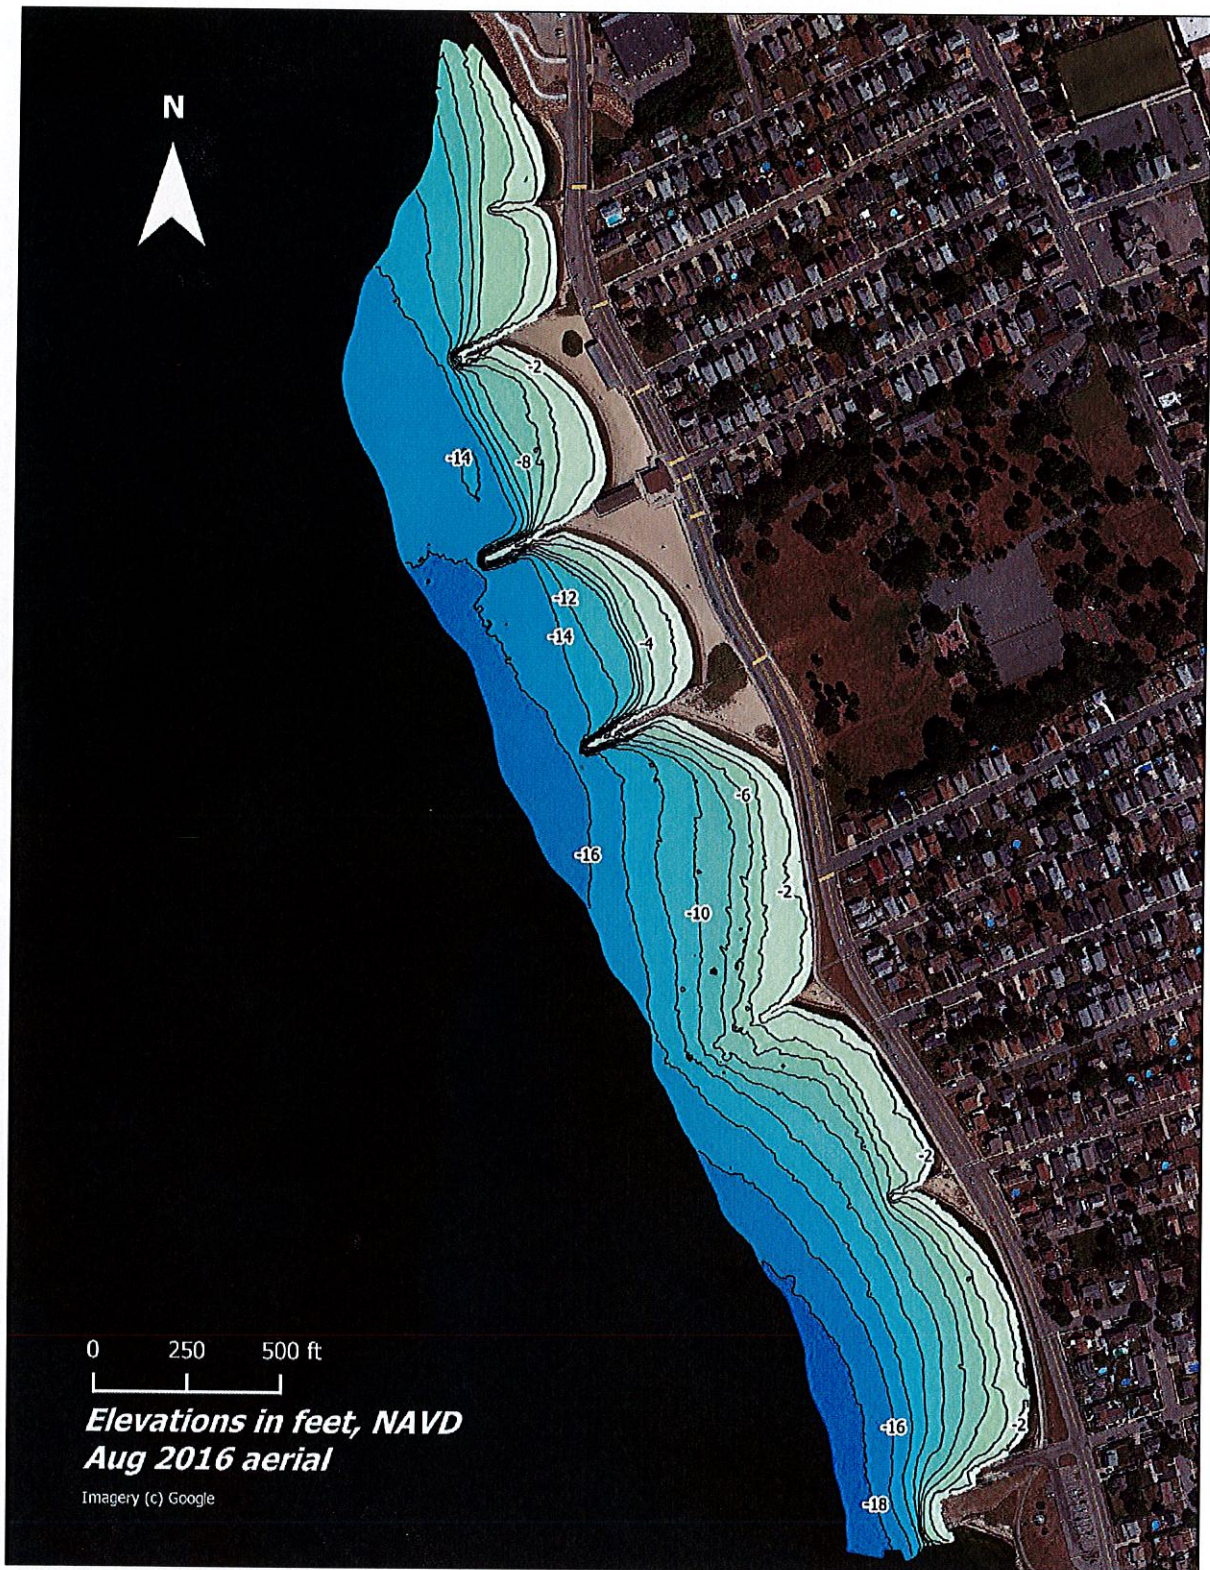
Figure 2.11 Bathymetric contour data from 2017 multi-beam survey.

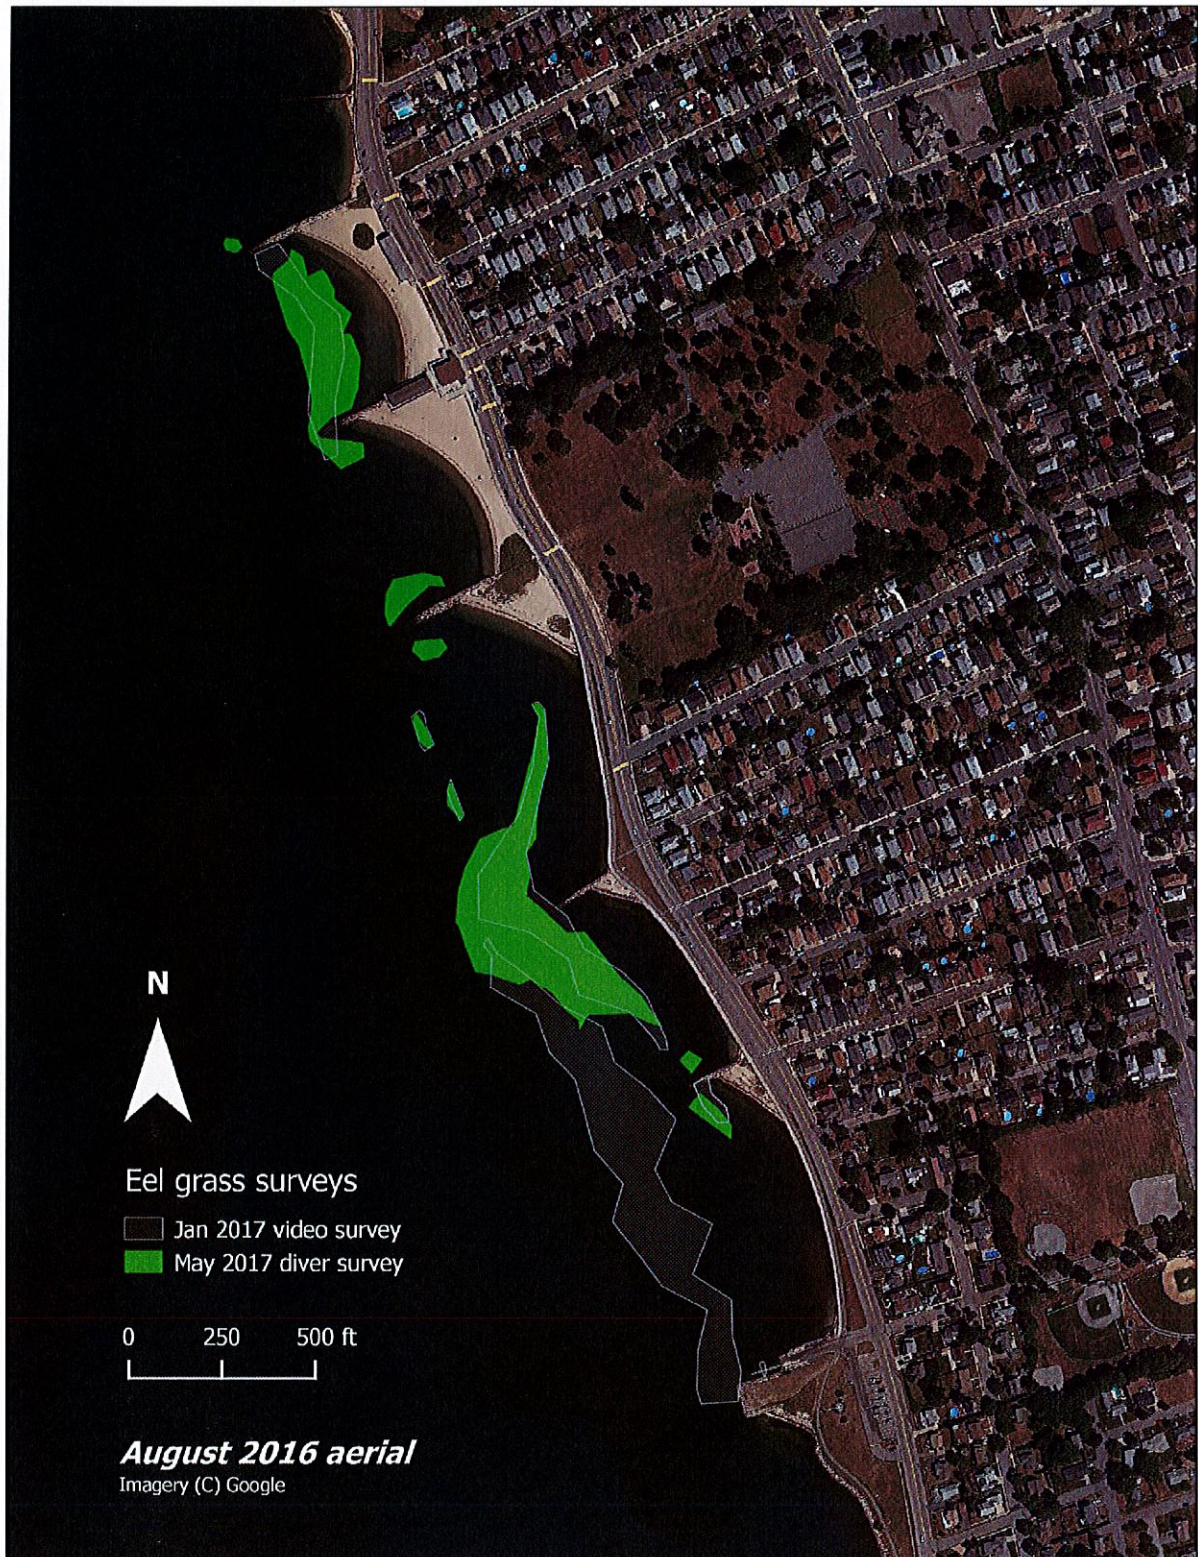
Figure 2.12 Eelgrass coverage based upon results of January 2017 reconnaissance video survey by CLE, Inc. and in-season May 2017 diver survey by Stantec.

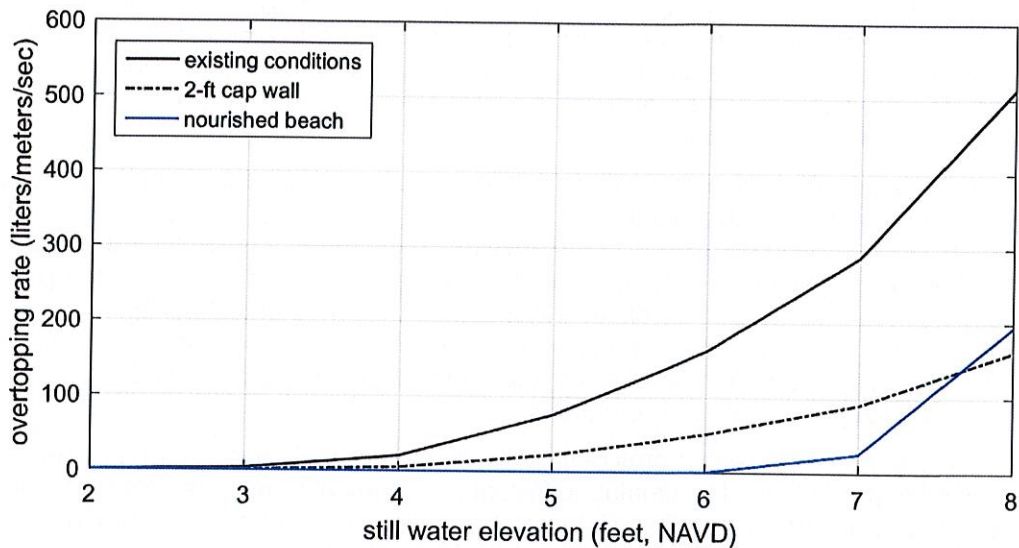
Figure 3.1 Mean overtopping rate of the West Beach seawall as a function of still water elevation, for the three structural alternatives compared in this analysis.

Increasing the crest height of the seawall was evaluated for storm performance. This evaluation used overtopping rates of the West Rodney French Boulevard seawall for three engineering scenarios during storms, and for a range of water levels. The structural scenarios used in this analysis include 1) the existing conditions of the beach and seawall, 2) the existing beach with a two-foot-high cap wall added to the seawall and 3) the existing seawall with the planned nourishment. The water levels used range from just above MHHW (1.9 feet NAVD) to the point where mean overtopping volume rates become large enough in all scenarios to damage the paved promenade of the seawall. Based on guidance provided by Owen (as presented in Herbich, 2000), overtopping discharges should be limited to 200 liters/meter/second to prevent damage to pavement.

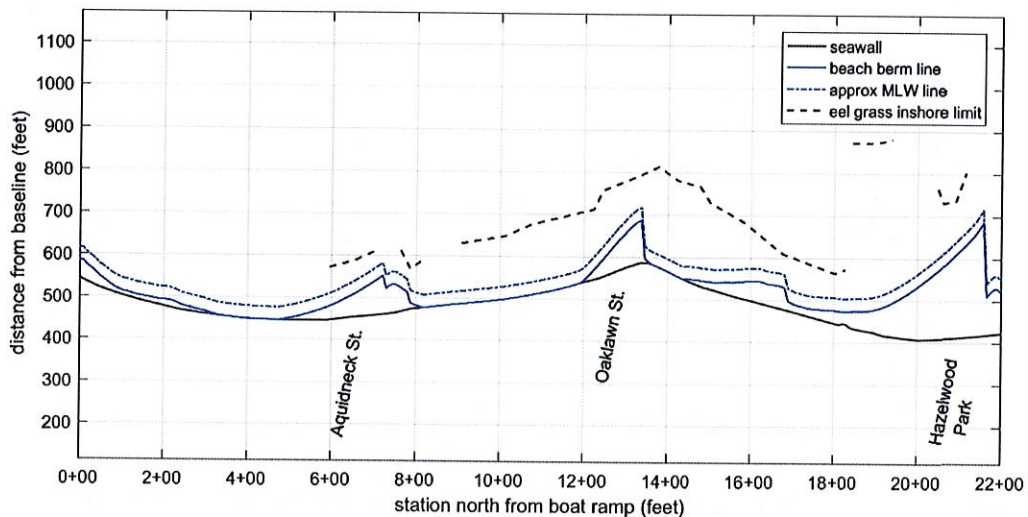
Figure 3.3 Modeled shoreline at the end of the 10-year simulation of a 40-foot-wide nourishment template. Beach berm line, and approximate MLW shoreline are shown with the inshore limit of identified eelgrass resources (from May 2017 survey).

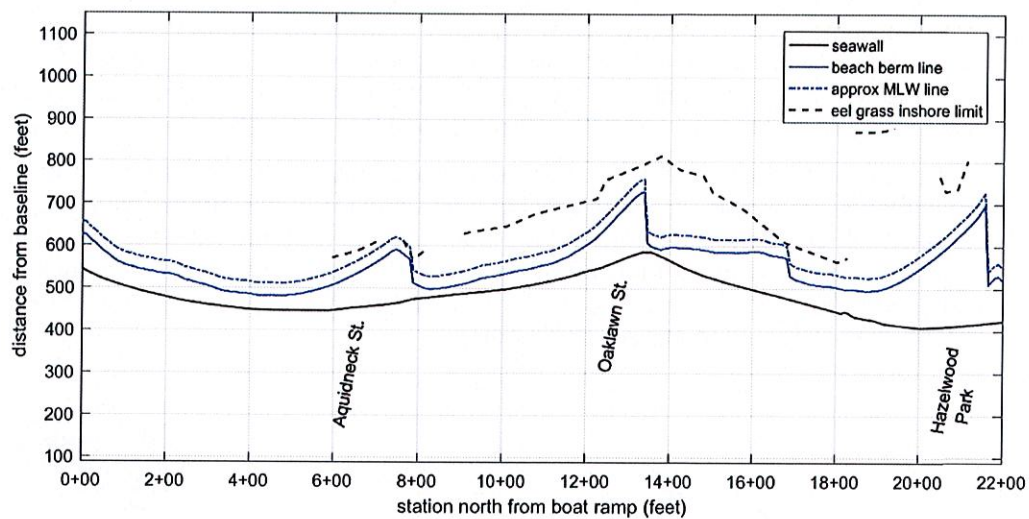
Figure 3.6 Modeled shoreline at the end of the 10-year simulation of an 80-foot-wide nourishment template. Beach berm line, and approximate MLW shoreline are shown with the inshore limit of identified eelgrass resources (from May 2017 survey).

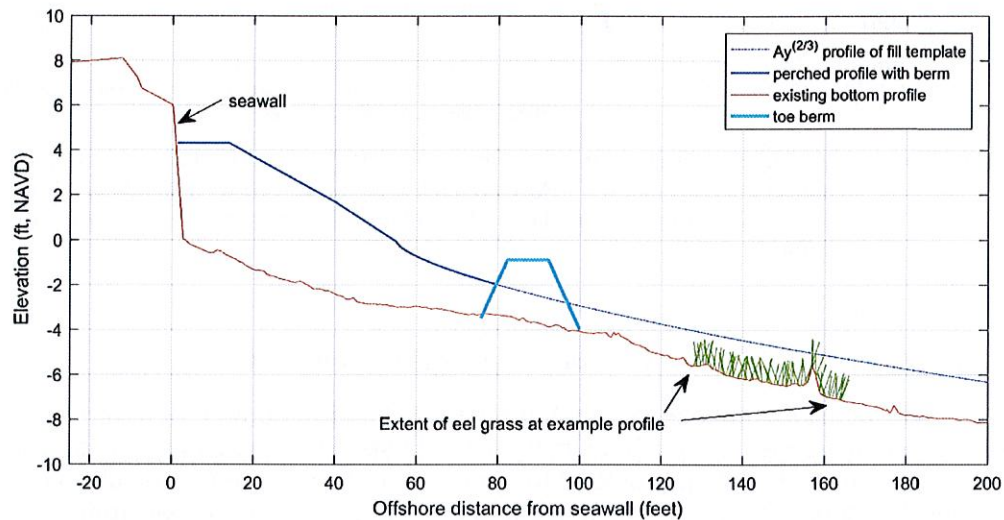
Figure 3.7 Conceptual profile of perched beach alternative, showing the positioning of the toe berm structure and filled nourishment profile relative to the existing eelgrass extent.

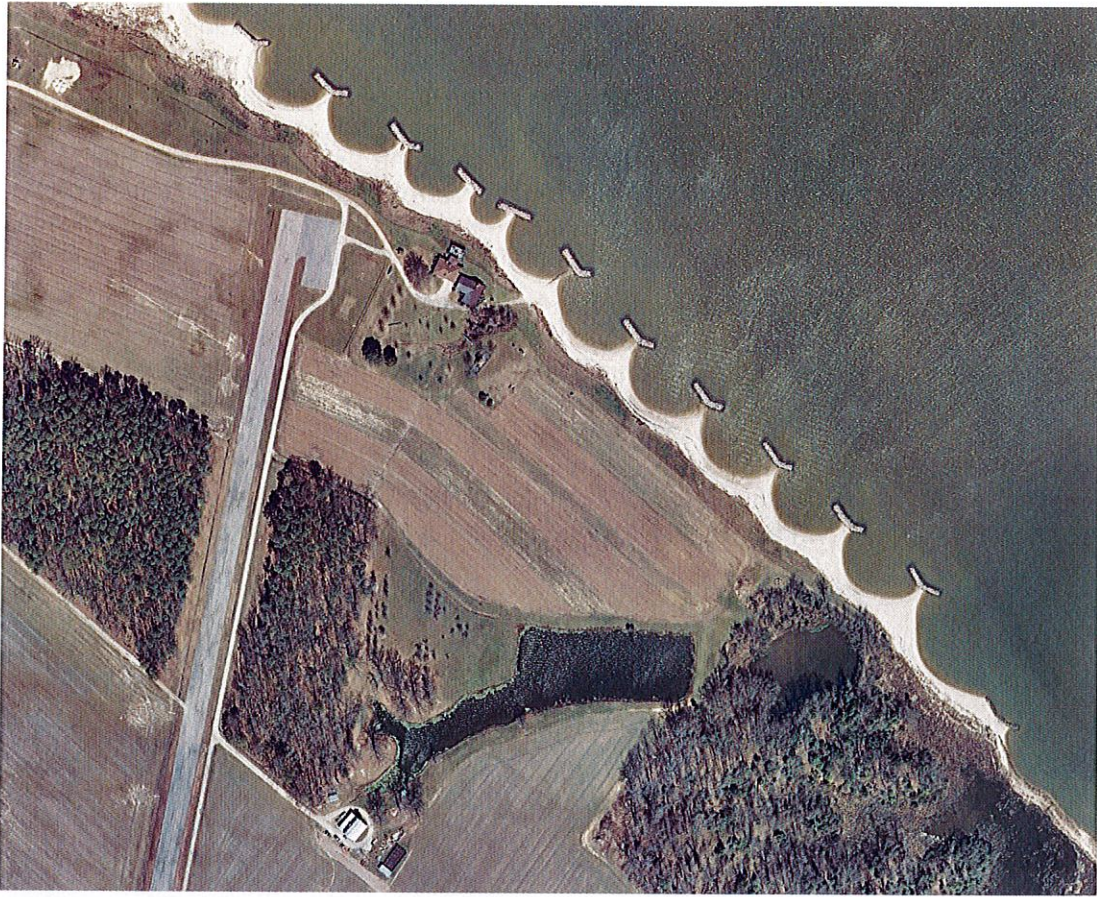
Figure 3.10 Aerial imagery of a T-head groin field along the James River in Virginia. Imagery is from USGS 2013 satellite observations.

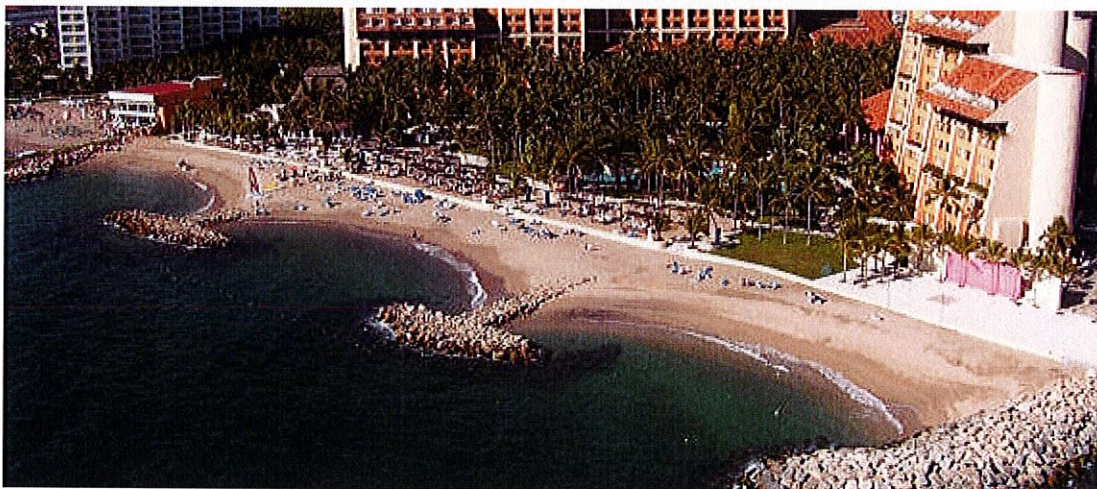
Figure 3.11 Example of a T-head groin project by Olsen and Associates (Photo by Olsen and Associates).

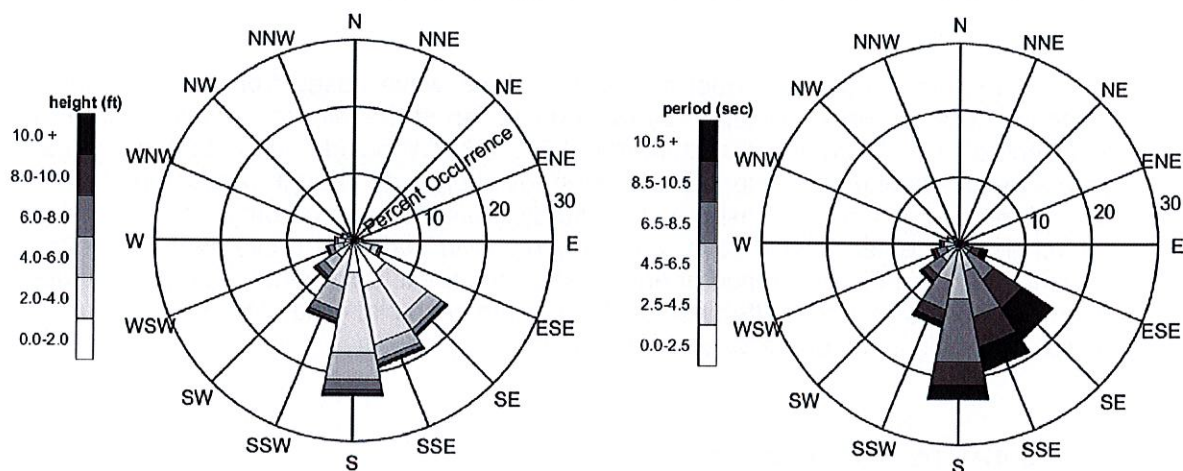
Figure 4.3 Wave height and period for hindcast data from WIS station 63074 (Rhode Island Sound) for the 33-year period between January 1980 and December 2012. Direction indicates from where waves were traveling, relative to true north. Radial length of gray tone segments indicates percent occurrence for each range of wave heights and periods. Combined length of segments in each sector indicate percent occurrence of all waves from that direction.

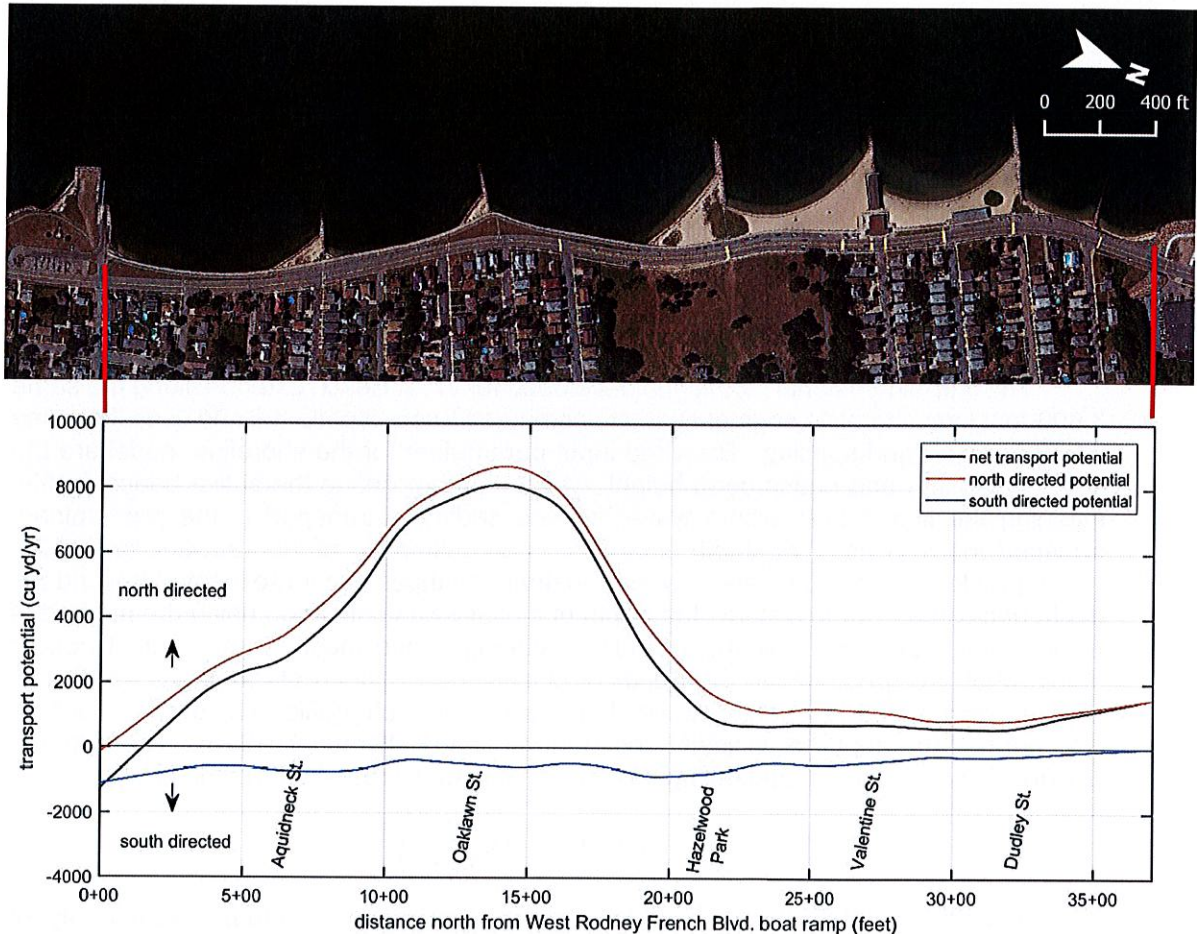
Figure 4.9 Annualized average sediment transport potential (positive north-directed; negative south-directed) computed for the shoreline of West Beach. The net transport (solid black line) is the resultant of the north-directed (red line) and the south-directed (blue line) components of transport. The August 2016 aerial photo provided for reference is via Mass GIS and Google Images (©2017).

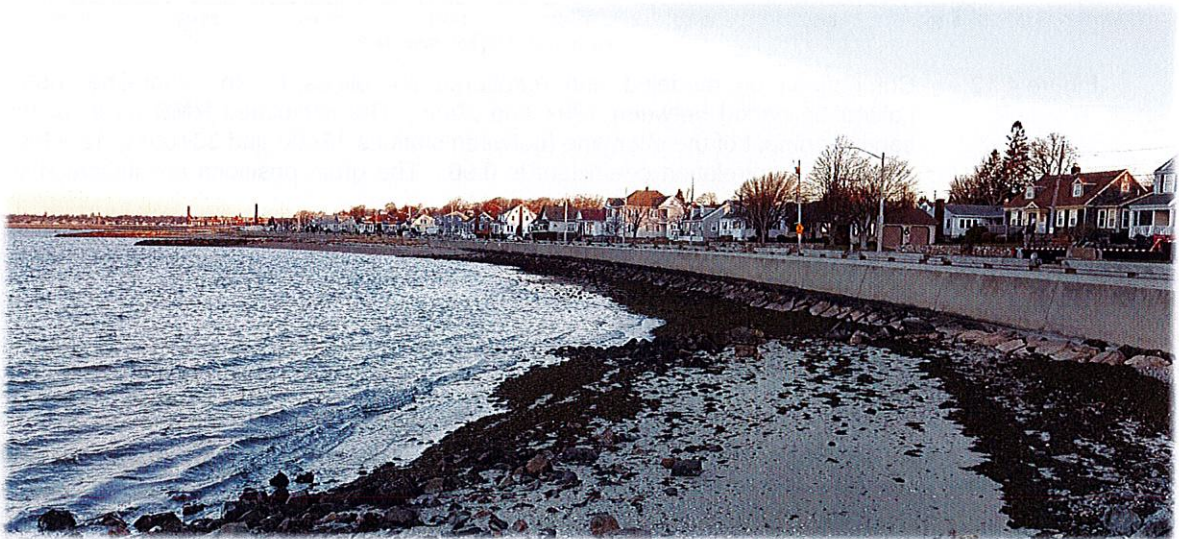
Figure 4.11 Photo a section of the seawall along West Rodney French Boulevard, viewed from the boat ramp, looking north (Jan 2017).

Coastal engineering structures along the modeled shoreline segment are included in this model. Six groins are included (e.g., Figure 4.10), as is the seawall along Rodney French Boulevard (Figure 4.11). The groins act to impound sand, and are included in the model by introducing a permeability factor that reduces the transport rate across the grid cell where each groin exists. Permeability ranges between 0.0 and 1.0, where 0.0 would

The seawall acts to limit the shoreward movement of the shoreline as it moves during the course of the simulation. If the shoreline at any grid cell erodes to the point where it comes into contact with the seawall, the shoreline is not allowed to move farther shoreward. Unlimited accretion is allowed in front of the seawall.

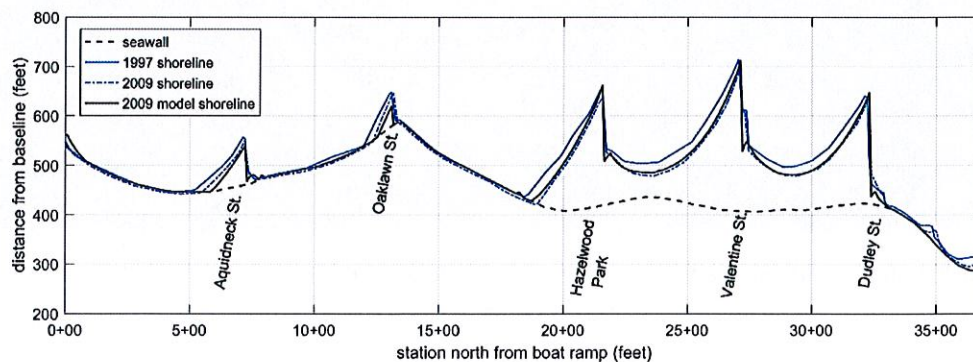
Figure 4.12 Comparison on modeled and measured shorelines for the shoreline model calibration period between 1997 and 2009. The calculated RMS error for the sandy segment of the shoreline (between stations 18+00 and 33+00) is 12.9 feet, and the  $R^2$  correlation coefficient is 0.96. The groin positions are indicated by reference from Figure 4.9.
