# Expanded Environmental Notification Form West Beach

New Bedford, MA

June 2018

Applied Coastal Research and Engineering, Inc.  
766 Falmouth Road, Suite A1  
Mashpee, Massachusetts 02649

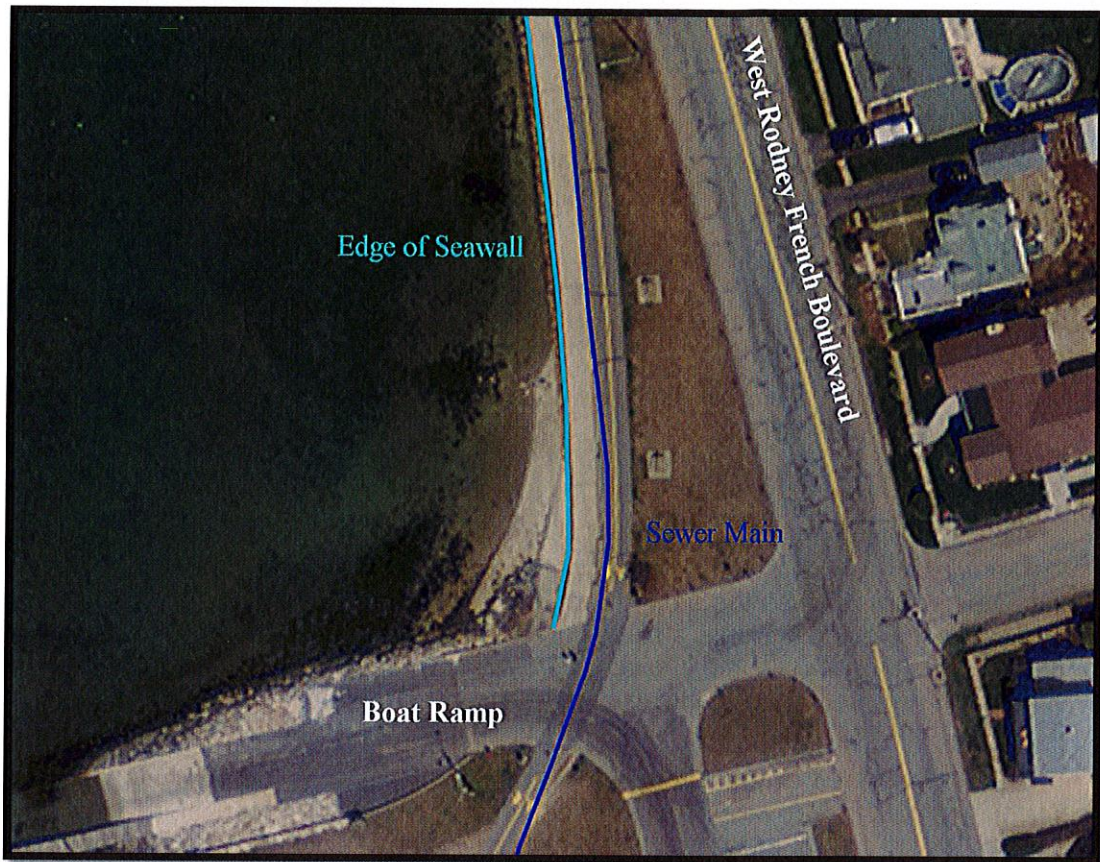
Figure 4.13 Aerial image of the approximate separation of the sewer main and the seawall. Just north of the boat ramp in the first groin compartment, the sewer main centerline (navy blue) is within 10 ft of the seaward edge of the seawall. This section of the seawall is exposed to the ocean during high tides.

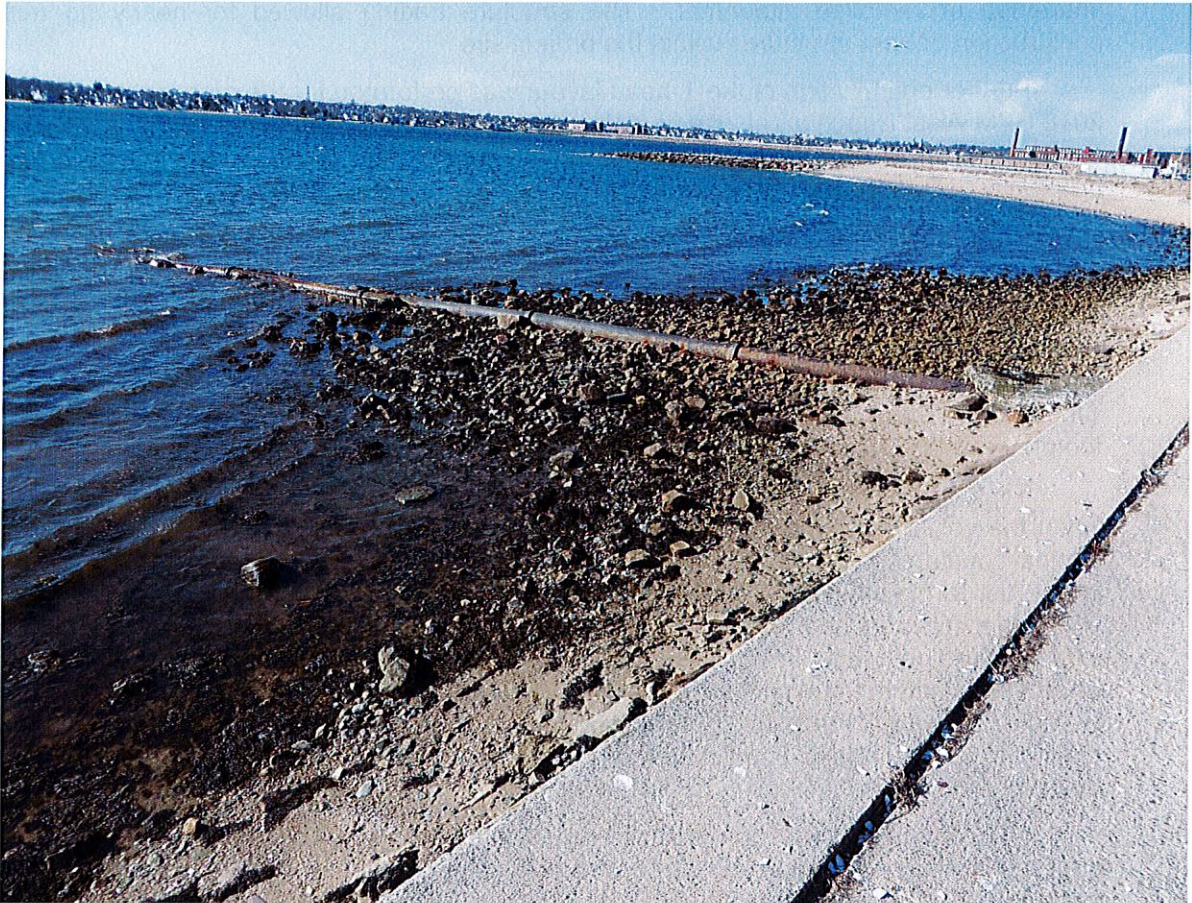
Figure 4.15 Example of existing cast iron CSO pipe that projects from the West Rodney French Boulevard seawall.

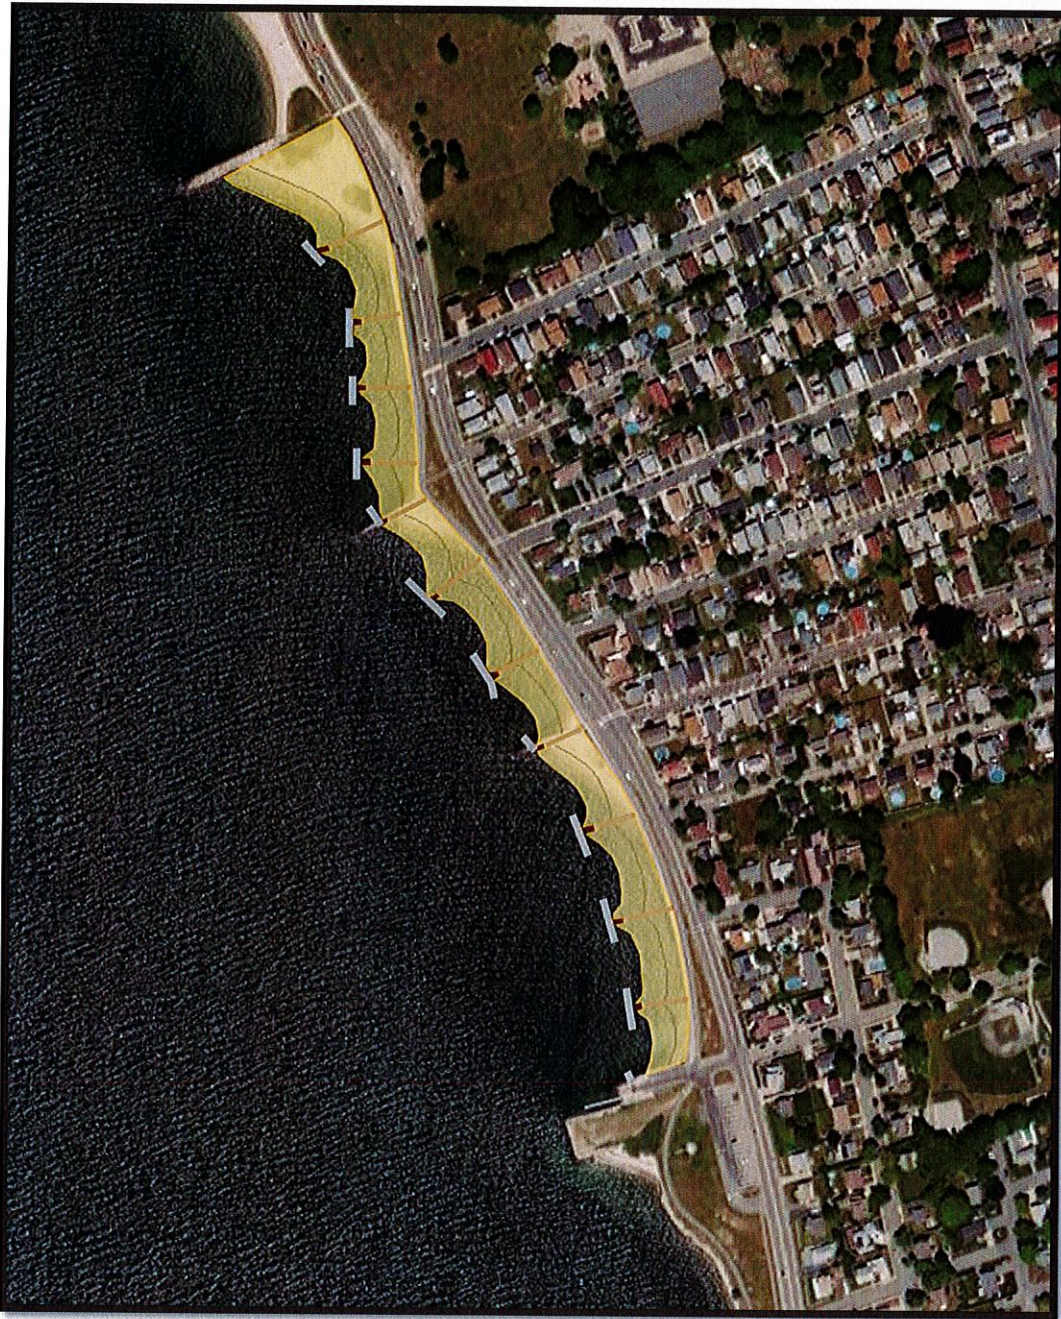
Figure 5.1 Proposed Project Area illustrating sand nourishment (tan shading) and T-head structures (breakwater sections shown in gray).

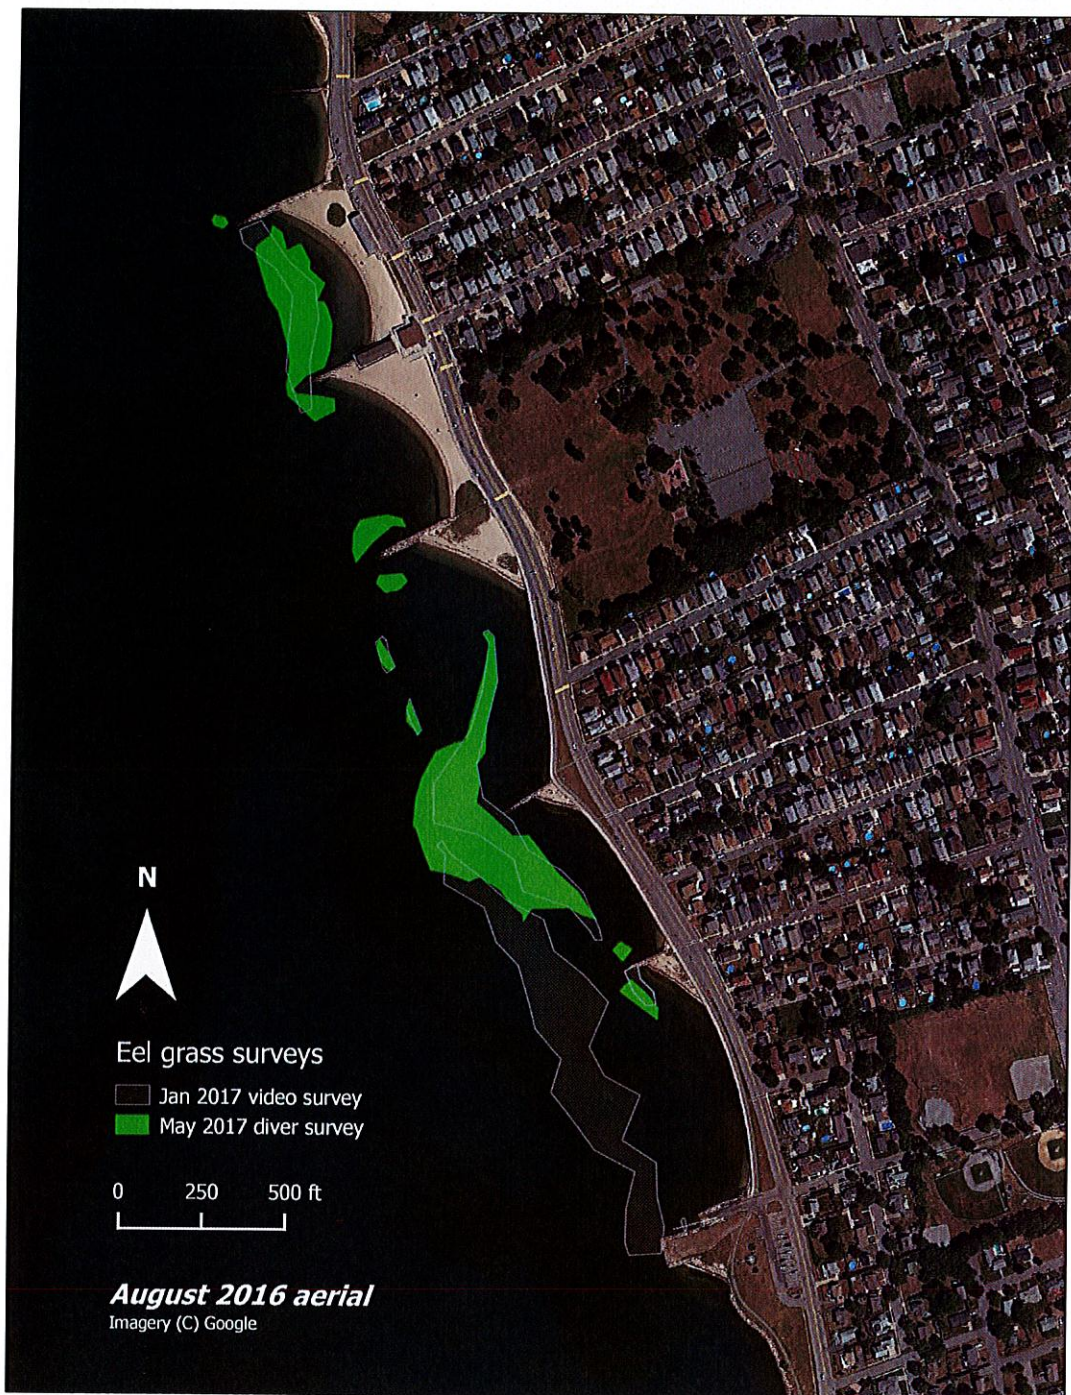
Figure 5.3 Stantec Eelgrass Assessment Results May 25, 2017 with CLE Eelgrass Video Assessment Results (January 2017).

Stantec was asked to ground-truth the presence of eelgrass observed in video as collected by CLE in January 2017. They conducted a diver-assisted survey during the growing season (May 2017). During the survey, historical MADEP eelgrass maps were reviewed (MassGIS OLIVER Mapping Tool), including maps available from 2001 and 2013. Field observations established that existing eelgrass was present beyond the area mapped by MADMF in 2013, as well as areas mapped by CLE (Figure 5.3); however, a large section of eelgrass delineated by CLE in January 2017 was observed to be dead and occupied by dead man's finger algae (*Codium fragile*). Regardless, the eelgrass area mapped by MADEP in 2013 has increased in size.

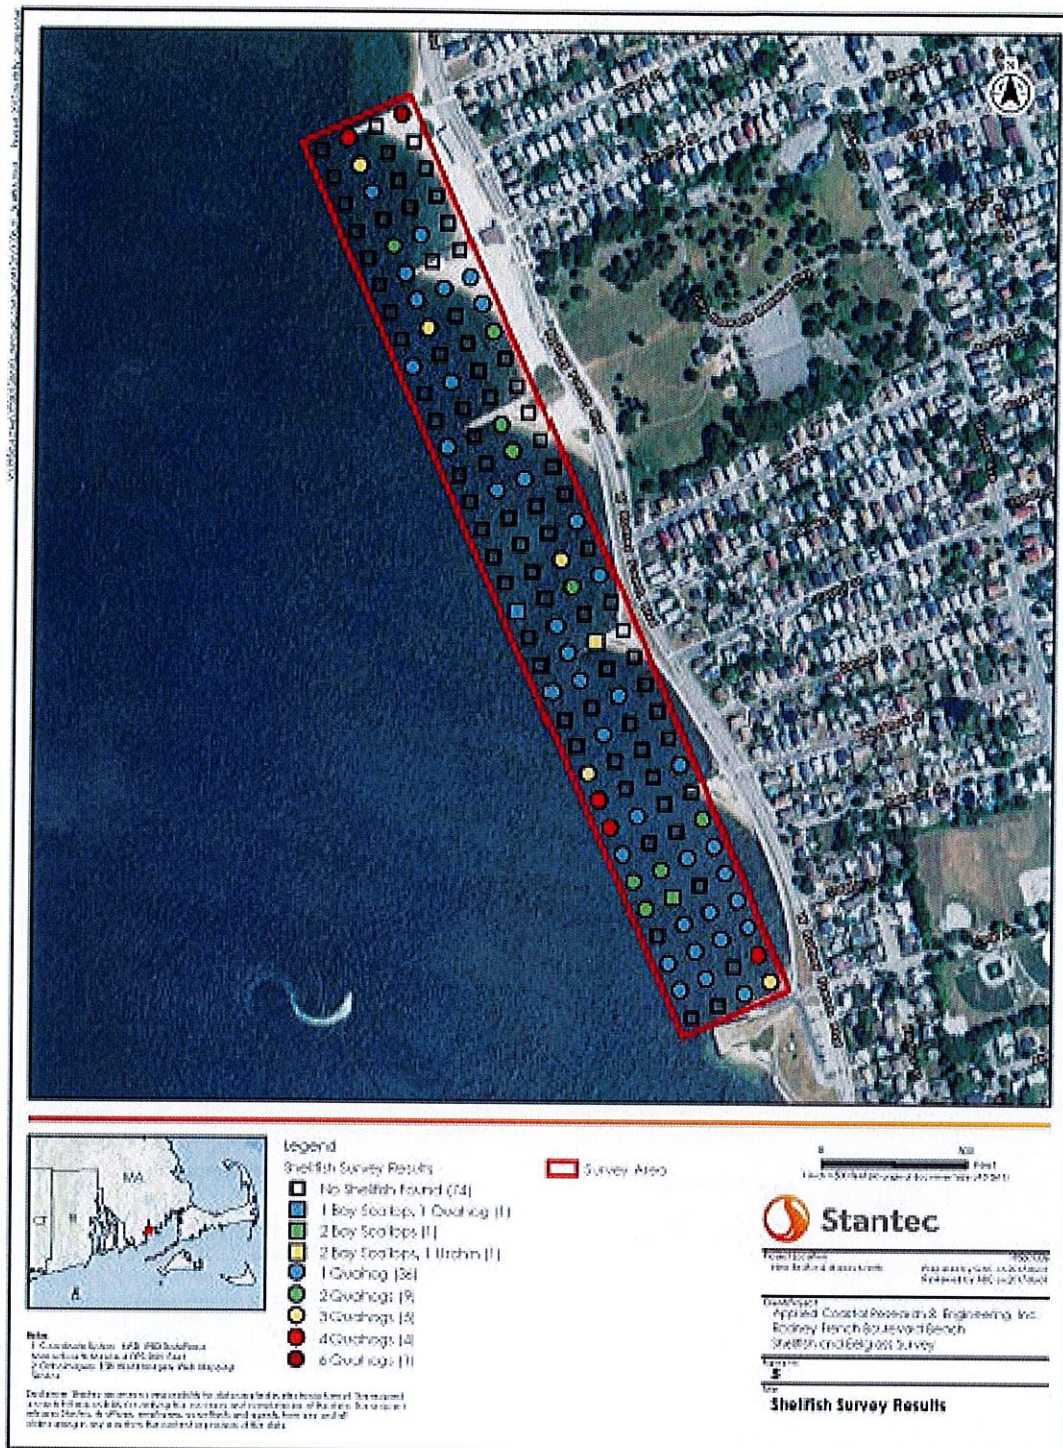
Figure 5.4 Stantec Shellfish Locations and Results, May 26, 2017.

Due to the extensive size of the project area, shellfish sampling stations were located at 50-foot intervals along four transects set 50-feet apart (Figure 5.4). Shellfish stations at the proposed project sites were arranged in a grid pattern (Figure 5.5). The study area included sampling along transects, which extended from the mean low water line. Shellfish stations were evaluated for the presence, abundance, and type of shellfish within sampled substrate. Shellfish targeted for abundance calculations included quahogs, soft-shell clams, bay scallops, razor clams, and American oysters. Sediment characteristics were visually observed at each location. A total of one-hundred thirty-two (132) stations were surveyed for the presence and abundance of shellfish and sediment type by two Stantec divers. Ninety-two (92) quahogs, five (5) bay scallops, one (1) sea urchin were collected within the project study area.

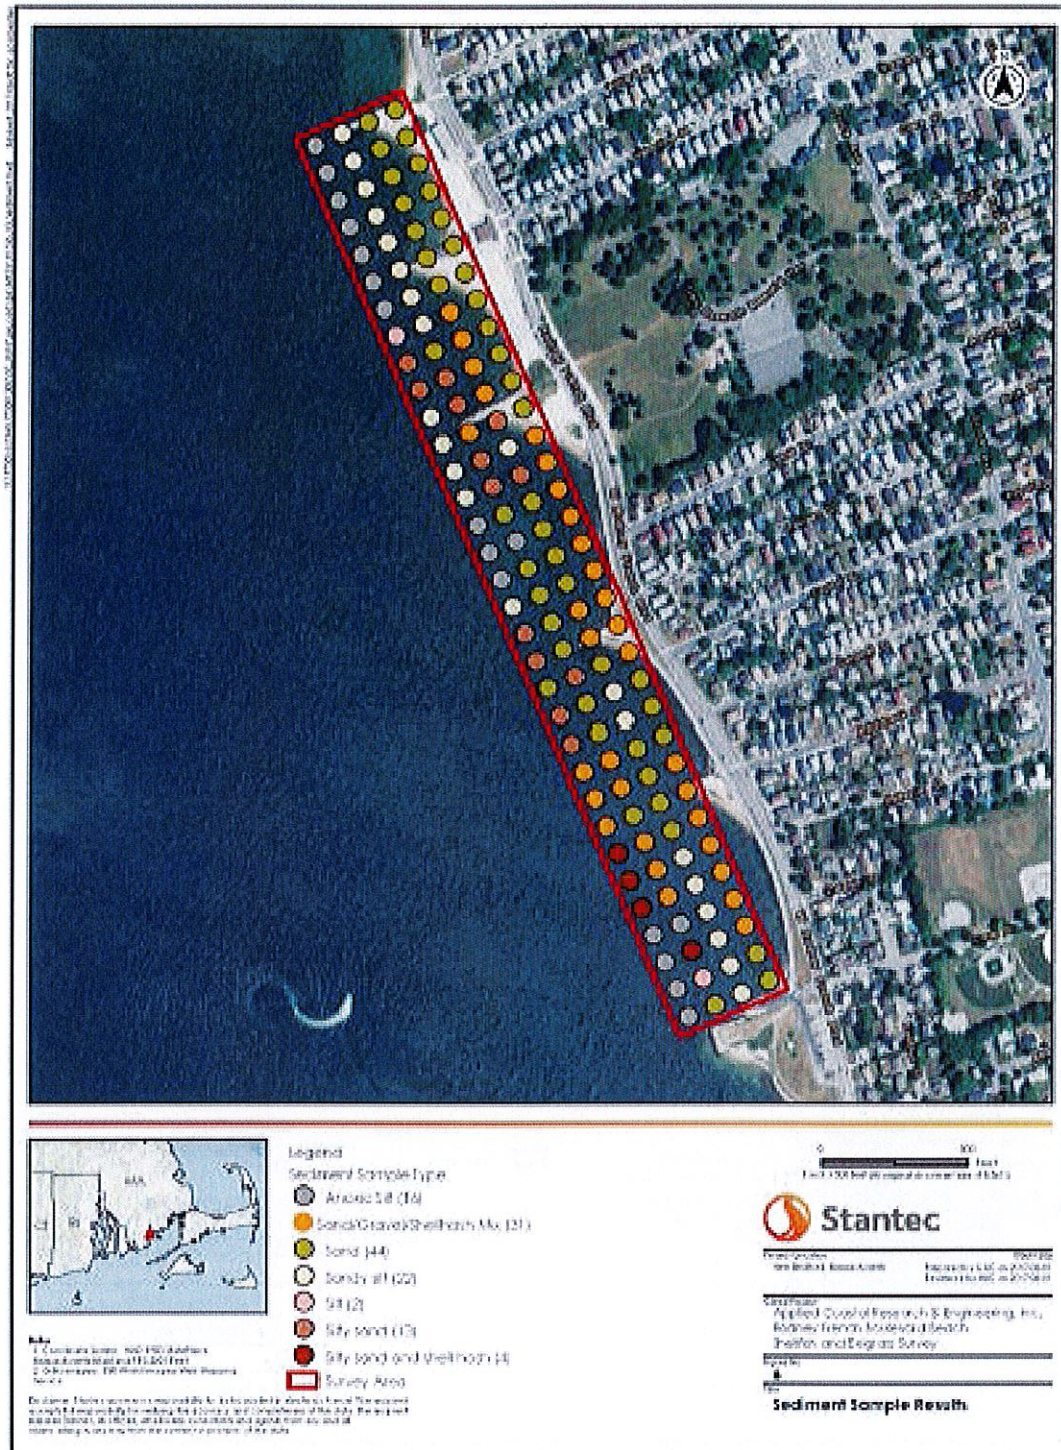
Figure 5.5 Stantec Visual Sediment Results, May 26, 2017.
