RESTORATION COMPLETION REPORT

TO: New Bedford Conservation Commission
FROM: Brad Holmes @ ECR, LLC
DATE: September 25, 2018
RE: Wetland & Buffer Zone Restoration Area – off Duchaine Boulevard

**off Duchaine Boulevard, New Bedford
Restoration Completion Site Photographs**

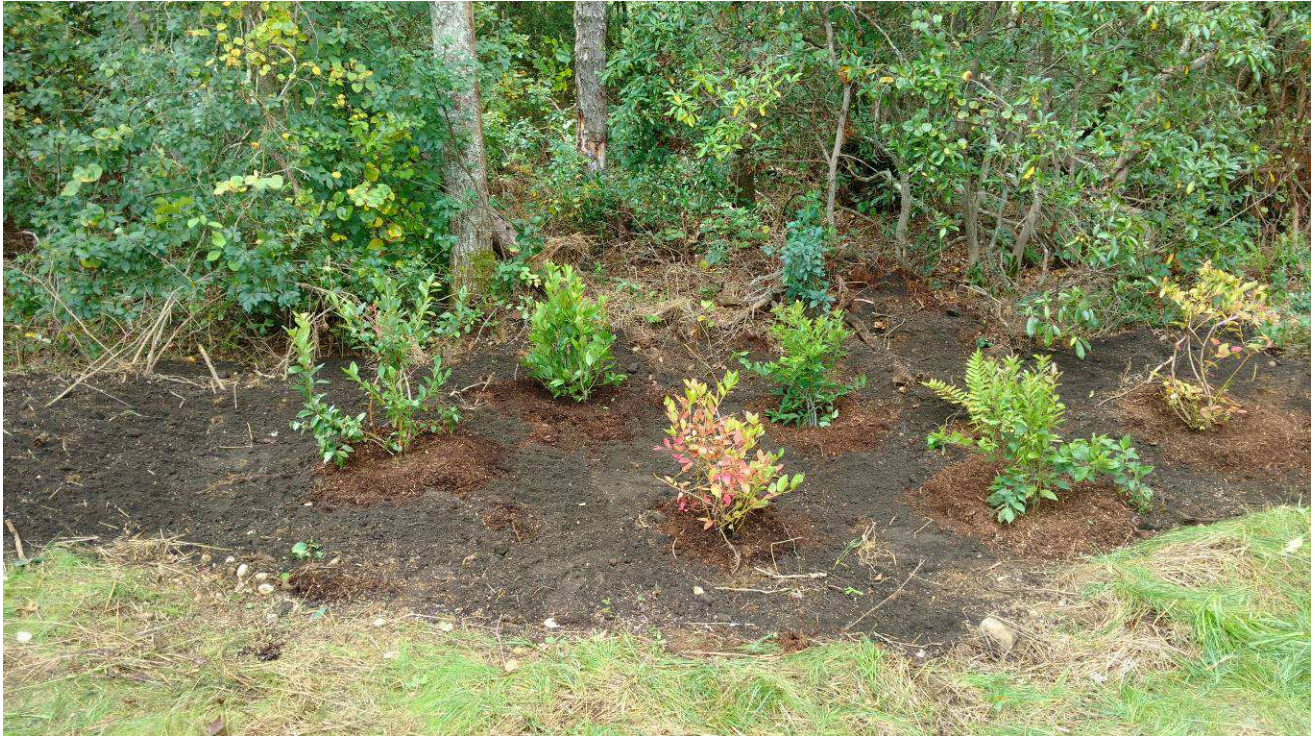
Photograph #1 – View across the wetland restoration area where debris was removed, the area covered with new loam, planted and seeded.

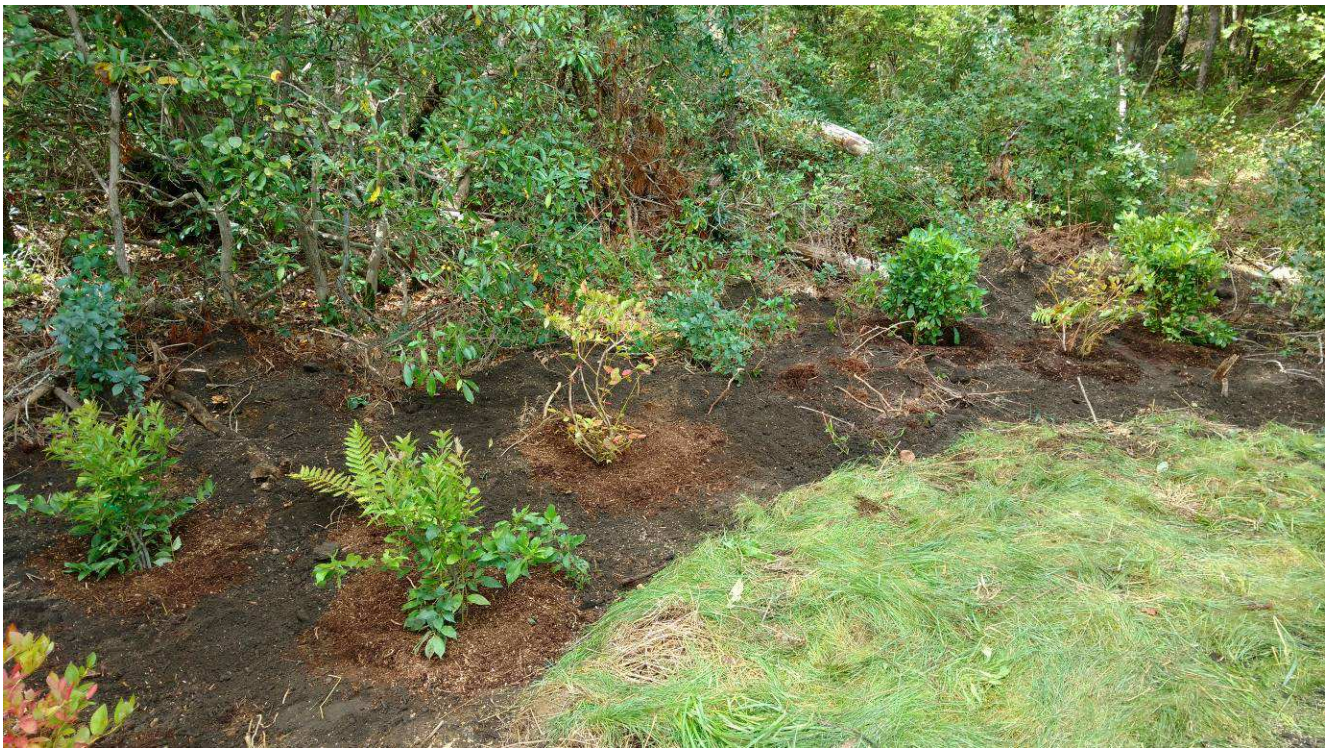
Photograph #2 – Another view across the complete wetland restoration area.

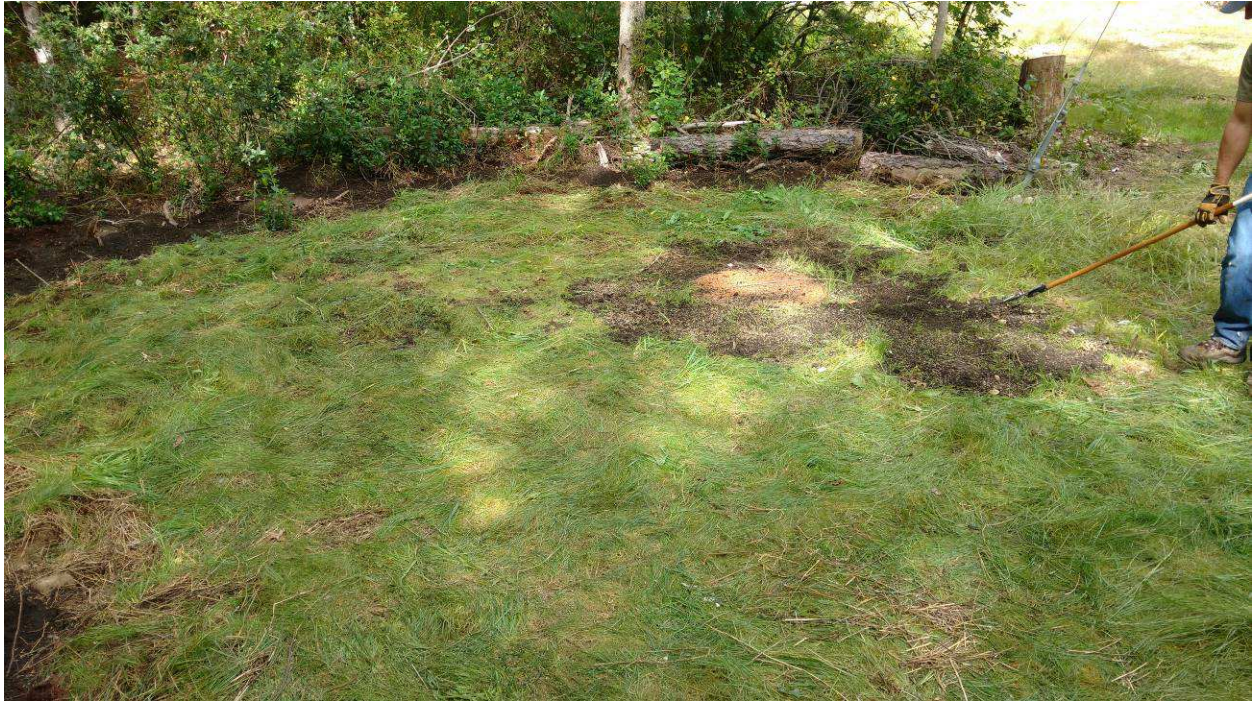
Photograph #3 – Example of restoration work within the buffer zone consisting of loaming and seeding sparsely vegetated area.

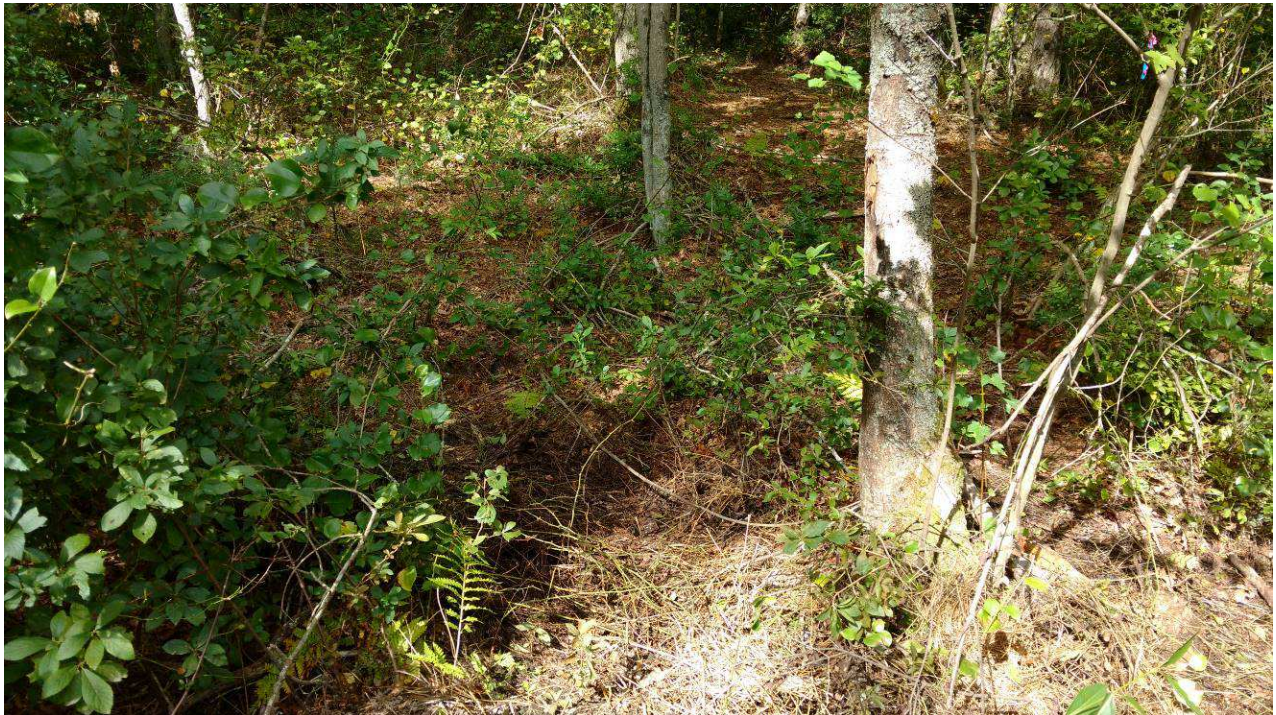
Photograph #4 – Example of areas within the wetland where piles of strawbales were removed.
