## **MEMORANDUM**

**RE:** 61 John Vertente Blvd – Construction Observations

The purpose of the memorandum is to summarize observations made during a construction site visit on April 13, 2018 at 61 John Vertente Boulevard in the New Bedford Business Park. These visits were also attended by Sarah Porter and representatives from Farland Corporation.

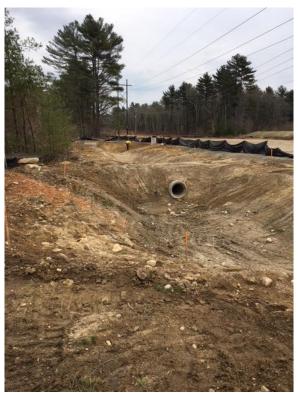
Photo 1

- 1. The purpose of the site visit to 61 John Vertente Boulevard was to review the ongoing sitework, including the clearing and excavation of Dry Detention Basin 1.
- 2. Excavation of Dry Detention Basin 1 was completed to the finished excavation depth (approximately 6 inches below finished grade to accommodate the loam and seed yet to be installed). The basin configuration has been revised to accommodate an existing electric duct bank. The duct bank effectively creates a berm that separates the west and east sides of the basin (Photo 1). Farland Corp. indicated that the basin revisions, including extending the length and making it slightly deeper, provided the required volume in the basin. Consistent with the approval conditions, Farland Corp. should provide an as-built grading plan to the Conservation Commission so that the volume of the basin can be confirmed.

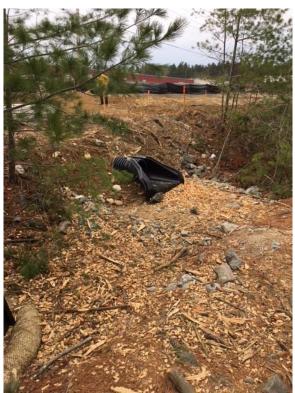
Photo 2

- 5. The flared end from Dry Detention Basin has been installed; however, Farland is awaiting approval from the design engineer to remove two small trees to install the riprap stabilization (Photo 2). The trees are within the previously approved limit of work area. Farland Corp. indicated that the area around the flared end would be graded and the riprap installed such that the flow within the existing drainage swale will continue to flow west to east.
