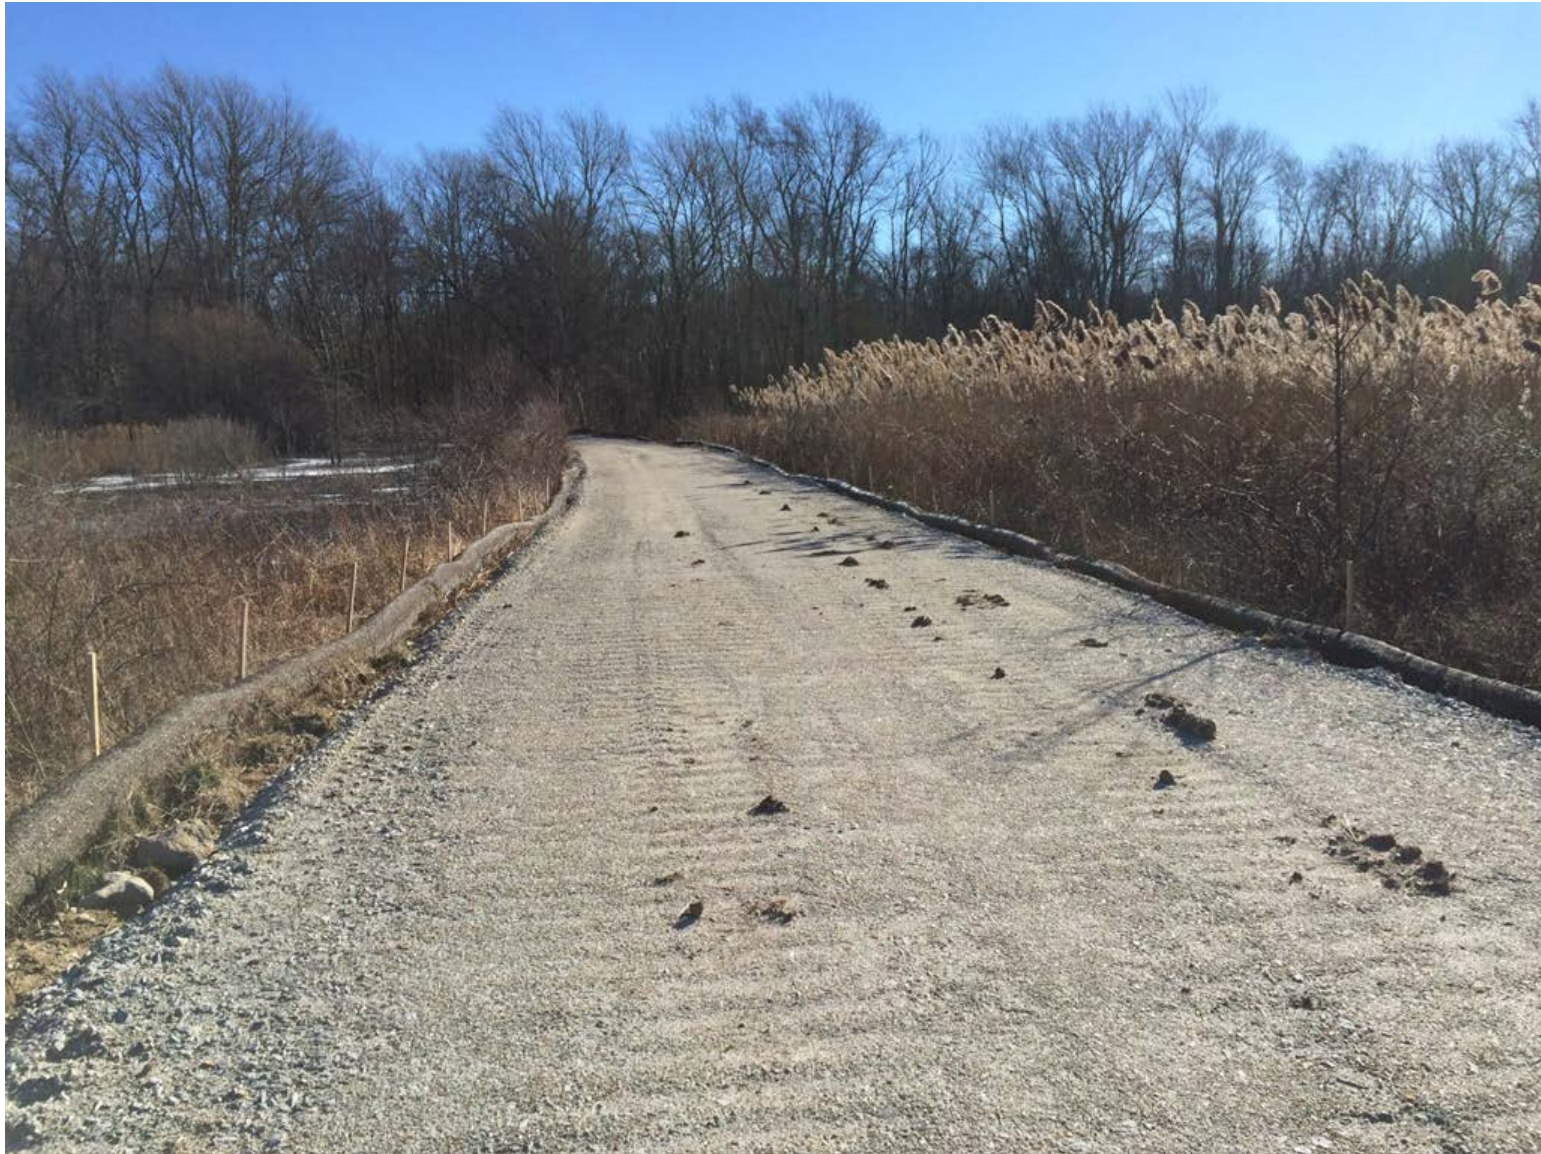
View of newly installed gravel roadway at the Runway 5 end, adjacent to the Colonial Apron. Erosion controls look good.

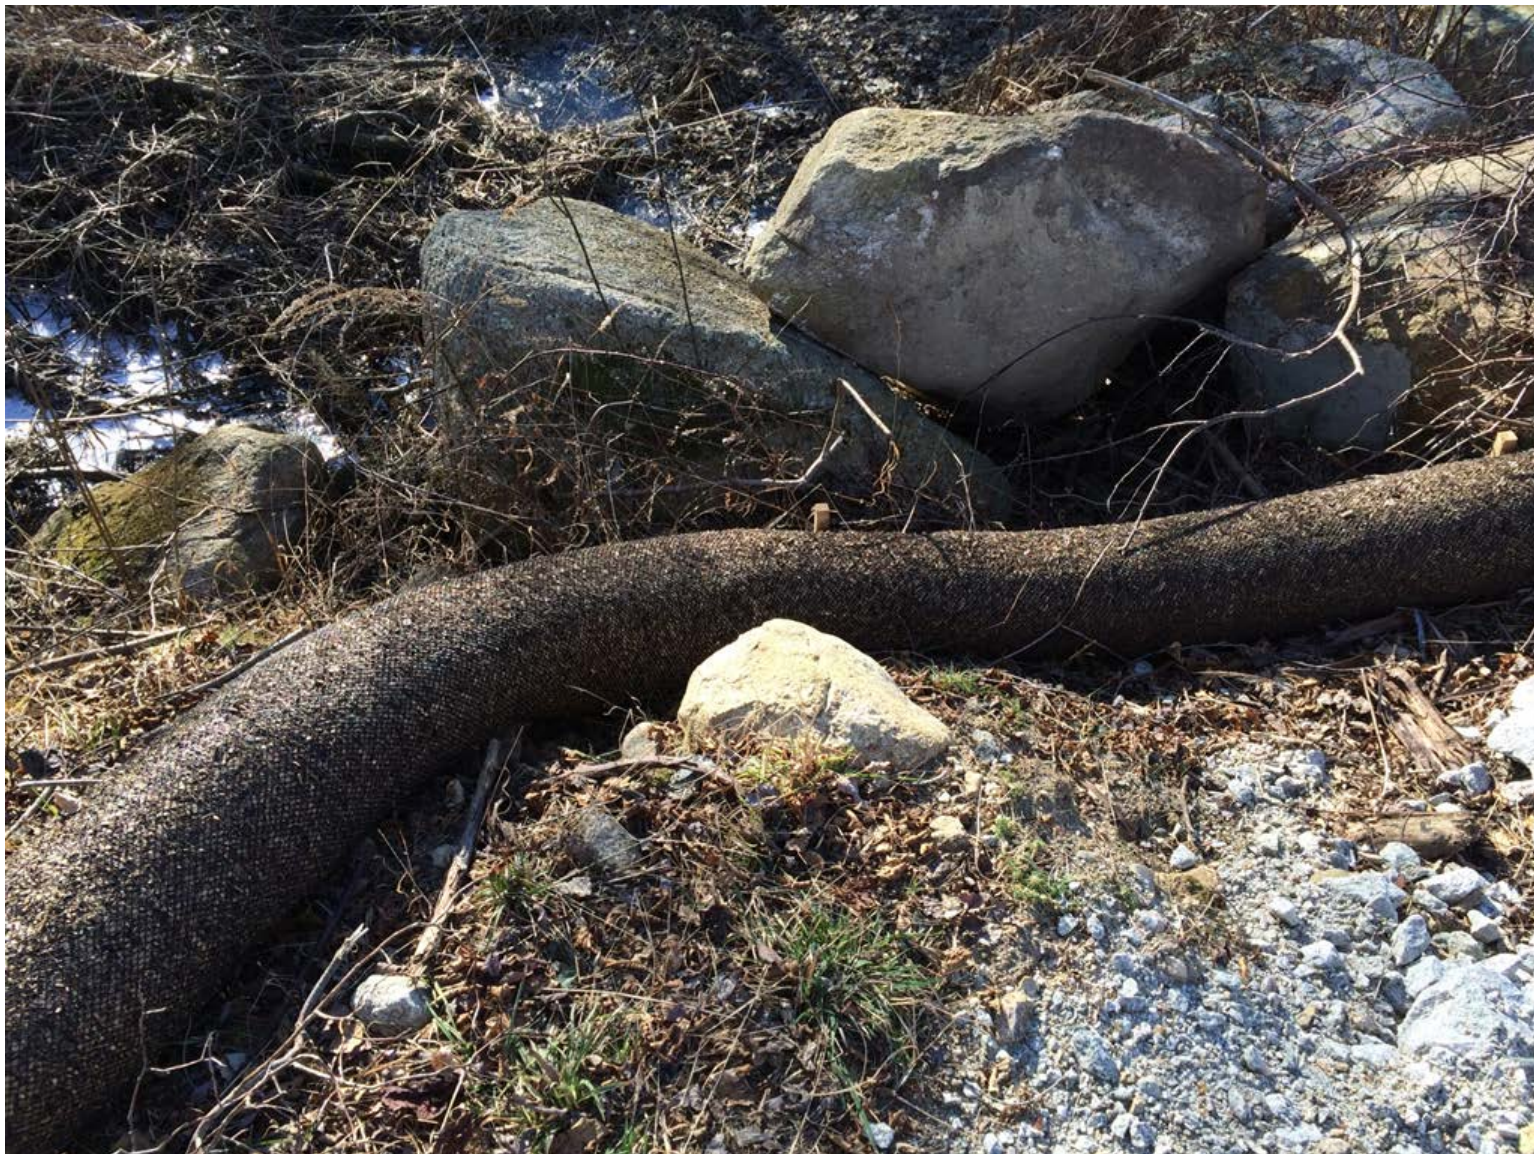
View of corner of roadway, leading from Shawmut Ave to the Runway 5 end. This corner will be reinforced with another line of compost tubes prior to construction. The contractor will ensure adequate ground contact prior to work.

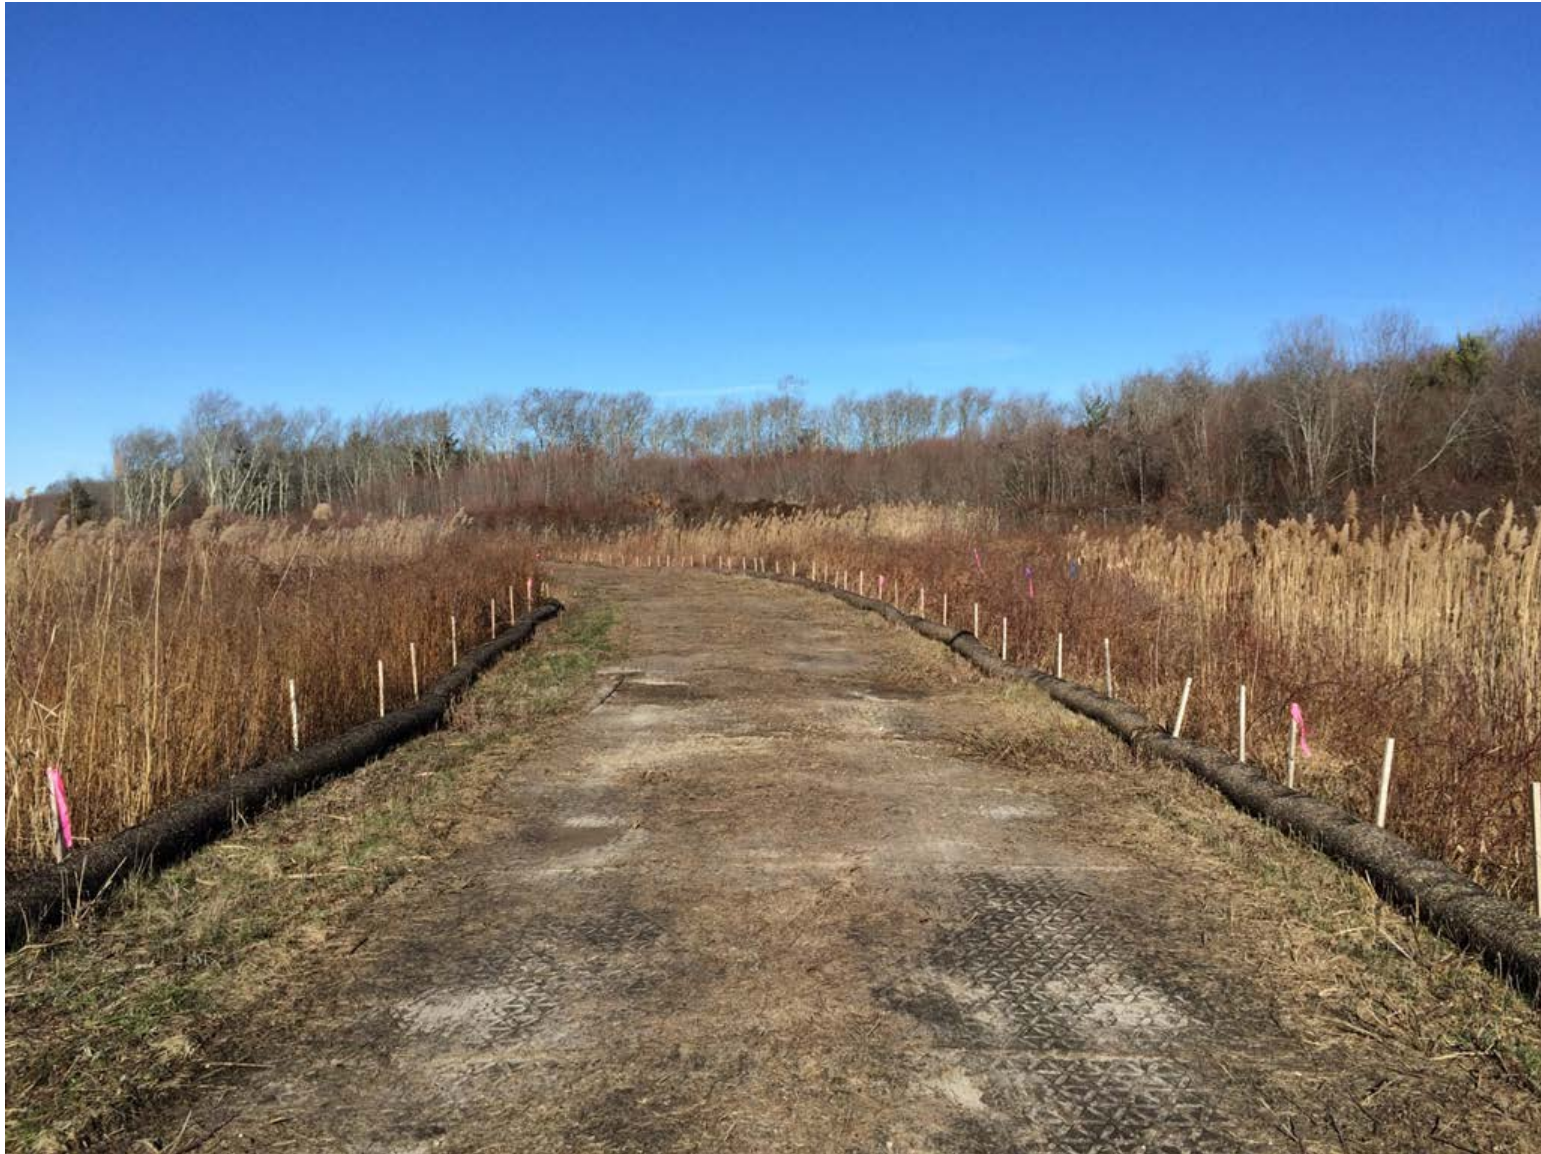
View of access road leading to Runway 23 end. The matting has been removed. The roadway and erosion controls remain in good condition.

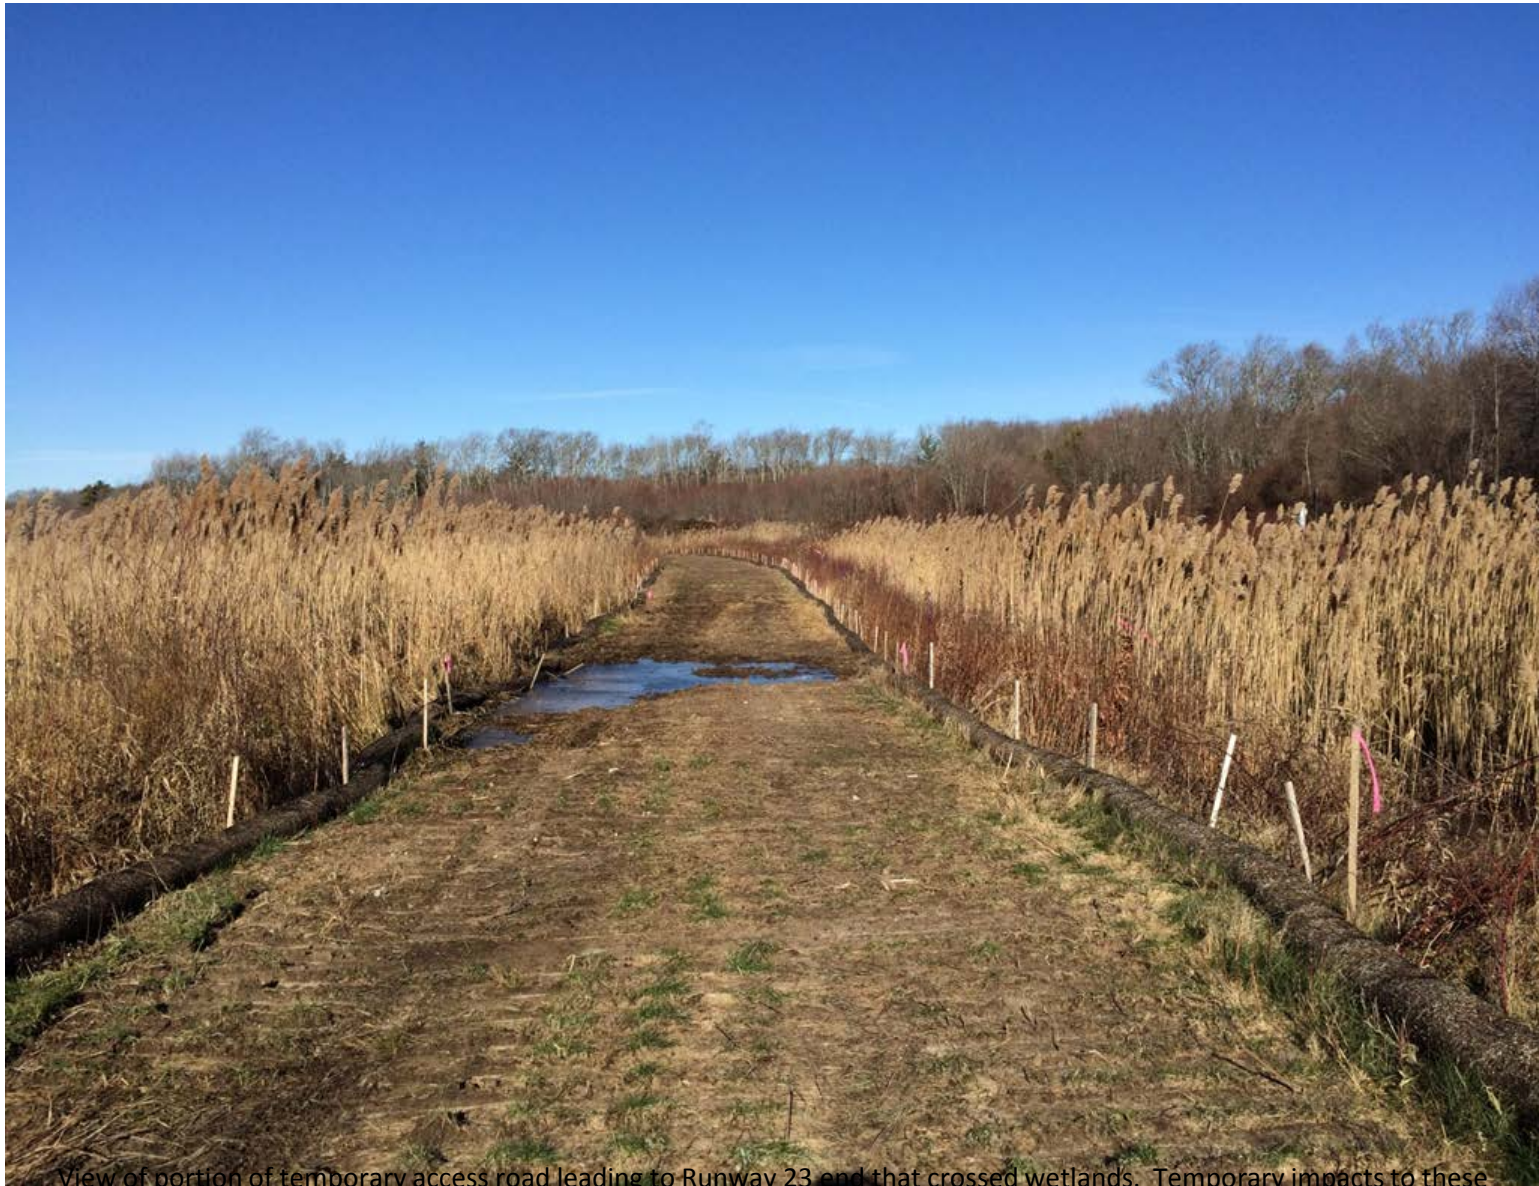
View of portion of temporary access road leading to Runway 23 and that crossed wetlands. Temporary impacts to these wetlands were protected with timber swamp mats. The matting was removed late in the season. Once spring thaws occur the roadway will be reassessed to determine if compaction occurred and tilling and seeding is necessary within the wetland. Erosion controls remain in good condition.
