New Bedford Regional Airport Runway Safety Improvements Project

Post Construction Monthly Wetlands Plantings Assessment – March/April 2014

Subject: **Special Condition 29(f); Post Construction Monthly Wetlands Planting Assessment; New Bedford Regional Airport Runway Safety Improvement Project; Variance Order of Conditions and Water Quality Certificate DEP File No. SE 049-0635.**

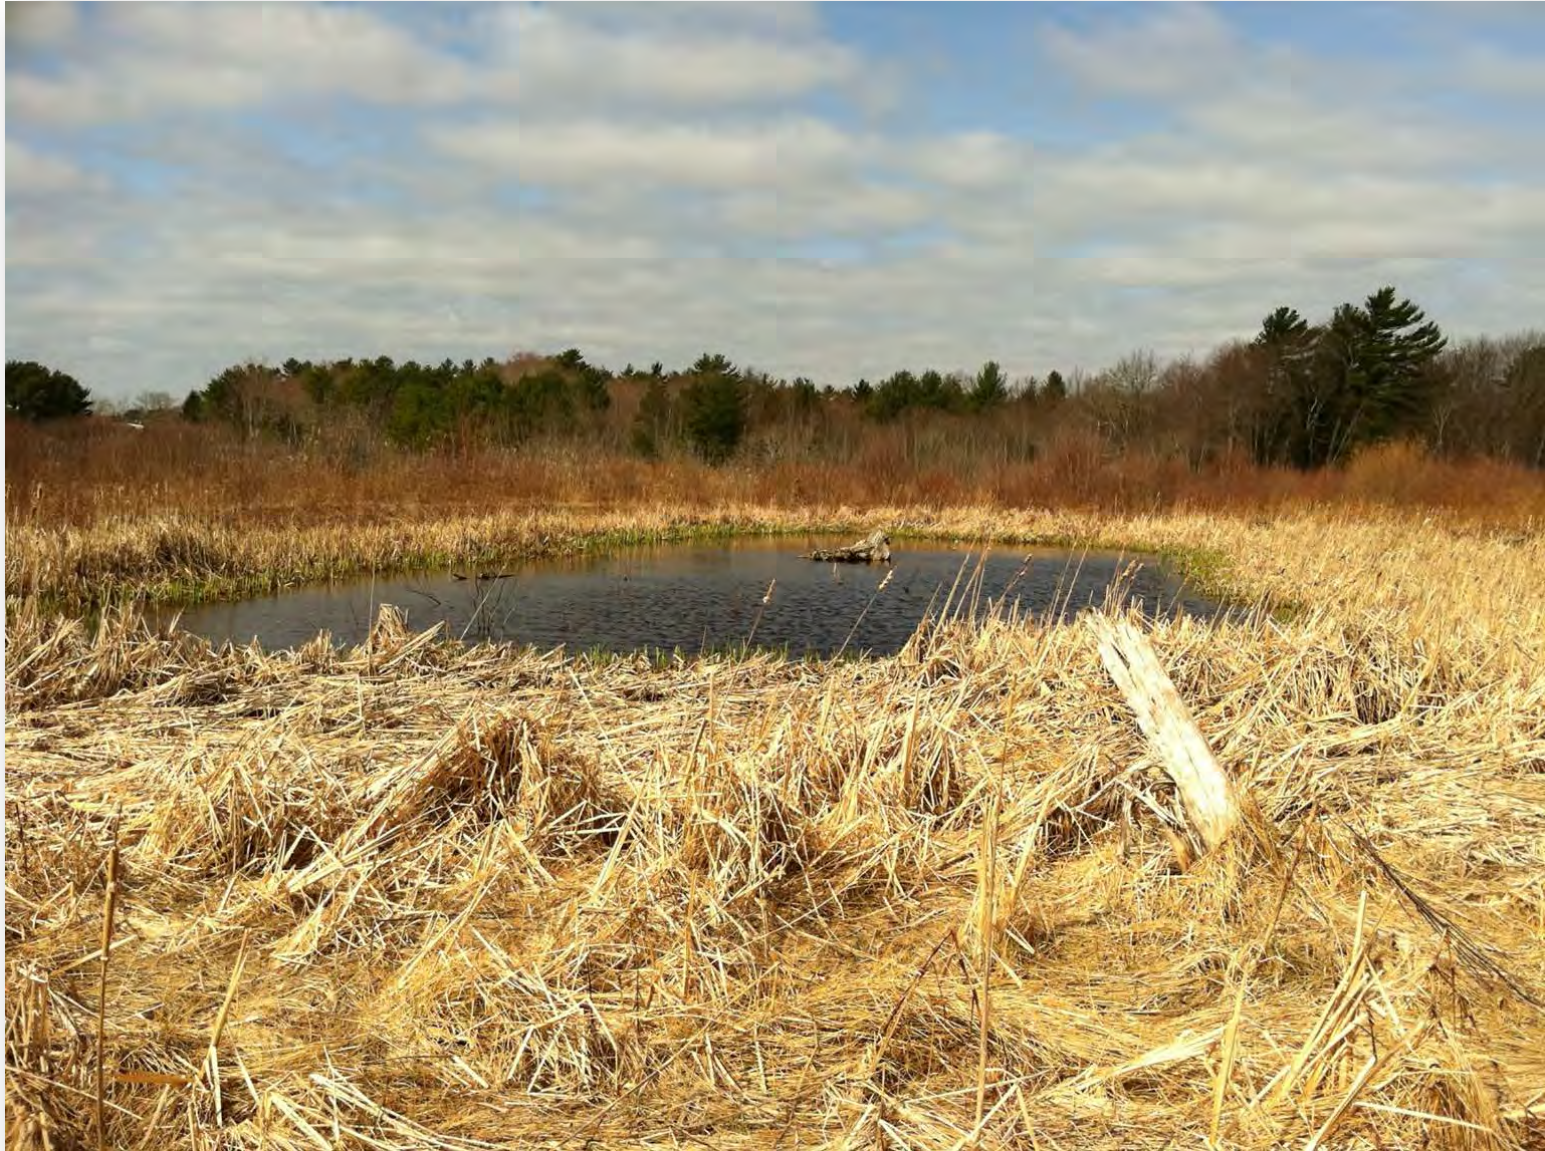
View of Site 5 vernal pool. Consistent with other spring-time observations made in 2012 and 2013 at the project site this water feature appears to be at bankfull, the maximum volume of water during the year. Note that some of the herbaceous vegetation adjacent to the vernal pool is starting to grow (green-up). At the time of inspection numerous American toad (*Bufo americanus*) egg masses (strings) and breeding adults were observed along the edges of the pool within the stands of cattail and herbaceous vegetation.

Many of the plantings observed during prior inspections [e.g., silky dogwood (*Cornus amomum*), buttonbush (*Cephalanthus occidentalis*), swamp rose (*Rosa palustris*), winterberry holly (*Ilex verticillata*), maleberry (*Lyonia ligustrina*), red chokecherry (*Aronia arbutifolia*), black chokecherry (*Aronia melanocarpa*), grey dogwood (*Cornus racemosa*), and northern arrow-wood (*Viburnum recognitum*)] were just beginning to bud break and appeared healthy. Groundcover at the time of inspection mostly included herbaceous die back from the previous growing season. Some trace monocots, dicots were also noted. The vernal pool was at its maximum water elevation which is a typical spring-time condition at the Airport.

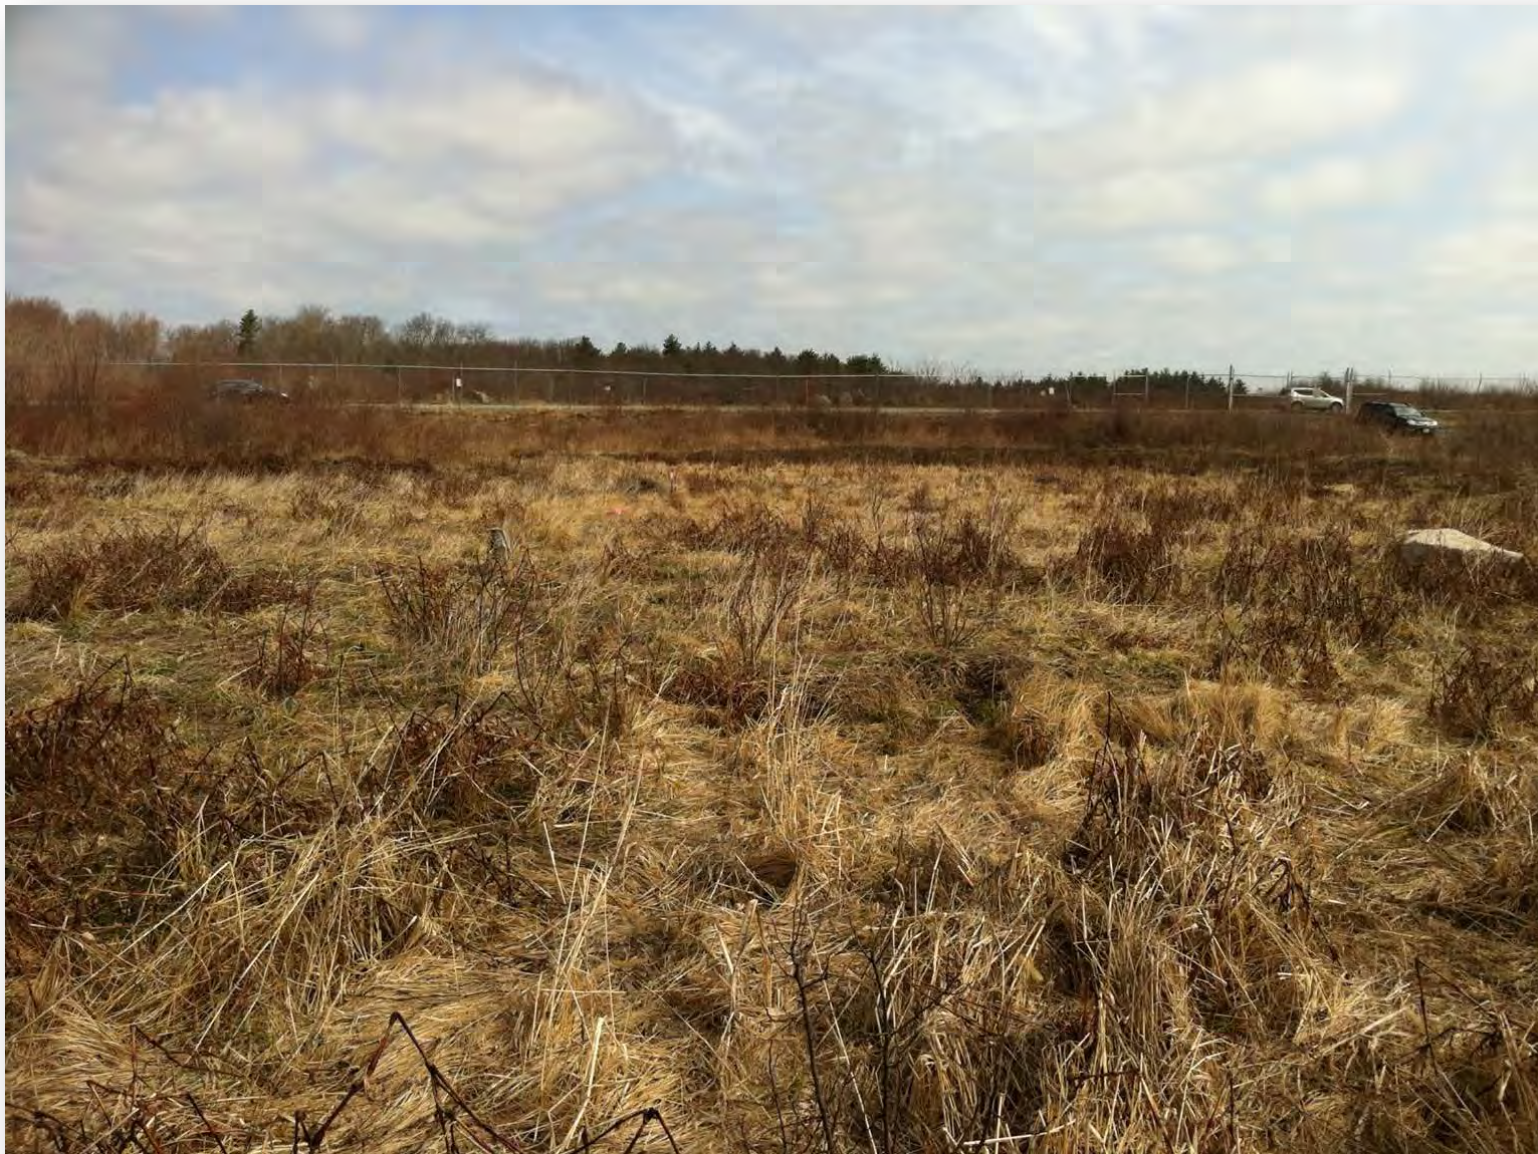
View looking generally north within Site 5. Some shrubs are starting to bud, but generally the site is still in senescence.

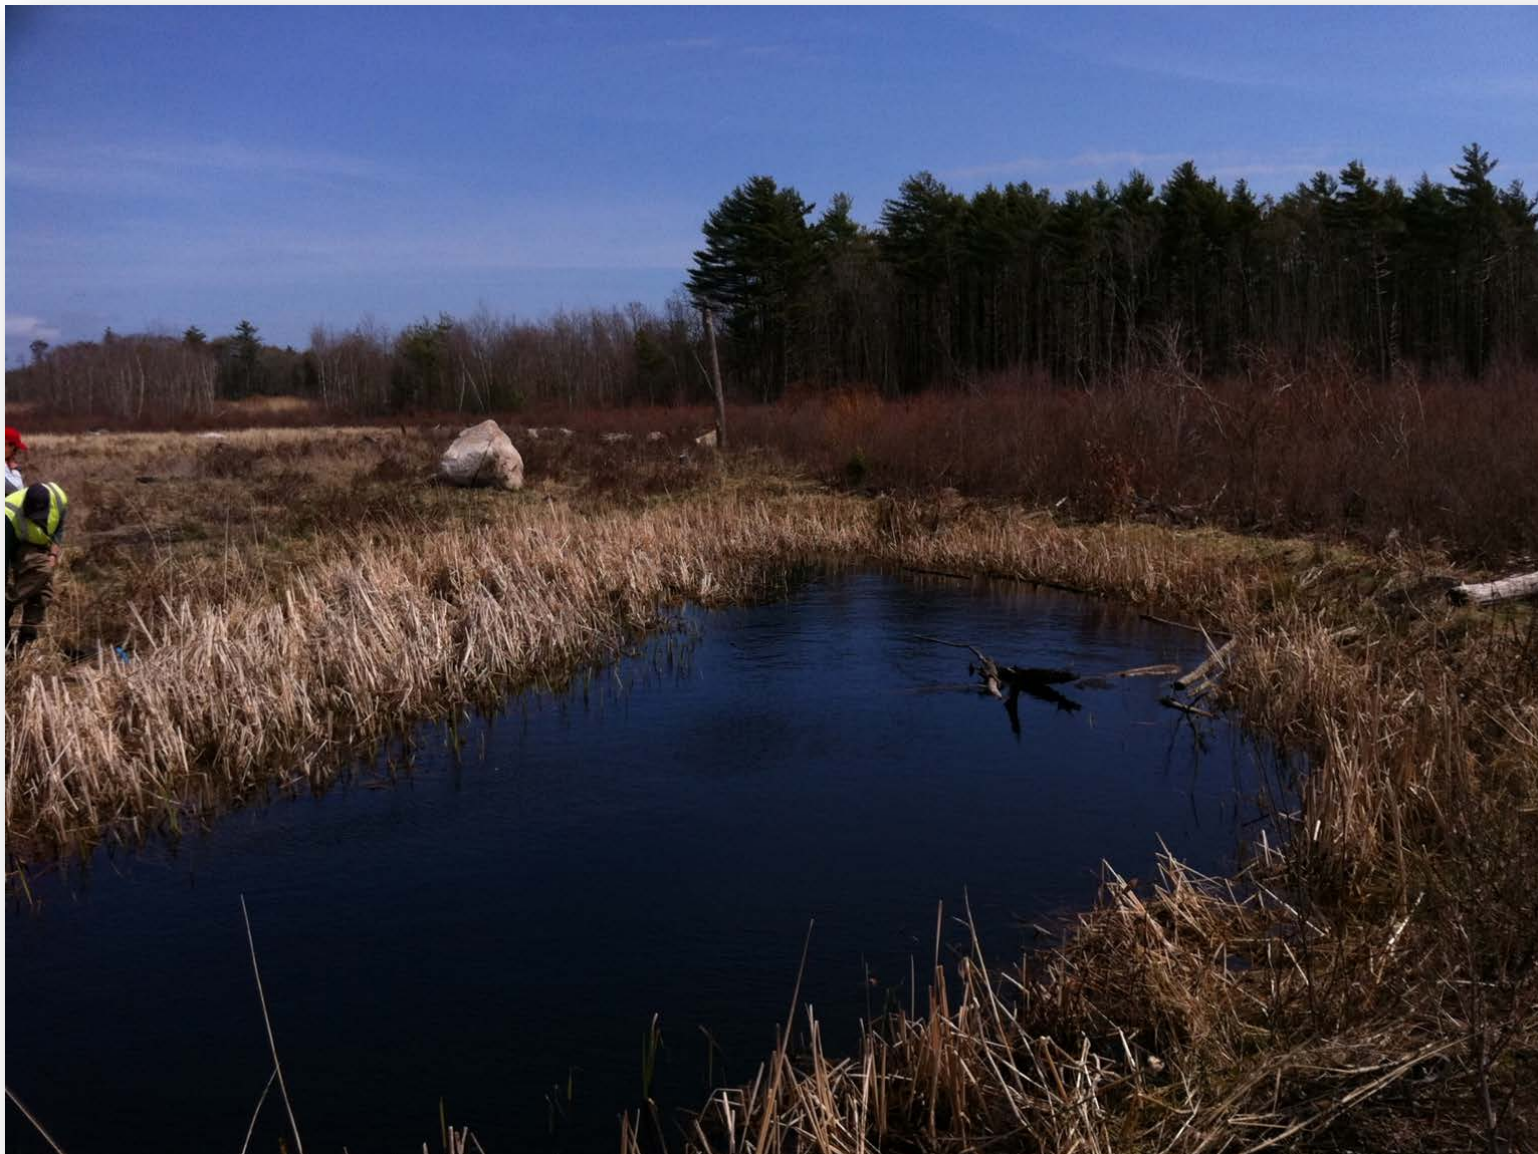
View of vernal pool in northeastern corner of Site 10. This vernal pool had multiple obligate vernal pool species egg masses (spotted salamander, wood frog) and breeding adult American toads (and related egg masses/strings) at the time of inspection. Egg masses and breeding adults were primarily identified within the fringe of cattails bordering the perimeter of the pool.

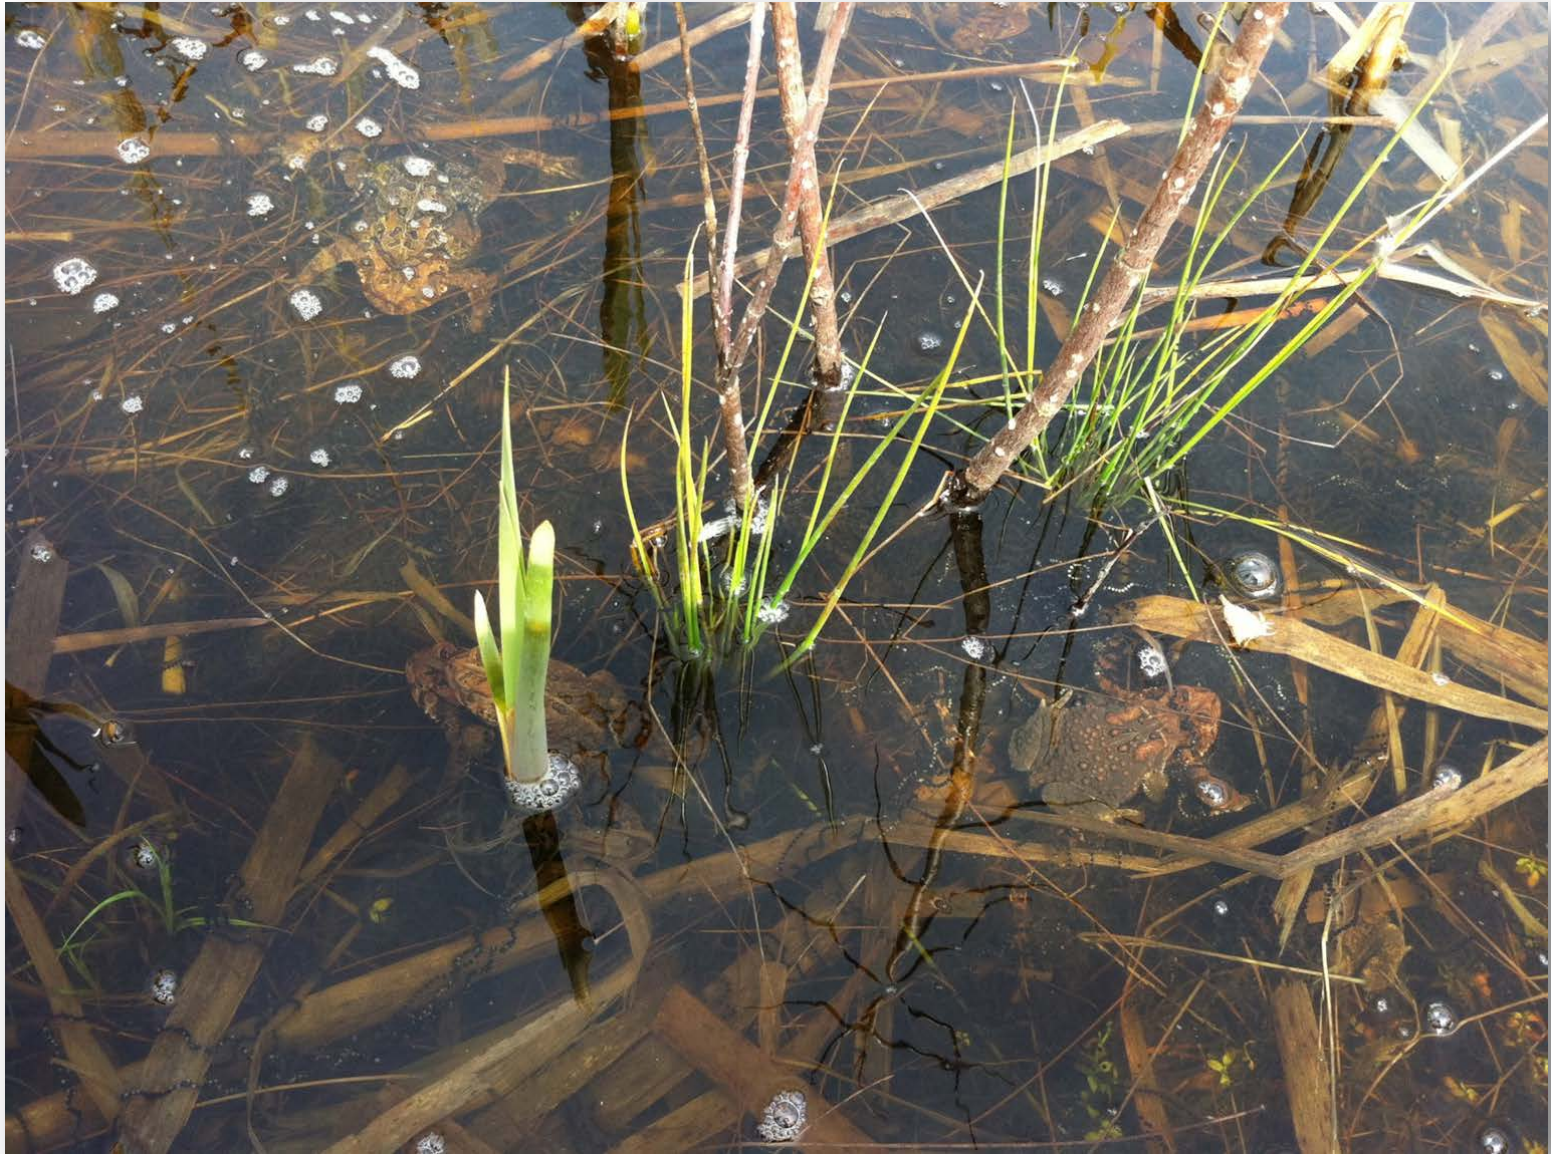
View of two mating pairs of American toads within the planted buttonbush and cattails that migrated in following construction of the mitigation site. Note that egg strings are visible adjacent to the toads on the right.

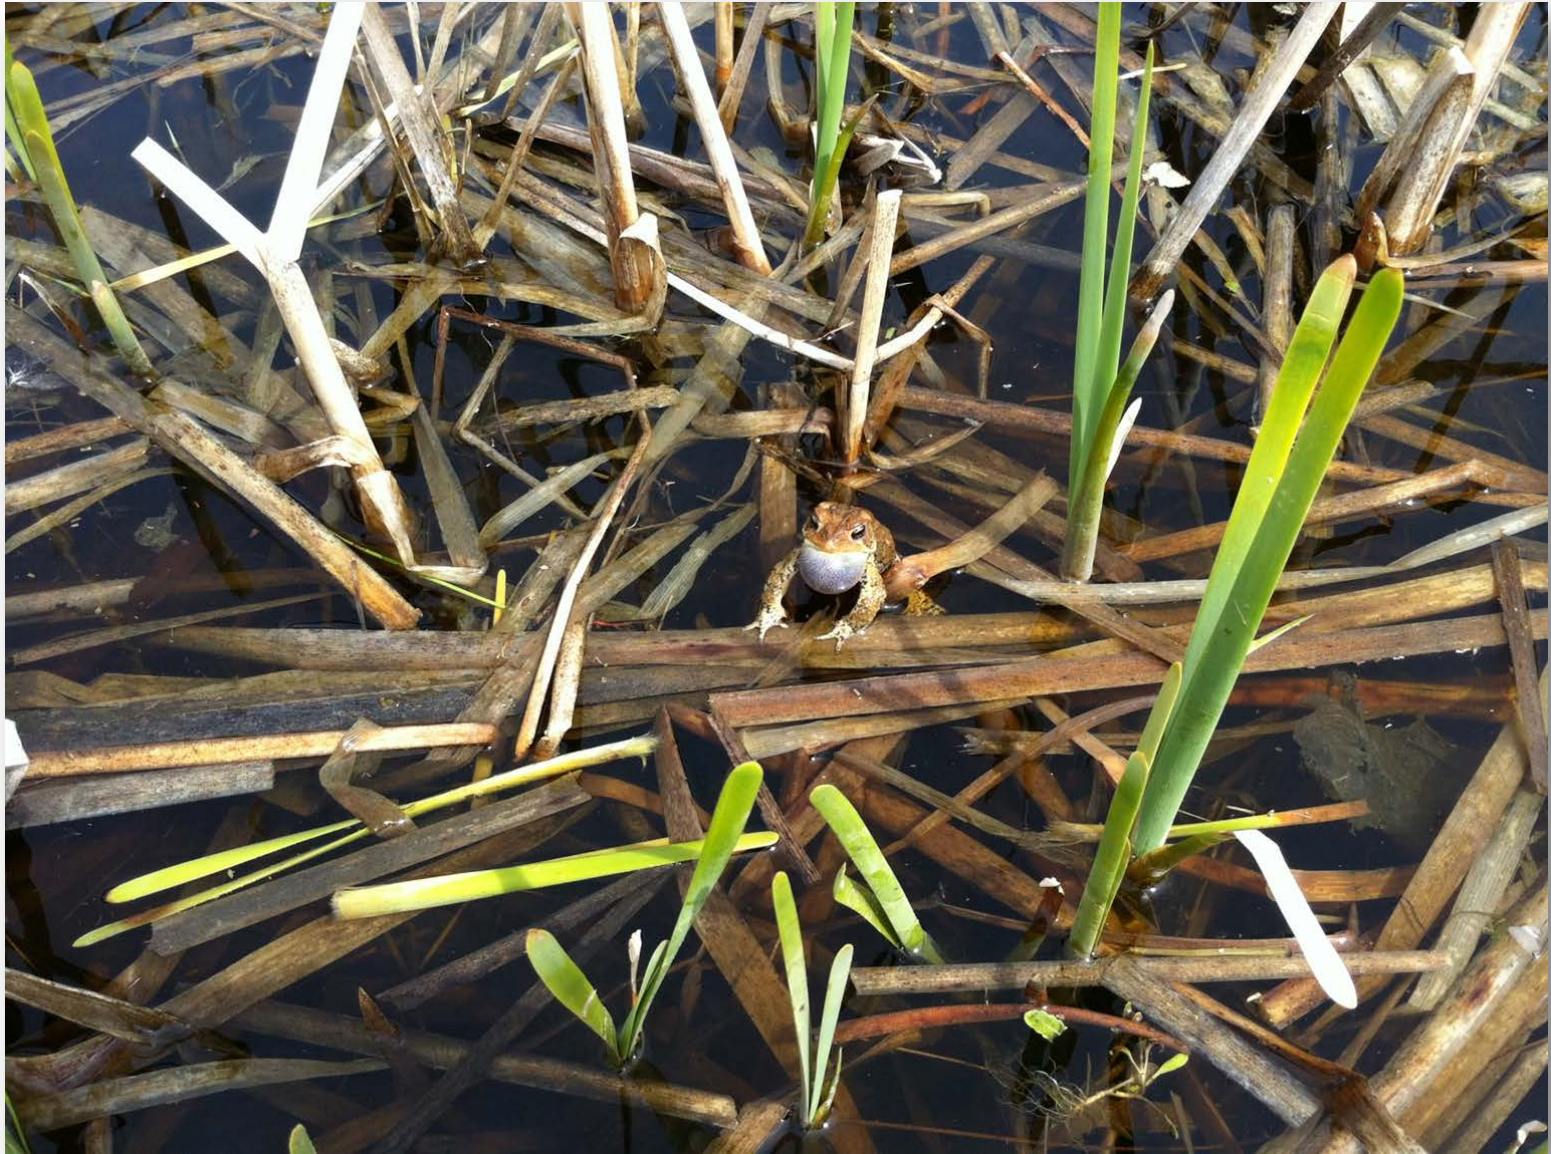
View of chorusing male American toad within the cattails.

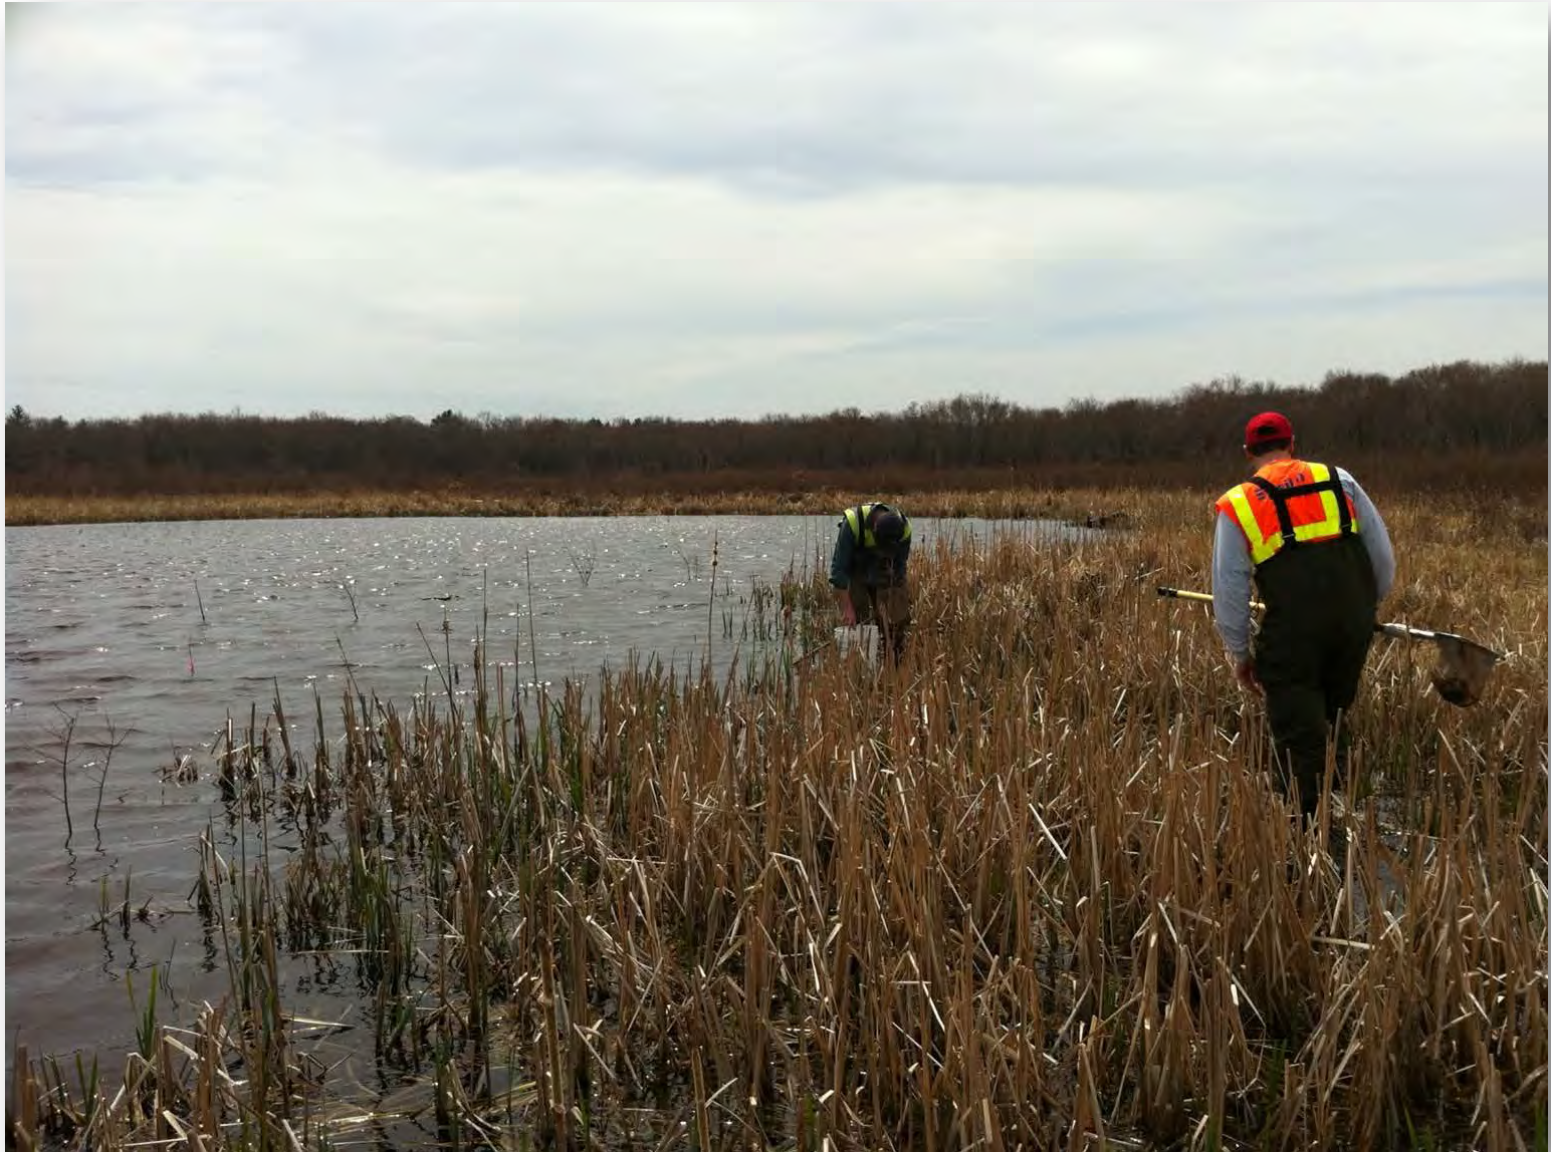
View of westernmost vernal pool at Site 10 during high water conditions in March/April 2014. Numerous breeding American toads and related egg strings were found within the cattails.

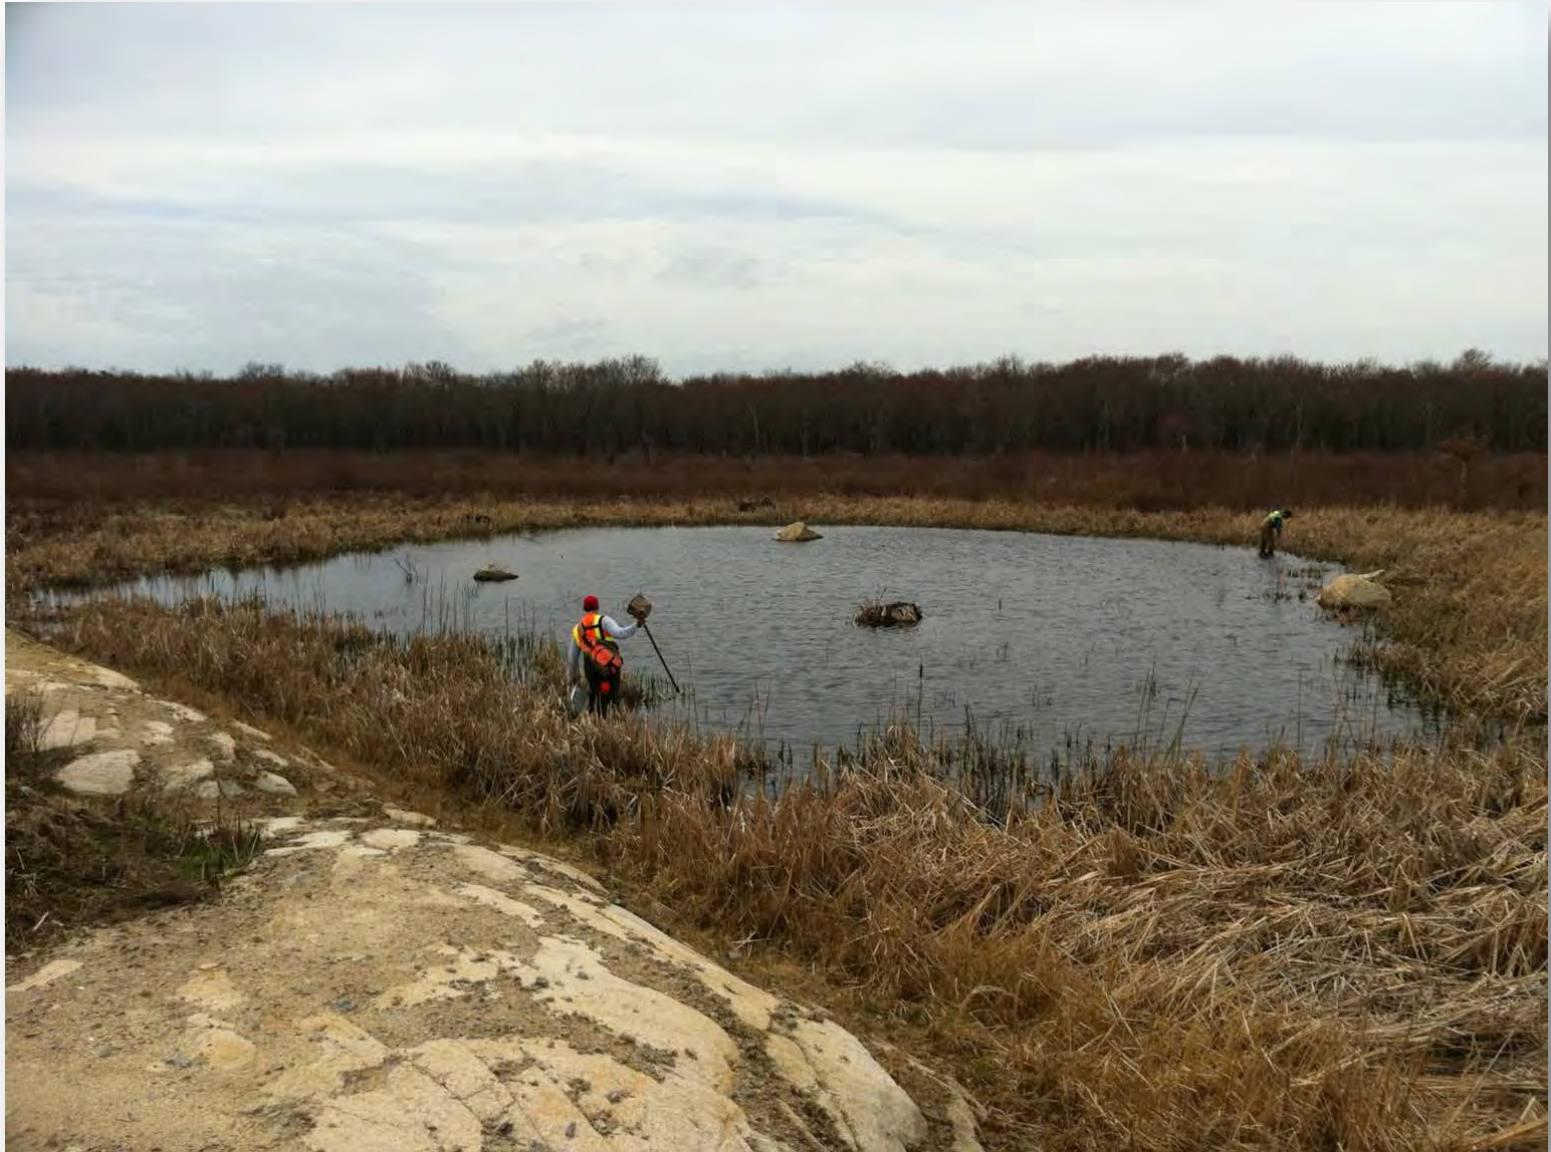
View of easternmost vernal pool in Site 10 from rock outcropping during high water conditions in March/April 2014. In addition to numerous breeding American toads we identified a spotted salamander egg mass within the cattail fringe during the inspection period .

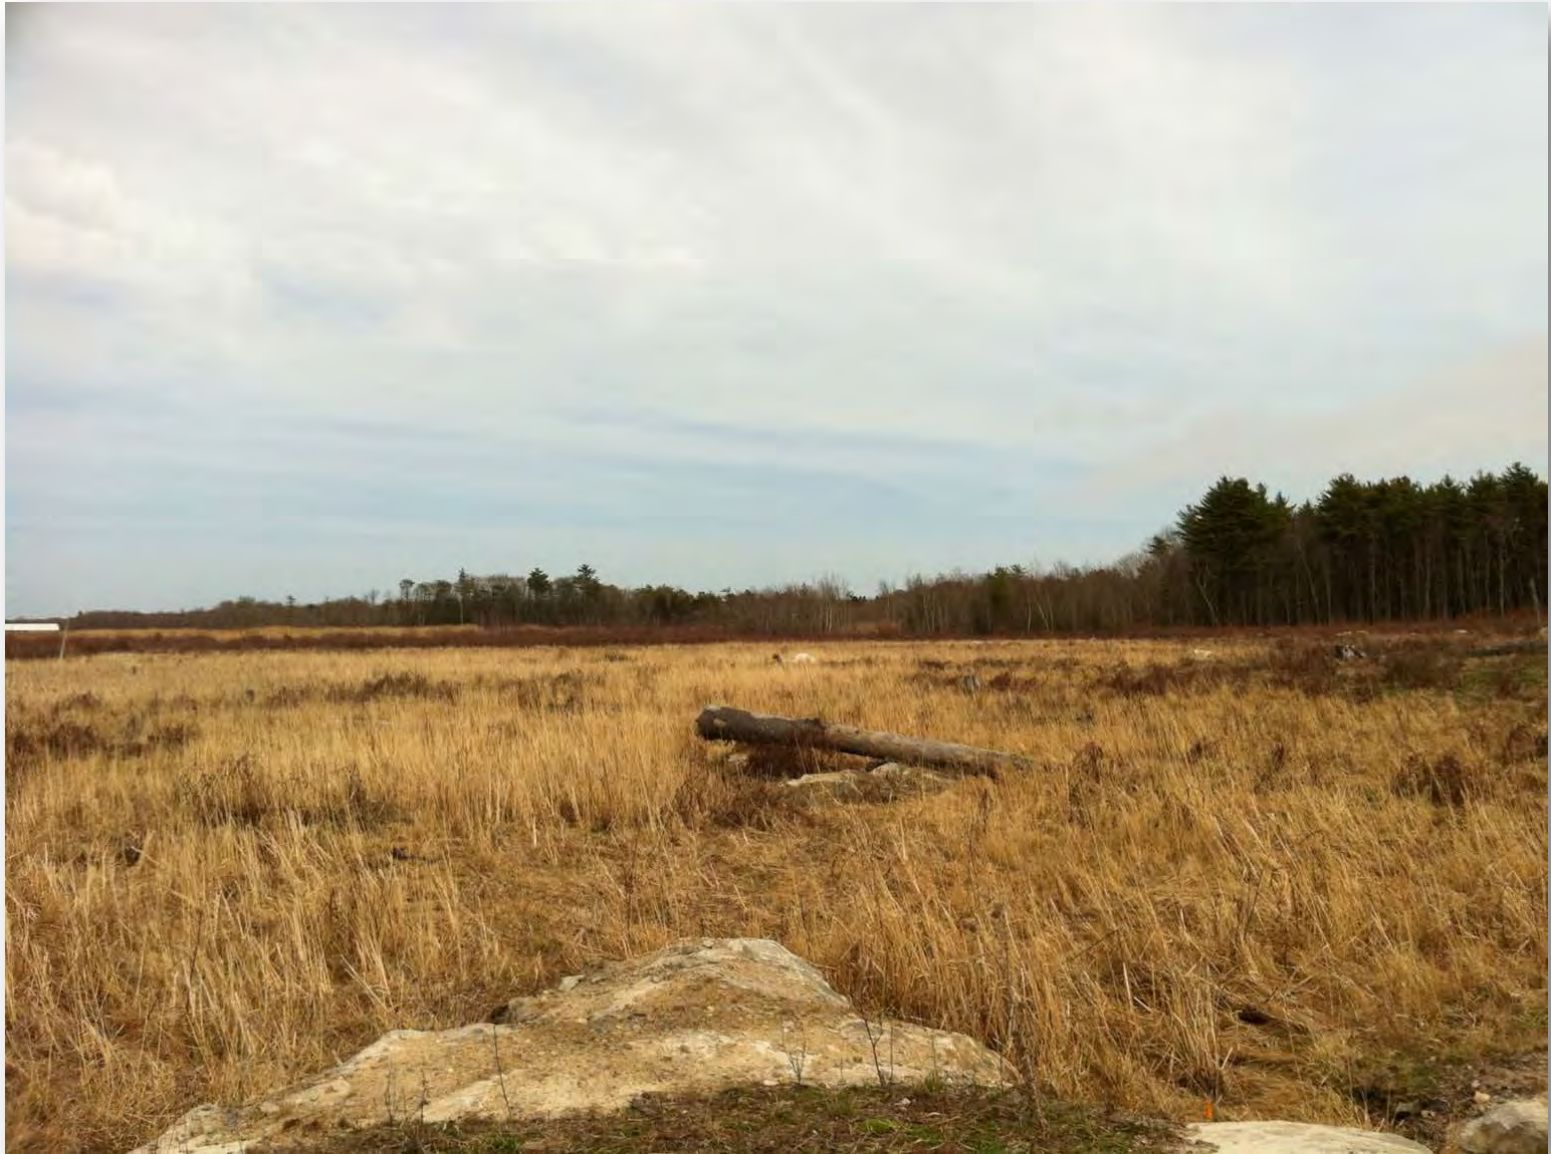
View of Site 10, the site is still largely in senescence.

The following woody shrub species were observed in Site 10 at the time of inspection: winterberry holly, northern arrowwood, swamp rose, highbush blueberry (*Vaccinium corymbosum*), buttonbush and maleberry. There was again evidence of deer browse throughout the mitigation area. As noted in last year's reports some of the planted shrubs were not able to be located in the field even after extensive inspections by Epsilon because of the dense herbaceous wetland vegetation, while the herbaceous vegetation was matted and underwent some significant die back over the winter, it was still challenging to find shrubs within Site 10. Groundcover at the time of inspection mostly included herbaceous die back from the previous growing season. Some trace monocots, dicots were also noted. All three vernal pools were at their highest level (approximately 3-4 feet) based on water marks at the time of inspection. There was standing water at lower elevations and there are some channels forming within the wetland.

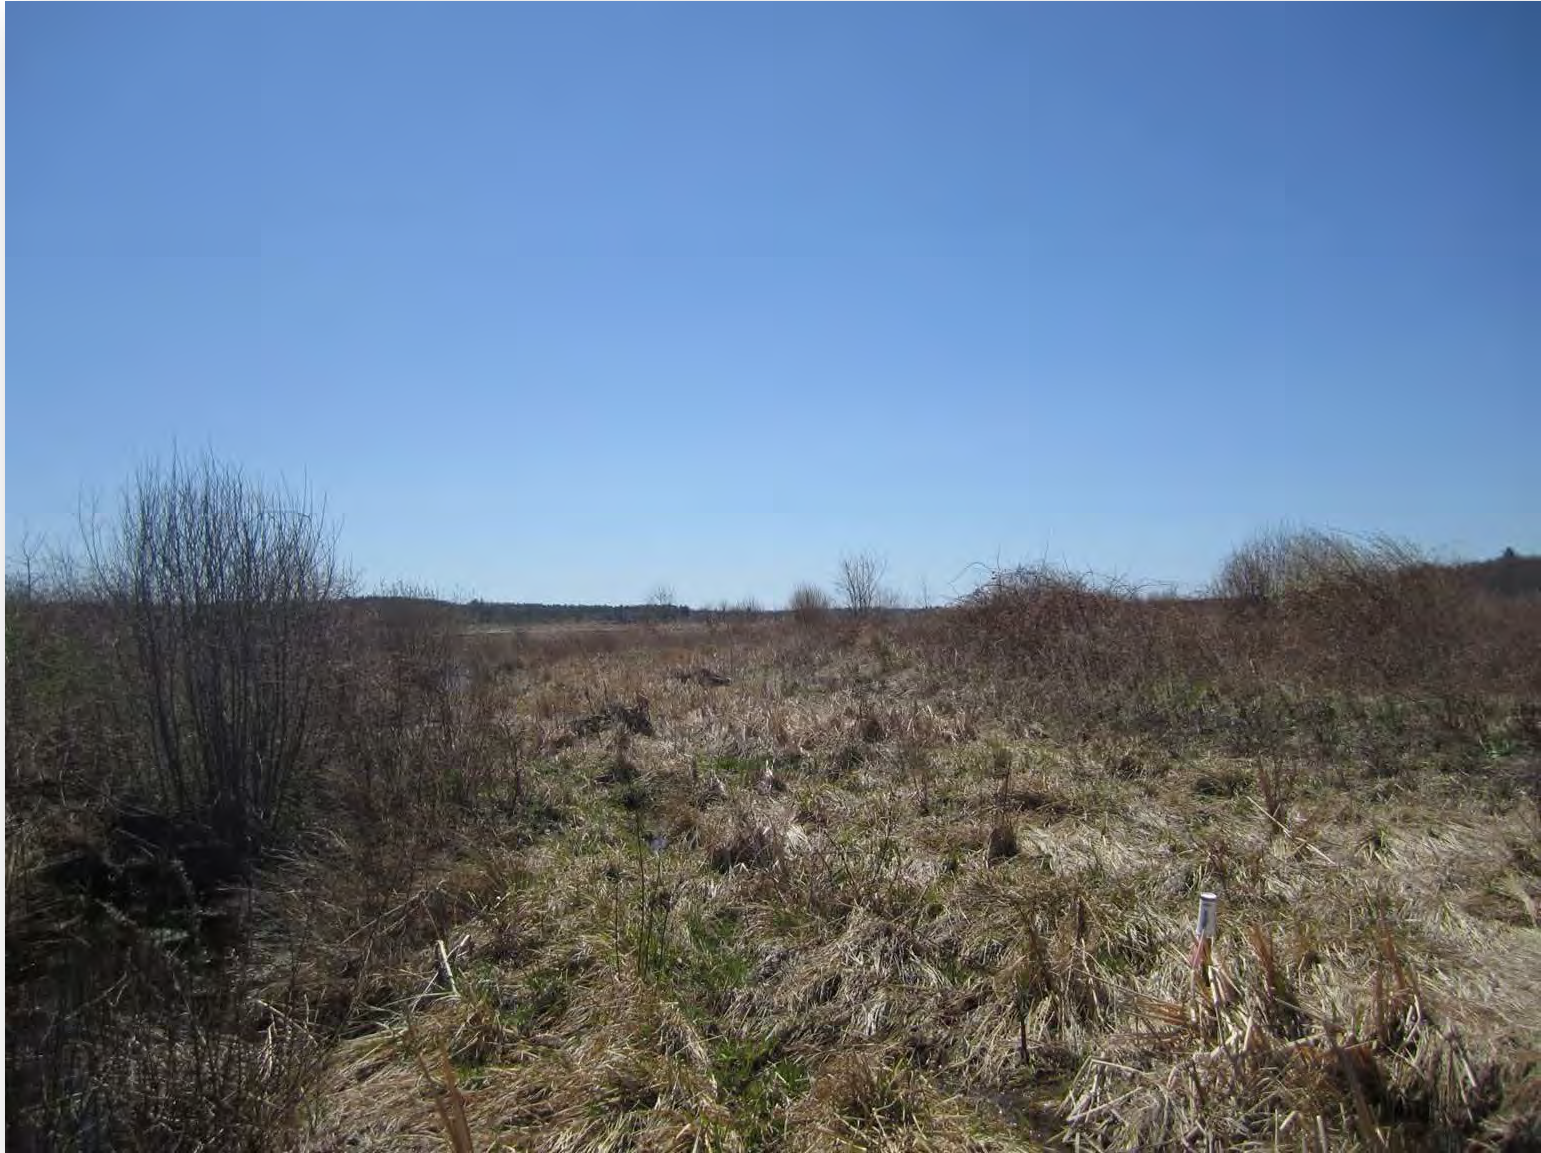
View of Site 6, the site is still largely in senescence.

northern arrowwood. Generally shrubs were undergoing bud break and appeared to be in good condition. Some shrubs are suffering from deer browse. Groundcover at the time of inspection mostly included herbaceous die back from the previous growing season. Some trace monocots, dicots were also noted. There was standing water at lower elevations and some channels forming within the wetland. Deer browse on the planted shrubs continues to be a challenge and there were numerous fresh deer tracks in the adjacent box turtle mitigation site.

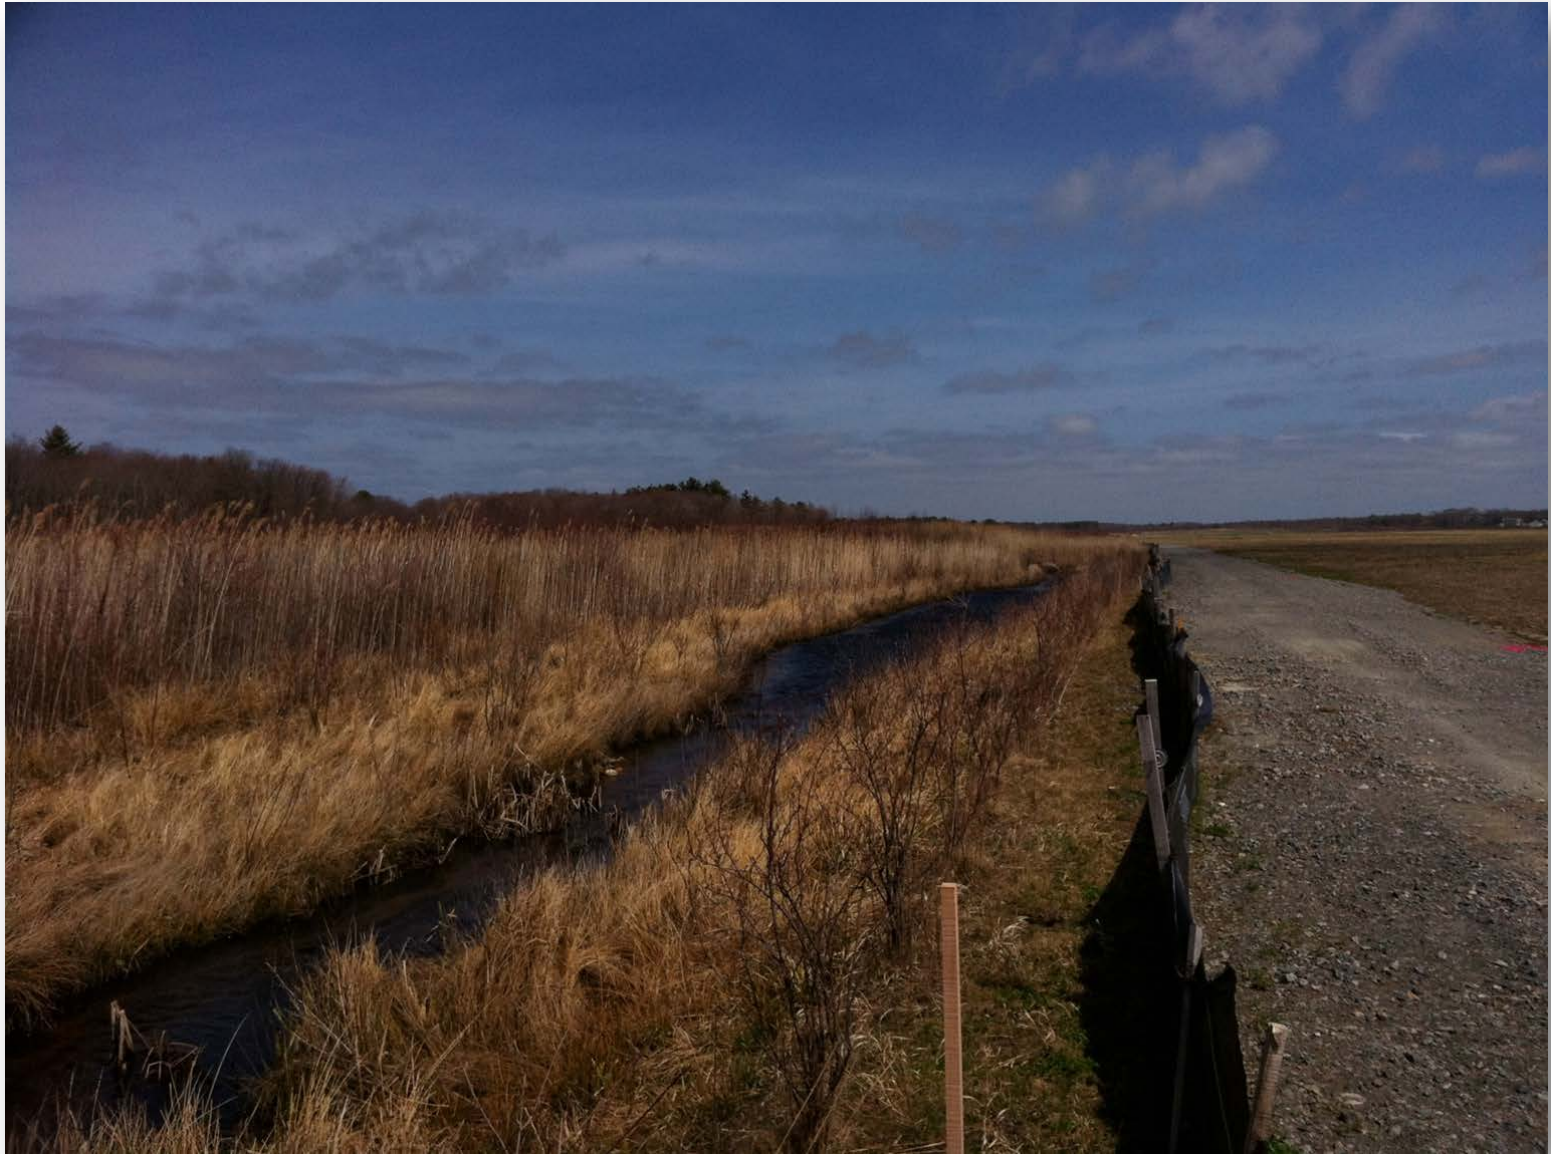
View of west ditch in early April prior to start of Phase 4 work.

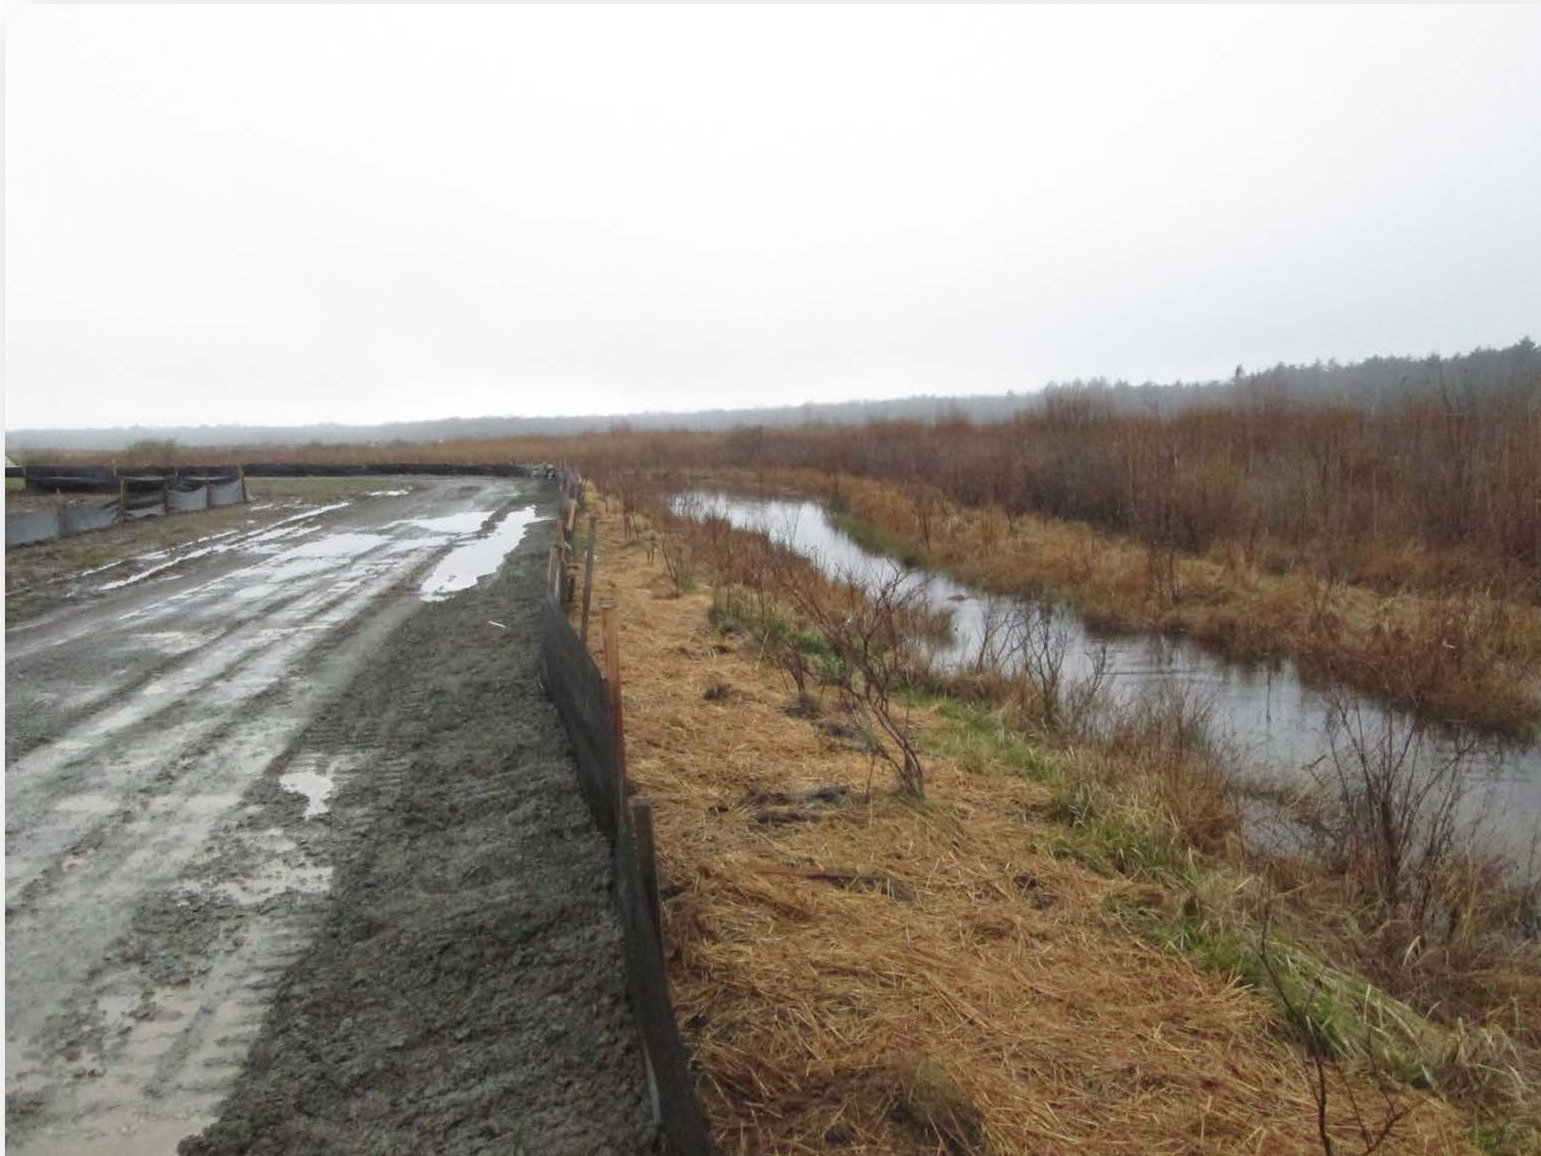
View of west ditch after disturbance (April 24, 2014). Some of the shrubs were undergoing bud break.

Shrubs within the west ditch are experiencing bud break and many appear healthy. As reported in the first EM report for Phase 4, a portion of the west ditch restoration area (approximately 450 linear feet) was disturbed during erosion control installation. The WS has provided DEP with a restoration and monitoring plan to remediate the disturbance. Except where noted, the side slopes were well vegetated with a robust and established mixed layer of herbaceous vegetation. Rooted aquatic vegetation remained persistent on the bottom of the West Ditch.

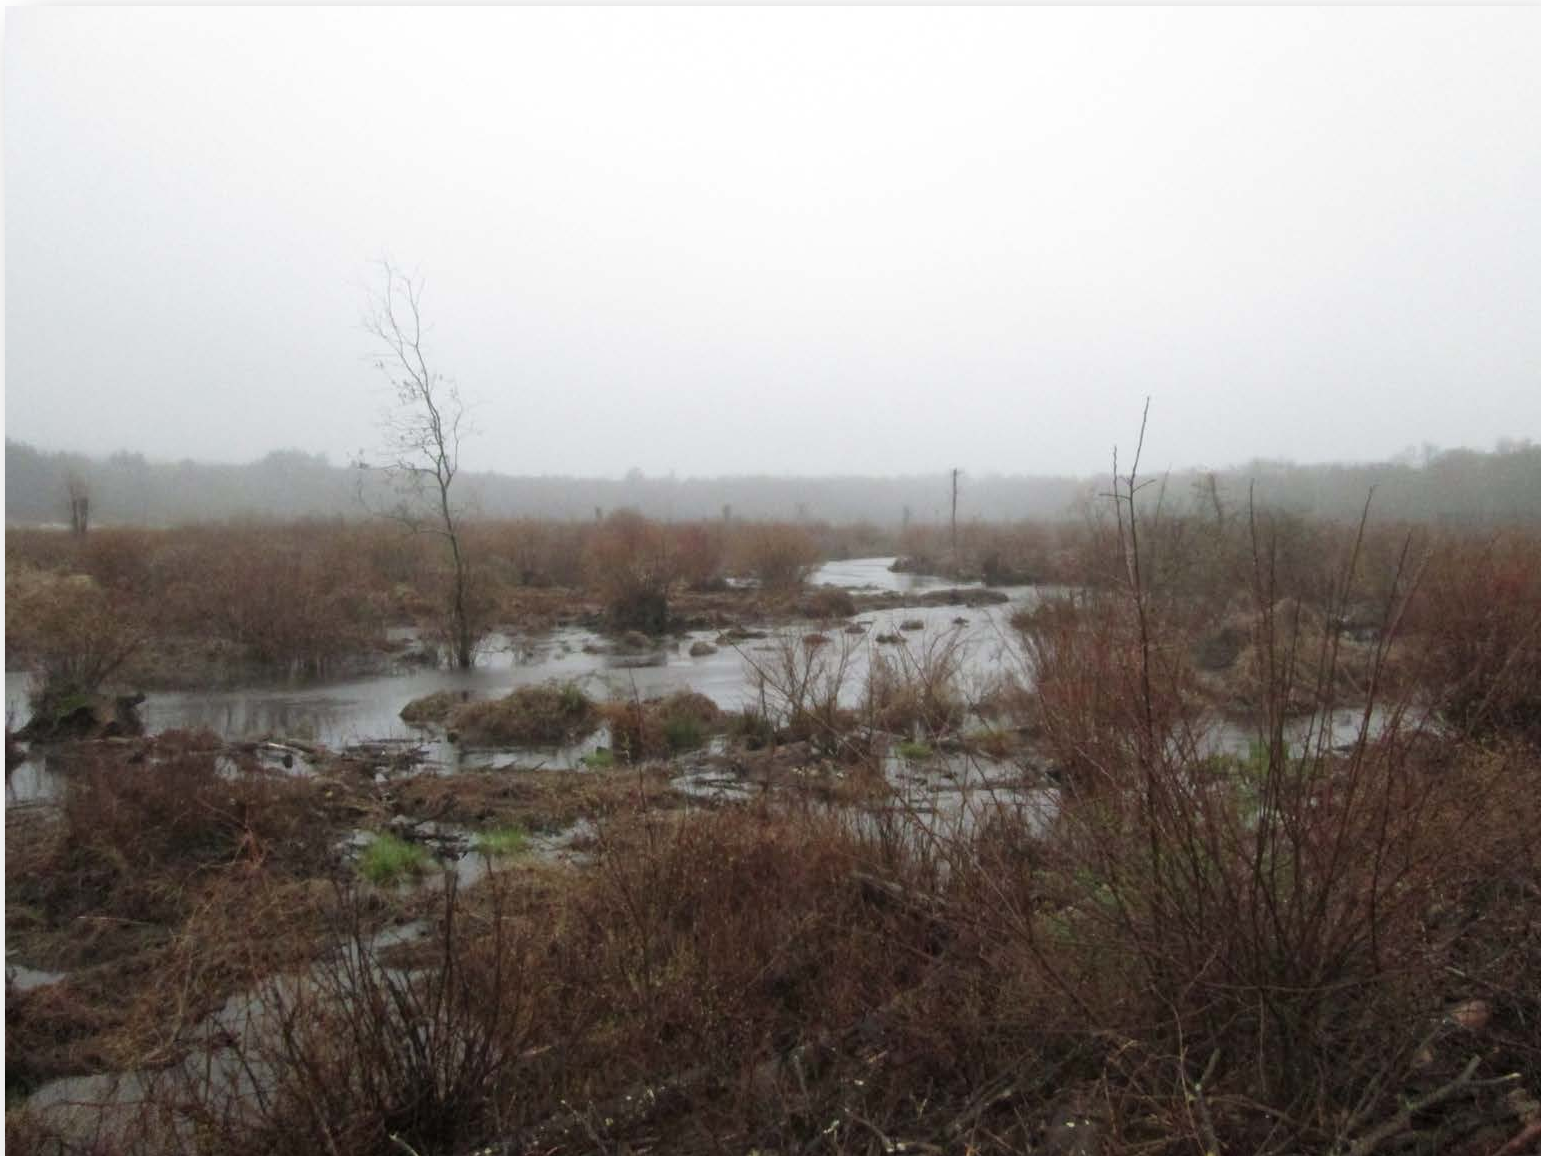
View of swollen banks of the Paskamansett River and adjacent floodplain and wetlands during significant rain event, many of the plantings were well under water.

The banks of the Paskamansett River remain thickly vegetated which was the goal following completion of obstruction removal activities. The River and adjacent floodplain and wetlands were inundated at the time of inspection.
