New Bedford Regional Airport Runway Safety Improvements Project

Post Construction Monthly Wetlands Plantings Assessment – March/April 2014

Subject: **Special Condition 29(f); Post Construction Monthly Wetlands Planting Assessment; New Bedford Regional Airport Runway Safety Improvement Project; Variance Order of Conditions and Water Quality Certificate DEP File No. SE 049-0635.**

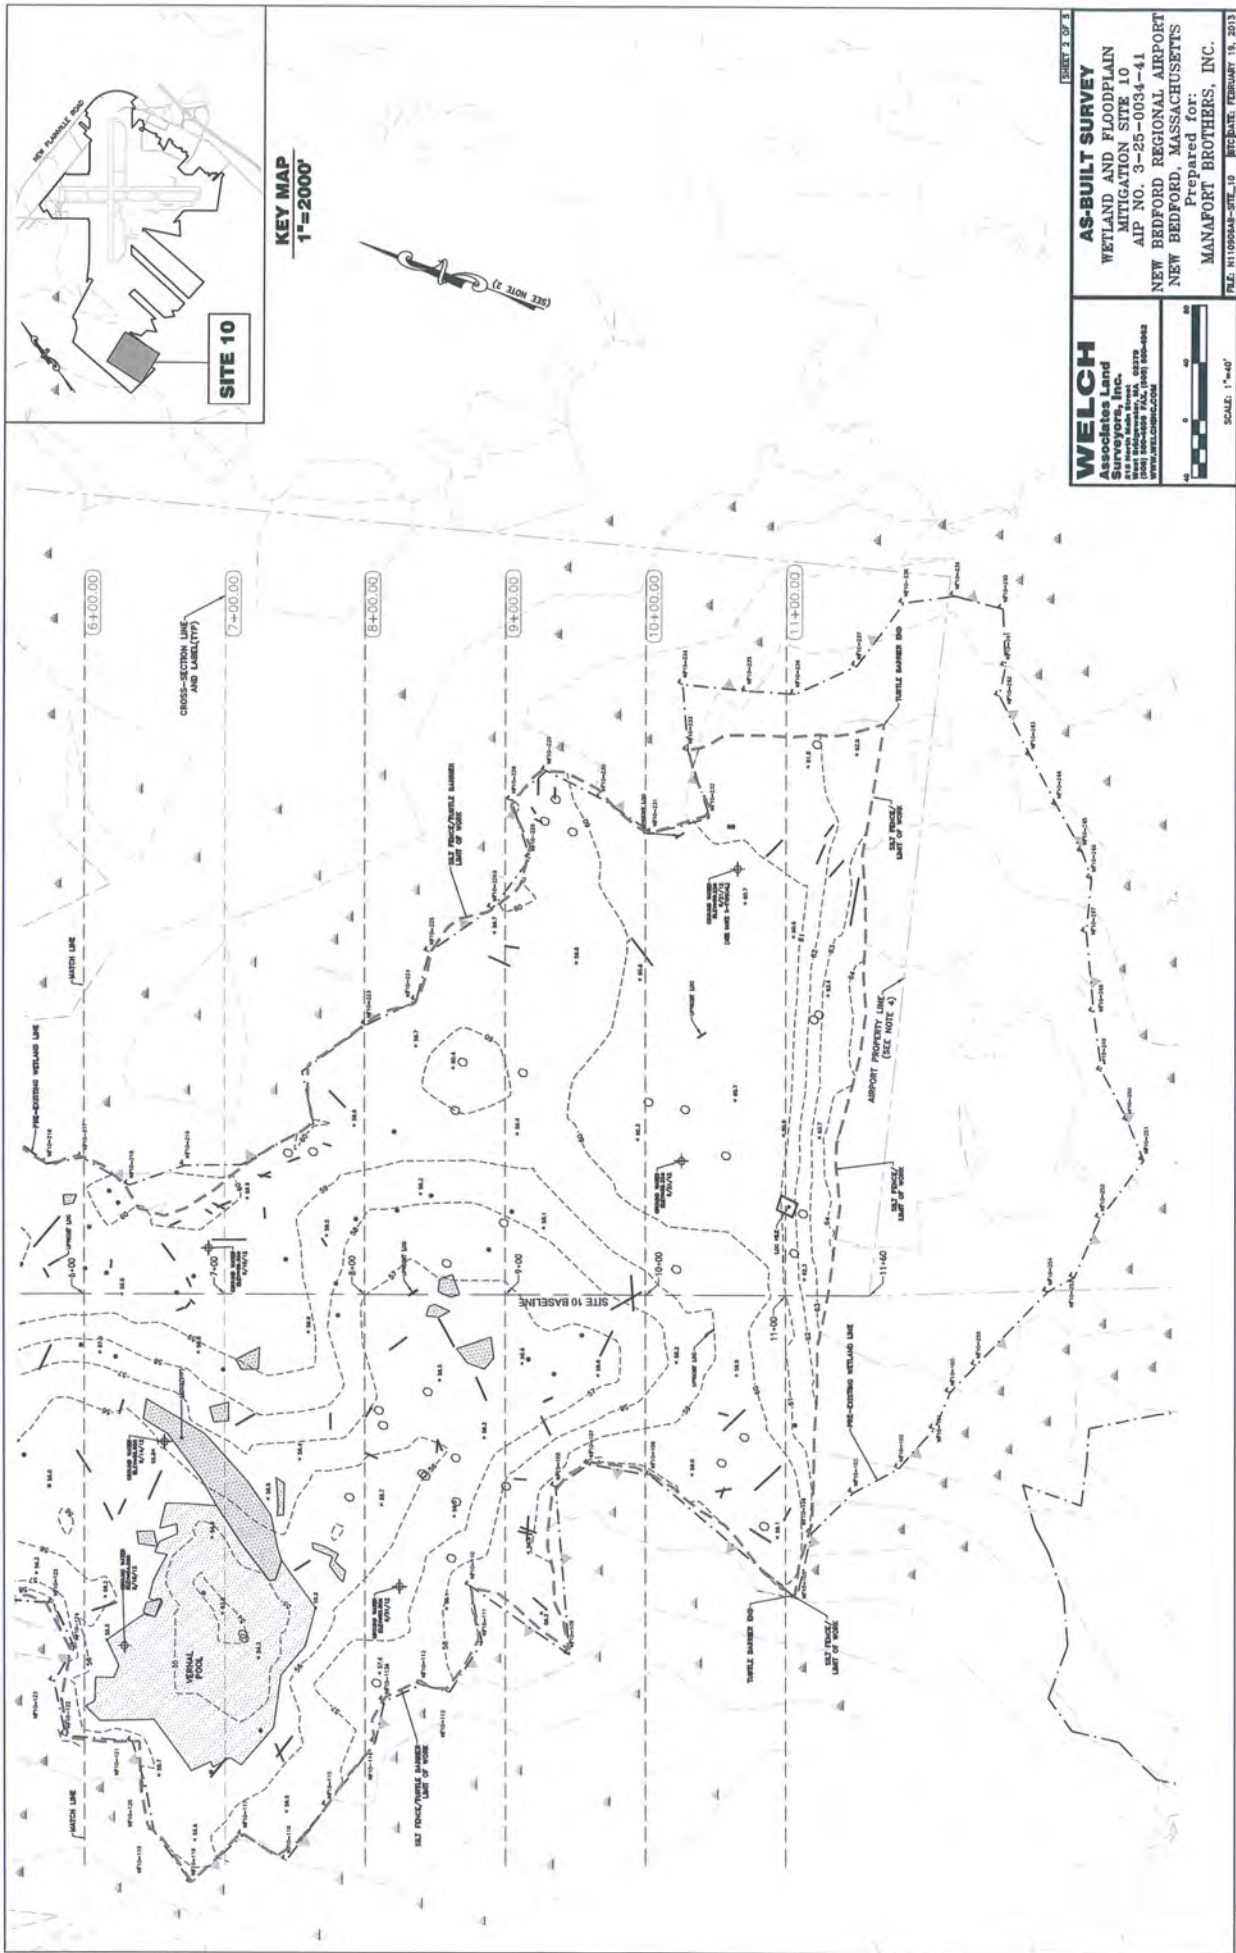
SHEET 3 OF 3

AS-BUILT SURVEY  
WETLAND AND FLOODPLAIN  
MITIGATION SITE 10  
AIP NO. 3-25-0034-41  
NEW BEDFORD REGIONAL AIRPORT  
NEW BEDFORD, MASSACHUSETTS  
Prepared for:  
MANAFORT BROTHERS, INC.
