ANNUAL REPORT NO. 3 AND REQUEST FOR CERTIFICATE OF COMPLIANCE

NSTAR BOAT SLIP REMEDIATION PROJECT

**180 MacArthur Drive / 1 Pine Street
New Bedford, Massachusetts**

FIELD OBSERVATION REPORT

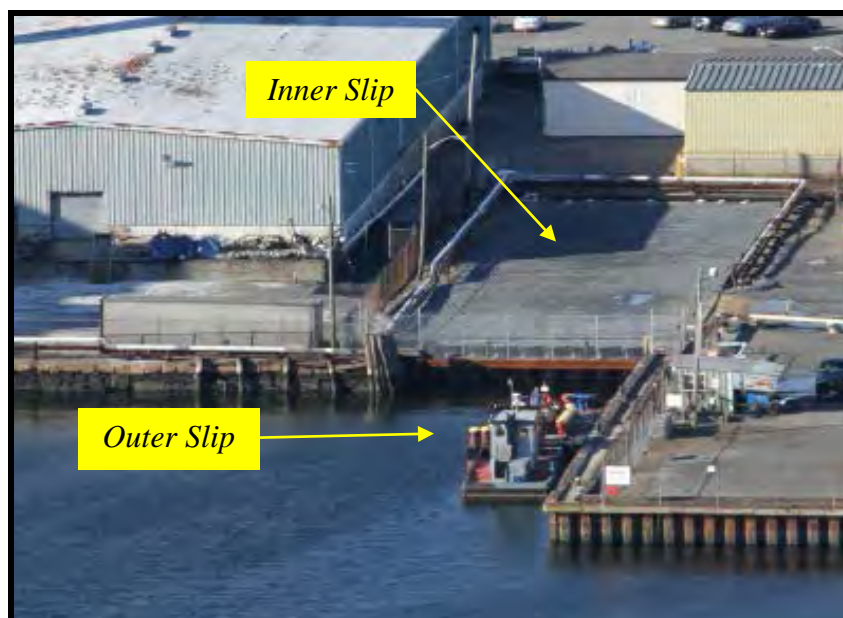
Completed Project, Photograph courtesy NSTAR

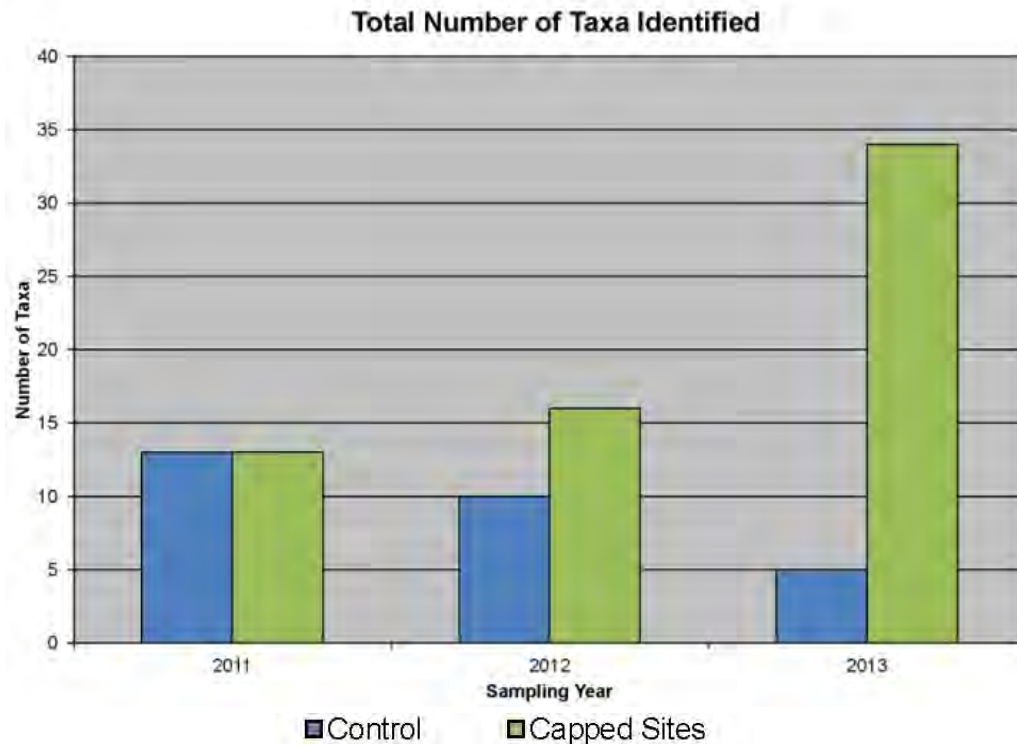
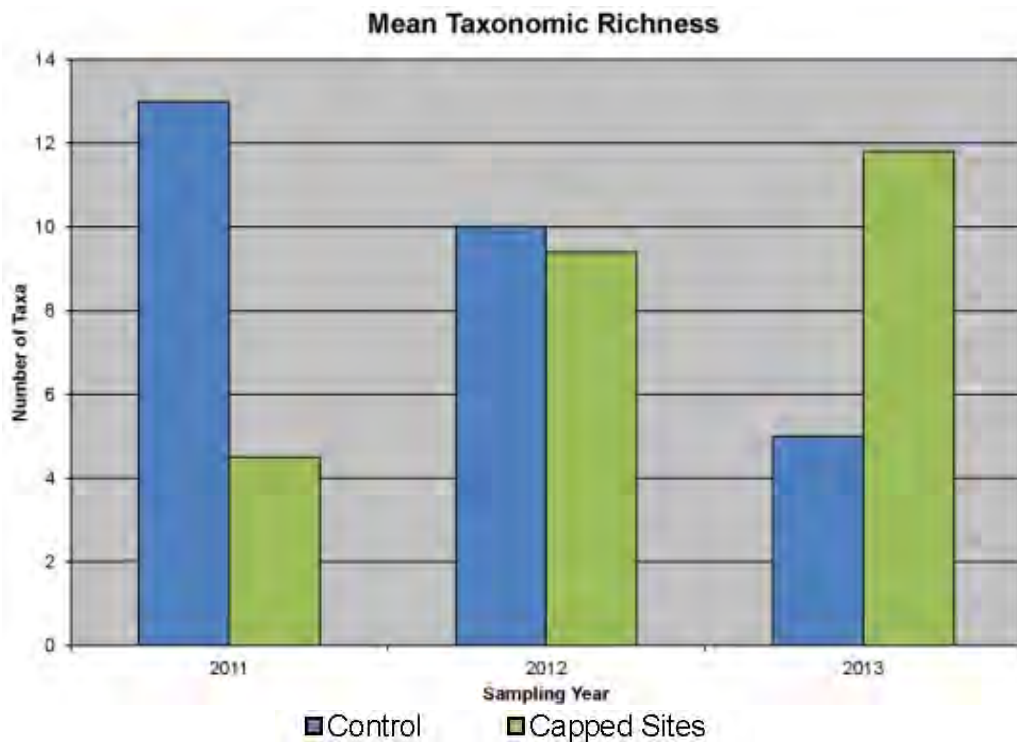
Taxonomic richness has substantially increased in the capped area since the initial benthic assessment undertaken in 2011, and now exceeds the taxonomic richness of the control site. Total taxonomic richness improved from 13 in 2011 to 16 in 2012 to 34 in 2013. More significantly, mean taxonomic richness per site improved from 4.5 in 2011 to 9.4 in 2012 to 11.8 in 2013. Mean taxonomic richness was more similar between the capped area (9.4) and control site (10) in 2012 than it was in 2011 (4.5 in the capped area vs. 13 in the control site), and is actually higher in the capped area in 2013 (11.8 in the capped area vs. 5 in the control site). While polychaete worms were the most common species across all 3 years, the capped area supported more live mollusks and crustaceans in 2013 than in previous years and, more importantly, than in the control site.

The sampling sites with the highest taxonomic richness in 2011 (8) were located adjacent to the uncapped areas of the harbor, indicating that species were beginning to migrate from the uncapped area to the capped area approximately one year after the completion of construction. By 2013, the taxonomic richness of the capped area was higher than that of the control site, indicating that the benthos has recovered and the capped area now provides a fully functioning habitat. Furthermore, the capped area now contains even greater diversity than the control site. Refer to the tables below, which depict the successful reestablishment of the benthic habitat in the remediation area over time.

While the capped sites represent a larger geographic area than the control, the data above suggests that the taxonomic diversity of the capped area is now similar to or greater than the diversity of the surrounding established habitat of the harbor.

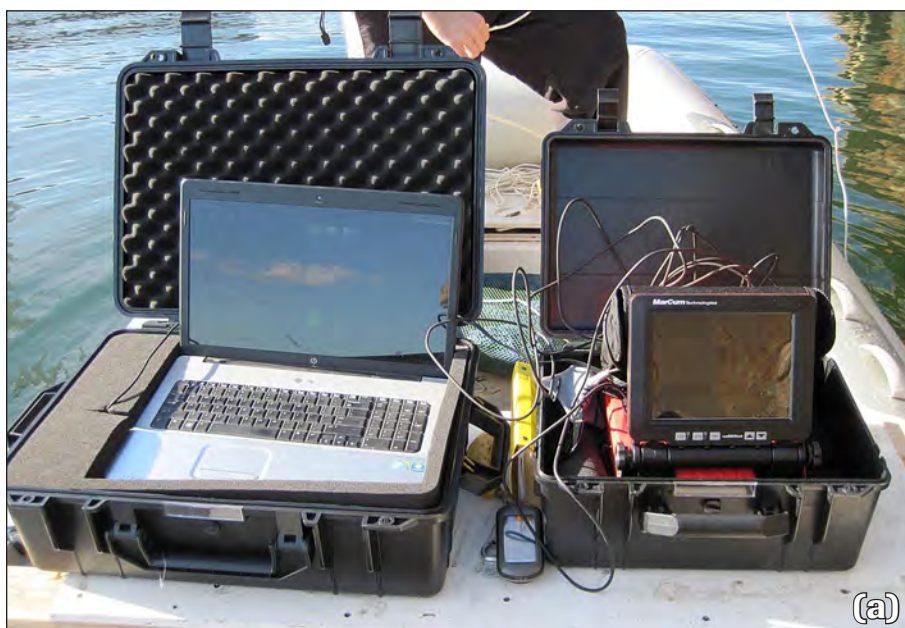
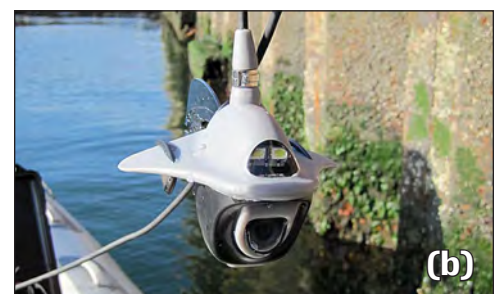
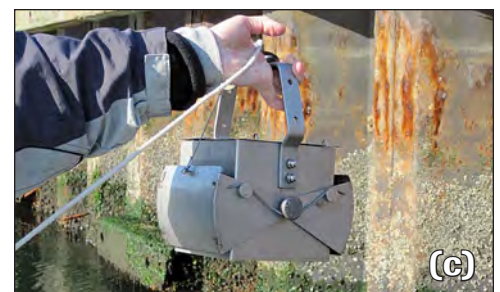
Setup for recording video footage (a), the camera for shooting the video (b), and the Ekman dredge for collecting samples (c).

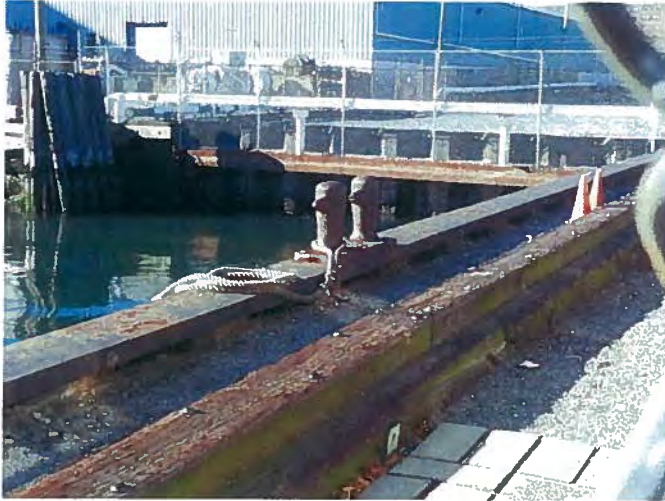
General view of bulkhead.

I performed a visual inspection of the steel sheet pile bulkhead. I performed the inspection near low tide. My observations are noted below:

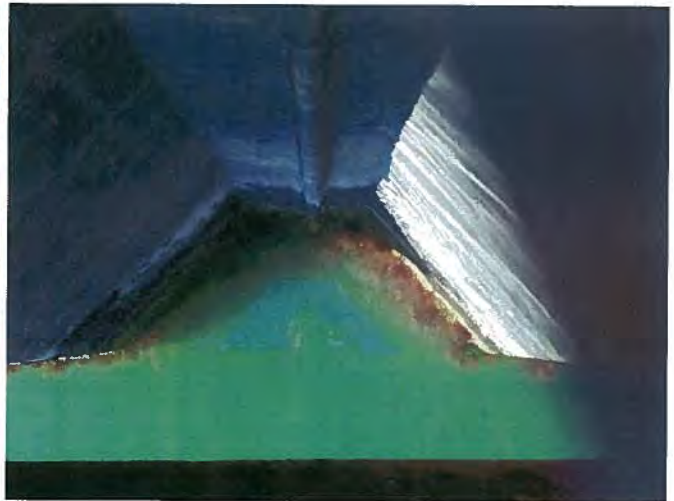
I did not observe signs of distress or failure in the steel sheet piles. The marine side is coated with a tar epoxy. The tar epoxy appears to be in good condition and I did not observe any signs of chipping or wearing. I observed some marine growth on the bulkhead below the water level. Visibility below water was approximately three feet deep; growth began approximately one foot deep.

Sheet pile (looking from above)

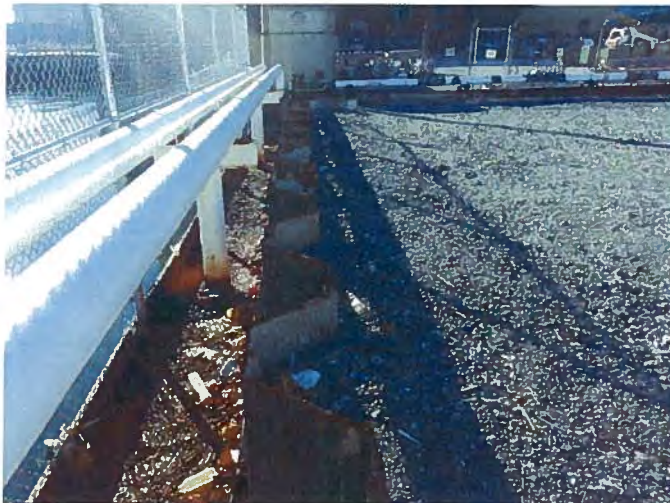
I did not observe tar-related sheen on the water surface near the bulkhead.

Top of water.

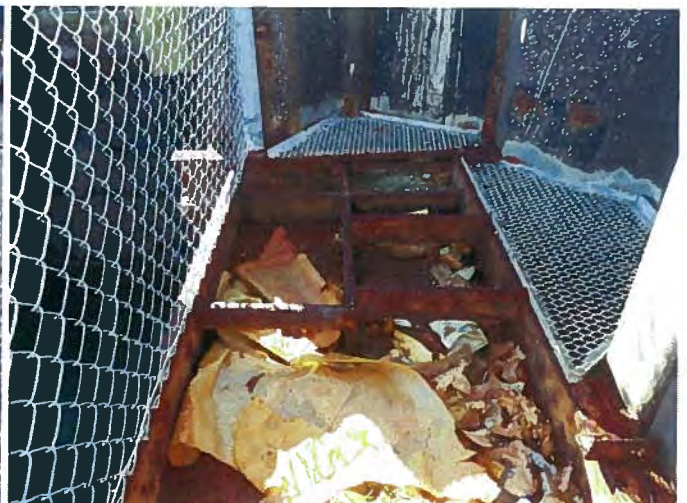
I did not observe signs of distress or distortion at the north and south connections. Non-welded components appear to be bearing uniformly on the appropriate connection.

South connection.
