STORMWATER REPORT

**APO ASSESSORS MAP 122, LOT 3
35 KEARSARGE STREET REDEVELOPMENT
35 KEARSARGE STREET
NEW BEDFORD, MASSACHUSETTS**

**SITEC – A PART OF CIVIL & ENVIRONMENTAL CONSULTANTS, INC.
449 FAUNCE CORNER ROAD
DARTMOUTH, MASSACHUSETTS 02747**

CEC Project 304-430

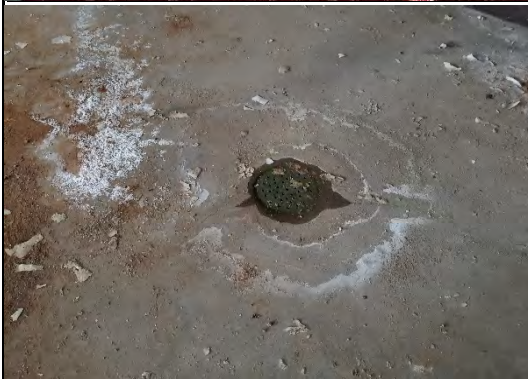
Project: 35 Kearsarge Street
Date: February 21, 2020
Description: Photograph of the interior of the Commercial Building. Floor drain in the concrete floor of the basement.

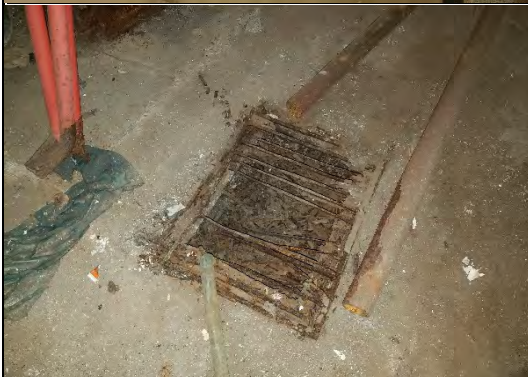
Project: 35 Kearsarge Street
Date: February 21, 2020
Description: Photograph of the Boiler Room. Floor drain in the concrete floor.

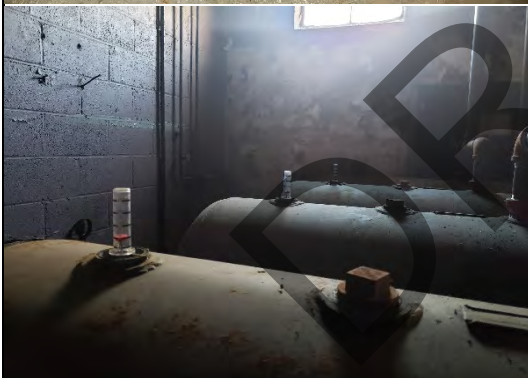
Project: 35 Kearsarge Street
Date: February 21, 2020
Description: Photograph of the Boiler Room. Fuel gauges on ASTs.

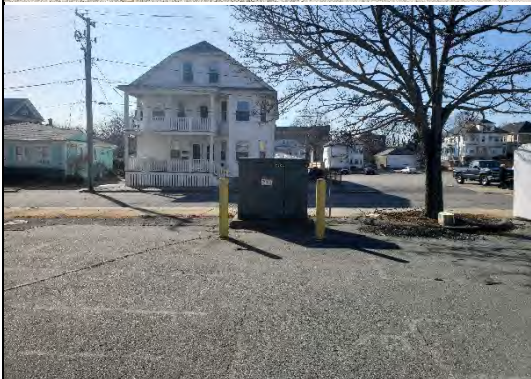
Project: 35 Kearsarge Street
Date: February 21, 2020
Description: Photograph of pad-mounted transformer at the Subject Property. View facing south.

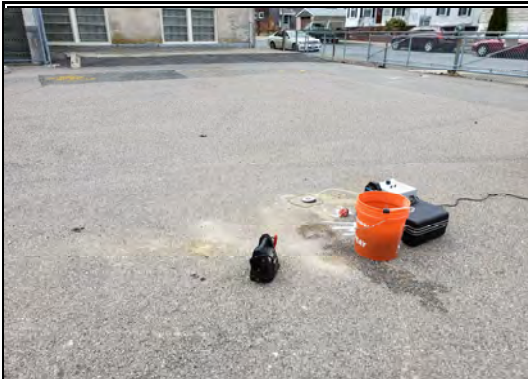
Project: 35 Kearsarge Street
Date: April 1, 2020
Description: Photograph during the development of monitoring well MW-1.

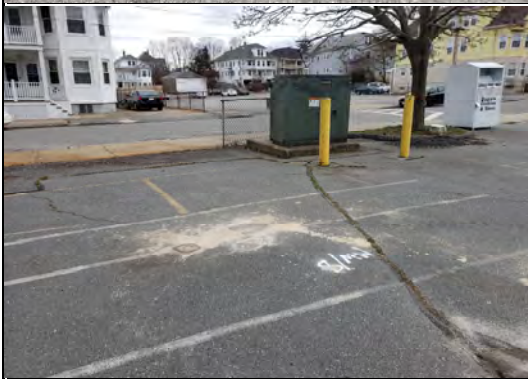
Project: 35 Kearsarge Street
Date: April 1, 2020
Description: Photograph of monitoring well MW-4.

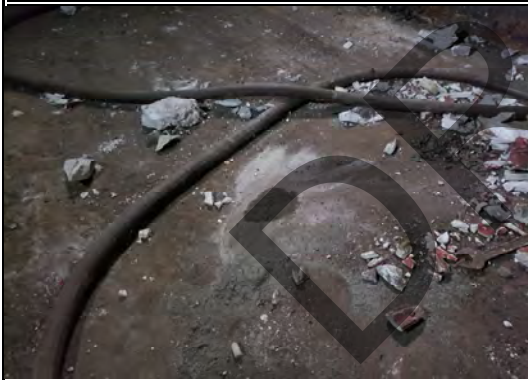
Project: 35 Kearsarge Street
Date: April 1, 2020
Description: Photograph of soil vapor sampling location SVP-2.

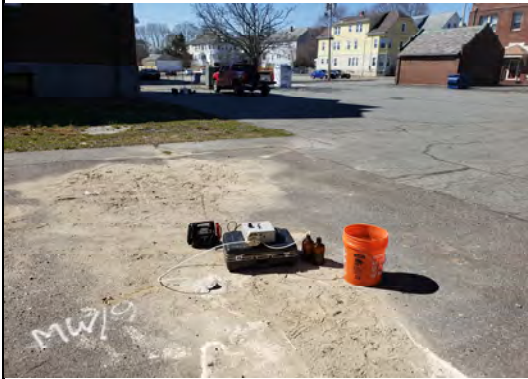
Project: 35 Kearsarge Street
Date: April 6, 2020
Description: Photograph during sampling of monitoring well MW-3.

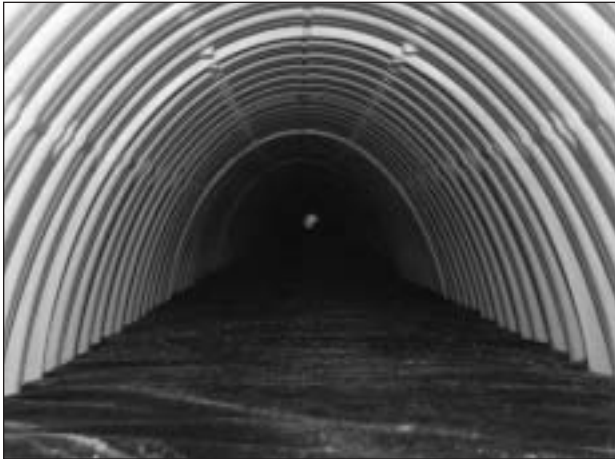
Looking down the Isolator Row from the manhole opening, woven geotextile is shown between the chamber and stone base.

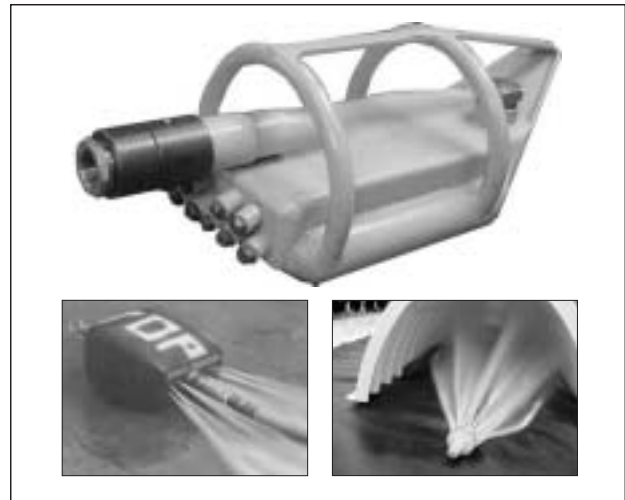
Examples of culvert cleaning nozzles appropriate for Isolator Row maintenance. (These are not StormTech products.)

Maintenance is accomplished with the JetVac process. The JetVac process utilizes a high pressure water nozzle to propel itself down the Isolator Row while scouring and suspending sediments. As the nozzle is retrieved, the captured pollutants are flushed back into the manhole for vacuuming. Most sewer and pipe maintenance companies have vacuum/JetVac combination vehicles. Selection of an appropriate JetVac nozzle will improve maintenance efficiency. Fixed nozzles designed for culverts or large diameter pipe cleaning are preferable. Rear facing jets with an effective spread of at least 45° are best. Most JetVac reels have 400 feet of hose allowing maintenance of an Isolator Row up to 50 chambers long. **The JetVac process shall only be performed on StormTech Isolator Rows that have AASHTO class 1 woven geotextile (as specified by StormTech) over their angular base stone.**
