CITY OF NEW BEDFORD
COMMUNITY PRESERVATION ACT FY26
PROJECT APPLICATION

THE
HISTORIC STRUCTURE REPORT
OF
THE ROTCH-JONES-DUFF HOUSE & GARDEN MUSEUM
396 COUNTY STREET, NEW BEDFORD, MA 02740

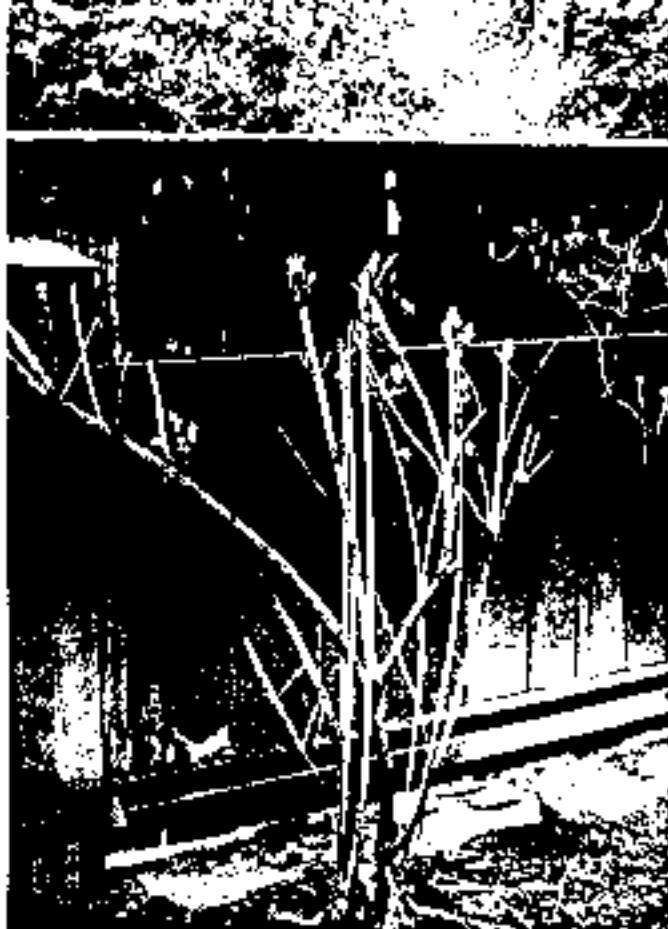
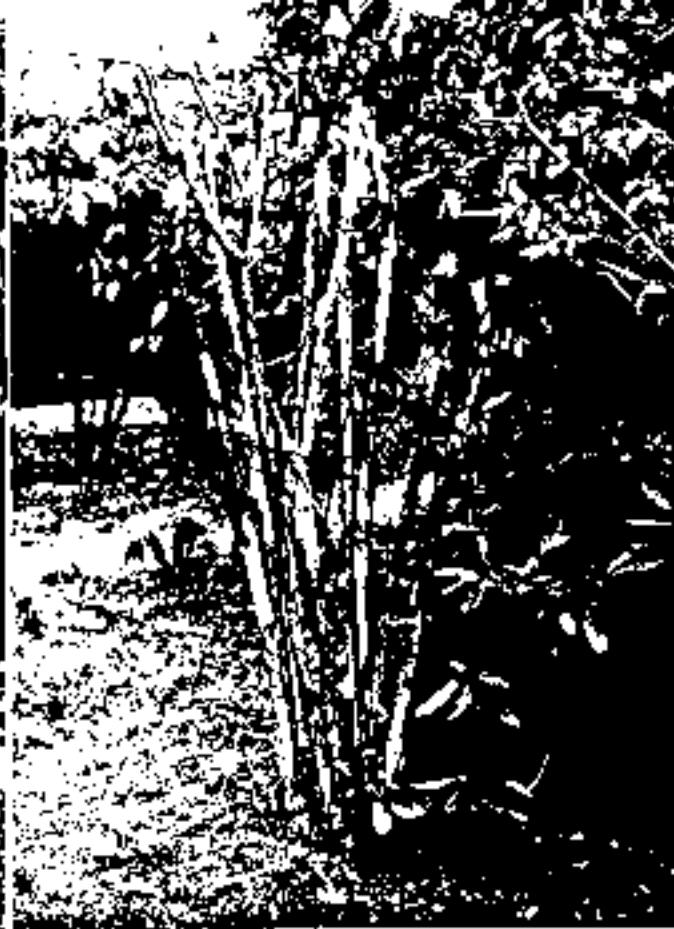
Garden Above: Shrubs in need of renovation pruning in proposed wildflower walk. Below: Granite steps near Crackman's House. Copper Beech tree.

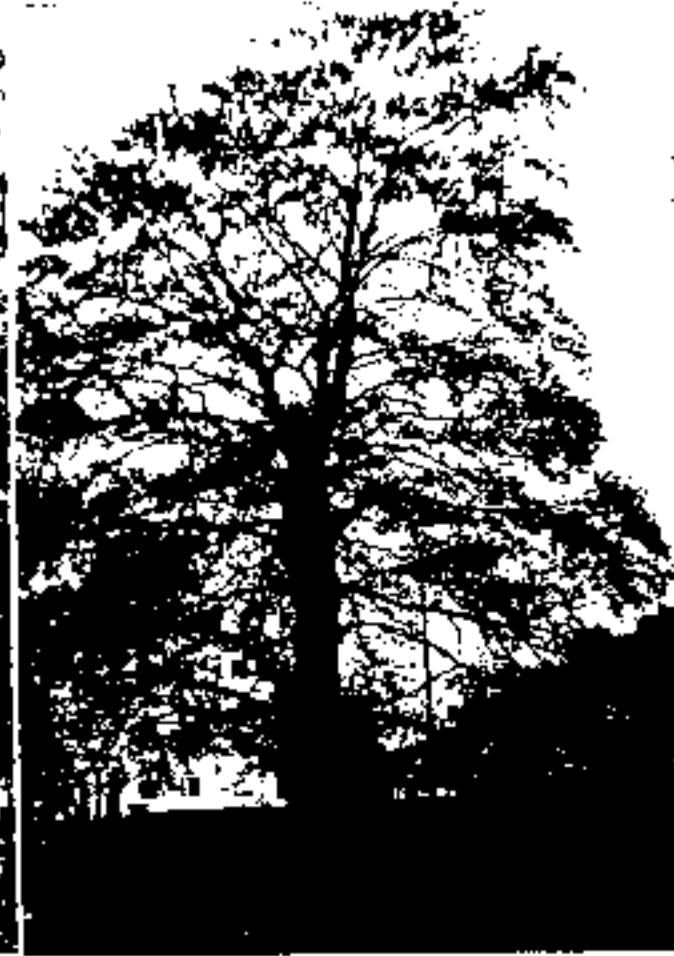
Garden Above: Forsythia in need of pruning near Enchanted's House.
Below: Diagonal lattice screen fence circa 1870 in need of reconstruction.

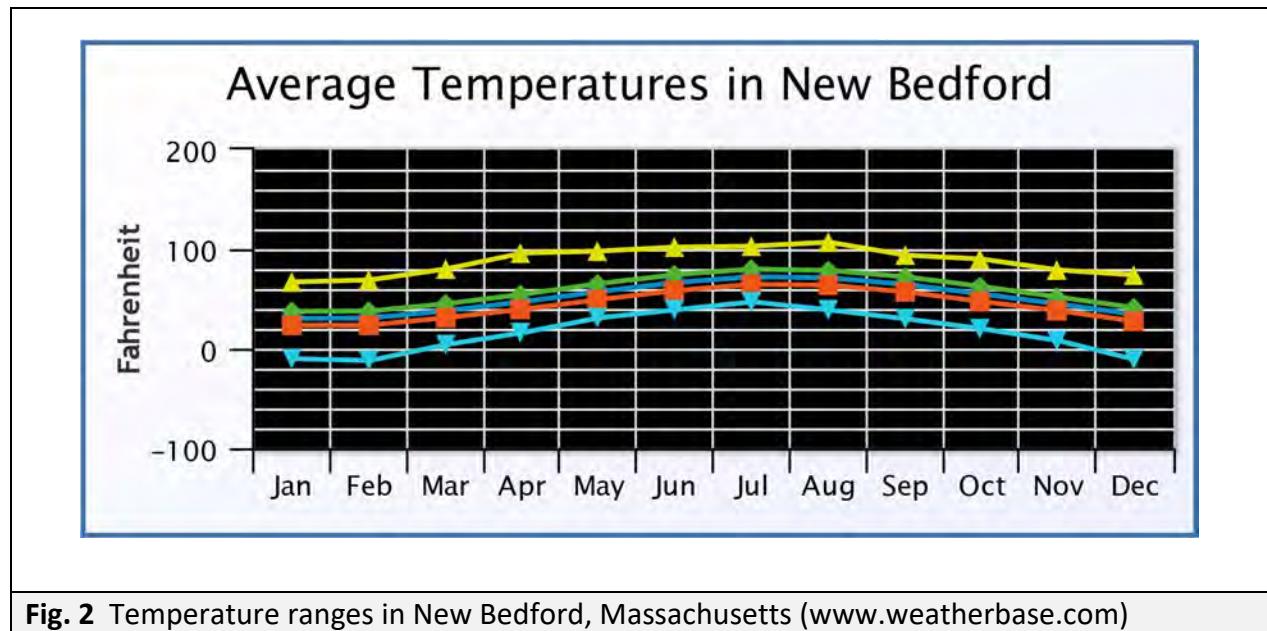
The below weather chart taken from www.weatherbase.com shows the temperature ranges for New Bedford, Massachusetts. The yellow line tracks the highest temperature reading for each month. the green line is the average high temperature. The blue line tracks the lowest temperature reading in each month. The red line tracks the average low temperature.

Fig. 2 Temperature ranges in New Bedford, Massachusetts (www.weatherbase.com)

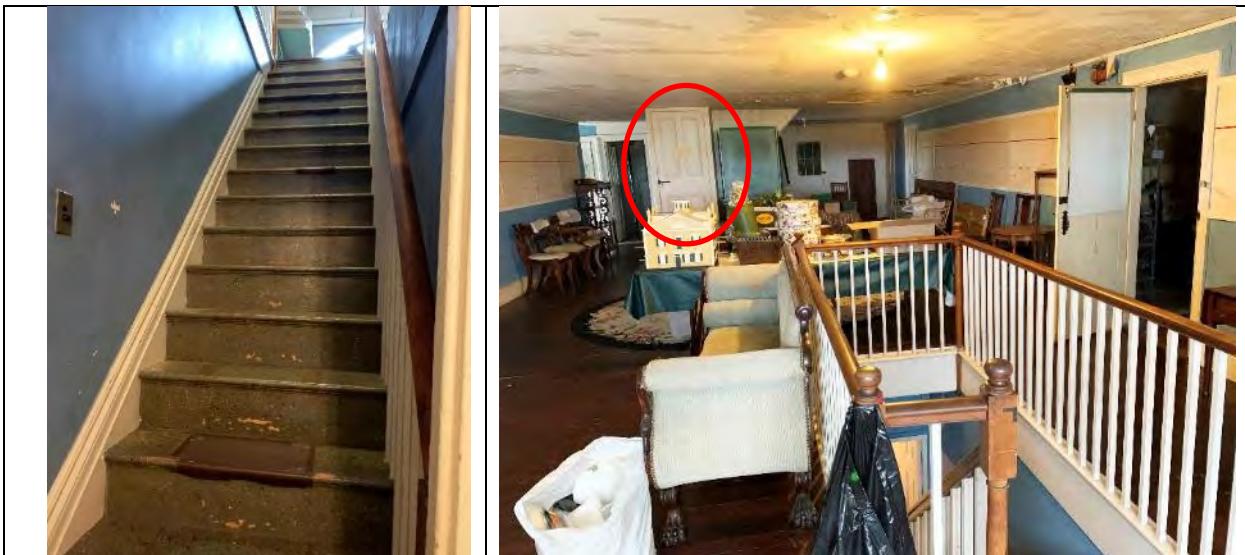
Fig. 3 A steep stairway provides access to the attic, opening in the middle of the floor at the east end (left). A second enclosed stairwell (red circled) at the center west end of the room provides access to the cupola (right).

The attic is accessed from the second story below by a staircase opening towards the center east end. It is not known whether this staircase is code-compliant, but it does heighten risks to moving collections between floors. The code compliance would need verification with the City. An enclosed stairway to the cupola is set in the west center of the open area.

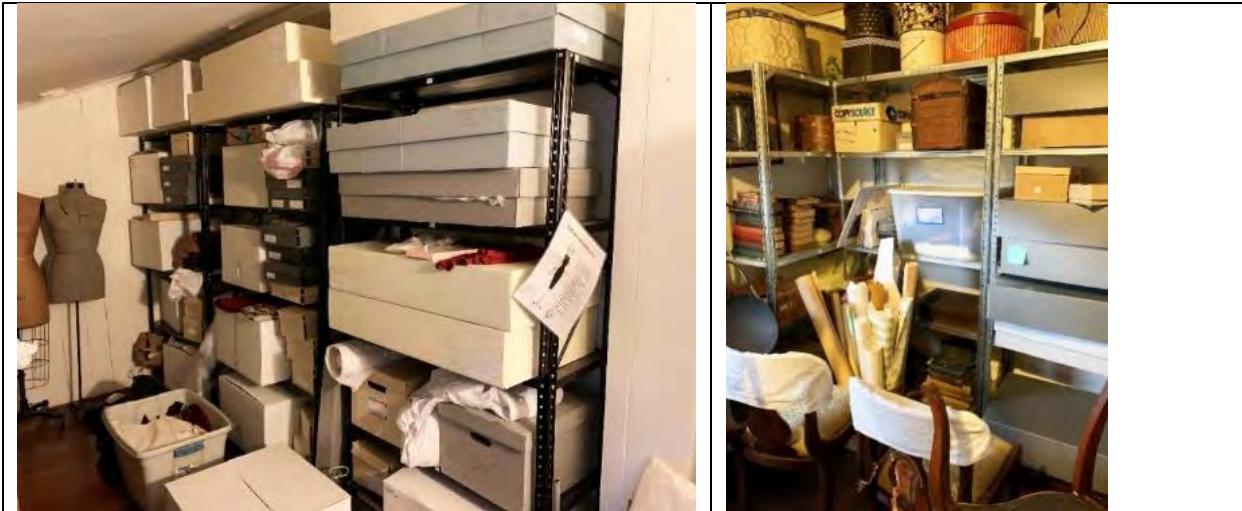
Fig. 4 Boxed collections recognize best practices, but space constraints and mixed storage functions impose physical access and security risks.

tissue lined cedar drawers, in acid free boxes or on padded hangers in covered racks following recognized standards of practice. This rehousing project is a commendable protective preservation action, but space constraints require most boxes and drawers to be packed in multiple layers. This presents deleterious physical risk to clothing accessibility and long-term care. Storage constraints require their location in several unheated and drafty attic rooms, exposing these fragile materials to accelerated deterioration from extremes in environmental fluctuations throughout the year.

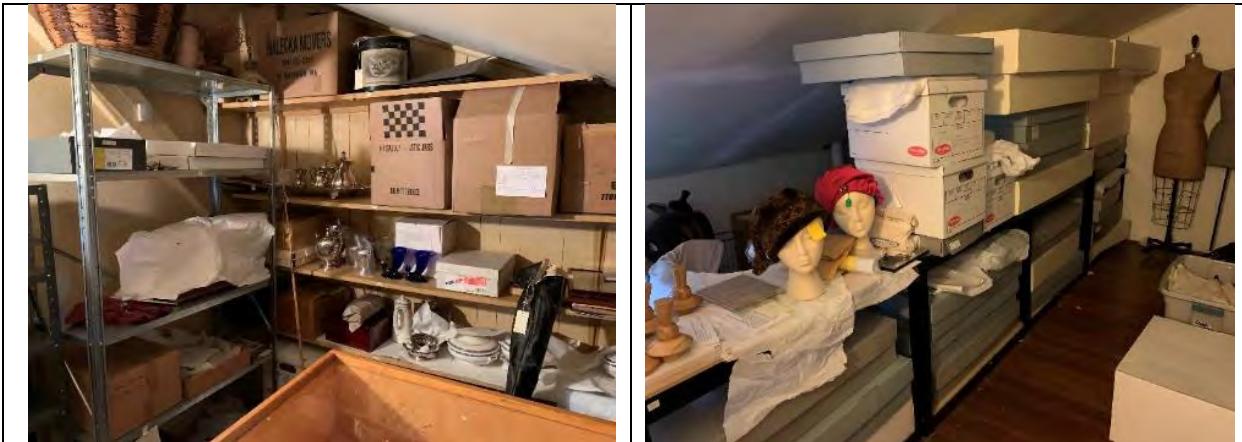
Fig. 5 The north side attic rooms fit into the roof eaves, have been fitted with shelving to maximize available space and are dedicated to storage of a variety of collections.

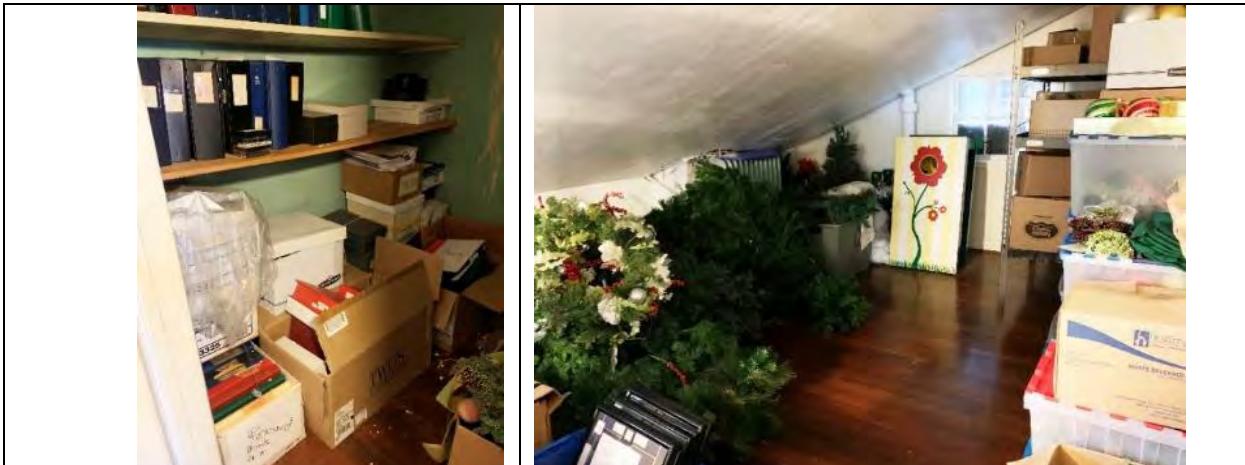
Fig. 6 Institutional records are stored in the attic mixed with holiday and event supplies south side eave rooms.

The south side attic rooms serve as a mixed storage area for furnishings, architectural features, institutional records, programming, and holiday decorations. They are protectively housed in acid free boxes or covered with sheets, but accessibility is challenging and verging on overcrowding. The mixture of collections with non-collections compromises security and further impedes safe access.

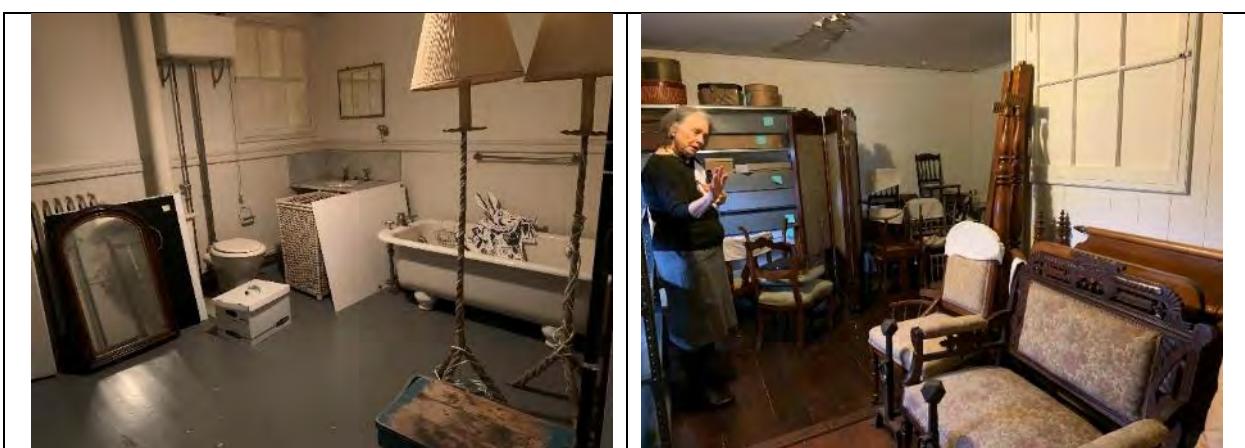
Fig. 7 Rooms against the west end of the attic are an inactive bathroom and repurposed adjacent room for excess boxed textiles and an assortment of furniture

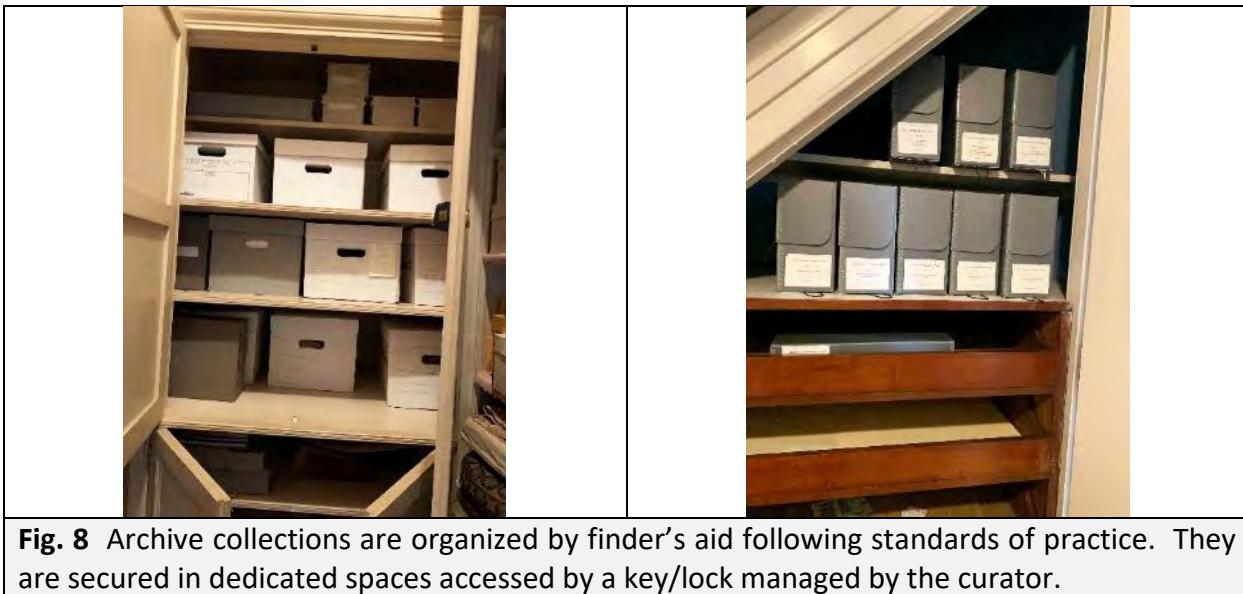
Fig. 8 Archive collections are organized by finder's aid following standards of practice. They are secured in dedicated spaces accessed by a key/lock managed by the curator.

A discreet archive and a mixture of framed artworks are stored in two second floor closets. Archives are stored by finders' aids inside bankers' boxes and document boxes and demonstrate good practices. Additional processing is needed to make them publicly available. They support of in-house research needs. A staff position is unavailable to focus on remaining and ongoing management needs.

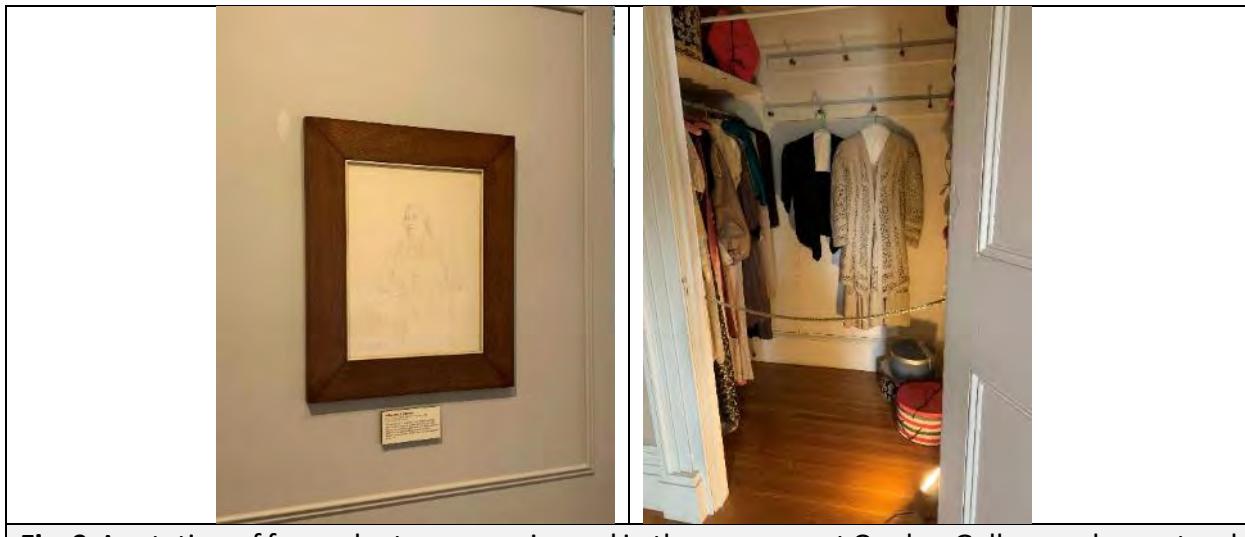
Fig. 9 A rotation of framed art on paper is used in the permanent Quaker Gallery and no natural light falls on the surface (left). Dimmer exhibit areas, like this closet, use spot lights (right).

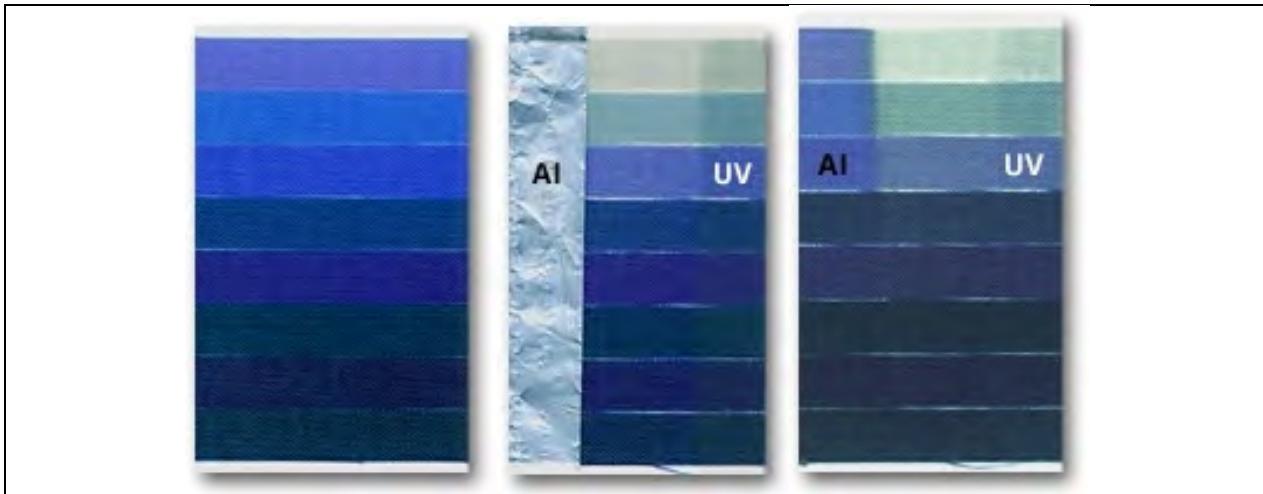
Fig. 12 The card on the left is a fresh unfaded card. The card in the middle has an aluminum (AL) strip protecting the left side, and a UV filtering film strip (UV) protecting the right edge. The middle of the card is unprotected. The card on the far right has had the aluminum barrier and the UV filtering film strip removed, showing the amount of fading in the protected area. The middle has also been unprotected. Placed in a south window for eight months, the Blue Wool Standard on the right shows fading equivalent to several decades of exposure under both controlled and uncontrolled exhibition lighting conditions.

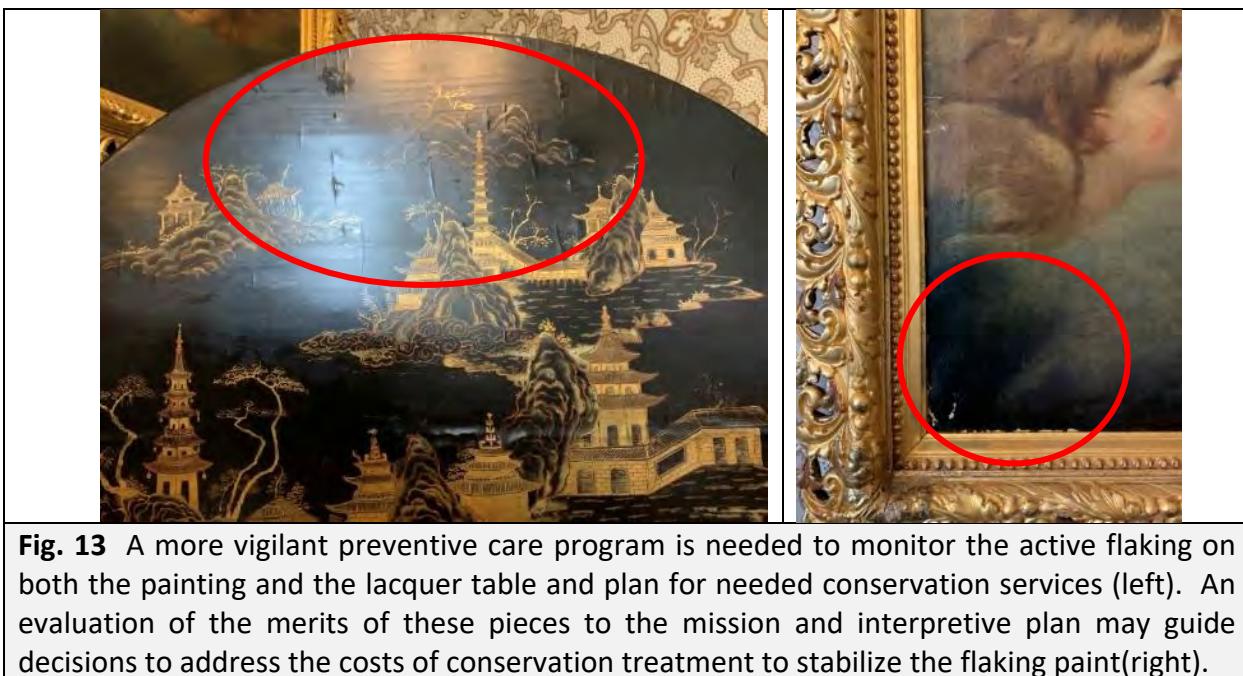
Fig. 13 A more vigilant preventive care program is needed to monitor the active flaking on both the painting and the lacquer table and plan for needed conservation services (left). An evaluation of the merits of these pieces to the mission and interpretive plan may guide decisions to address the costs of conservation treatment to stabilize the flaking paint(right).

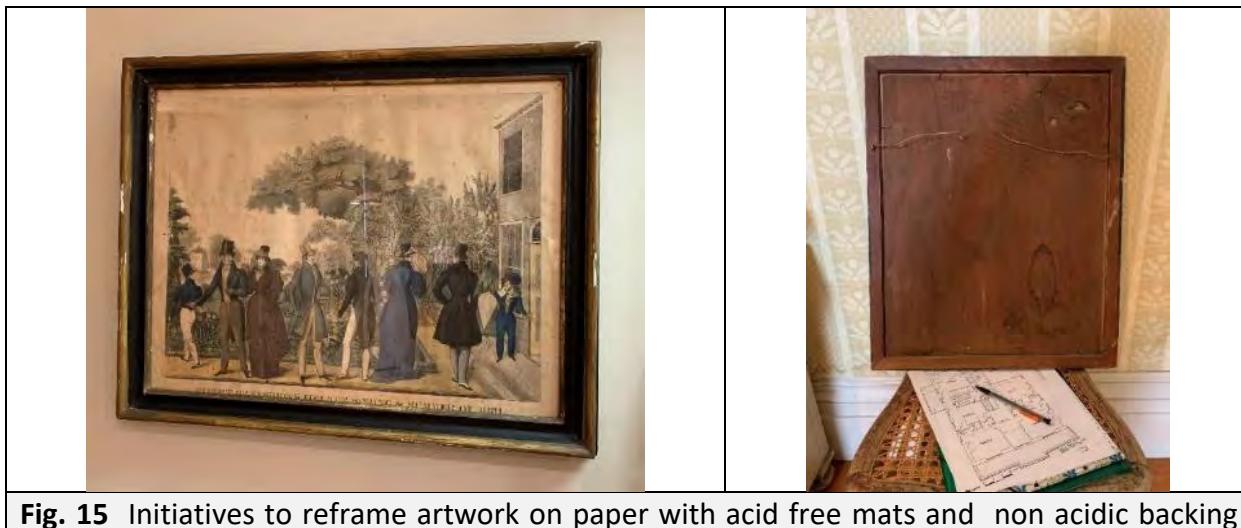
Fig. 15 Initiatives to reframe artwork on paper with acid free mats and non acidic backing boards is recommended for all paper based artwork on exhibit. Adding cork stops to the lower corners to raise them off the wall increases airflow and reduces risks of microclimates that foster mold growth.

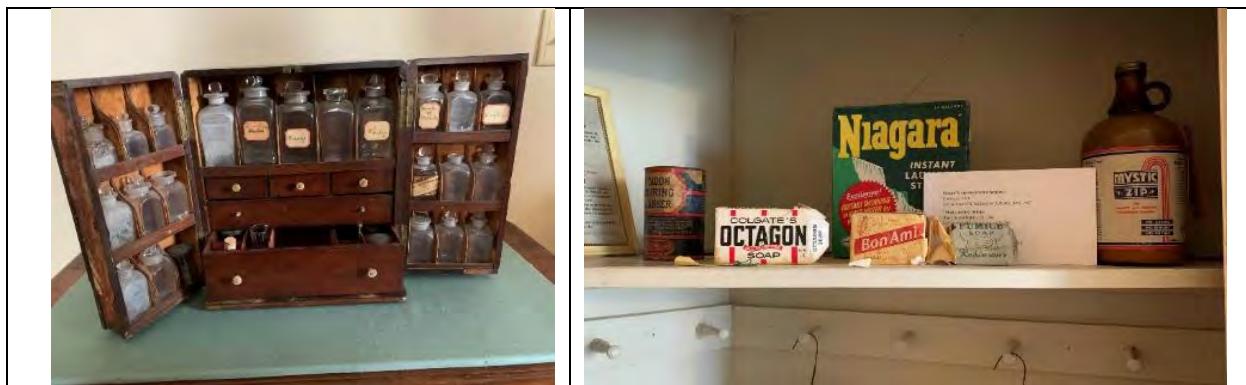
A medicine chest and household cleaning products were noted on display. A best practice is to evaluate the potential of hazards. Commonly only the containers of household products are kept, and the contents disposed of.

Fig. 16 A best practice is to remove the contents from inside household products but to keep the containers intact for display. Medical chests often have hazards due to the dried concentration of medicinal tinctures. Testing for identification and subsequent removal, with documentation of findings in the collection record, is also a best practice.

Household products commonly are corrosive in their undiluted product form or are attractive to pests. An evaluation of collections for potential health and safety hazards is recommended. A

best practice recommendation is to remove the contents and to preserve the containers for display. If the contents are important to keep, they are best housed and stored separately.

Medicine chests often masked chemical hazards in the array of bottles. Laudanum, a tincture of opium is a common medicinal, often apparent as a white powder residue. As these dry out, they become concentrated elevating the risks. A best practice is to remove them from exhibit until the contents are identified by an industrial hygienist or medical toxicologist.

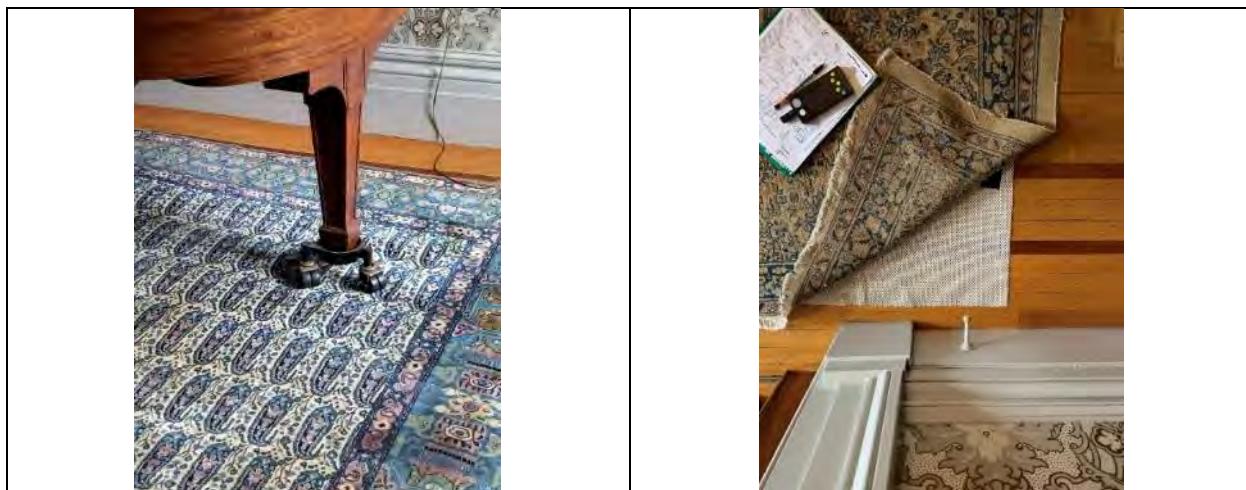
All furnished rooms are carpeted with synthetic open weave rubber pads. A number of the rugs are part of the visitor pathways or cover areas used for program seating arrangements. These areas are vacuumed regularly and kept clean.

Fig. 17 Evaluating the rugs for permanent or service collections in visitor pathways is recommended due to the wear and soiling from foot traffic. A preventive care protocol uses needlepunched polyester as rug pads as a best practice and silicone moving discs to distribute the weight over a larger surface mitigating the physical compressin risks from heavy objects with small feet.

An evaluation of the rug placement and the impact of visitor traffic on them is recommended as part of a preventive care plan. A preventive care protocol is to either substitute a rug that is not from the permanent collection or to recategorize the existing rug as “resources,” a collection category that is used and its replacement planned for. A recommended practice to protect rugs from deforming due to pointed heavy objects, such as the piano, is to use silicone moving cups under the feet to distribute the weight over the surface.

To incorporate a best practice to maintain the rugs, the use of needle punched (no glues no finishes) polyester kaput, 1/8th inch (white) is recommended for an underlay. The direct source is Buffalo Felt at <http://buffalofelt.com/felt-products/needle-punched-felt/#polyester> (716/674-7990 x207). The current rubber mats readily degrade and off gas harmful products directly degrading the rug and flooring finish. The use of these rubber mats are not recommended for long term exhibit.

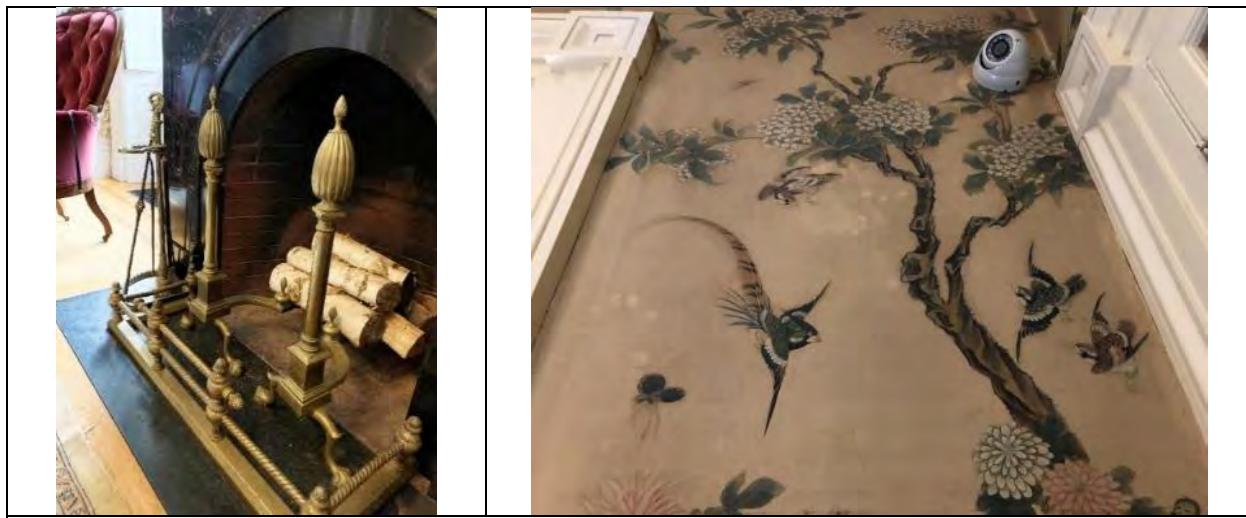
An often-overlooked housekeeping need is to clean the wallpaper surfaces every few years of the air borne particulate deposited from open windows or heating systems. An example is the visible buildup on the dining room wallpaper, now evident from the fingerprints left behind.

Fig. 19 A notebook with task sheets for frequency, procedural information and materials is recommended. Examples are how often and how to clean dull brass, and the dining room wall paper that is disfigured by an accumulation of air borne dirt, revealed by fingerprint marks.

To ensure consistent use of products as well as cleaning and handling procedures, the formation of a housekeeping manual is recommended. This is particularly helpful with the rotation of staff. Often prepared by room when furnishing do not rotate, each notebook contains a task sheet by object. The sheet identifies the object, any handling or mount risks, the procedure for cleaning and the list of products used and their source for purchase. Each task sheet also references online resources for learning about how to undertake the task and what specific products to use or not to use. The handbook can be developed overtime, with new sheets added as part of the tasks for annual cleanings.

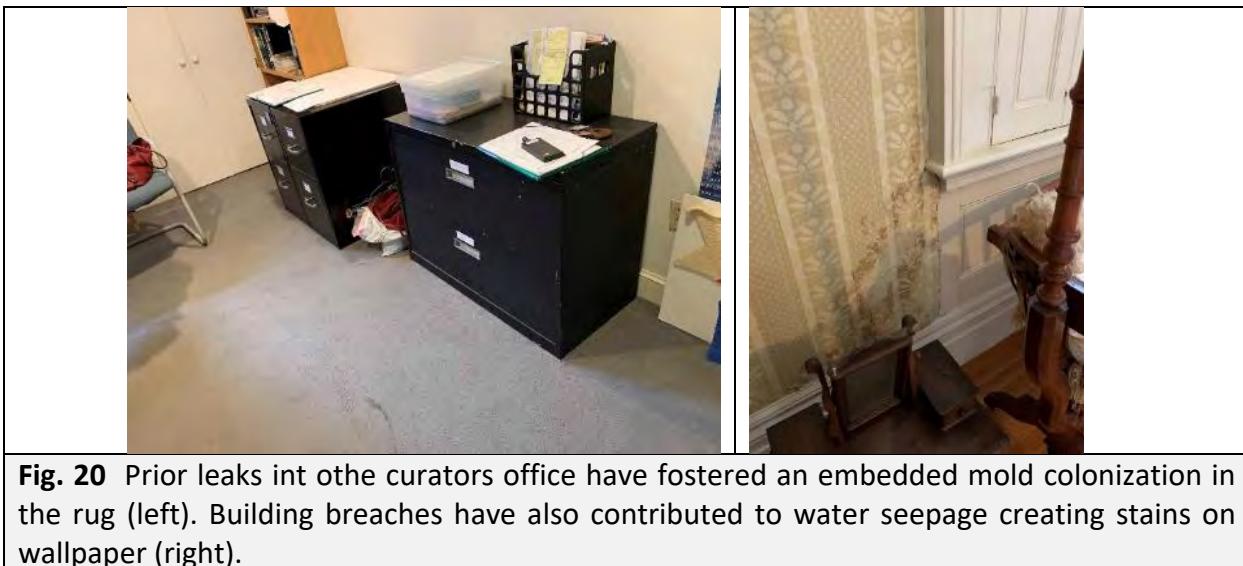
Fig. 20 Prior leaks in the curators office have fostered an embedded mold colonization in the rug (left). Building breaches have also contributed to water seepage creating stains on wallpaper (right).

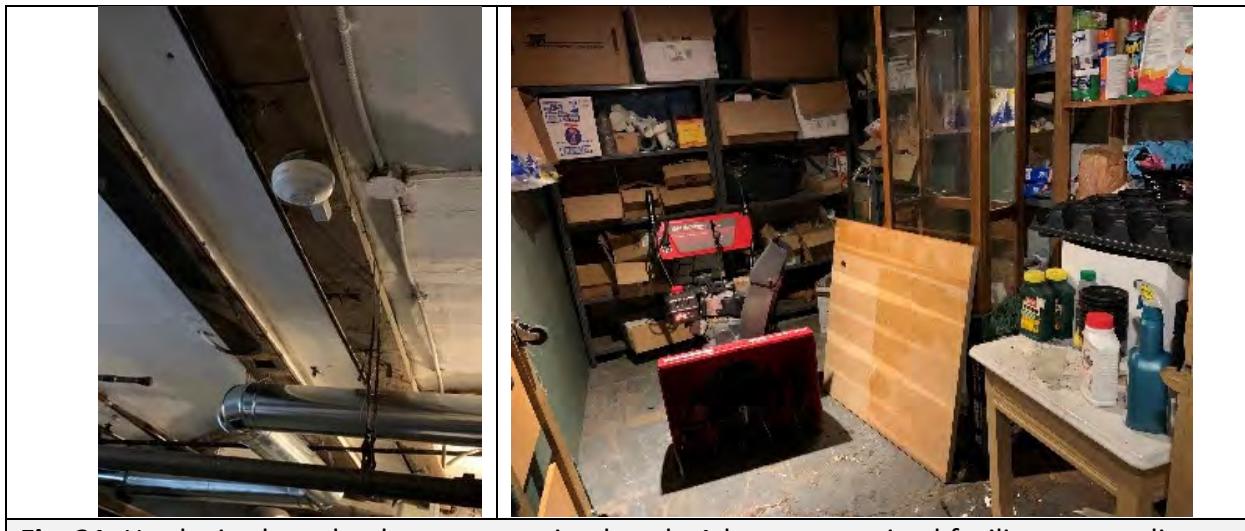
Fig. 21 Hard wired smoke detectors are in placed. A basement mixed facility space adjacent to the furnace room presents a fire hazard.

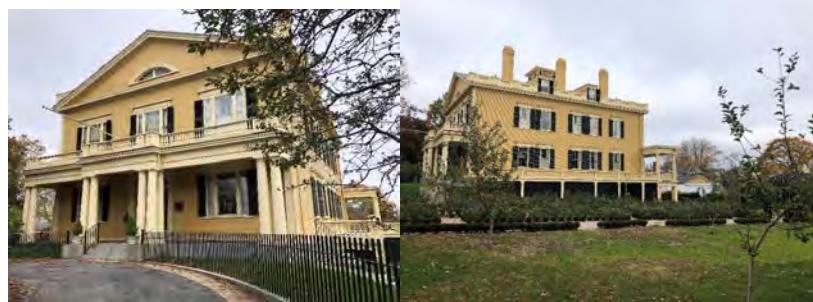
Fig. 24 Main House façade (west elevation) looking east from County Street (left) and south elevation looking northeast (right).

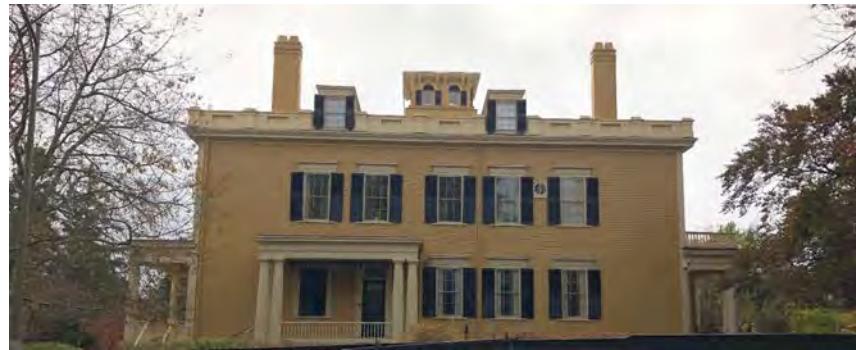
Fig. 25 Main House north elevation looking south

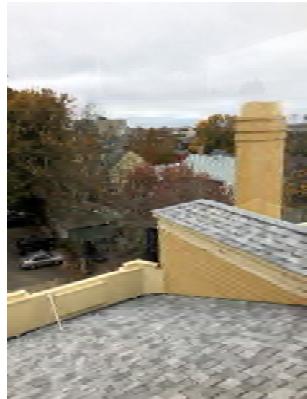
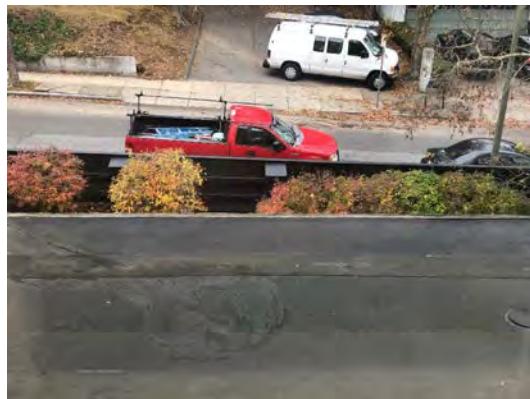
The Rotch-Jones Duff House features a gable roof with its ridge running west to east. A composite paneled parapet with aluminum frame surrounds the roof; two large dormers at both the north and south roof planes intersect the parapet at the roof's edge. The main gable roof, including the dormer roofs, is covered in architectural asphalt shingles that were installed in 2018. The cupola roof is also sheathed in architectural asphalt shingles installed in 2018. The three porch roofs are rubber membrane. These roofs are showing signs of deterioration and end-of-life issues, such as patching and fraying.

Fig. 27 Roofing: Asphalt and membrane roofing conditions. Main roof (left) and north porch (right).

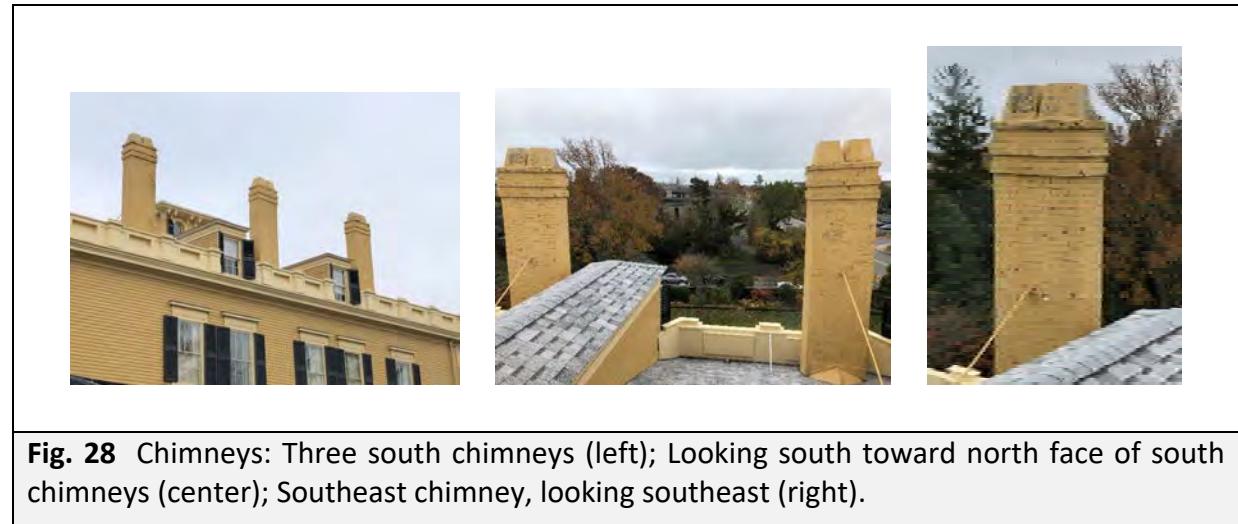
The Main House has five tall and narrow and rectangular corbelled brick chimneys: three are located on and integral to the south roof plane, near the edge of the roof, and the other two are located on and integral to the north roof plane, also near the edge of the roof. All of the chimneys are painted and each appears to have two flues. The Main House chimneys are no longer actively used for wood-burning fires; however, the furnaces may vent through one or more of the flues, so routine (at least annually) professional chimney inspections and cleaning, if necessary, are recommended to ensure that the chimneys are structurally sound and appropriately venting.

Fig. 28 Chimneys: Three south chimneys (left); Looking south toward north face of south chimneys (center); Southeast chimney, looking southeast (right).

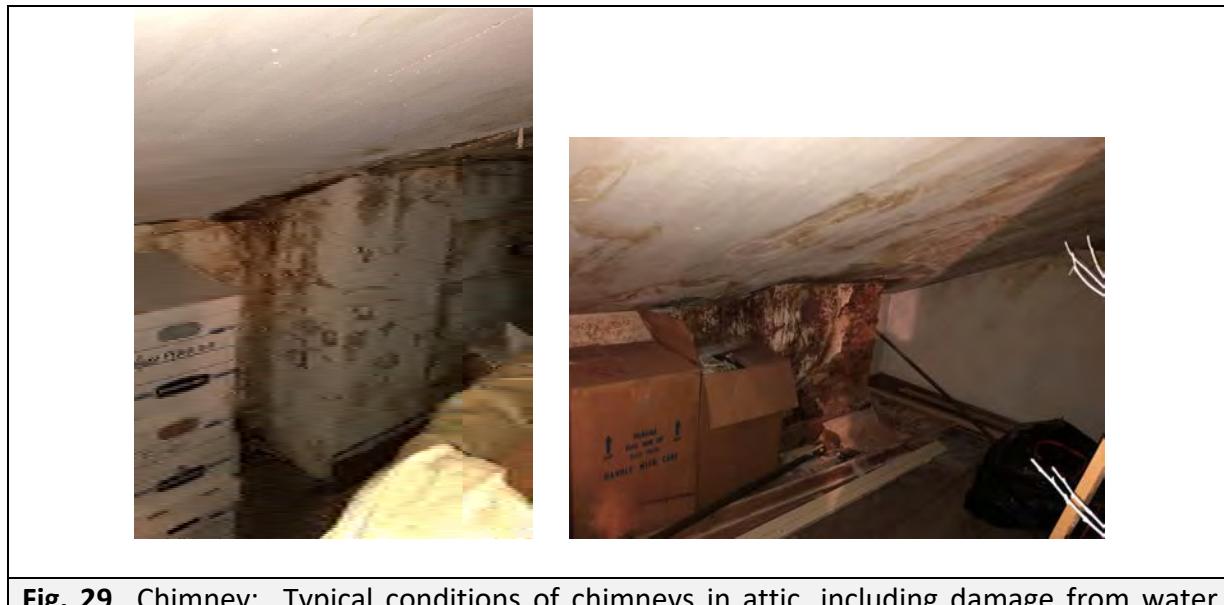
Fig. 29 Chimney: Typical conditions of chimneys in attic, including damage from water intrusion around the chimney, resulting in creosote-staining as well as failing plaster parging.

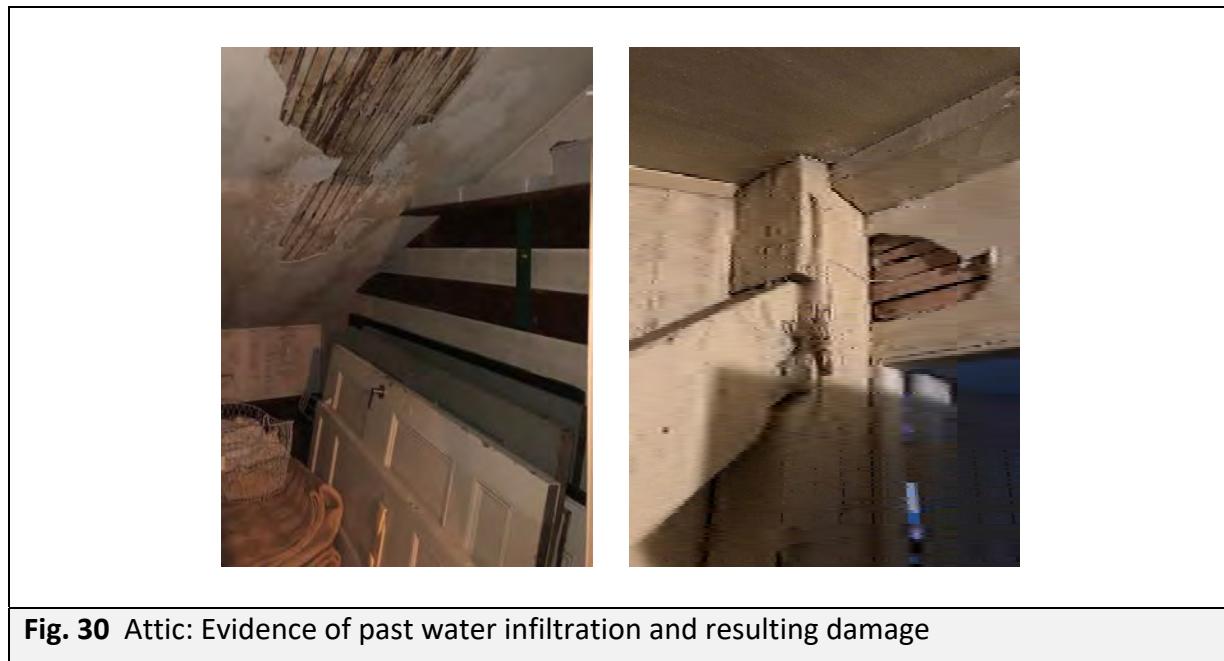
Fig. 30 Attic: Evidence of past water infiltration and resulting damage

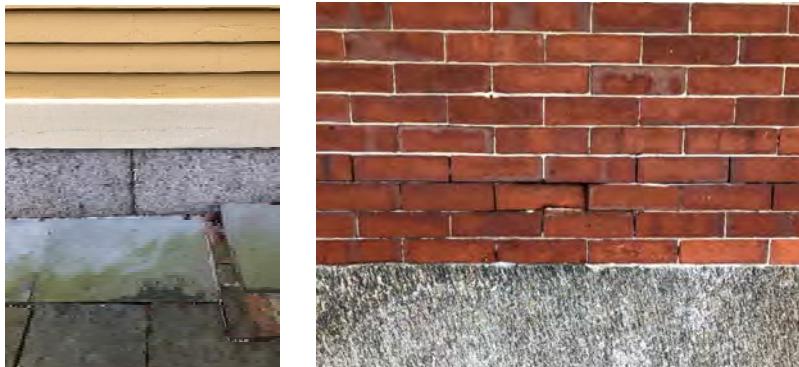
Fig. 31 Foundation: Showing areas where water splashes back or accumulates, resulting in brick and mortar deterioration

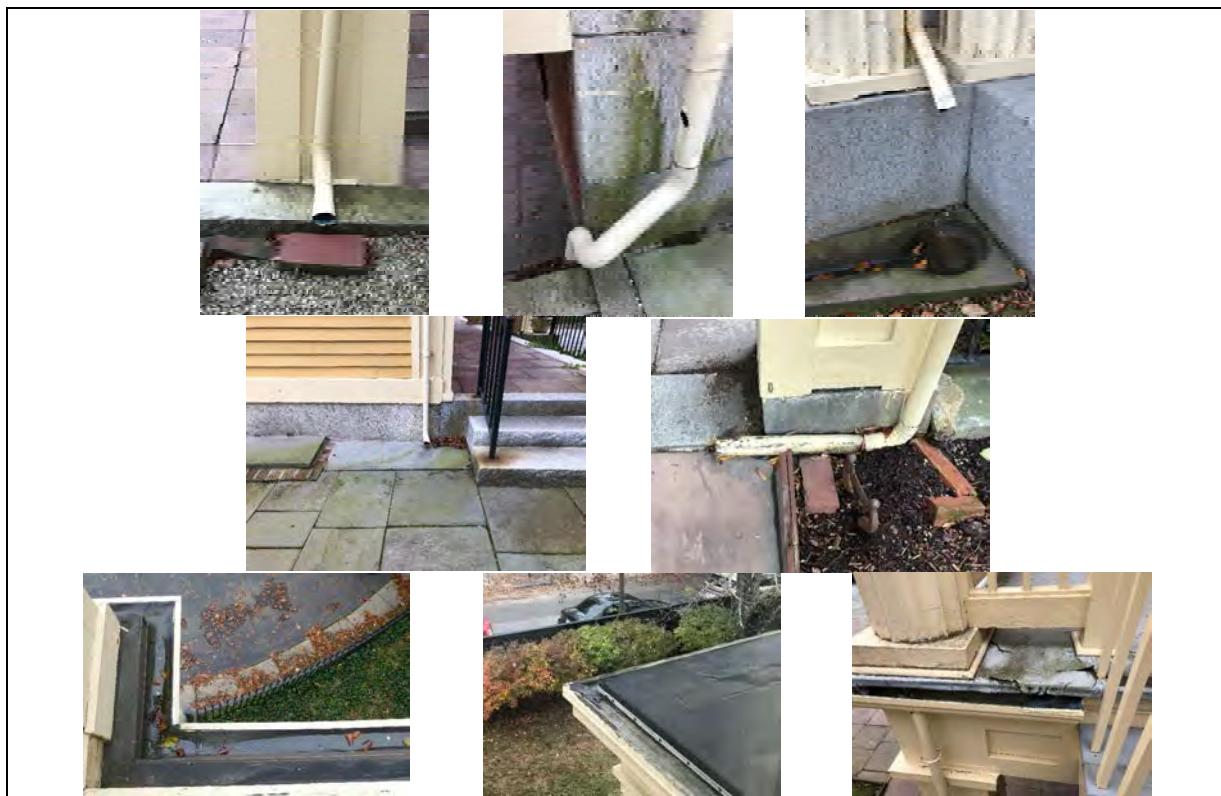
Fig. 32 Gutters, Downspouts, and Leaders: Typical conditions, including shallow gutters

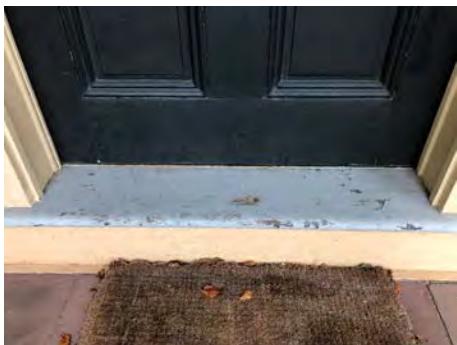
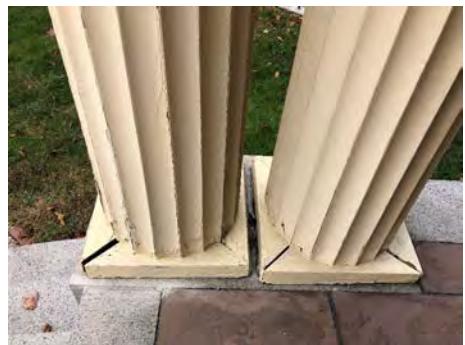
Fig. 33 Woodwork: Conditions needing repair/re-painting

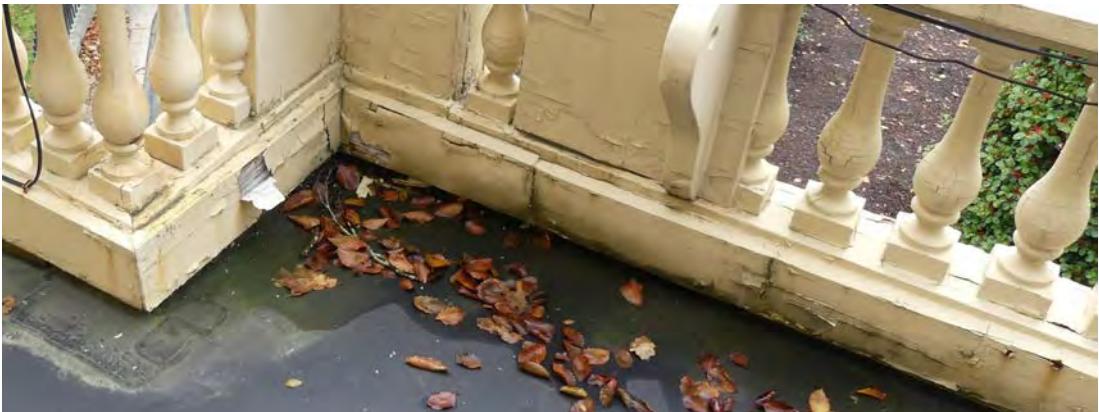
Fig. 34 Woodwork: West façade balustrade needing repair and re-painting

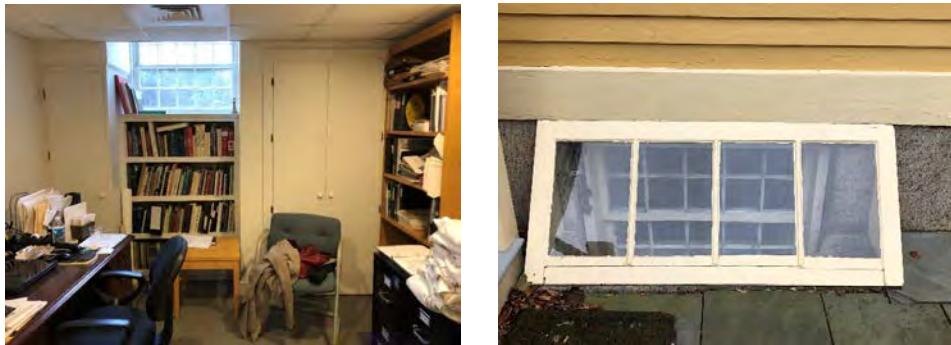
Fig. 36 Windows: North room, cellar window/well that is not weathertight and allowing water into the building's basement (center) office, near electrical panels

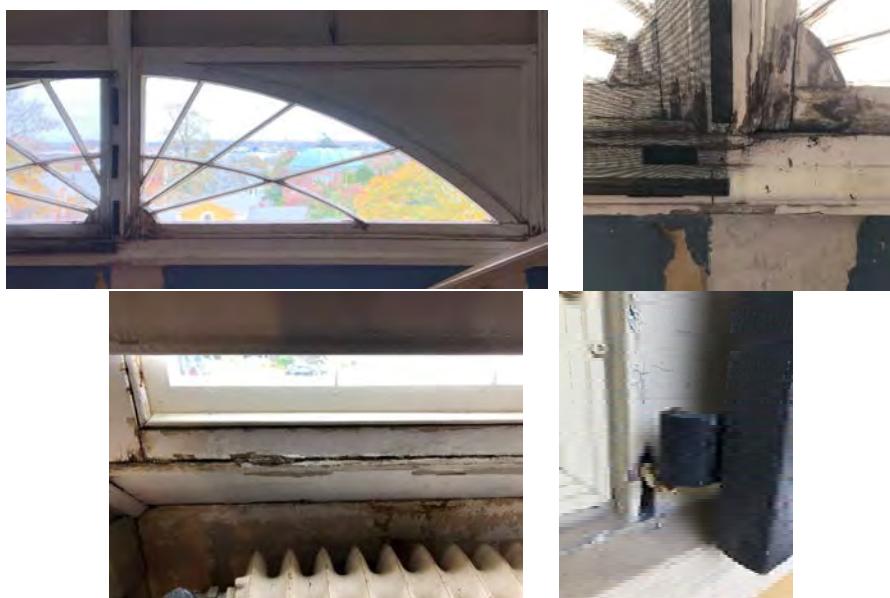
Fig. 37 Windows: Typical window conditions that need repair

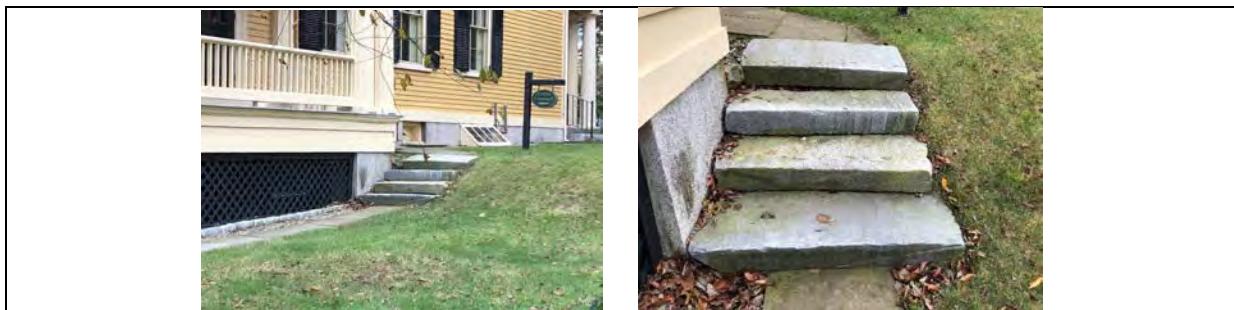
Fig. 38 North elevation showing displaced granite steps (shedding water south toward building)

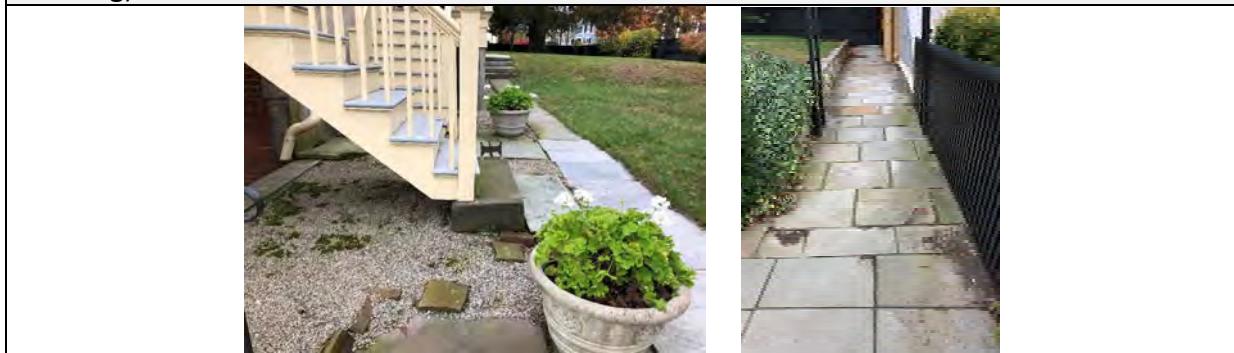
Fig. 39 North elevation showing displaced step (shedding water south toward building) (left); paved walkway west of the Coachman's House and Greenhouse.

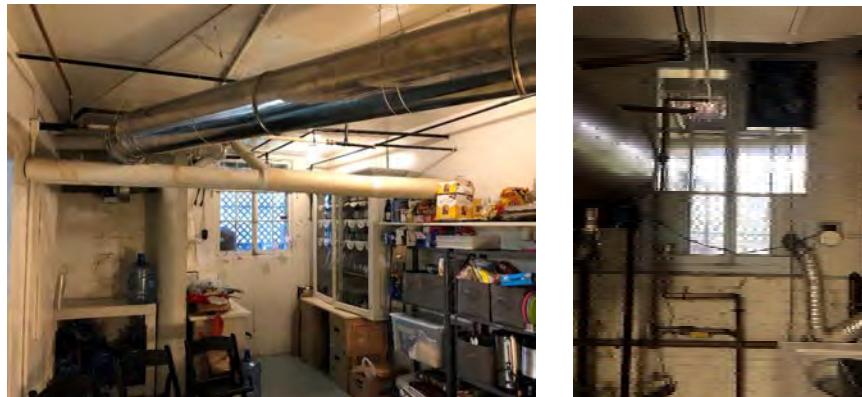
Fig. 41 HVAC: Ductwork, pipes, and wiring for various systems in the basement
