CITY OF NEW BEDFORD
COMMUNITY PRESERVATION ACT FY26
PROJECT APPLICATION

THE
HISTORIC STRUCTURE REPORT
OF
THE ROTCH-JONES-DUFF HOUSE & GARDEN MUSEUM
396 COUNTY STREET, NEW BEDFORD, MA 02740

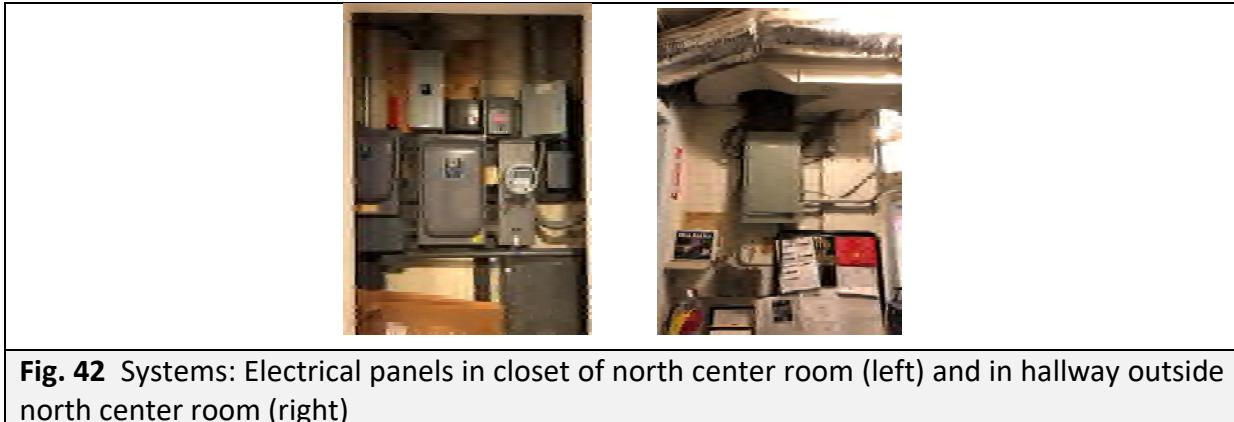
Fig. 42 Systems: Electrical panels in closet of north center room (left) and in hallway outside north center room (right)

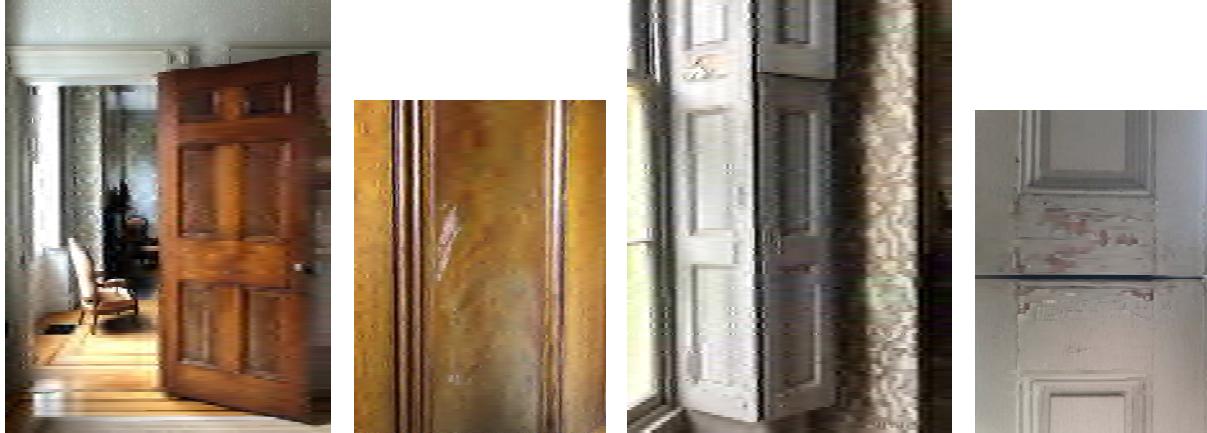
Fig. 43 Interior UV: Deteriorated finishes at doors and shutters at first story south rooms

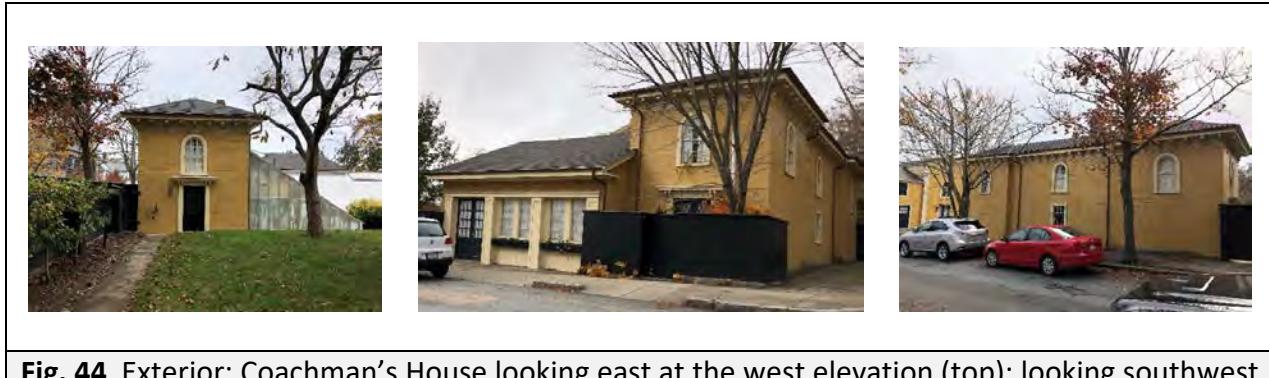
The buildings that comprise the Coachman's House are in good condition overall, and although toured as part of the two-day assessment, were not examined in detail. The assessment considered but quickly dismissed the prospect of using the Coachman's House for staff offices or collections activities, including storage. This building is too small and inaccessible for these uses, but more importantly, provides the RJD institution with consistent monthly rental revenue. It should be noted that the Coachman's House asphalt roof was replaced approximately ten years ago.

Fig. 44 Exterior: Coachman's House looking east at the west elevation (top); looking southwest at the east elevation, Garage at left (left); southeast at the north elevation (right)

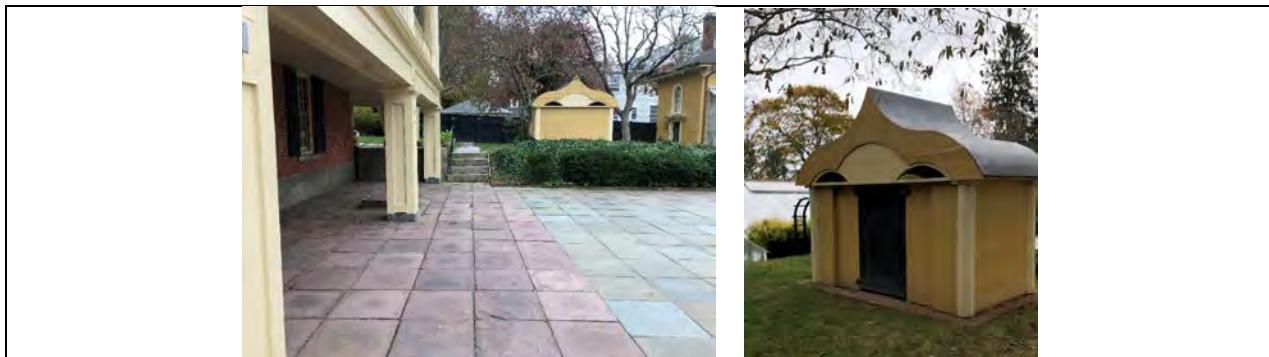
The existing Apiary, located in the north yard between the Main House and the Coachman's House, was constructed in ca. 1995, based on plans developed to recreate an apiary that had historically existed on the site. This small wooden building is currently used for programming related to bees and beekeeping. Due to the openings and lack of flashing details, this structure is inherently vulnerable to the weather and, as a result, cannot be utilized in any useful way for storage, for example.

Fig. 45 Apiary: Looking north (left) and southeast (Greenhouse behind)
