NEW BEDFORD REGIONAL AIRPORT  
RUNWAY 5-23 – PHASE 4

Reconstruct, Mark and Grove

Weekly Environmental Report

WEEK 12

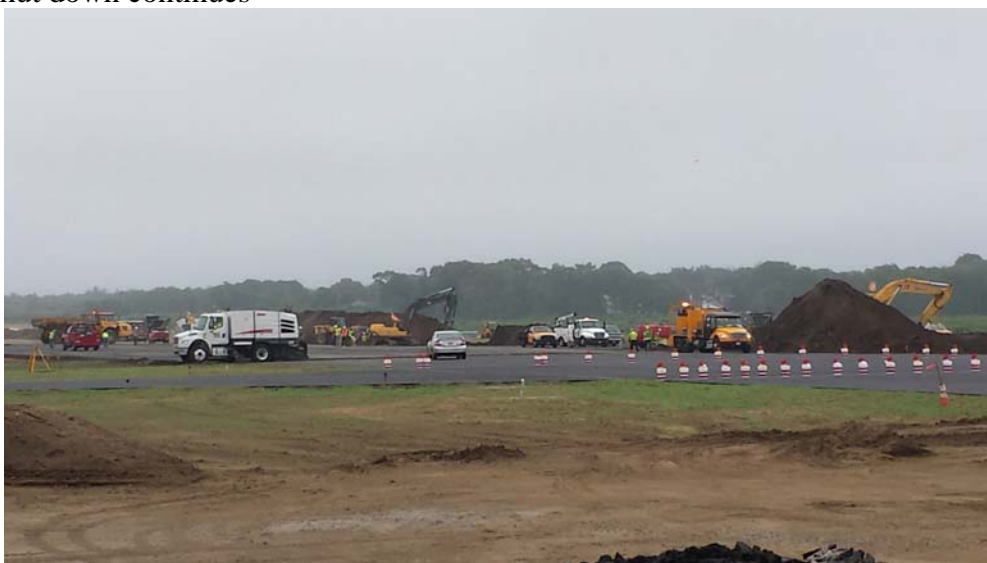
81 hour shut down is well underway by 7:00AM, grinding of pavement has been completed, electrical and storm drain trenches are being dug and loam piles are being shifted out of the area.

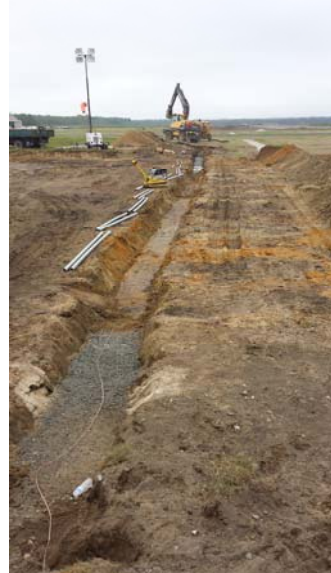
Electrical work was ongoing along the RW23 end of the runway.

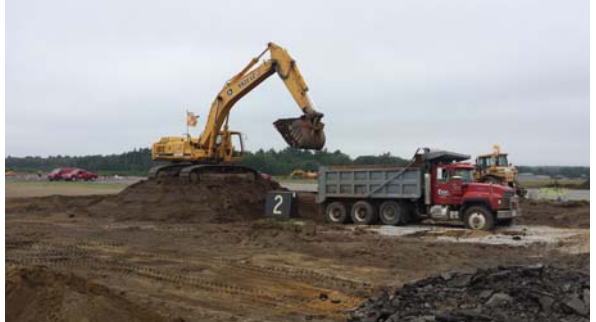
<p>Loam piles were being relocated outside the 81-hour shut down area in preparation for final grading and stabilization.</p>

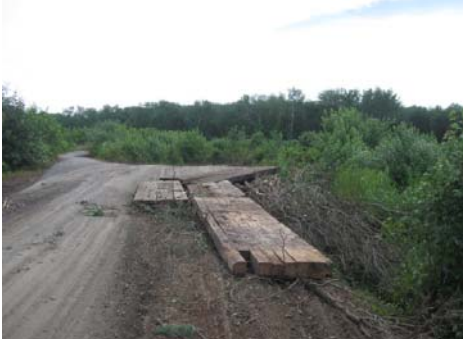
<p>81-hour shut down in progress. 2 crews working 12-hour shifts from ETL and all sub contractors.</p>	
<p>Additional log mats were placed at one section along the edge of the main access road down to the cut area to protect the adjacent wetland contingent.</p>

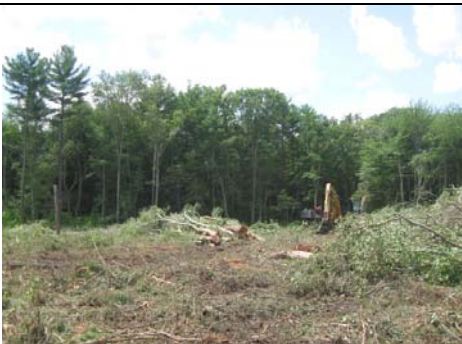
<p>81-hour shut down completed by 7:00AM. ETL provided 3 laborers, plus equipment operators to focus on erosion and sediment control repairs.</p>	
<p>This photo shows the limits of the cut-over are on 7/18/2014 – ETL is monitoring cut and estimates 200 more feet needs to be cleared before the side line is reached.</p>

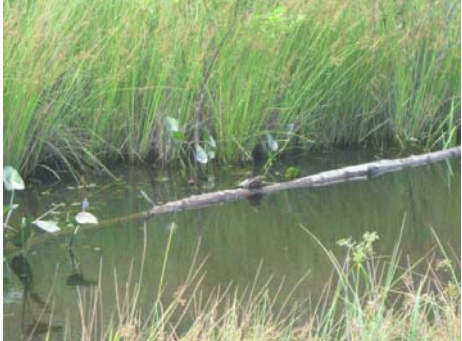
<p>A painted turtle was observed on a basking log in the section of wetland between the western and eastern Concrete Headwalls - North Side of RW 5 along the main road. Earlier in the day five painted turtles were observed here.</p>
