NEW BEDFORD COMMUNITY PRESERVATION COMMITTEE

COMMUNITY PRESERVATION ACT PROJECT APPLICATION FY24

PROJECT TITLE	Completion of Mansard, Dormers, Cornice Restoration		WARD	5
PROJECT LOCATION	427 County Street, New Bedford			
LEGAL PROPERTY OWNER OF RECORD	James Arnold Mansion, Inc.			
CPA PROGRAM CATEGORY (Select relevant categories for your project)	<input type="checkbox"/> OPEN SPACE		<input checked="" type="checkbox"/> HISTORIC RESOURCE	
	<input type="checkbox"/> RECREATION		<input type="checkbox"/> HOUSING	
ESTIMATED START DATE	1 July 2024	ESTIMATED COMPLETION DATE	31 October 2024	
ONE SENTENCE DESCRIPTION OF PROJECT	Completion of Mansard, Dormers, and Cornice Restoration begun with NB CPC FY23 Funding.

Mansard Replacements and Dormer / Cornice Repairs – Part 2

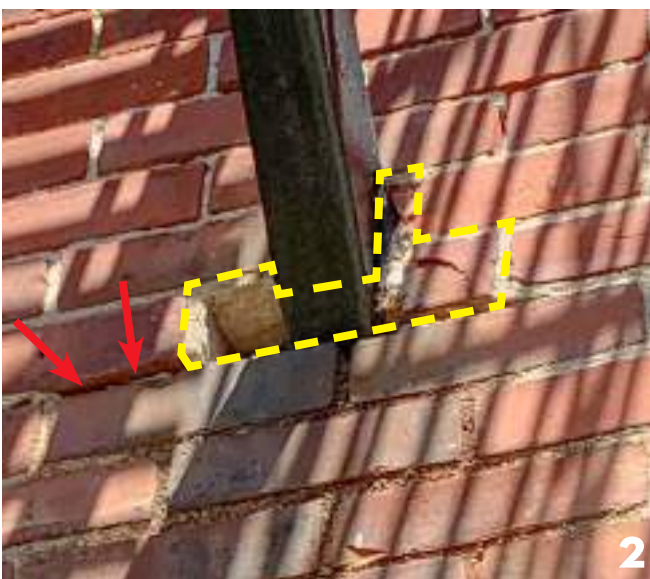
In some cases, patching efforts have failed entirely and bricks have fallen out entirely, leaving large openings around the supports (Img. 2). Gaps in the brick masonry suggest that other bricks may be loose and at risk of falling, a life safety issue that should be addressed immediately.

There are selective areas of stepped cracking in brick masonry, which typically originate at windows and in some cases, doors (Img. 3, right). Given that most brickwork is in fair condition, these cracks are likely suggestive of structural deficiencies more so than water penetration. This is a common condition that can mean rusting of internal structural members in the mildest cases or building settlement in the most severe. Closer observation of stone lintels and sills (outlined in further detail on the following page) suggests that stepped cracks are likely the result of shearing and/or compression caused by sagging at the heads and sills of openings. Similar cracking can be observed originating from many of the steel fire escape supports (Img. 4), suggesting additional structural deficiencies caused by those openings. Cracking of this sort can be observed in brick masonry from both 1821 and 1924.

Treatment of the deficiencies wrought by fire escapes will involve close coordination of modifications to or replacement of the fire escapes (currently being addressed by Fire Escape Engineers) and selective rebuilding of brick masonry. Existing bricks should be salvaged and reused where possible, and a mortar closely matching the original (that is, original to whichever portion of the building is being addressed) should be selected by a qualified preservation specialist.

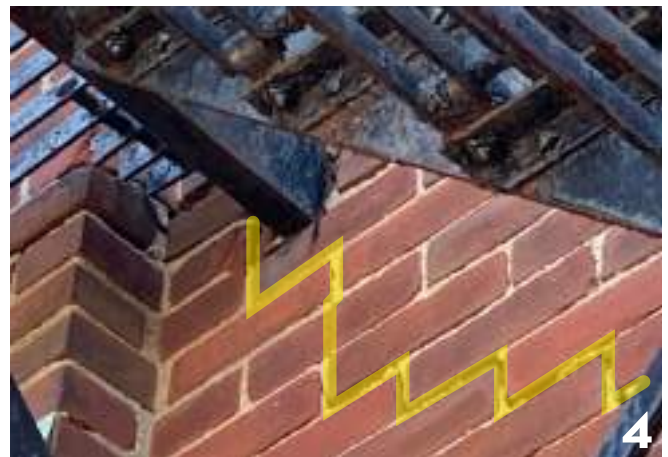
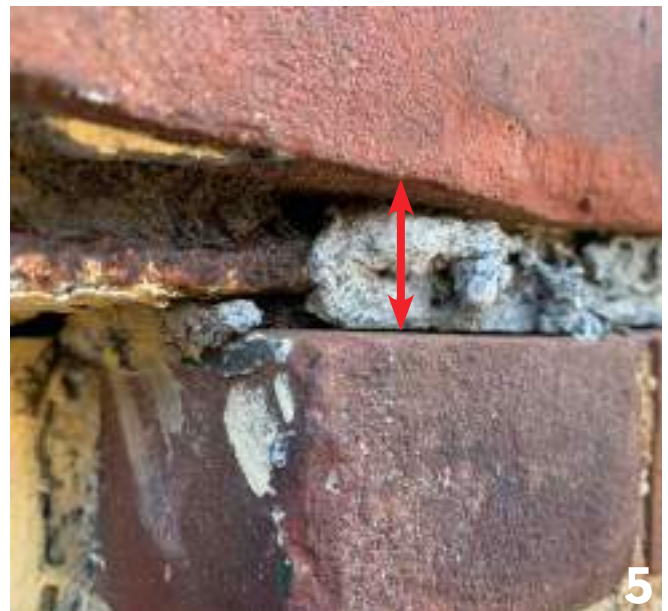
Some of these cracks have evidently been present for some time, as evidenced by their having been patched with mortar. *Cutting and repointing is a fair short-term solution in these areas, given that few or none of the cracks are over 1/4" in width. Any cracked bricks should be replaced in-kind.*

As previously mentioned, a wide variety of materials have been employed for window lintels and sills. In some cases, as seen in Img. 3, movement of natural and cast stone lintels and sills has caused cracking in the brick masonry. However, other less visible windows, such as those accessing the basement at the 1924 addition at the west elevation, have steel lintels. The condition of these structural members will be addressed in further detail as part of a later subsection of this narrative, but the fact that they have rusted – in some cases severely – related to the surrounding brick masonry. As can be observed in Img. 5, these steel lintels extend several inches past the inner

In general, it appears that cracking in brick masonry is reflective of superficial deficiencies that can be readily treated through limited rebuilding and/or repointing as opposed to structural settlement. *We nonetheless recommend commissioning a structural engineer to assess masonry conditions throughout and determine if any reinforcement is necessary in the long term.*

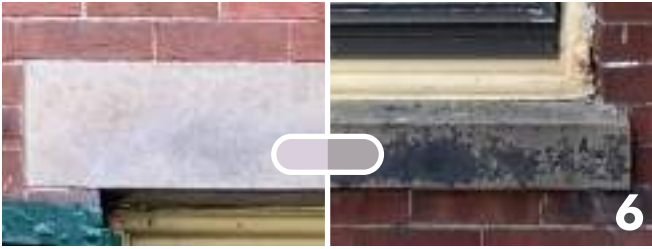
6

edges of the masonry opening, between brick courses. The resulting opening was patched with mortar, almost all of which has failed, likely a result of movement of the lintel paired with water penetration.

The lintels require replacement, to be addressed in a later subsection. This will require removal of the existing mortar; the joint should then be repointed with mortar closely matching the surrounding historic mortar mix. Staining on salvageable areas of brick and stone should be removed through gentle cleaning with a brush and mild solution.

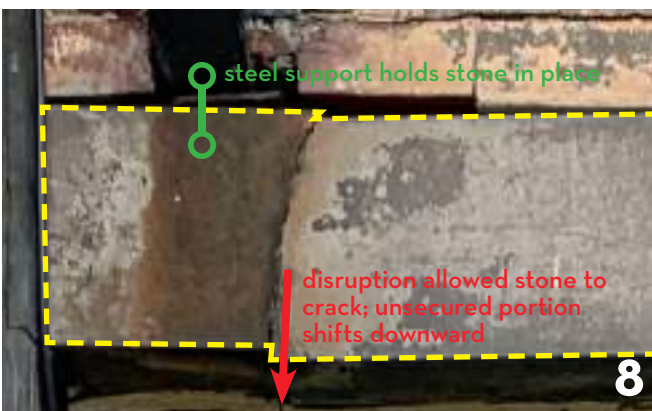
8

The most pressing issue with natural stone is structural cracking. In many cases, cracks run through both the lintel and sill (Img. 7), a result of either (a) the window sagging or (b) related structural cracking in the brick masonry, such as that described on the previous page (see Img. 8). *Treatment of stone lintels should be undertaken as part of a larger masonry project. That is, during repointing and or rebuilding of the surrounding brick masonry.*

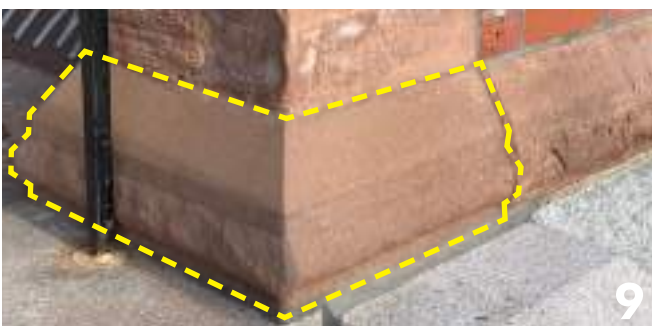
9

Cast stone closely matching the appearance of the existing could also be used. This is not typically recommended as it is not as durable as natural stone and becomes discolored more rapidly, though SSV has successfully specified cast brownstone in the past, at Bagg Hall in Princeton, Massachusetts (see Img. 9).

It is highly recommended that cracked masonry units be replaced with matching natural stone. The challenge, however, is that this stone was quarried in the early 19th century. A masonry expert may be able to assess the stone and determine where it was quarried, but it is likely that said quarry is now defunct. It follows that stone salvaged from other historic buildings could be used (qualified masons can often source matching stone). Otherwise, newly quarried stone could be used, with the condition in

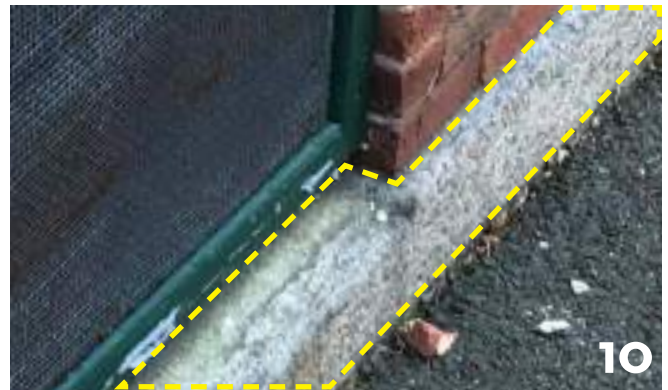
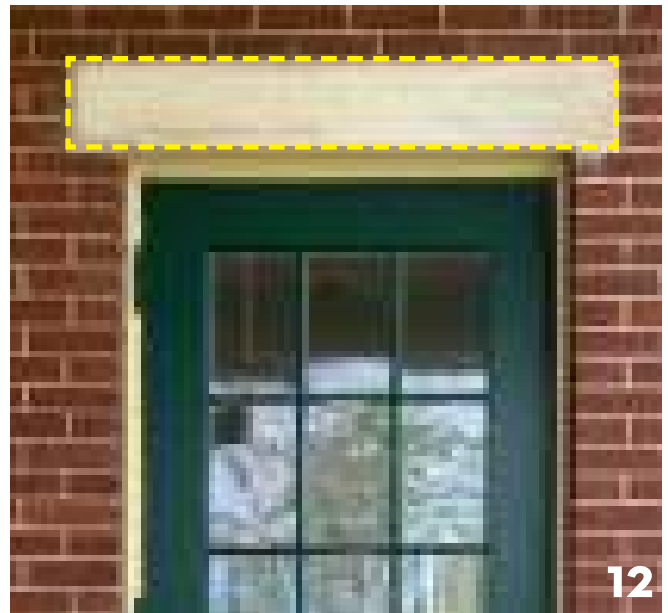
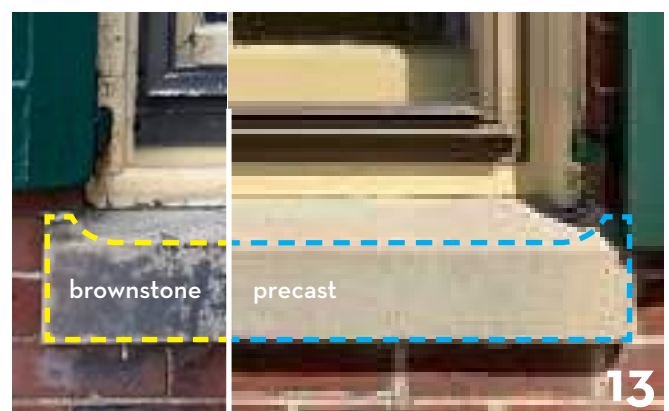
The third type of natural stone utilized at the building is granite (Img. 10). As was typical in the early 19th century and continues to be today, the foundations of the original house and ell are coursed granite (the most commonly quarried stone in New England). The apparent lack of moisture in the basement suggests that the granite foundation walls have withstood the test of time. That said, the building's situation at the highest point in the downtown area could also be a contributing factor. *Nonetheless, intervention does not seem necessary at this time, testament to granite's durability as a building material.*

Other areas where cut granite has been employed include five door sills and a single window lintel. It can be assumed here that the granite dates to the original construction of the portion of the building in which it has been employed, as there are two distinct types (see Img. 11, right). Once again, granite lintels and sills remain in good condition *and require no intervention, short of some repointing along with the brick masonry.*

The final type of natural stone utilized at the building was only employed in a single instance, clearly after the construction of the Wamsutta Club additions. There is a single limestone lintel at the currently unused door on the east elevation of the north wing (see Img. 12). The thick course of mortar around the stone and its mismatched nature both suggest that it replaced whatever was originally there. This theory holds especially true when compared against the 1923 drawings for the Wamsutta Club, which specify this door opening, but with a six-lite transom overhead that no longer exists. What is more: a 1941 photograph of the Wamsutta Club shows the window opening to the left before it was bricked in, suggesting that some modifications have been made to this portion of the building in the time since. While this lintel shows no signs of cracking or spalling, *it nonetheless disrupts the historic character of the structure and should be removed and replaced along with the other 1920s lintels (discussed on the following page).*

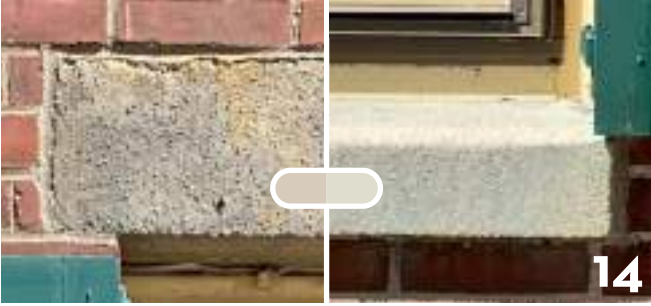
Most openings at the 1920s additions have precast lintels and sills, excepting those noted above. In a nod to the mansion's original construction, the builders precisely cast the concrete to the profile of the original sills, as can be seen in the side-by-side in Img. 13, right. Two concrete mixes were evidently used at each window (Img. 14).

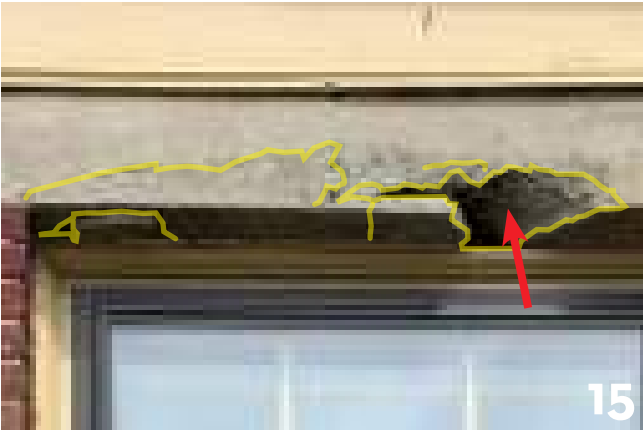
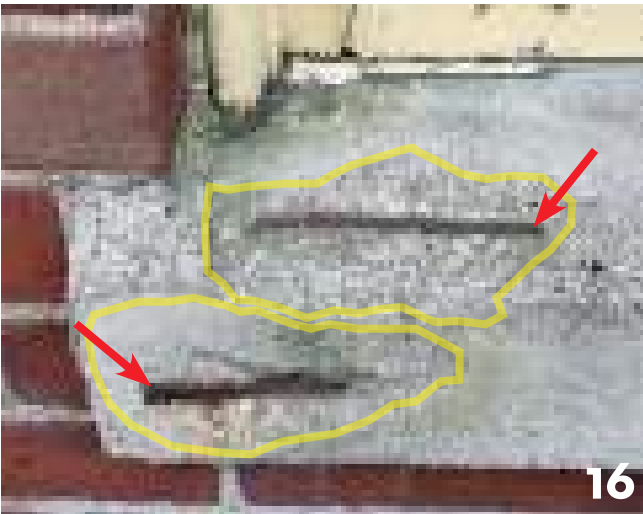
Precast concrete and cast stone are today often marketed as more durable alternatives to natural stone, but the current state of the precast members seems to suggest the opposite. Here, breakage occurs differently: the natural stone tends to crack from tensile forces whereas precast tends to spall. An example of this can be observed at the west elevation of the one-story kitchen addition (Img. 15), where the outer and lower faces of a precast lintel have crumbled, exposing the steel rebar embedded therein. This is the result of the material becoming saturated with moisture that then freezes and thaws to cause small, internal cracks. A similar condition can be seen at precast lintels and sills throughout the building, such as at the east elevation (Img. 16).

Not all precast stone pieces are damaged, but their general state suggests that all are nearing the end of their useful lives. What is more: to selectively replace only damaged stones would disrupt the overall appearance of the structure in that similar window and door openings would be mismatched. *It follows that all precast stones should be replaced with precast matching the existing. Given that the existing original (1924) material is precast, the implementation of new precast would be historically appropriate (assuming it closely matches the color, composition, and profile of the original). Fortunately, precast and cast stone have largely improved in the past century, and many companies offer a product that is similar in quality to natural stone.*

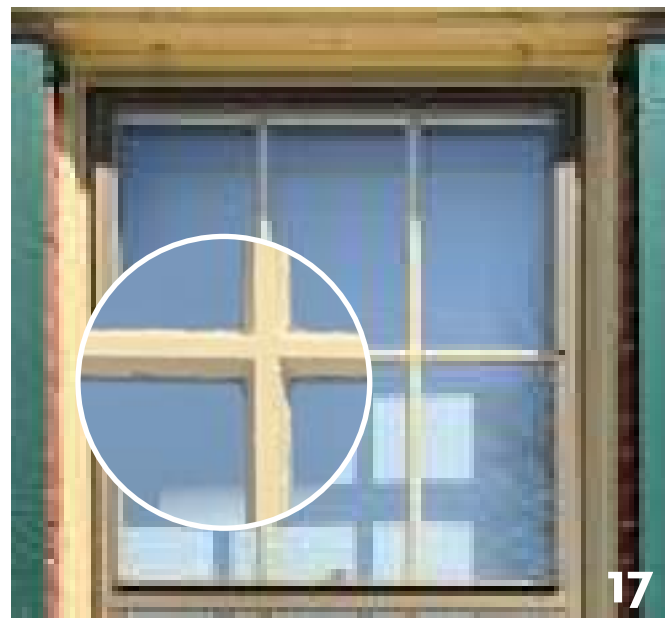
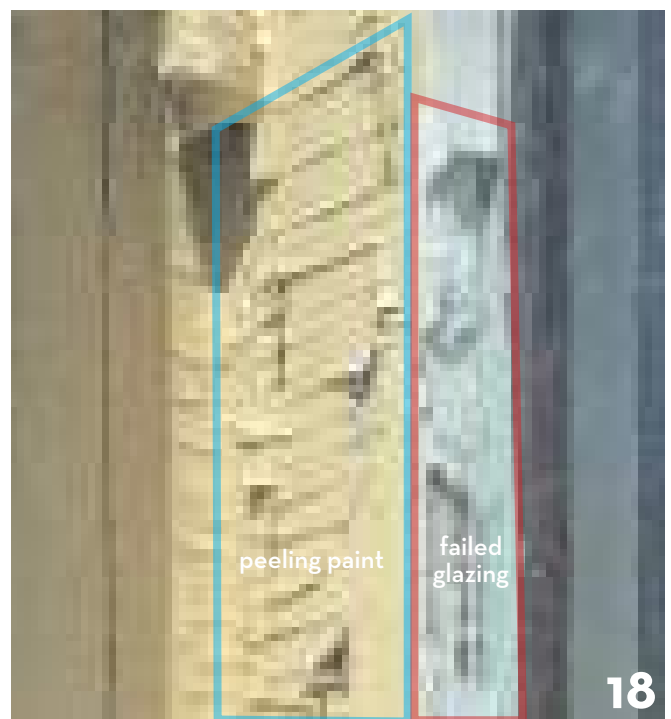
Wood windows at the east elevations are in particularly good condition (Img. 17), particularly those sheltered under the front porch. As noted above, storm panels were installed sometime in the last thirty years or so. It is likely that these were installed following a window restoration, otherwise it seems unfeasible that the wood sash would show so little glazing failure after a century. The only visible problem with these windows is some mild peeling of paint, which is caused by moisture retention and sun exposure. Others, however, while outwardly appearing to be in good condition, have limited functionality and require restoration – or in some cases replacement – of hardware, including sash cords and pulleys. *It is good practice to prepare and repaint historic windows every few years to slow the absorption of moisture into the wood (which in time causes decay). Nonetheless, this is a low-priority item compared to other necessary treatments – most notably, repointing and other masonry repairs.*

Wood windows in other areas show slightly more advanced signs of deterioration, such as alligating of the paint and selective glazing failure. Image 18 shows both conditions manifesting at a casement window on the sun room off the south wing (which is also, it should be noted, protected

by a storm panel). These deficiencies are not pervasive enough to be considered urgent, and pose no immediate threat to the building envelope or the windows themselves, especially given that most of the character-defining wood windows are protected by storm panels. *Once again, these deficiencies should be addressed in time, but they are not pressing right now. All sash and casings should be scraped and repainted. By the time this phase is undertaken, glazing failure may have accelerated, in which case sash should be removed, all finishes and putties scraped off, and the existing glass panes should be set in new glazing beds following repainting. Replacement of dysfunctional hardware, including pulleys and weather stripping, is part of any proper wood window restoration. All sash cords should also be replaced at this time. These measures do not come with much additional cost and will extend the windows' functionality.*

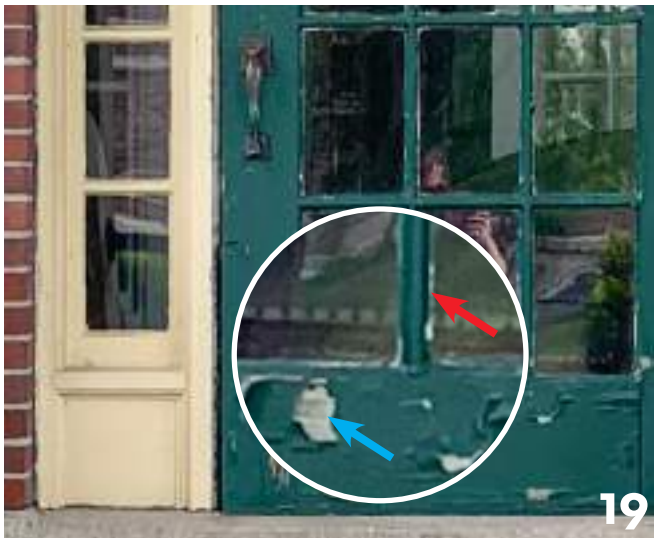
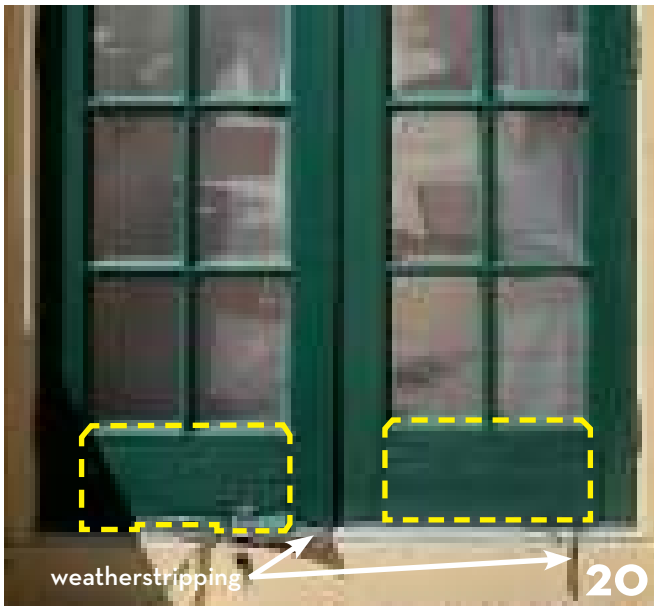
Time has not been as kind to other doors, particularly at less visible areas of the building. The north entrance accessing the former ladies' portion of the club (Img. 19) shows more advanced signs of deterioration, including dramatic peeling of paint and pervasive glazing failure, despite the fact that its sidelites are in fairly good condition. Given that this door and its sidelites are character defining features, *they should be removed and restored: existing paint scraped, the assembly dismantled, existing panes re-set in new glazing, and the reassembled units prepared and repainted.*

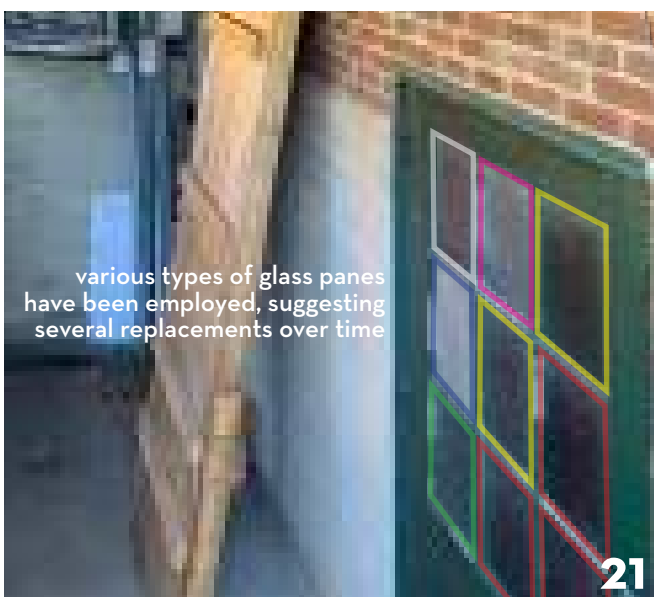
various types of glass panes have been employed, suggesting several replacements over time

caused severe damage to the weatherstripping and has even begun to splinter the lower edge of the left leaf (Img. 20). *This two-leaf door is not MAAB compliant, and as such is slated for replacement in the near future. Therefore, treatment of the existing assembly is not necessary.*

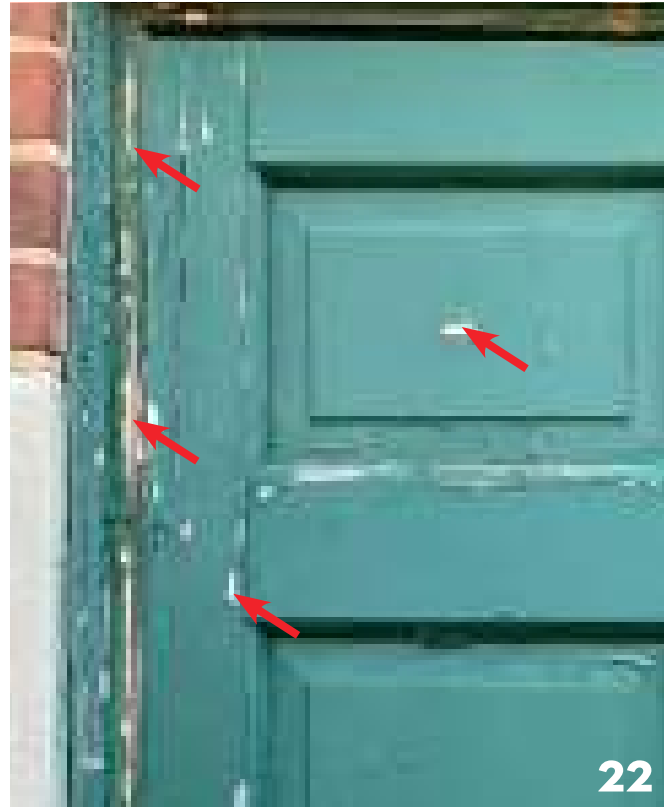
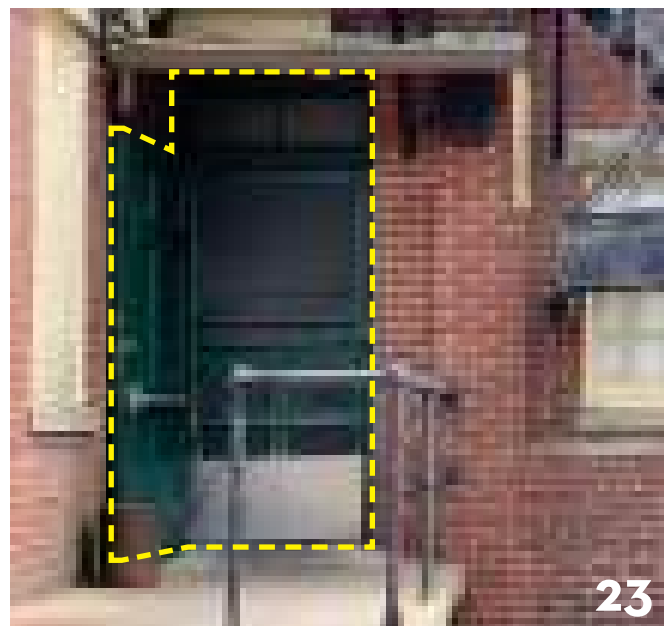
The third basement door is at the west elevation of the squash courts and shows signs of significant deterioration (Img. 22). The door, though it is not frequently used, serves as a means of emergency egress from the basement and Glass Museum, as required by the building code. *As such, our recommendation is to remove the existing assembly and replace it with a new door. The new door should be painted to match the Mansion's other doors for visual cohesion. Replacement is acceptable in this scenario because the door is not considered a character-defining feature.*

The egress doors from the first and second levels at the intersection of the squash court addition and kitchen expansion (see Img. 23, left) are in working condition *and require no intervention short of a fresh coat of paint. The transom at the first-floor door and both interior screen doors similarly require no treatment aside from proper preparation and re-painting.*

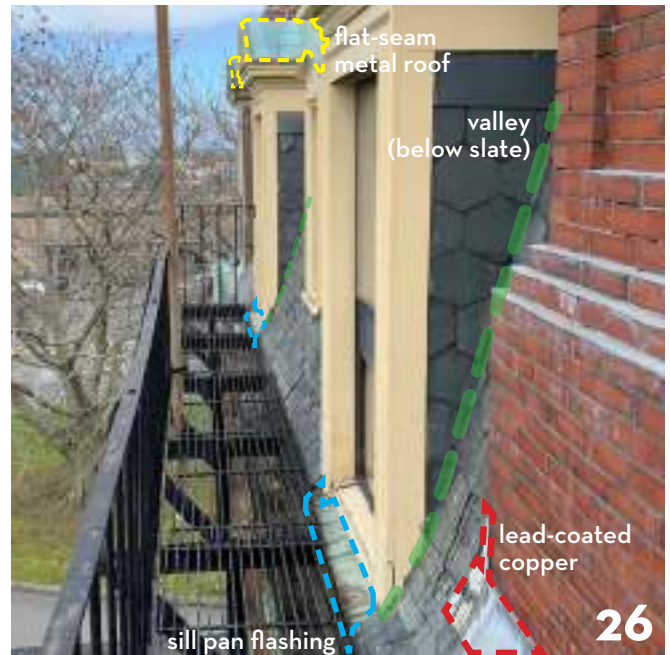
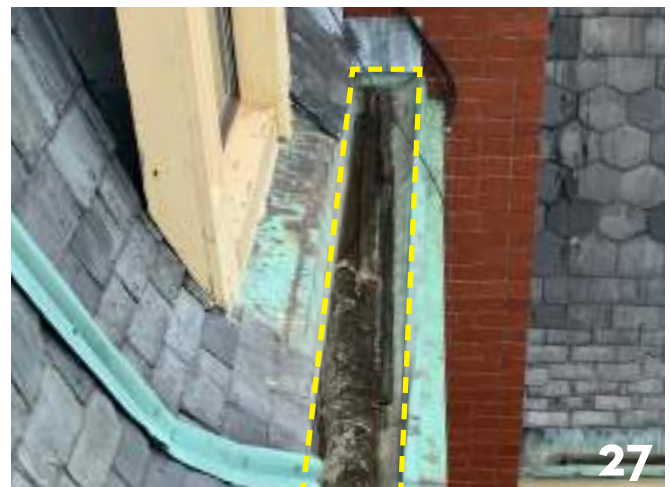
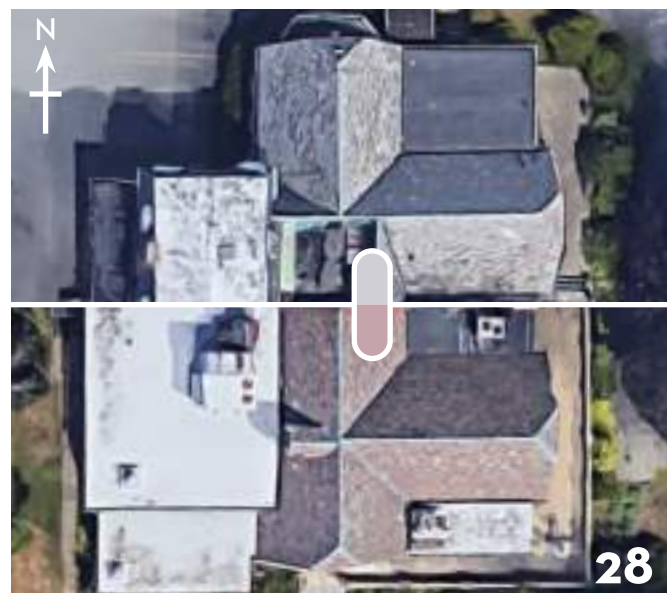
The mansards are in 'moderate' condition because there are some loose and missing slates (Img. 25). During site investigation, some fallen slates were discovered on the fire escape and in gutters at the north and west elevations. Further observation suggests that no more than 5% of slates are loose or missing, mostly at intersections of the roof and dormers or otherwise adjacent to copper assemblies. While this condition is not dire in the short term as far as its potential to allow water into the building, it is a life safety issue: falling slates could seriously harm passersby below. *Loose slates should be secured with new nails and missing slates should be replaced in-kind.*

Copper assemblies at these roofs (Img. 26) are generally in working condition, except for over the dormers, which are slated for replacement with in Summer 2022. Sill pan flashings at dormers, though corroded, show no signs of failure, and the same can be said for corner flashings and drip edges. Lead-coated copper stepped flashings at the intersection of the roof and chimneys, as far as can be observed, are also in working condition and appear not to require immediate replacement.

Copper gutter liners have held up moderately well at these roofs, despite being somewhat corroded (Img. 27). They appear to still retain water well, but heavy corrosion bodes poorly for their long-term performance. Areas of gutter observed from the fire escapes had some standing water more than 24 hours after the most recent rainfall, likely the result of a clogged downspout. *Given the presence of large trees around the mansion, gutters and downspouts should be monitored annually for clogs and cleaned when necessary. Further recommendations for phased treatment of gutters are provided on p. 42.*

Further, the existing downspouts are aluminum. While they are in working condition, they are somewhat disruptive to the building's historical appearance. *Copper downspouts would be more appropriate and are recommended. However, this is a low-priority item given that it is purely aesthetic and that the existing downspouts appear somewhat new.*

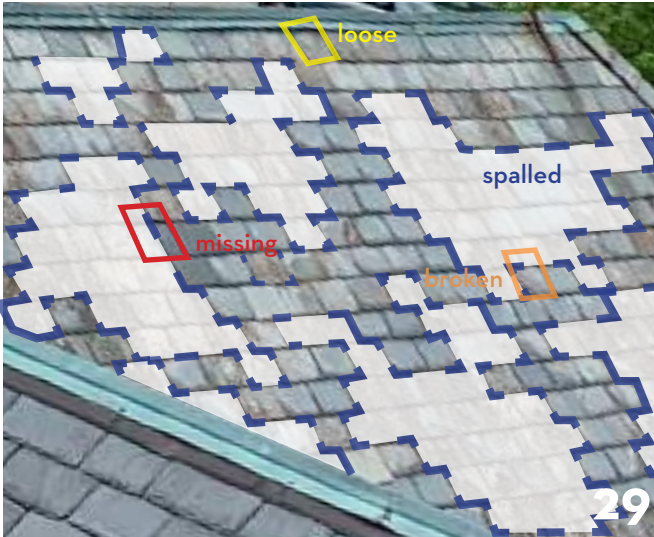
the west slope intersecting the ell, which were evidently replaced very recently and require no intervention. All other roof areas at this wing appear to still be surfaced with slates from the 1920s (Img. 29). Nearly all of these older slates are weathered around the edges, and about 75% have faced more substantial damage. Around 10% are broken, but very few are missing, suggesting that the slates are well secured. Sheet metal assemblies including ridge caps and valleys appear to be in good condition, allowing for proper drainage of water to the membrane roofs below. One of the slate ridges at the northmost clipped gable has been replaced with sheet metal, suggesting that others may soon begin to develop deficiencies. *Given that this roof area appears relatively secure, intervention is not a high priority. That said, any missing or broken slates should be replaced in kind; the roof should be monitored regularly for loose slates as falling debris is considered a life safety issue. If any fallen slates are discovered, immediate intervention will be required.*

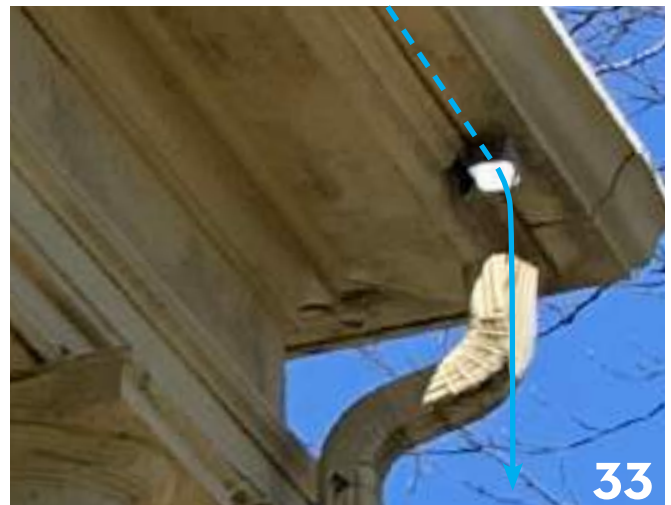
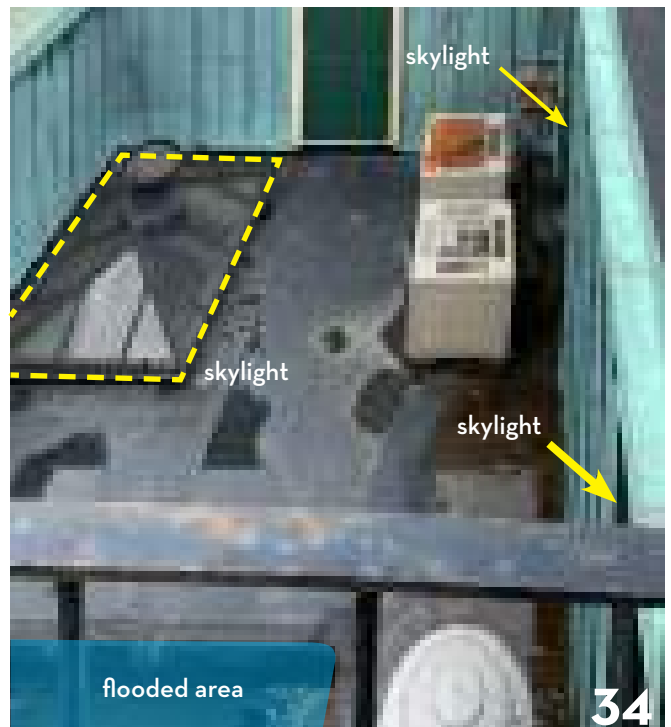
The one notable deficiency at these flat roofs is linked to drainage, specifically at the flat roof over the front porch and the attached porte cochère. Here, at least two problems were observed, the most pressing of which is a hole in the gutter at the southeast corner of the pavilion roof (Img. 32). This was likely caused by deterioration of the copper liner and related rotting of the wood trim below. Also, at the northeast corner of the porte cochère roof, the downspout has become detached from the gutter above (Img. 33). *While this is an easy fix, it draws attention once again to the downspouts' disruption of the building's historic character. Once again, aluminum downspouts throughout should be replaced with copper assemblies. Treatments for deficiencies at the wood gutters and cornice will be addressed in the following subsection of this narrative, but it follows that copper gutters throughout the building should be regularly inspected for deterioration like this. In a case like this, the most sustainable solution is replacement; and, if one area of copper gutter is being replaced, it is sensible to replace the entire section. Doing so in phases according to priority over the next several years would ensure that emergency repairs will not be required in the future.*

The final roof area requiring assessment has until now been referred to as a **'courtyard'** (Img. 34) for the sake of expediency. In actuality, this is an area of flat roof bounded on the north and east sides by vertical walls extending to the roof ridge, and at the south and west by the walls of the original house and historic ell, respectively. This roof area is approximately level with the building's second story, and can be accessed via a stair connecting the historic ell and north wing. The original drawings show five skylights here (there are currently three, with two having been removed in 2017) suggesting that its intended purpose was to provide natural light to the spaces below (originally a private dining room, a serving room, and a barber shop). Today, there are also two rooftop air conditioning units in this area. The original drawings called for copper roofing in the courtyard, in addition to its copper walls. Whether or not this was ever installed is difficult to tell, as the roof is now surfaced with EPDM; two of the four walls and the

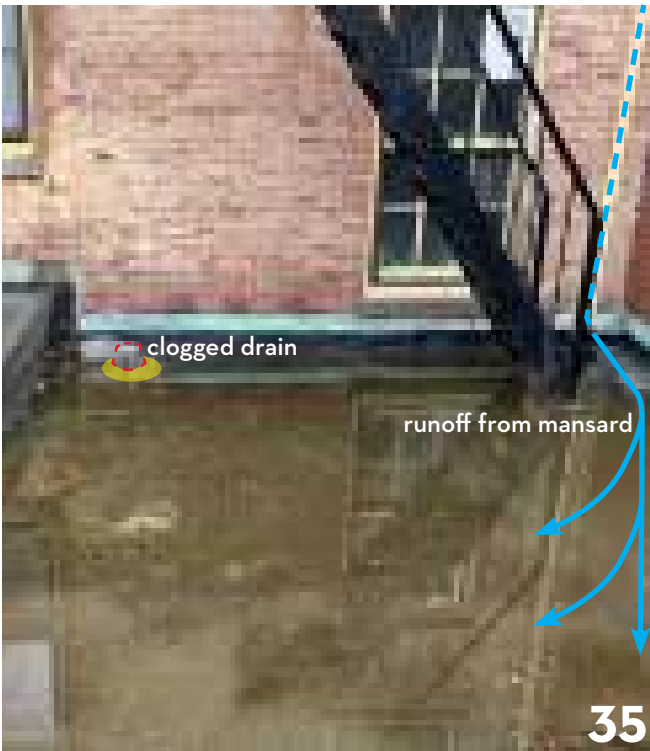
Upon inspection, more than 24 hours after the most recent rainfall, the courtyard was flooded with up to 3" of water (see Img. 35). Given that there is no evidence of leaking at the walls and ceiling of the interior spaces below, this condition is more reflective of deficiencies with the drainage system's maintenance than with the EPDM itself. In fact, the EPDM's ability to retain such a large amount of moisture suggests that it is actually in very good condition. The adjacent mansard roofs drain directly into the courtyard via two downspouts, where runoff is evidently directed to the ground via an internal drain system. Flooding can likely be attributed to a blockage in the drain, *which should be inspected via camera and cleared if necessary. The drain should be monitored at least once a month and after every rainstorm to ensure the drain is functioning properly, lest holes in the EPDM develop and water enter the building envelope.*

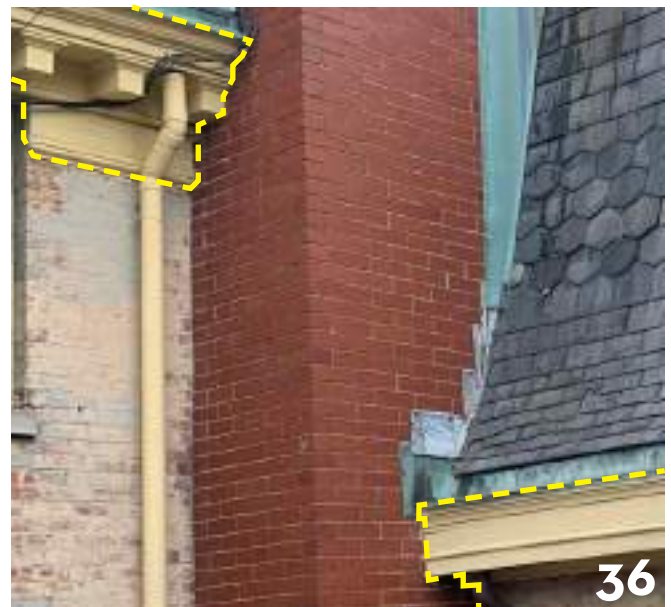
Wood cornices vary in condition across the building exterior. As would be expected, their level of deterioration typically depends on their level of exposure to the elements, particularly moisture, wind, and sunlight. For example, cornices at the 'courtyard' (Img. 36) discussed on the previous page have faced less deterioration in general than those at the building's outer faces, primarily due to the fact that they are inward-facing, protected by the surrounding walls. That said, some areas have peeling paint and missing dentils, suggesting some degree of moisture absorption. *The treatment recommendations for wood trim, on pp. 45-46, apply to all areas; restoration executed by phase alongside repairs to the adjacent roof/mansard areas, is most sensible; grouping work by area minimizes costs associated with scaffolding.*

The most pervasive issue with wood cornices is the loss of paint (Img. 37). As mentioned earlier in the context of doors and windows, paint prevents aging. The most important step in preserving exterior wood elements at a building is regular re-painting. While detailed paint analysis could tell us for sure if and when wood trim has been painted, visual evidence suggests that it has been some time. Failure of paint, caused primarily by exposure to sunlight, has allowed the wood below to absorb moisture, which, in turn, has caused the wood to expand, cracking more paint and allowing for further absorption of moisture. In other words, the problem compounds itself over time, especially when measures are not taken to properly maintain the structure (i.e. repainting, caulking open joints, ensuring proper function of gutters, etc.).
