CITY OF NEW BEDFORD
COMMUNITY PRESERVATION ACT FY26
PROJECT APPLICATION

PROJECT INFORMATION			
PROJECT TITLE	Arnold Mansion - Millwork Repairs and Paint		WARD 5
PROJECT LOCATION	427 County Street, New Bedford, MA 02740		
LEGAL PROPERTY OWNER OF RECORD	James Arnold Mansion, Inc.		
CPA PROGRAM CATEGORY <i>(Select relevant categories for your project)</i>	<input type="checkbox"/> OPEN SPACE	<input checked="" type="checkbox"/> HISTORIC RESOURCE	
	<input type="checkbox"/> RECREATION	<input type="checkbox"/> HOUSING	
ESTIMATED START DATE	1 July 2026	ESTIMATED COMPLETION DATE	31 December 2026

JAMES ARNOLD MANSION

CONDITIONS ASSESSMENT & TREATMENT RECOMMENDATIONS

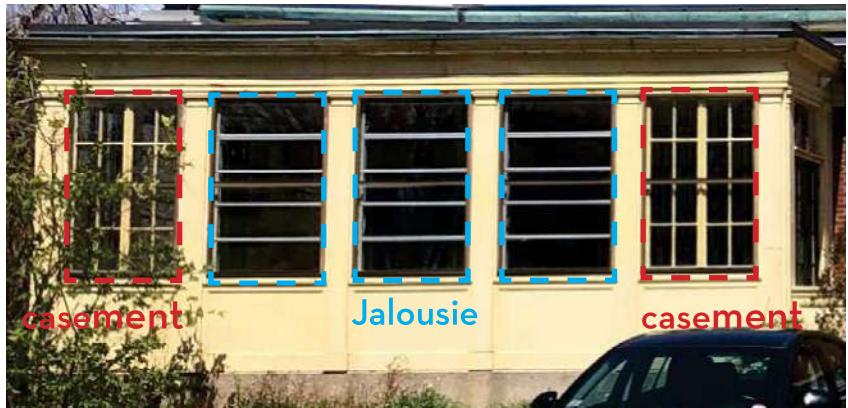
- The sunroom at the southwest corner of the structure is characterized by a ribbon of large windows wrapping the space (hence 'sunroom'). Some are wood casement windows, with each leaf having eight panes in a four-by-two array. These appear to be original to the 1924 construction, as evidenced by their being called out in the 1923 drawings. The Jalousie windows are a later intervention and as such are not character defining.

In fact, these windows – though very much of their time (likely the 1960s or '70s) – disrupt the building's historic character. Some consideration should be given to replacing these with replicas of the surrounding casements.

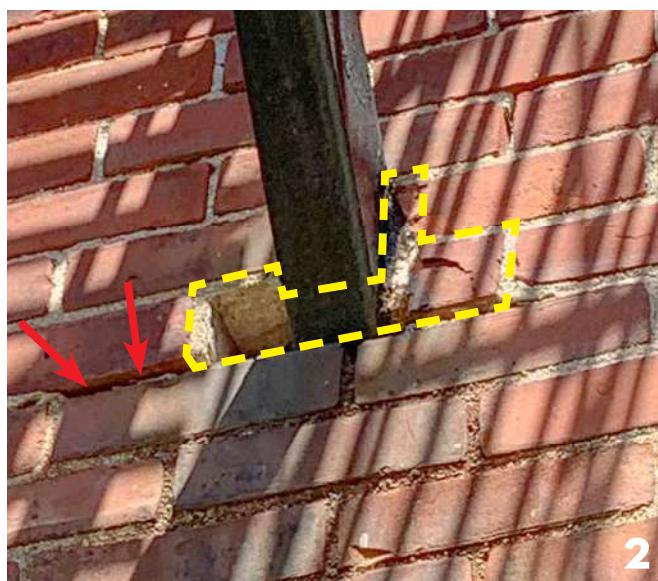
2

In some cases, patching efforts have failed entirely and bricks have fallen out entirely, leaving large openings around the supports (Img. 2). Gaps in the brick masonry suggest that other bricks may be loose and at risk of falling, a life safety issue that should be addressed immediately.

Treatment of the deficiencies wrought by fire escapes will involve close coordination of modifications to or replacement of the fire escapes (currently being addressed by Fire Escape Engineers) and selective rebuilding of brick masonry. Existing bricks should be salvaged and reused where possible, and a mortar closely matching the original (that is, original to whichever portion of the building is being addressed) should be selected by a qualified preservation specialist.

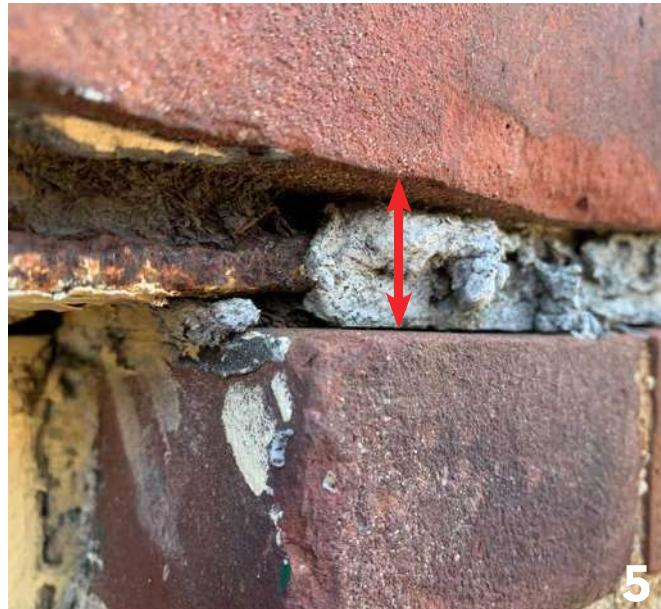
5

As previously mentioned, a wide variety of materials have been employed for window lintels and sills. In some cases, as seen in Img. 3, movement of natural and cast stone lintels and sills has caused cracking in the brick masonry. However, other less visible windows, such as those accessing the basement at the 1924 addition at the west elevation, have steel lintels. The condition of these structural members will be addressed in further detail as part of a later subsection of this narrative, but the fact that they have rusted — in some cases severely — related to the surrounding brick masonry. As can be observed in Img. 5, these steel lintels extend several inches past the inner

edges of the masonry opening, between brick courses. The resulting opening was patched with mortar, almost all of which has failed, likely a result of movement of the lintel paired with water penetration.

The lintels require replacement, to be addressed in a later subsection. This will require removal of the existing mortar; the joint should then be repointed with mortar closely matching the surrounding historic mortar mix. Staining on salvageable areas of brick and stone should be removed through gentle cleaning with a brush and mild solution.

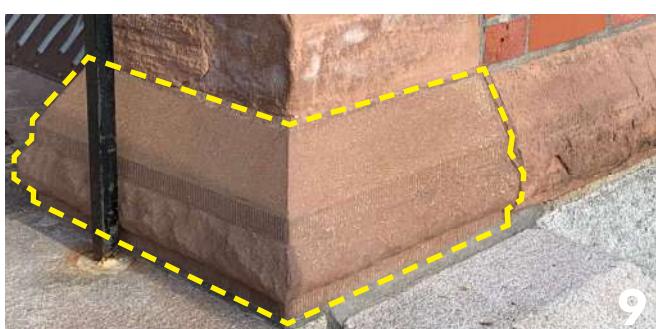
9

Cast stone closely matching the appearance of the existing could also be used. This is not typically recommended as it is not as durable as natural stone and becomes discolored more rapidly, though SSV has successfully specified cast brownstone in the past, at Bagg Hall in Princeton, Massachusetts (see Img. 9).

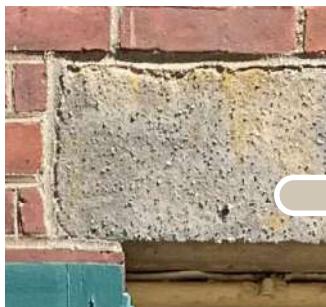
14

Most openings at the 1920s additions have precast lintels and sills, excepting those noted above. In a nod to the mansion's original construction, the builders precisely cast the concrete to the profile of the original sills, as can be seen in the side-by-side in Img. 13, right. Two concrete mixes were evidently used at each window (Img. 14).

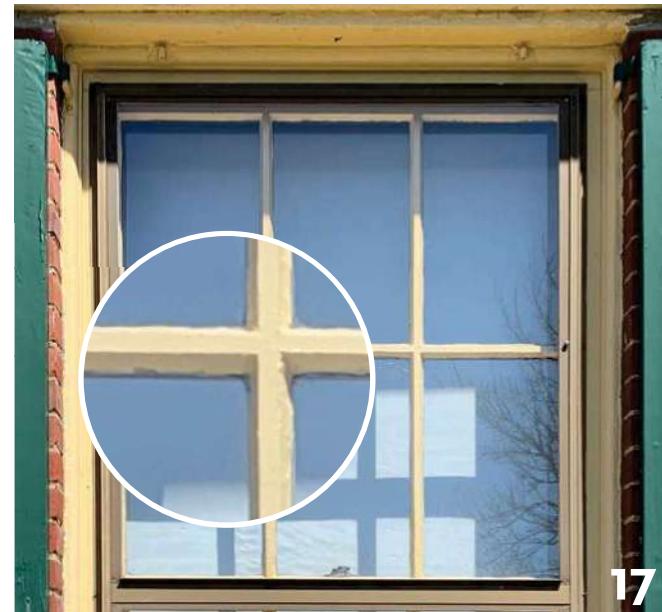
17

Wood windows at the east elevations are in particularly good condition (Img. 17), particularly those sheltered under the front porch. As noted above, storm panels were installed sometime in the last thirty years or so. It is likely that these were installed following a window restoration, otherwise it seems unfeasible that the wood sash would show so little glazing failure after a century. The only visible problem with these windows is some mild peeling of paint, which is caused by moisture retention and sun exposure. Others, however, while outwardly appearing to be in good condition, have limited functionality and require restoration - or in some cases replacement - of hardware, including sash cords and pulleys. *It is good practice to prepare and repaint historic windows every few years to slow the absorption of moisture into the wood (which in time causes decay). Nonetheless, this is a low-priority item compared to other necessary treatments – most notably, repointing and other masonry repairs.*

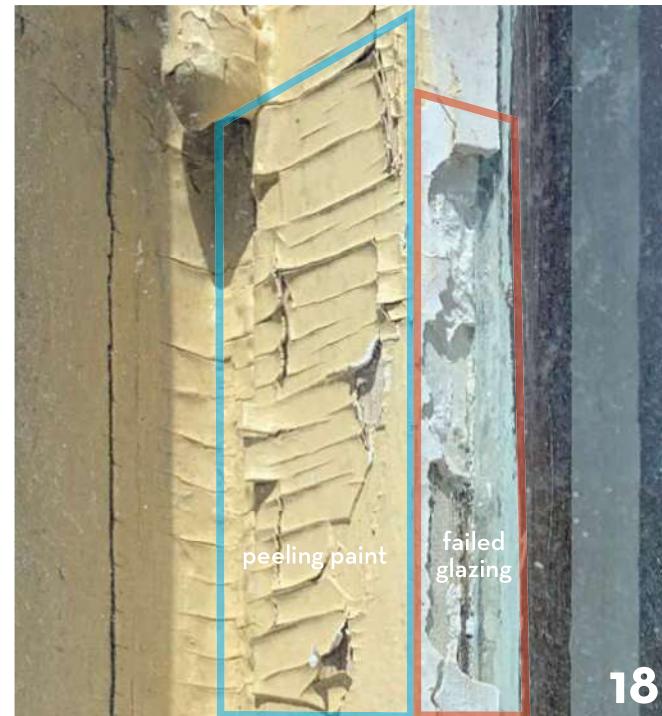
Wood windows in other areas show slightly more advanced signs of deterioration, such as alligatoring of the paint and selective glazing failure. Image 18 shows both conditions manifesting at a casement window on the sun room off the south wing (which is also, it should be noted, protected

by a storm panel). These deficiencies are not pervasive enough to be considered urgent, and pose no immediate threat to the building envelope or the windows themselves, especially given that most of the character-defining wood windows are protected by storm panels. *Once again, these deficiencies should be addressed in time, but they are not pressing right now. All sash and casings should be scraped and repainted. By the time this phase is undertaken, glazing failure may have accelerated, in which case sash should be removed, all finishes and putties scraped off, and the existing glass panes should be set in new glazing beds following repainting. Replacement of dysfunctional hardware, including pulleys and weather stripping, is part of any proper wood window restoration. All sash cords should also be replaced at this time. These measures do not come with much additional cost and will extend the windows' functionality.*

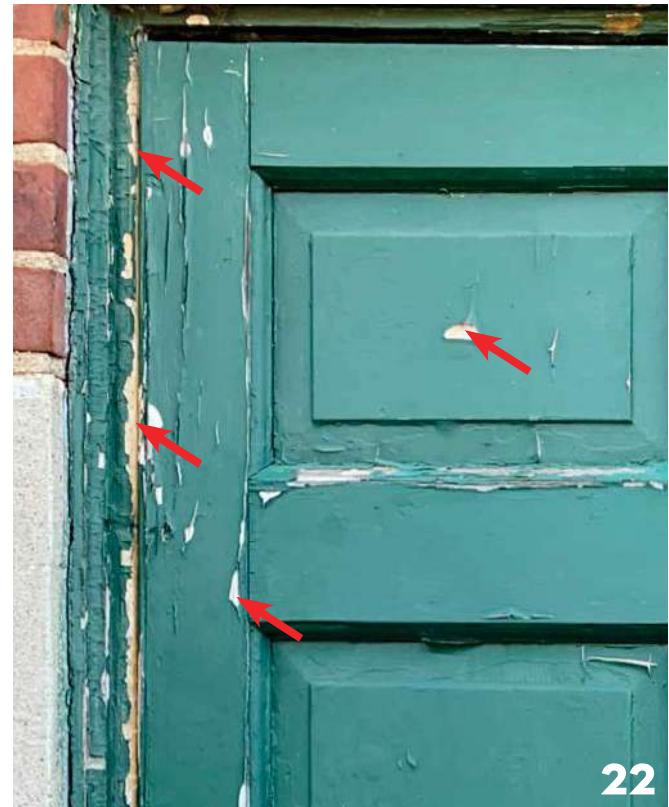
22

The third basement door is at the west elevation of the squash courts and shows signs of significant deterioration (Img. 22). The door, though it is not frequently used, serves as a means of emergency egress from the basement and Glass Museum, as required by the building code. *As such, our recommendation is to remove the existing assembly and replace it with a new door. The new door should be painted to match the Mansion's other doors for visual cohesion. Replacement is acceptable in this scenario because the door is not considered a character-defining feature.*

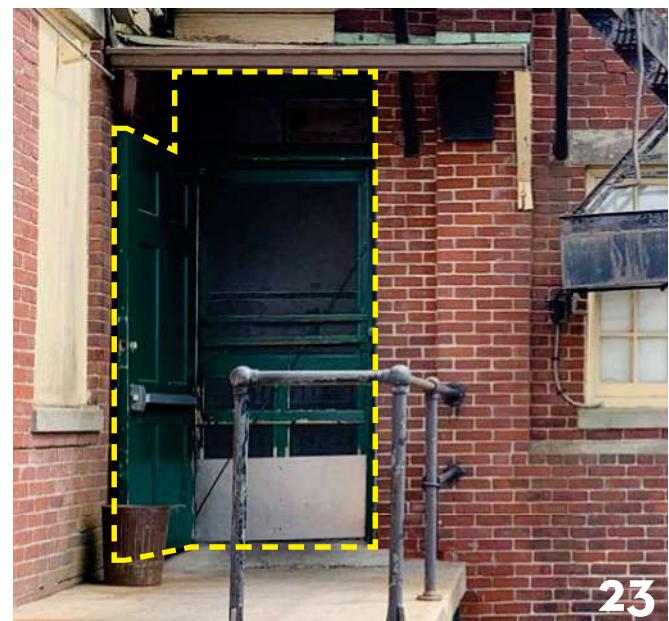
23

The egress doors from the first and second levels at the intersection of the squash court addition and kitchen expansion (see Img. 23, left) are in working condition *and require no intervention short of a fresh coat of paint. The transom at the first-floor door and both interior screen doors similarly require no treatment aside from proper preparation and re-painting.*
