AS-BUILT SEPTEMBER 9, 2016

DEPARTMENT OF PUBLIC INFRASTRUCTURE

Howard Avenue Pump Station Map 116 Lot 99 99 River Road, New Bedford MA 02745

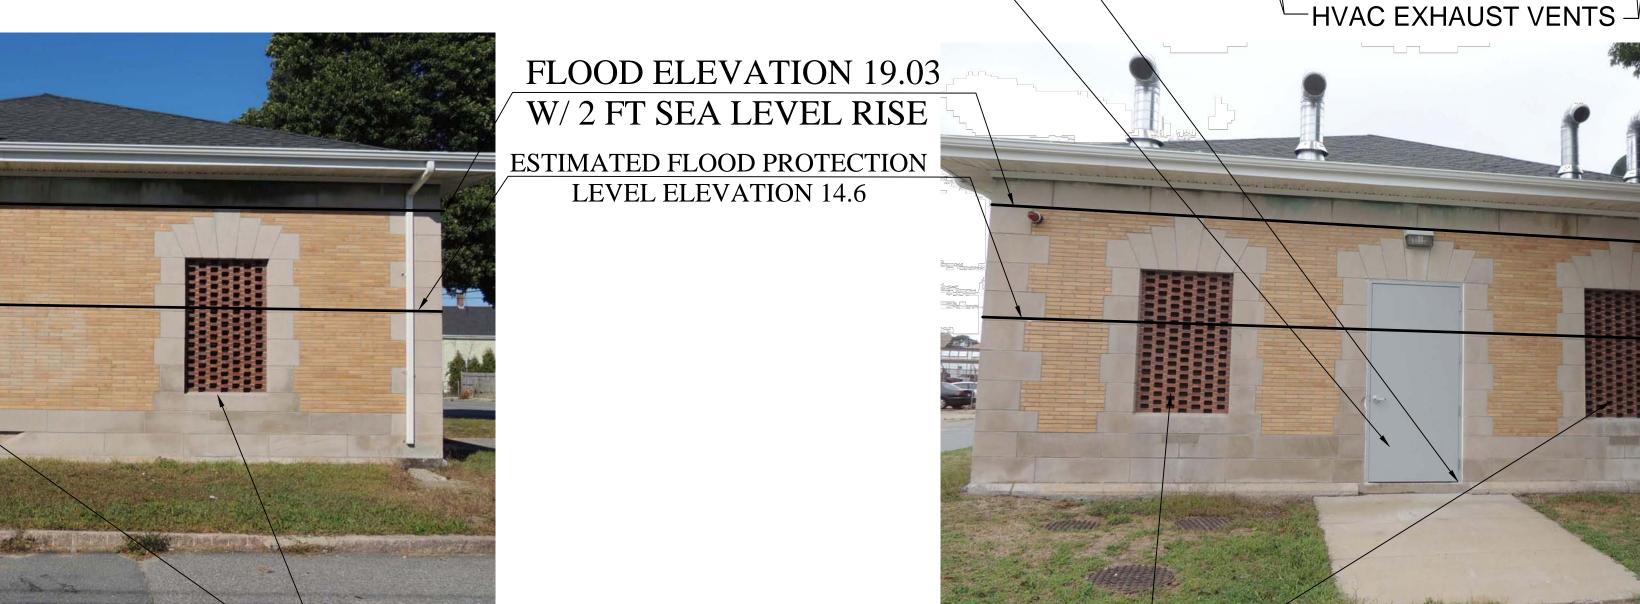
WEST ELEVATION

GRATE ELIMINATED AND PIT FILLED AND CAPPED IN **CONJUNCTION WITH** VENTING **RE-CONFIGURATION**

REPLACEMENT COMPLETE WITH HEAVY DUTY FLOOD-PROOF HATCH AND **HARDWARE**

MAIN ENTRY DOOR REPLACED WITH NEW FIBERGLASS FLOOD-RESISTANT DOOR AND NEW ALUMINUM STOP LOG SYSTEM

EACH WINDOW HAS BEEN COMPLETELY BLOCKED WITH IN-FILL MASONRY ON THE INTERIOR SIDE IN LIEU OF EXTERIOR FLANGED INSERTS.

SCREEN ROOM DOOR REPLACED WITH NEW FIBERGLASS FLOOD-RESISTANT DOOR

NONE OF THE FLOODPROOFING MEASURES TO DATE ARE COMPLETELY WATERTIGHT NOR EXPECTED TO HANDLE SURGING CURRENTS OR DEBRIS COLLISION WITH THE BUILDING.

RELOCATE TEMPORARY GENERATOR PLUG AND PANEL TO ABOVE ELEVATION 19.03. (PENDING)

STORY POLE TO BE MOUNTED TO BUILDING WALL. (PENDING)
