RE: Nitsch Project #9972 209 Theodore Rice Blvd Test Pit Results New Bedford, MA

City/Town of New Bedford
Form 11 - Soil Suitability Assessment for On-Site Sewage Disposal

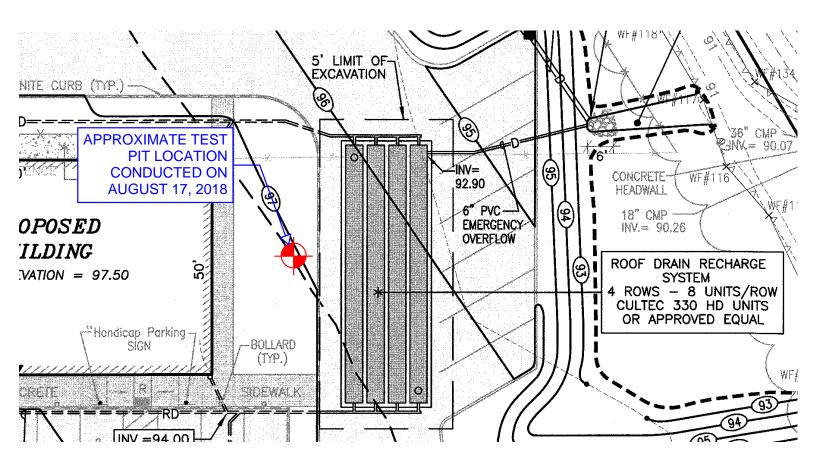
Additional Notes: No verying or standing water was observed, Moist soil was observed in the area of mottles near the bottom of excavation, signs of a perched not considered ESHOW. Top elevation of excavation was provided by the contractor.

I arrived at the site at 10:00am on August 17, 2018 and conducted a soil evaluation of the excavation. The site contractor informed us that the top elevation of the excavation was at approximate elevation 96.5 and the bottom elevation of the excavation was at approximate elevation 89.5. The contractor used a laser level to obtain the elevations. I concluded that the excavation consisted of 71-inches of fill material over a 2-inch buried organic layer (A Horizon) followed by 17-inches of a naturally occurring loamy sand material. Redoximorphic features, and moist soils, were observed at a depth of 86-inches within the naturally occurring loamy sand material. These features indicate the presence of an estimated seasonal high groundwater table (ESHGW) at this depth. This information correlates to an approximate elevation of 89.3 for ESHGW. Please refer to the enclosed test pit log for additional information.
