DRAINAGE SUMMARY

TIRE REPAIR FACILITY 956 – 958 BROCK AVENUE

STORMWATER OPERATION & MAINTENANCE PLAN

PROJECT: Tire Repair Facility
956-958 Brock Avenue
New Bedford, MA 02744

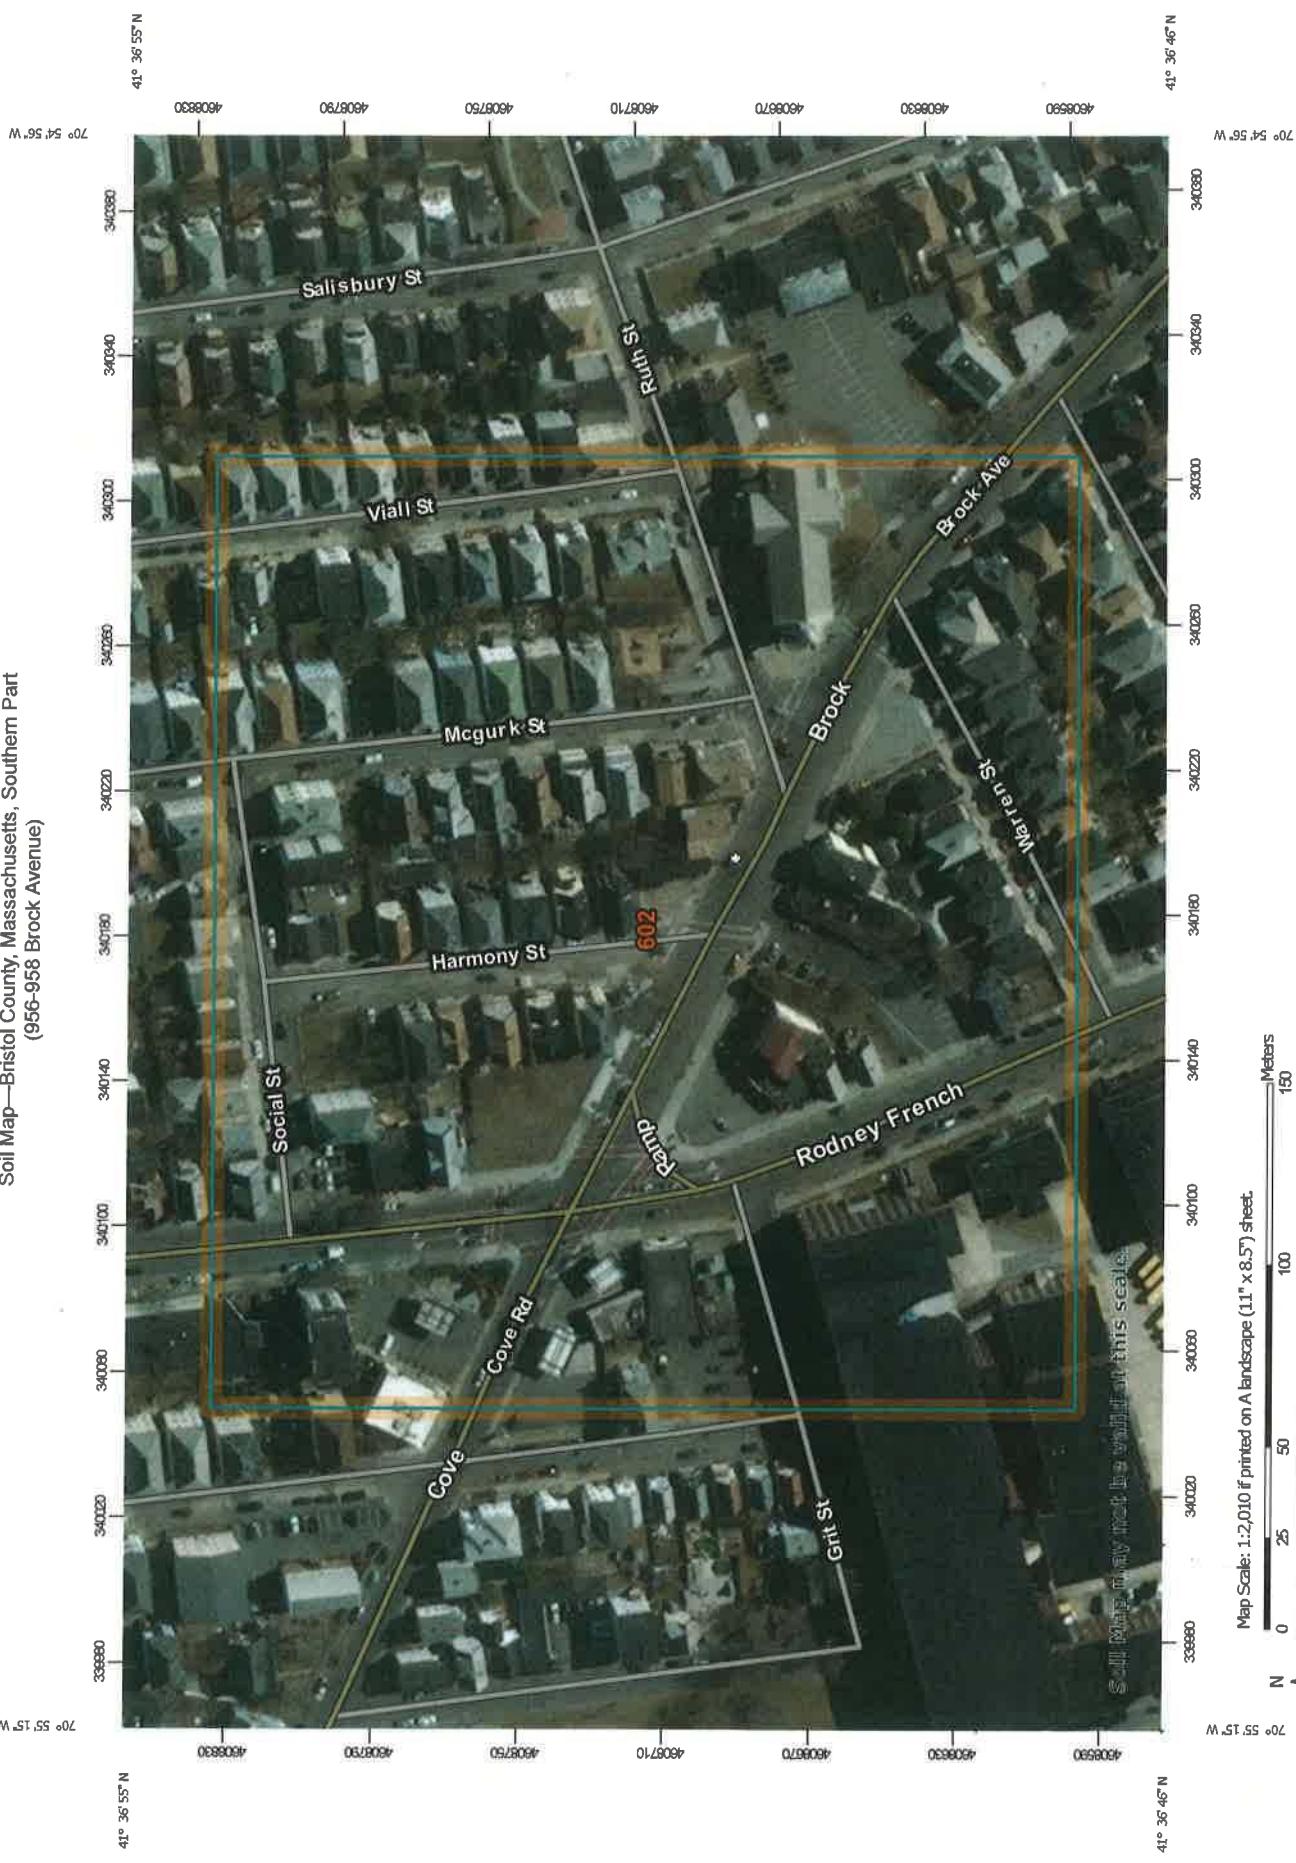
Soil Map—Bristol County, Massachusetts, Southern Part
(956-958 Brock Avenue)

Soil Survey Area: Bristol County, Massachusetts, Southern Part
Survey Area Data: Version 11, Oct 6, 2017

Map Unit Symbol	Map Unit Name	Acres In AOI	Percent of AOI
602	Urban land	15.4	100.0%
Totals for Area of Interest		15.4	100.0%

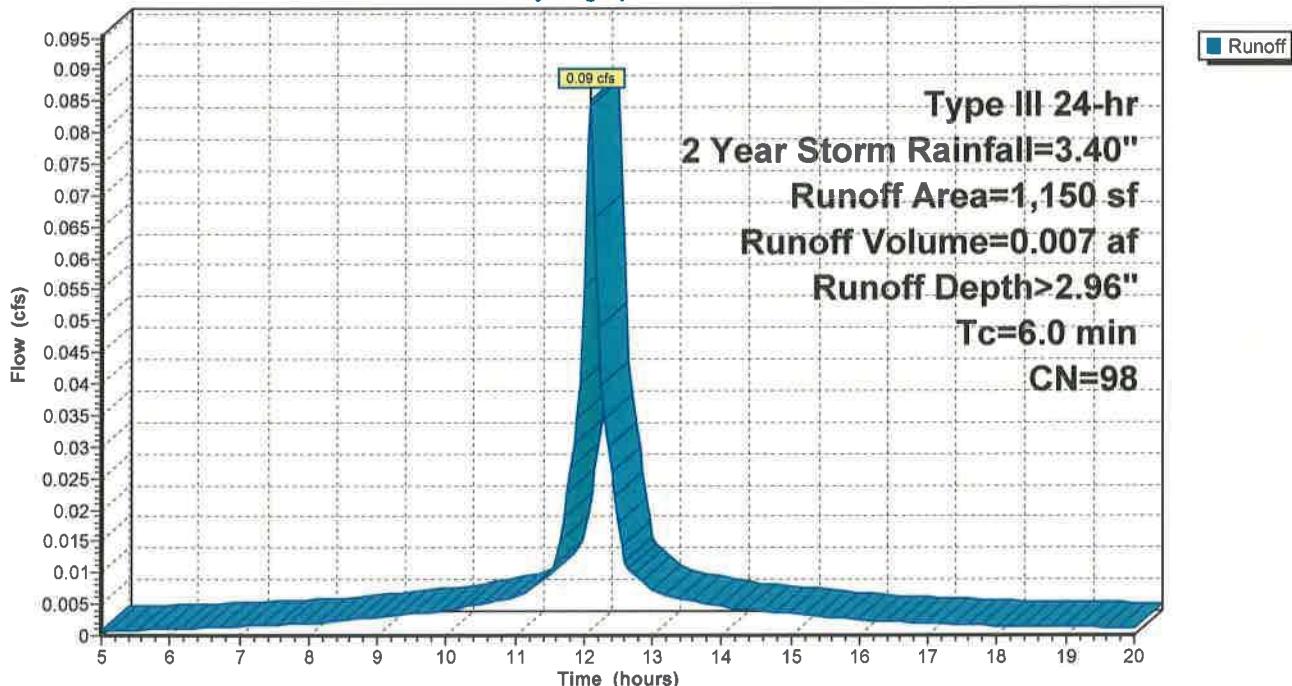
Subcatchment D-1: Storage Area**Hydrograph**

Summary for Subcatchment D-1: Storage Area

Runoff = 0.09 cfs @ 12.09 hrs, Volume= 0.007 af, Depth> 2.96"

Runoff by SCS TR-20 method, UH=SCS, Time Span= 5.00-20.00 hrs, dt= 0.05 hrs
Type III 24-hr 2 Year Storm Rainfall=3.40"

Area (sf)	CN	Description
* 1,150	98	Impervious
1,150		100.00% Impervious Area

Tc (min)	Length (feet)	Slope (ft/ft)	Velocity (ft/sec)	Capacity (cfs)	Description
6.0				0.09	Direct Entry, AB

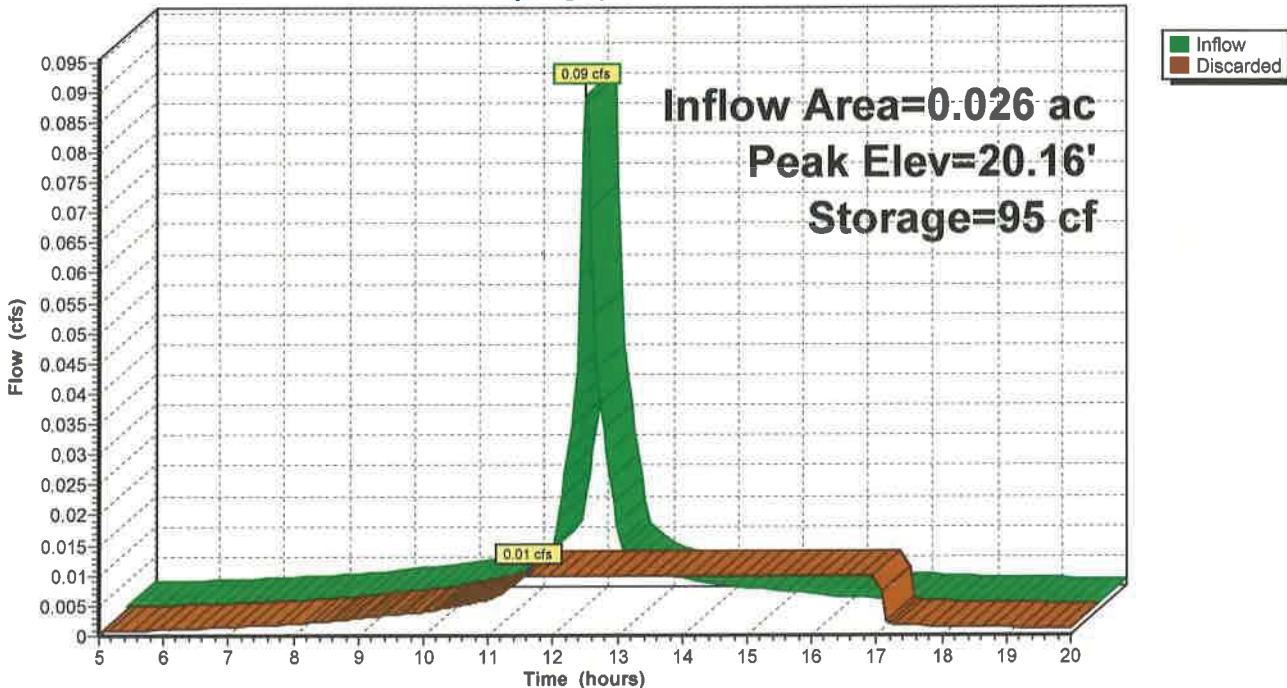
Summary for Pond 1P: Recharge Strip

Inflow Area = 0.026 ac, 100.00% Impervious, Inflow Depth > 2.96" for 2 Year Storm event
 Inflow = 0.09 cfs @ 12.09 hrs, Volume= 0.007 af
 Outflow = 0.01 cfs @ 11.60 hrs, Volume= 0.007 af, Atten= 88%, Lag= 0.0 min
 Discarded = 0.01 cfs @ 11.60 hrs, Volume= 0.007 af

Routing by Stor-Ind method, Time Span= 5.00-20.00 hrs, dt= 0.05 hrs
 Peak Elev= 20.16' @ 12.69 hrs Surf.Area= 0 sf Storage= 95 cf

Plug-Flow detention time= 64.8 min calculated for 0.007 af (100% of inflow)
 Center-of-Mass det. time= 64.4 min (802.4 - 738.0)

Hydrograph

The HydroCAD analysis for this drainage indicates that the trench can intercept and retain 100% of the surface runoff for storms up to and exceeding the 2 year event (3.4" of rainfall in 24 hours). This recharge coupled with the reduced lot coverage results in a significant reduction in stormwater runoff that currently drains into the City system.

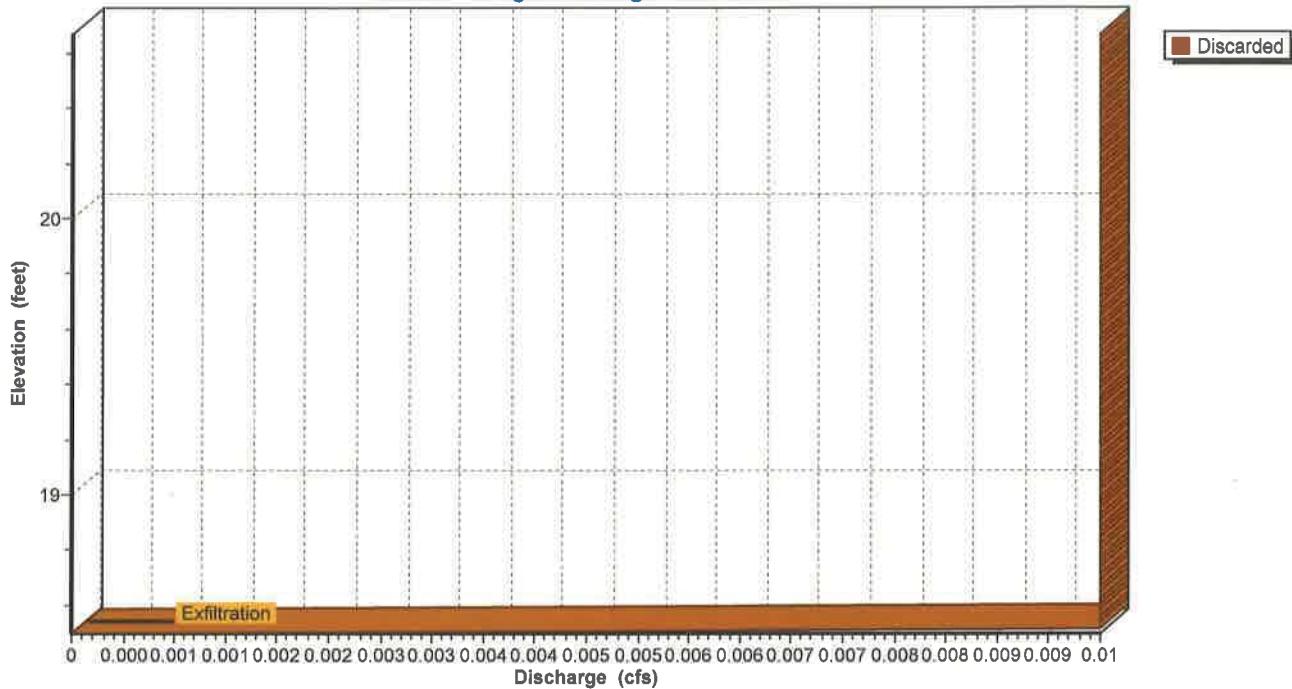
Pond 1P: Recharge Strip**Stage-Discharge**

Volume	Invert	Avail.Storage	Storage Description
#1	18.50'	124 cf	Custom Stage Data Listed below
