RE: Notice of Intent and Request for Public Hearing
New Bedford Business Park Upgrades Project
Flaherty Drive, New Bedford, MA

NEW BEDFORD BUSINESS PARK UPRADES

NOTICE OF INTENT

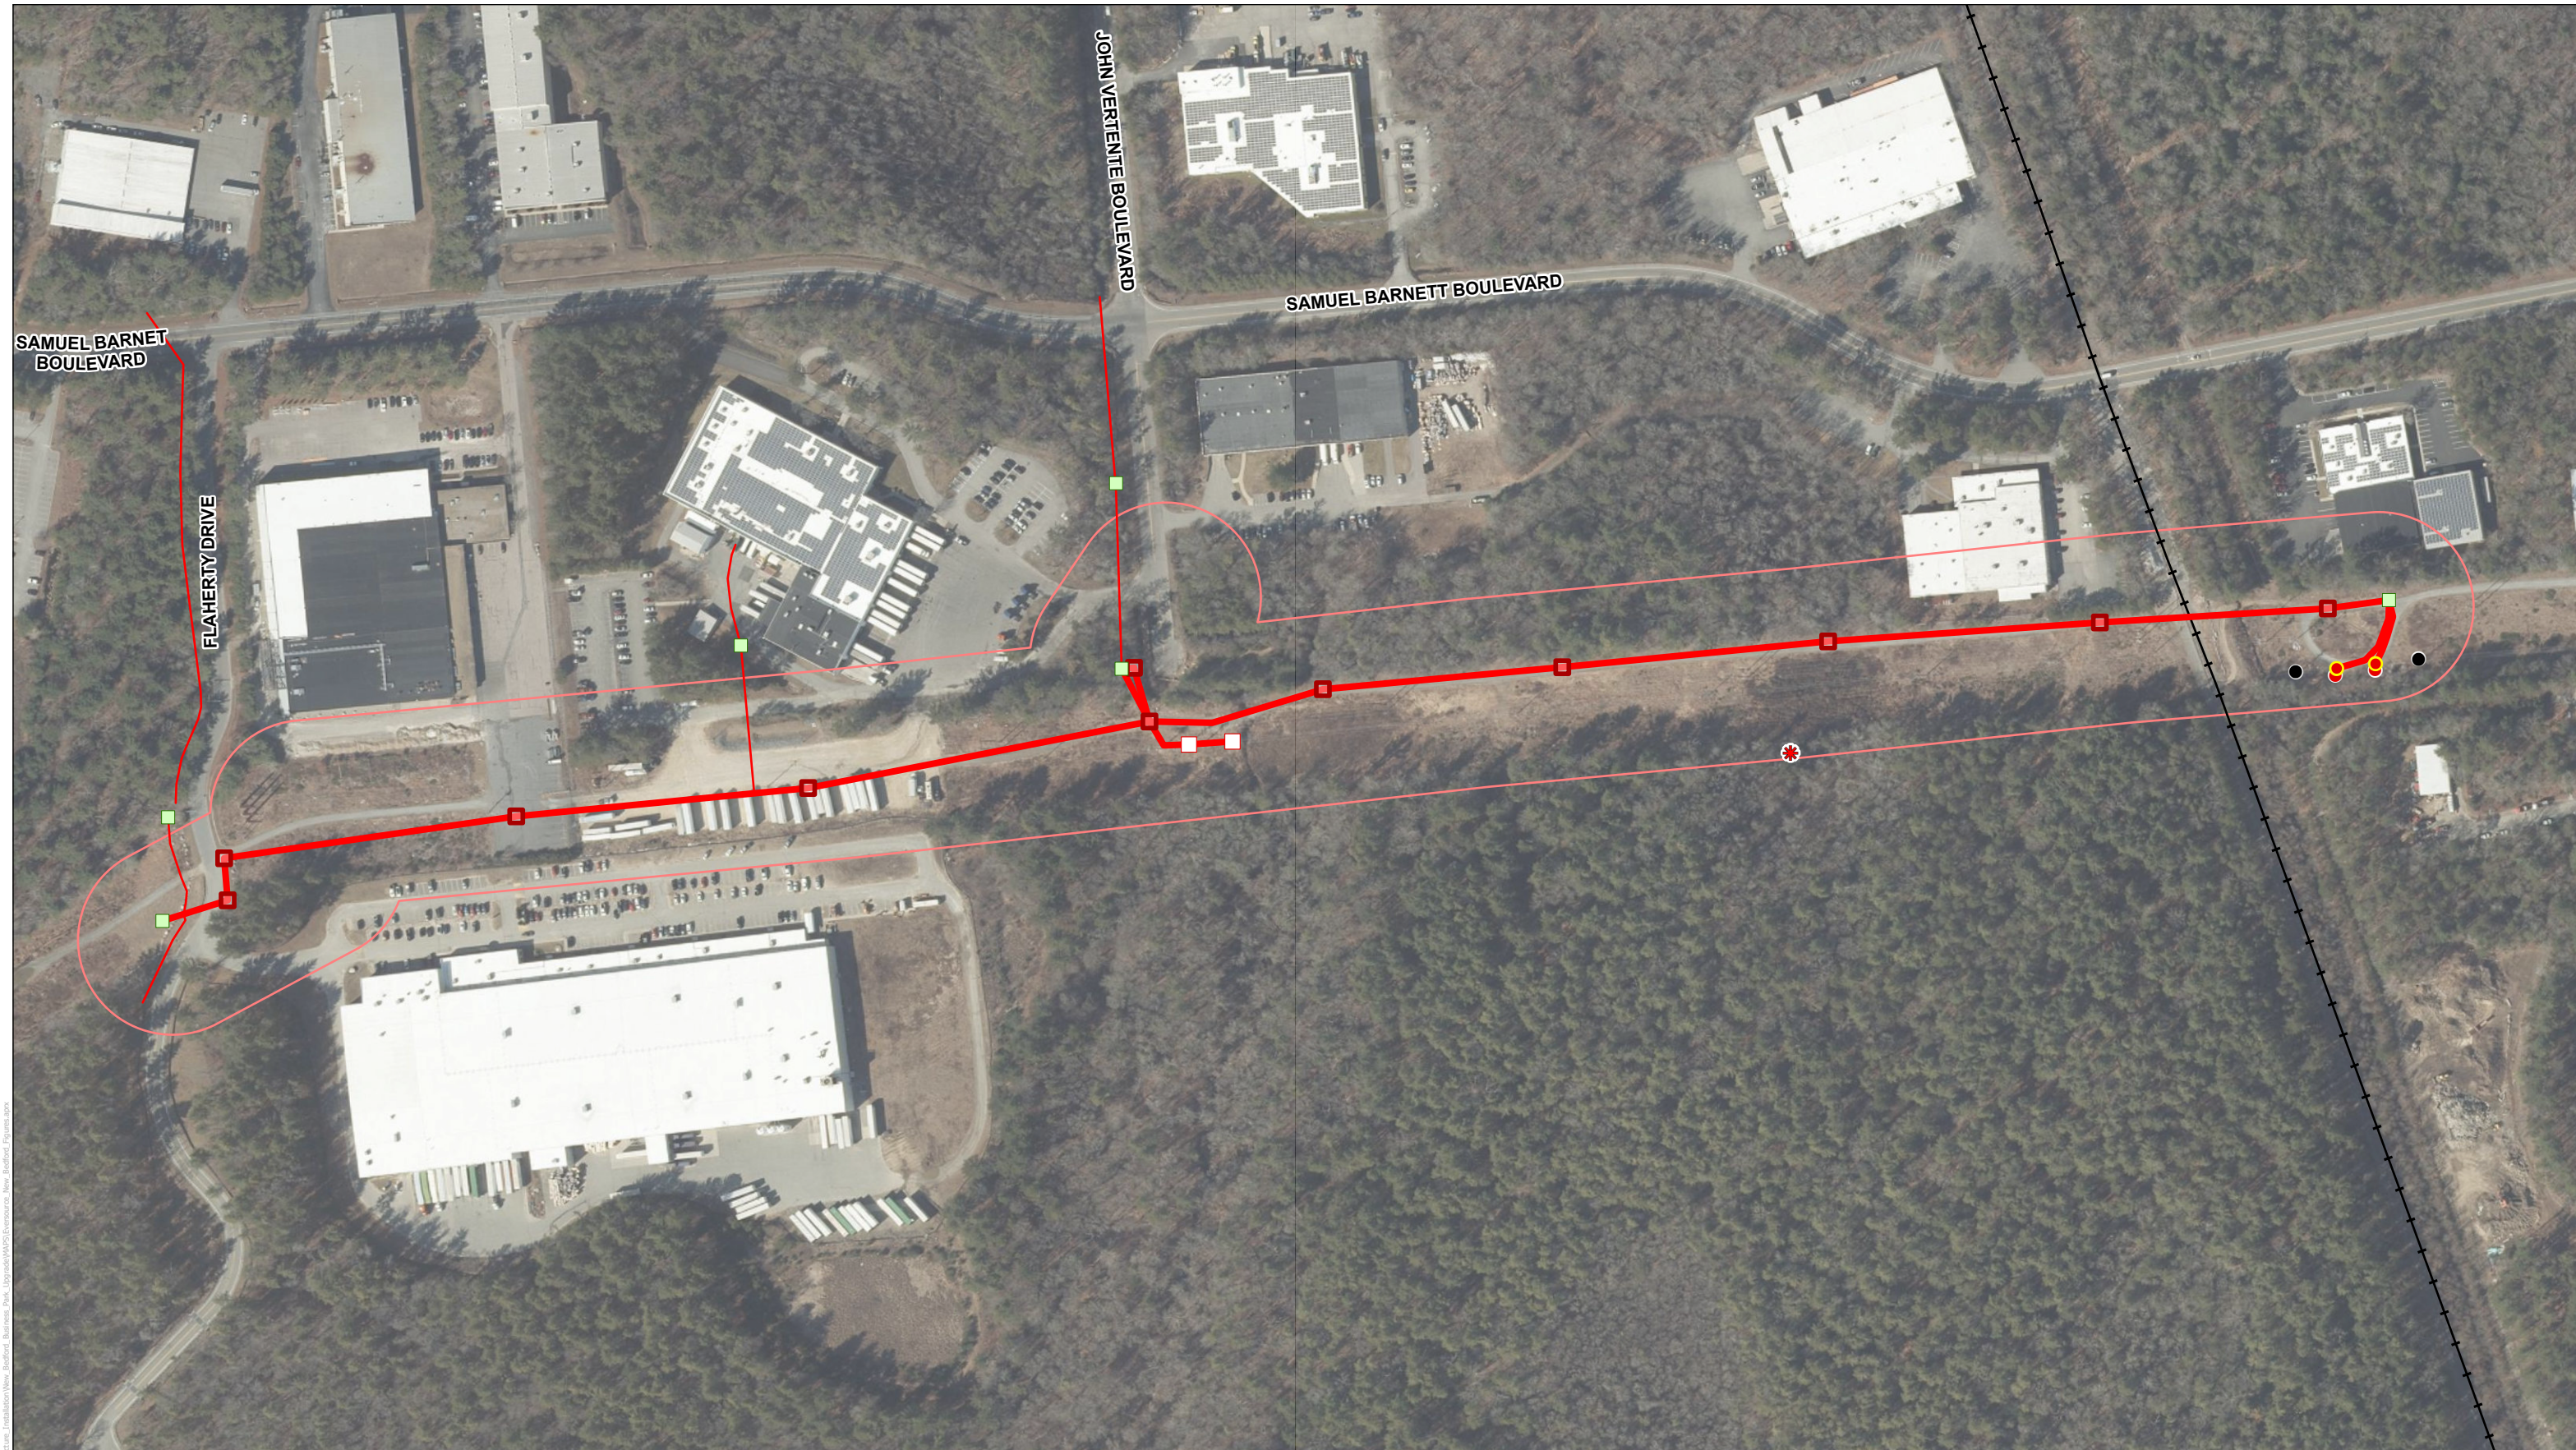
- Existing Structure
- Proposed Structure
- Proposed Riser Pole
- Existing Manhole
- Proposed Manhole
- Padmounted Switch Box Pad
- * Certified Vernal Pool
- ☼ Potential Vernal Pool (Not within map view)
- Existing Ducts, Concrete Encased
- Proposed Ducts, Concrete Encased
- Railroad
- Area Of Investigation
- Rare Species (Not within map view)
- Area of Environmental Concern (Not within map view)
- Outstanding Resource Waters (Not within map view)

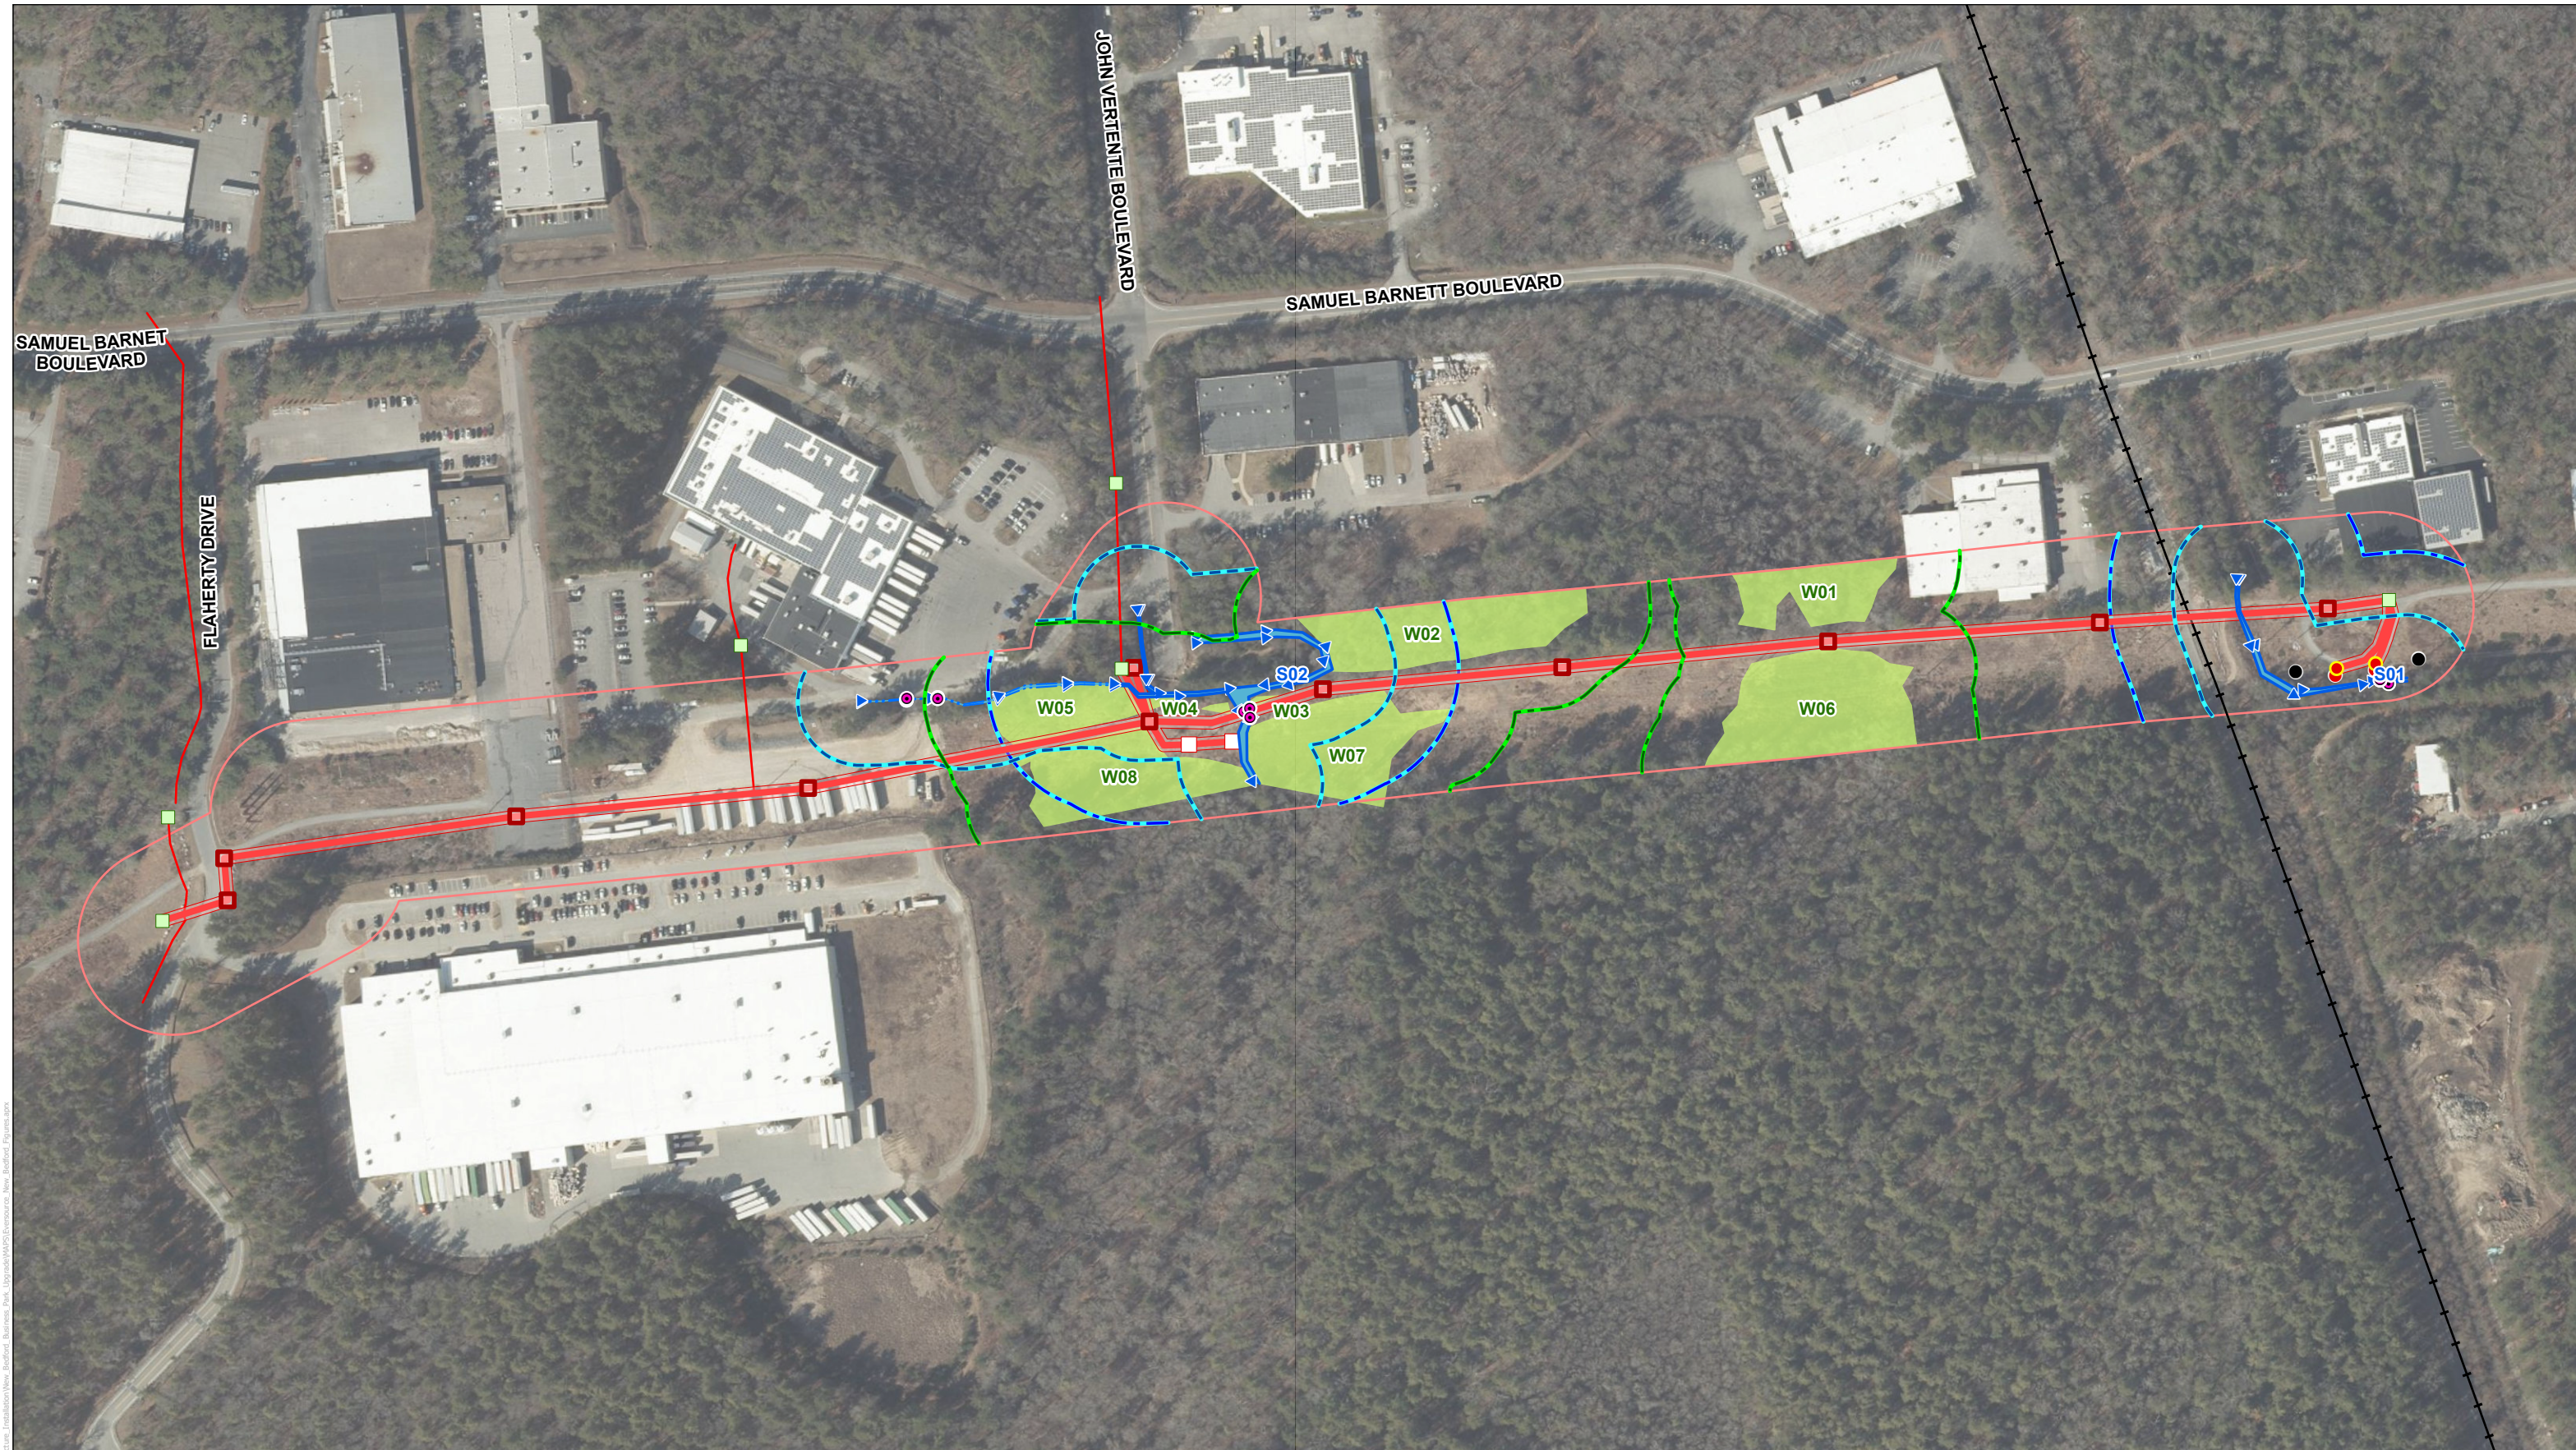
- Existing Structure
- Proposed Structure
- Proposed Riser Pole
- Existing Manhole
- Proposed Manhole
- Padmounted Switch Box Pad
- Culvert
- Existing Ducts, Concrete Encased
- Proposed Ducts, Concrete Encased
- Railroad
- 100' Buffer to BW
- 100' Buffer to Bank
- 200' Riverfront Area
- Delineated Intermittent Watercourse
- Delineated Perennial Watercourse
- Open Water
- Field Delineated Wetland
- Area Of Investigation
- 20' Disturbance Area

Stream S02 has an existing culvert under the access road within the ROW that has failed. As part of this project, Eversource would replace the culvert in-kind and restore the access road so vehicles can cross without impacting the stream.

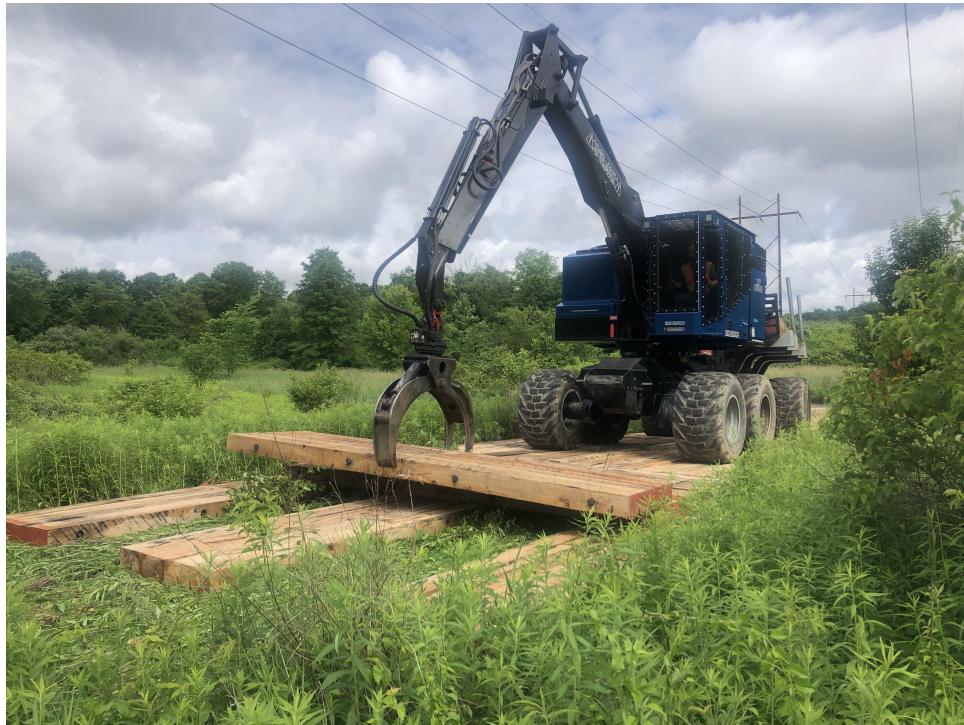
**CONSTRUCTION MAT
(WETLAND CROSSING)**

1. CONSTRUCTION MAT DIMENSIONS OF 12'x4'x8", 16'x4'x8" OR OTHER TO BE USED.

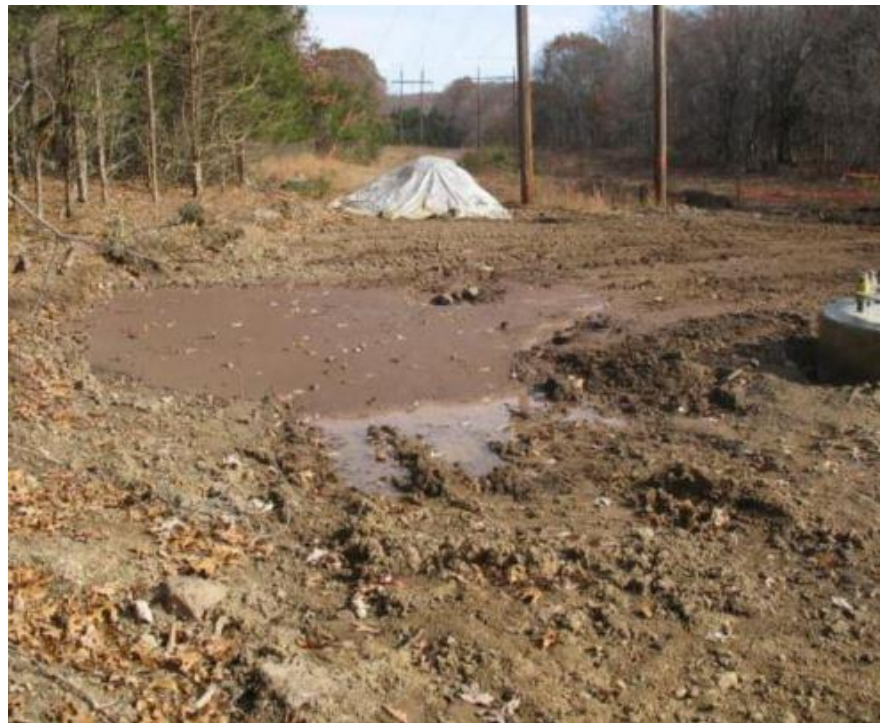
SOIL STOCKPILE MANAGEMENT

CONTAMINATED SOILS MUST BE ON AND COVERED WITH POLYETHYLENE SHEETING TO LIMIT EROSION. SHEETING NOT REQUIRED FOR NON-CONTAMINATED SOILS IF SEDIMENTATION AND EROSION CONTROLS COMPLETELY ENCLOSE STOCKPILE.

SANDBAG EACH BALE IN PAVED AREAS (TYP)
STRAW BALES AND/OR SILT FENCE

BALES TO BUTT TOGETHER
2 STAKES EACH BALE IN UNPAVED AREAS (TYP)

1. TOPSOIL SEGREGATION TO BE USED IN WETLANDS AND AGRICULTURAL LAND.
2. IF WORKING WITHIN WETLANDS, MATTING BENEATH STOCKPILES MUST BE LINED OR UNDERLAIN BY GEOTEXTILE FABRIC.
3. STOCKPILES SHOULD BE ENCLOSED BY STRAW BALES OR WATTLES.

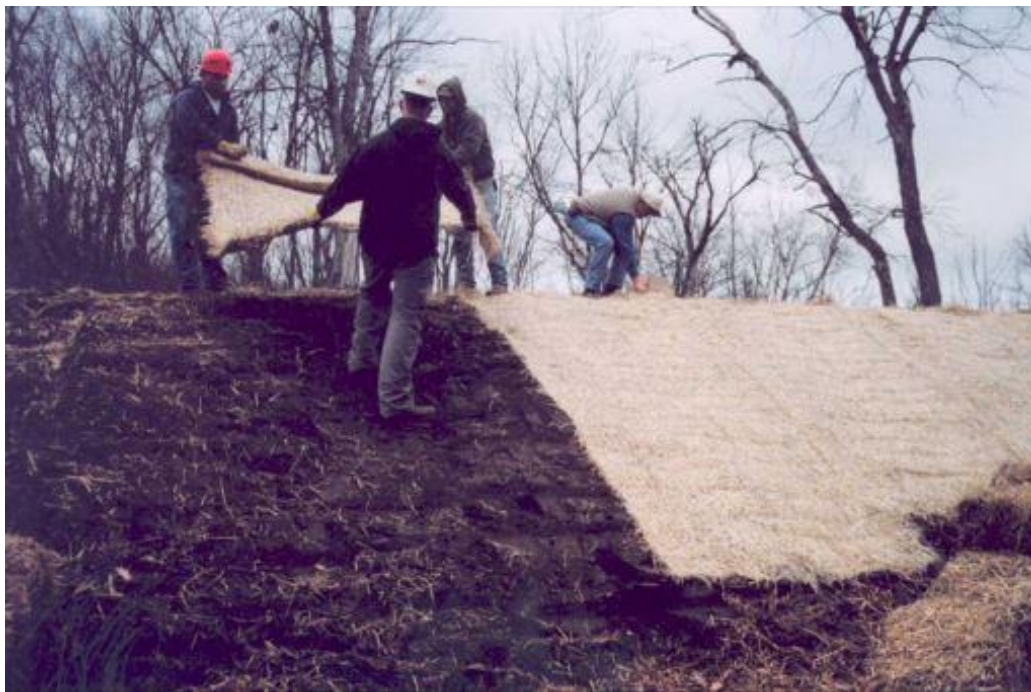
EROSION CONTROL BLANKETS

1. EROSION CONTROL BLANKET SHOULD BE INSTALLED VERTICALLY DOWNSLOPE.
2. STAKES/STAPLES SHOULD BE PLACED NO MORE THAN 3 FT. APART VERTICALLY, AND 1 FT. APART HORIZONTALLY.
3. SLOPE SURFACE SHOULD BE FREE OF STICKS, ROCKS, AND OTHER OBSTRUCTIONS.
4. BLANKETS SHOULD BE ROLLED OUT LOOSELY AND STAKED/STAPLED TO MAINTAIN DIRECT SOIL CONTACT. DO NOT STRETCH THE BLANKETS.
5. USE OF PRODUCTS WITH PLASTIC AND/OR NYLON NETTING IS PROHIBITED.

Upon completion of the Project, all disturbed areas will be seeded with a native seed mix. The site will be stabilized with biodegradable erosion control blankets, with a layer of straw and seed underneath. The seed mix will be applied at a rate specified by the manufacturer.

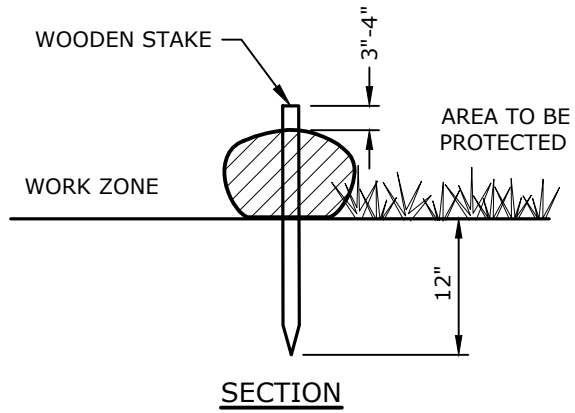
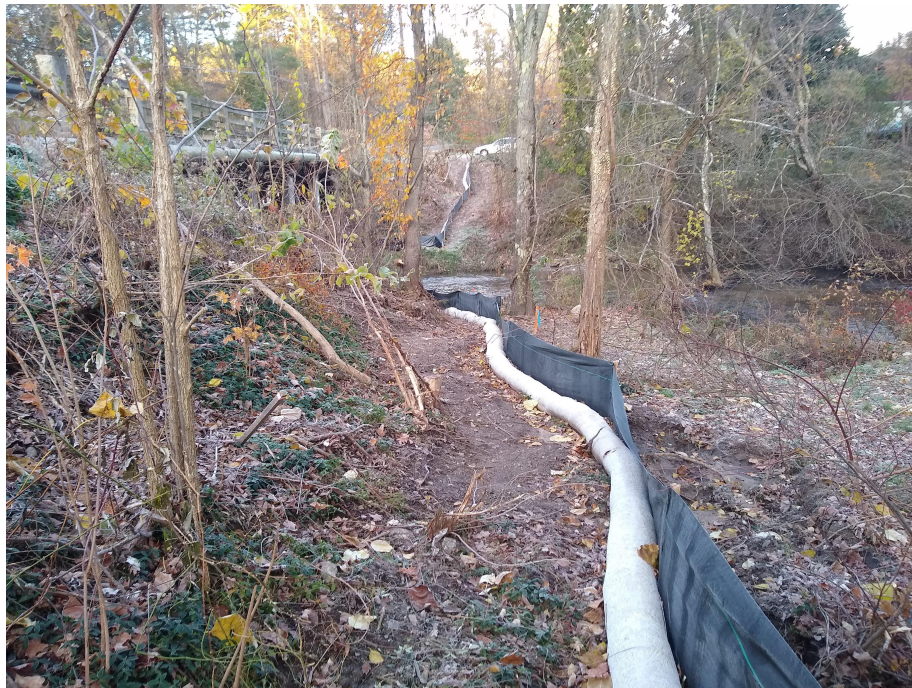
STRAW WATTLE/MULCH LOG

1. USE OF PRODUCTS WITH PLASTIC AND/OR NYLON NETTING IS PROHIBITED.

Prior to any ground disturbance, an approved erosion control barrier, specifically straw wattles, will be installed around the limit of disturbance of the work area and installed around the base of stockpiles and other erosion prone areas. The barriers will be staked into the substrate to prevent underflow. If sediment has accumulated to a depth which impairs proper functioning of the barrier, it will be removed by hand or by machinery operating upslope of the barriers. This material will be either reused in the Project area or disposed of at a suitable offsite location. Any damaged sections of the barrier will be repaired or replaced immediately upon discovery.

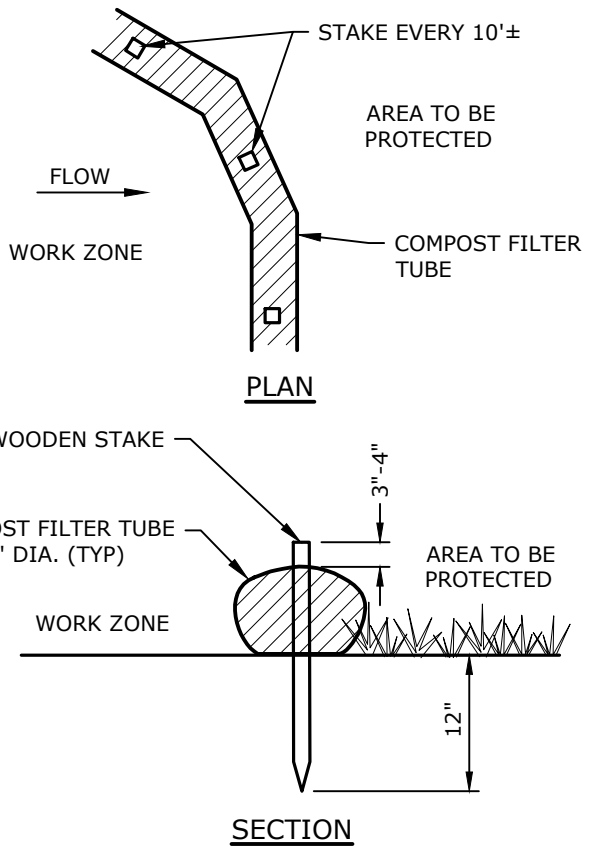
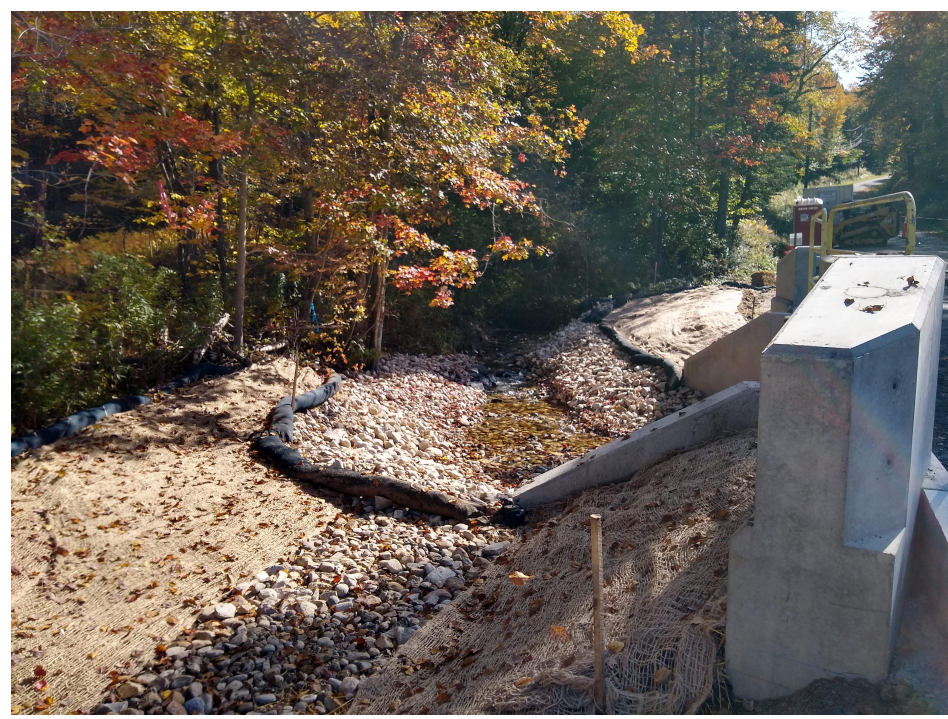
COMPOST FILTER TUBE	
DATE:	12/2021
SCALE:	NO SCALE
FIGURE:	A28

- NOTES:**
1. TUBES FOR COMPOST FILTERS SHALL BE JUTE MESH OR APPROVED BIODEGRADABLE MATERIAL.
 2. TAMP TUBES IN PLACE TO ENSURE GOOD CONTACT WITH SOIL SURFACE.
 3. PROVIDE 3' MINIMUM OVERLAP AT ENDS OF TUBES TO JOIN IN A CONTINUOUS BARRIER AND MINIMIZE UNIMPEDED FLOW.
 4. COMPOST MATERIAL SHALL BE DISPERSED ON SITE WITHIN LIMITS OF WORK, AS DIRECTED.
 5. INSTALL TUBES ALONG CONTOURS AND PERPENDICULAR TO SHEET OR CONCENTRATED FLOW.
 6. DO NOT INSTALL IN PERENNIAL, EPHEMERAL, OR INTERMITTENT STREAMS.
 7. CONFIGURE TUBES AROUND EXISTING SITE FEATURES TO MINIMIZE SITE DISTURBANCE AND MAXIMIZE CAPTURE AREA OF STORMWATER RUN-OFF.

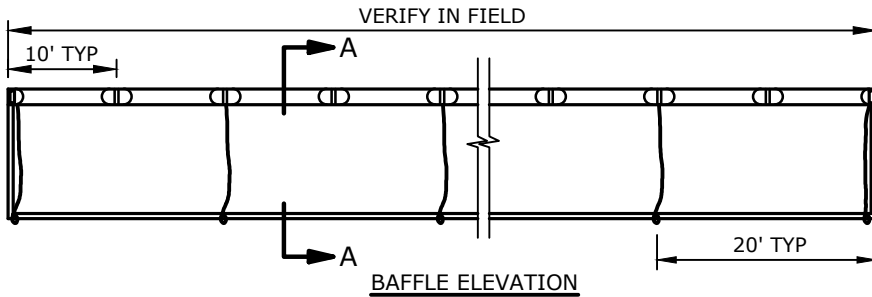
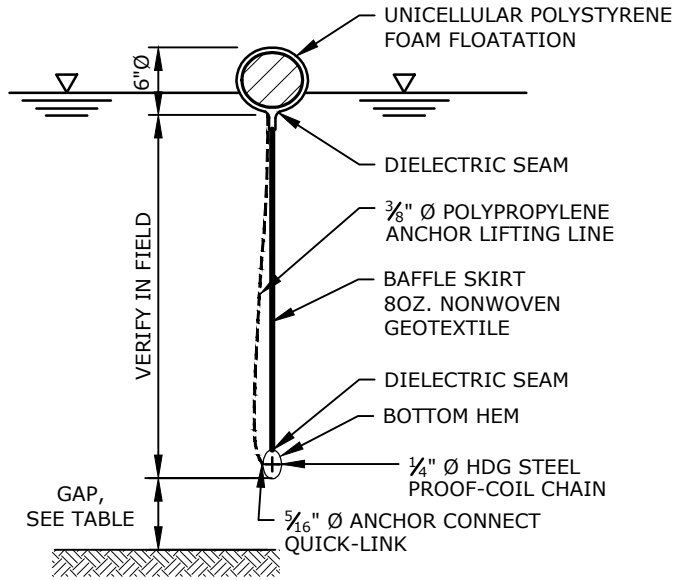
BAFFLE ELEVATION

<u>TYPE</u>	<u>DESCRIPTION</u>	<u>CONDITIONS</u>	<u>GAP (IN.)</u>
I	FLATWATER	CALM AND PROTECTED	0
II	LIGHTWEIGHT	SEMI-PROTECTED AREA, CURRENTS UP TO 2 FT/S	12
III	MIDDLEWEIGHT	EXPOSED AREA, CURRENTS UP TO 5 FT/S	12
IV	HEAVYWEIGHT	EXPOSED TO WIND, CURRENT, AND TIDES	0

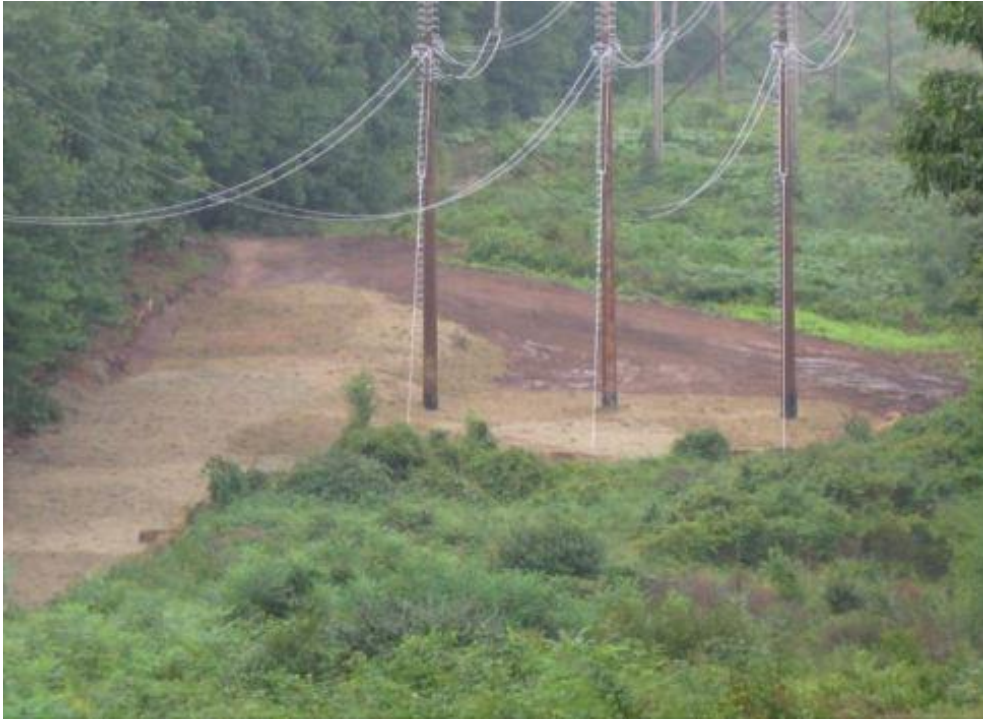
LOAM AND SEED	
DATE:	12/2021
SCALE:	NO SCALE
FIGURE:	A32

THE SEED MIX UTILIZED SHALL CONSIST OF QUICK GROWING, DROUGHT TOLERANT, NATIVE GRASSES, SUCH AS RYES. THE SEED MIX UTILIZED WITHIN THE BUFFER ZONE TO WETLAND RESOURCE AREAS MAY CONSIST OF QUICK GROWING, DROUGHT TOLERANT, NATIVE GRASSES BUT MUST CONTAIN AT LEAST 50% OF A NATIVE SEED MIX WITH HIGH HABITAT VALUE, SUCH AS ONES WHICH CONTAIN PERENNIAL SHRUBS, WILDFLOWERS. CONSULT WITH EVERSOURCE ENVIRONMENTAL LICENSING AND PERMITTING FOR PROJECT SPECIFIC REQUIREMENTS.

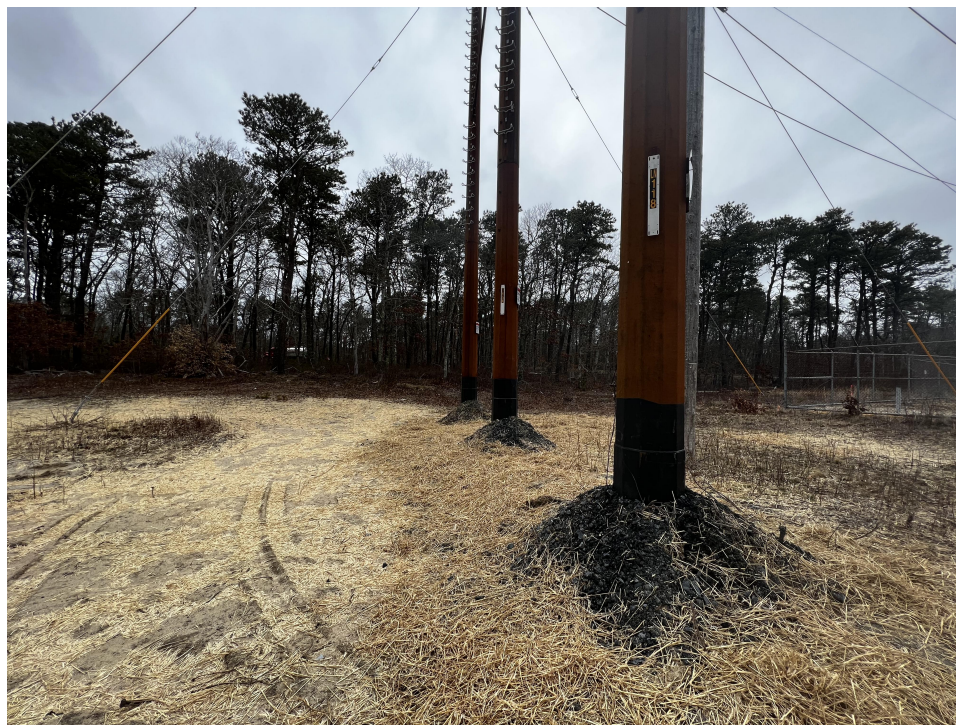
1. STRAW PRODUCTS ONLY; THE USE OF HAY OR HAY PRODUCTS IS STRICTLY PROHIBITED.
2. MULCH APPLICATION SHALL NOT EXCEED 1" IN THICKNESS.
3. WOOD CHIPS MAY BE SUBSTITUTED FOR STRAW MULCH SUBJECT TO EVERSOURCE ENVIRONMENTAL LICENSING AND PERMITTING APPROVAL.
4. CONSULT WITH EVERSOURCE ENVIRONMENTAL LICENSING AND PERMITTING FOR PROJECT SPECIFIC REQUIREMENTS.

LIMIT OF SOIL DISTURBANCE

STRAW MULCH

UNSTABLE SOILS

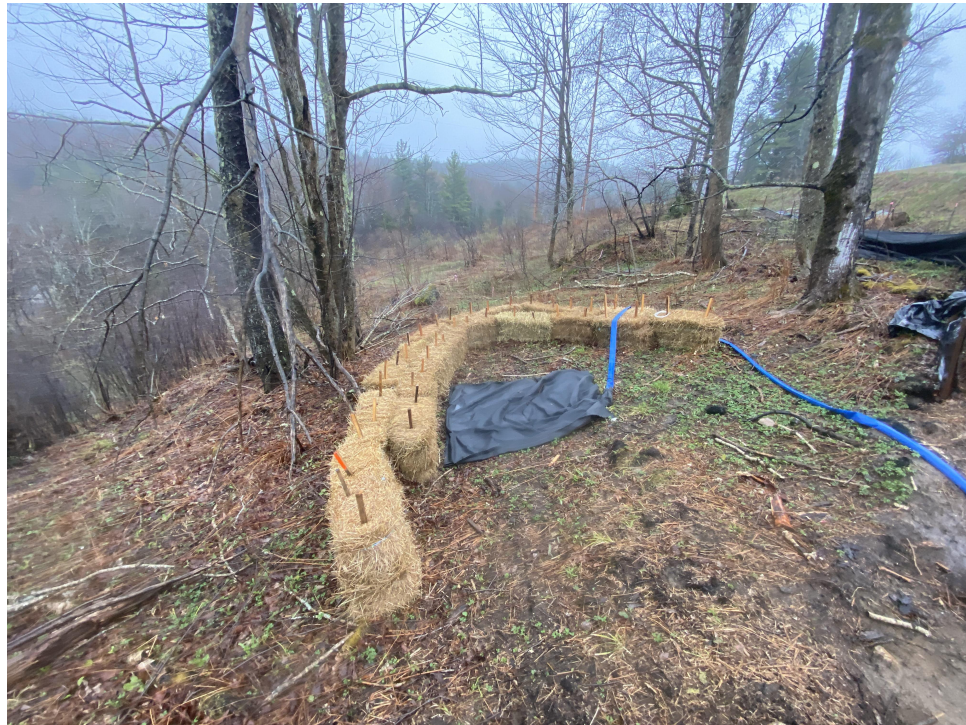
1. LOCATION OF SEDIMENT TRAP SUBJECT TO CONSULTATION WITH EVERSOURCE ENVIRONMENTAL LICENSING AND PERMITTING.
2. SEDIMENT TRAPS OR SETTLING BASINS SHALL BE USED FOR CONSTRUCTION DEWATERING.
3. DISCHARGE AWAY FROM WORK AREA/DEWATERING AREA.

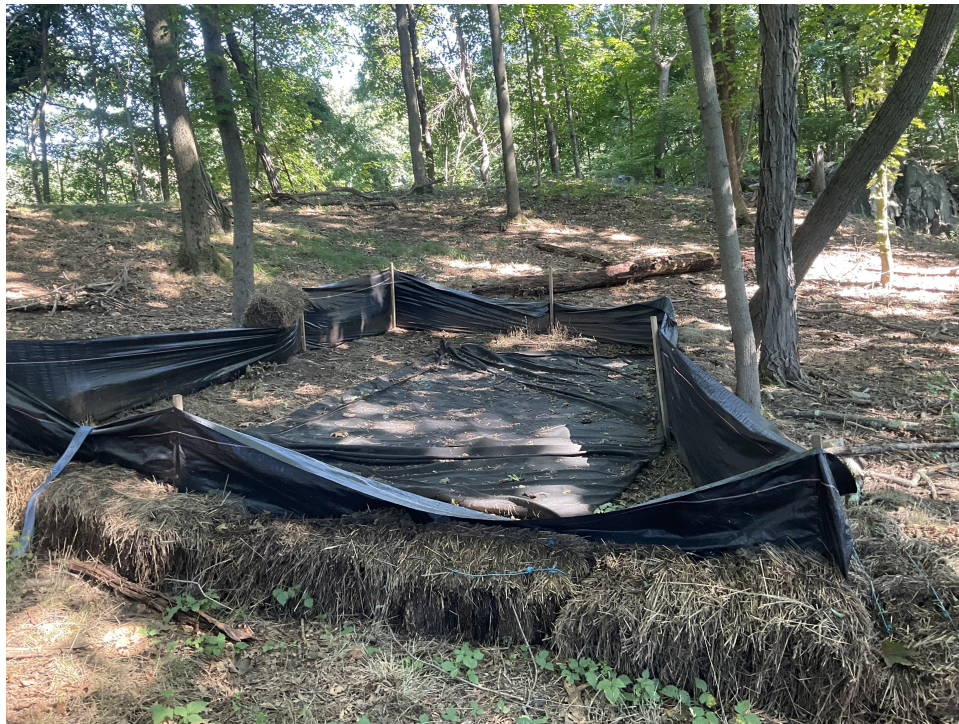
DEWATERING BASIN
(FILTER BAG)

PLACE FILTER BASINS IN A WELL-VEGETATED AREA, OUTSIDE OF WETLANDS WHENEVER PRACTICABLE.

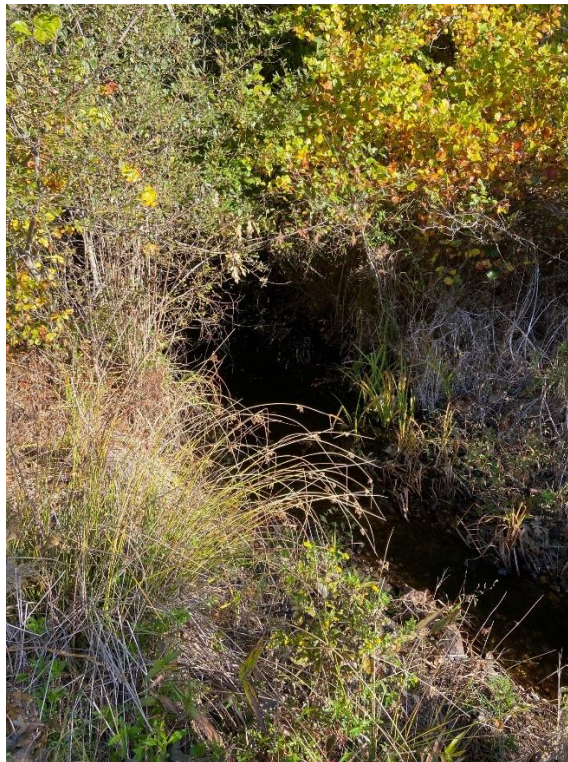
Upstream view of stream 1

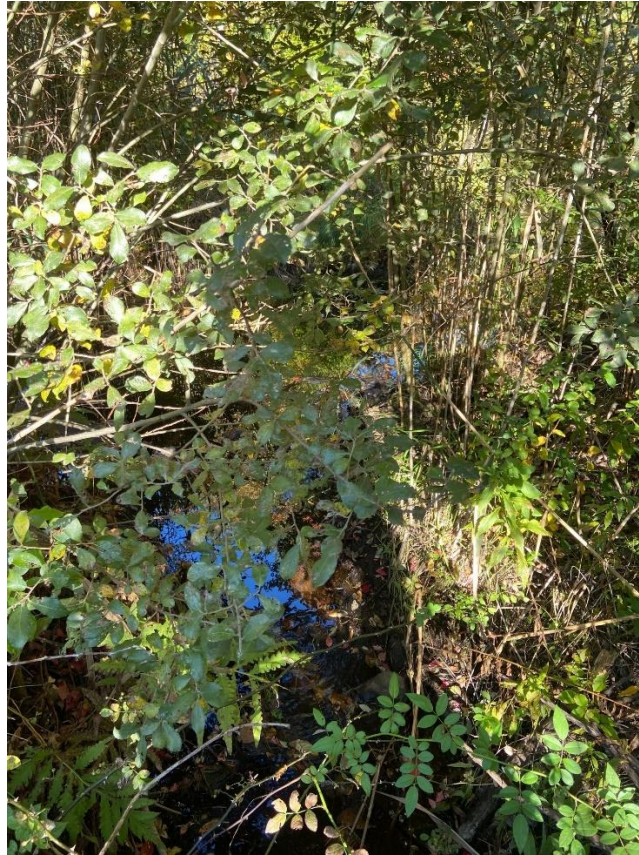
Upstream view of stream 2
